**Interim Report
to Investigation Report 52/18**

Serious Marine Casualty

**Allision between the container ship AKACIA
and a lock gate on the Kiel Canal
in Kiel-Holtenau on 19 February 2018**

18 February 2019

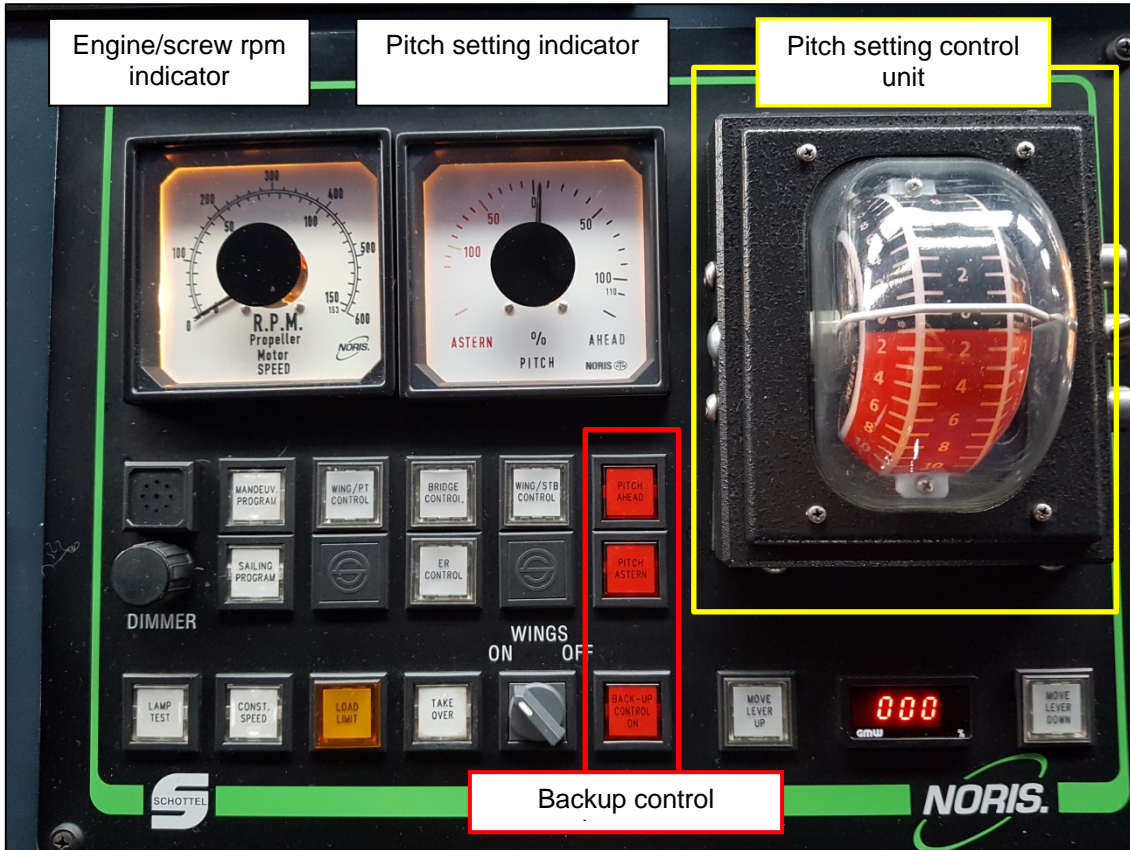
The master first tried, unsuccessfully, to cancel the given pitch by setting it to astern again. He then pressed the button to enable the backup steering. Although the illuminated push button indicated it was enabled, the master could not adjust the pitch using the PITCH ASTERN push button, which was intended for that purpose.

Figure 3: CPP system control panel

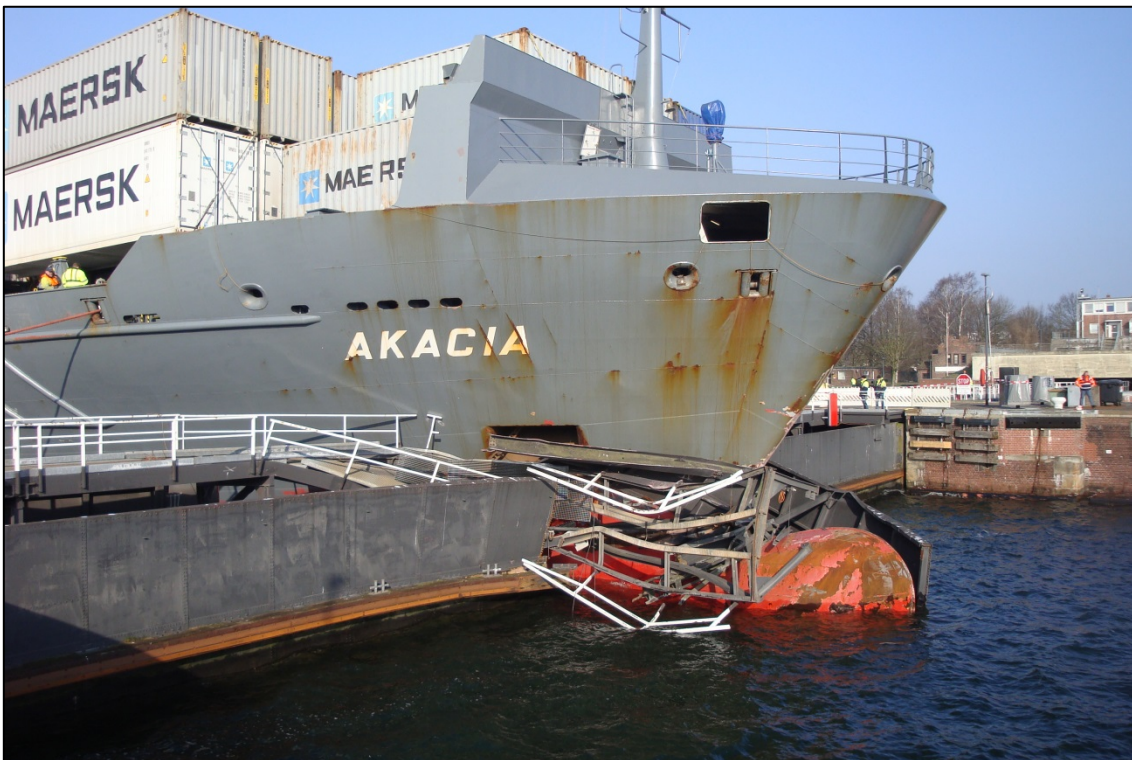
At 235358, shortly before the allision with the lock gate, the master once more ordered a crash-stop for the main engine. The allision with the Neue Südschleuse lock's seaward gate occurred at 235422 on 19 February 2018 at a speed of 8.1 kts. In the process, the AKACIA sailed several metres through the gate and damaged it severely. The ship also sustained heavy damage in the bow section. The bow thruster room was flooded. Nobody lost their life or was injured due to the allision. The water was not polluted.

Figure 4: The AKACIA and the damaged lock gate
