Bundesstelle für Seeunfalluntersuchung
Federal Bureau of Maritime Casualty Investigation
Federal Higher Authority subordinated to the Ministry
of Transport and Digital Infrastructure

Investigation Report 118/18

Less Serious Marine Casualty

Allision between VOS STONE and a wind turbine on 10 April 2018 in the Baltic Sea

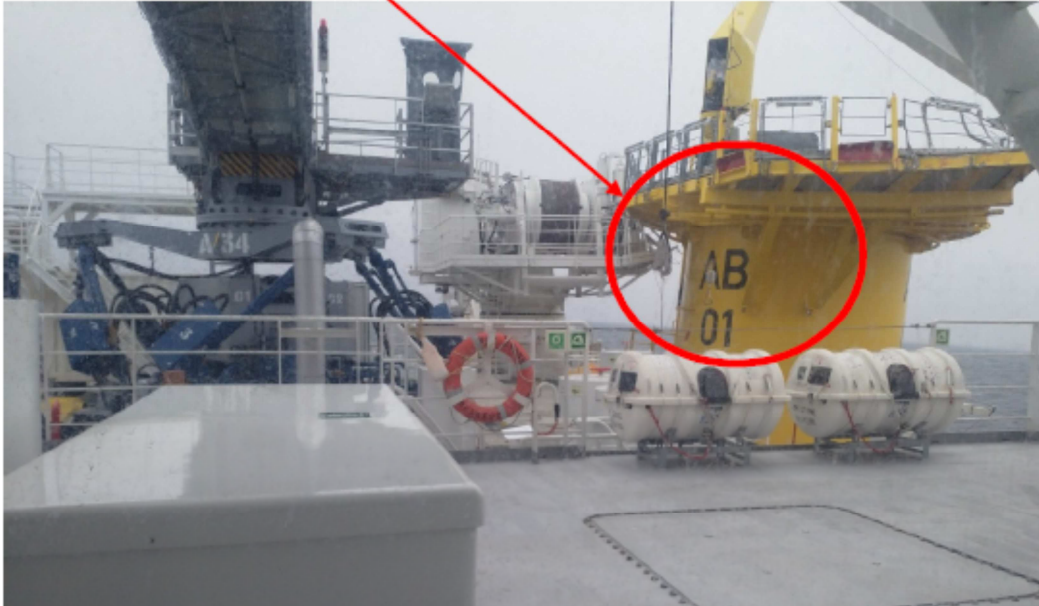
The evidence available suggests that there was no collision between the ship and the TP's actual primary structure but rather only between the external platform of the flange deck and bulkhead of the crew's cabins on the port side (see Figure 10 and Figure 11), and then subsequently with the handrails on the crane's maintenance platform. This is where the nitrogen cylinders for the crane's swell compensator are stored, resulting in damage to them and an ensuing release of nitrogen (see Figure 12). The handrails that were already bent caused damage to the TP's coating. As the ship continued to move forward, the swell caused her to heel to port and the rear side of the crane jib struck the outer edge of the flange deck, causing the flange to rotate anticlockwise.

Figure 10: Allision between the shipboard crane and flange deck

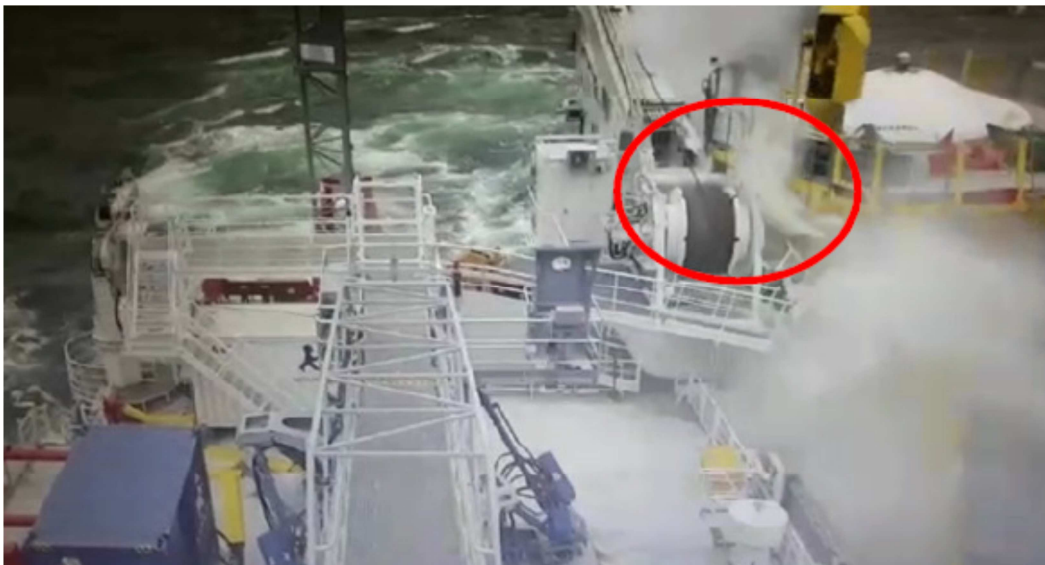
Figure 11: Damage to the nitrogen cylinder

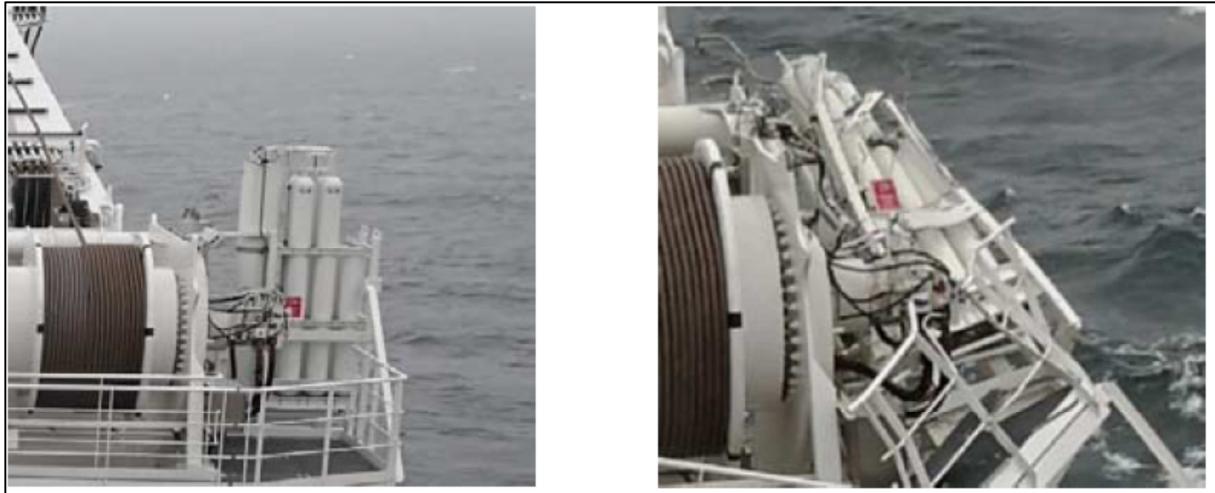
Figure 12: Shipboard crane before and after the collision

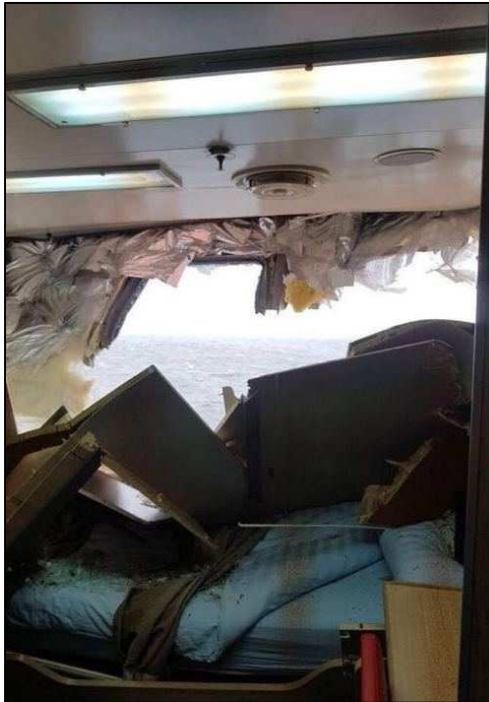
The VOS STONE's steward was cleaning the cabins when the accident happened. By coincidence, he was in the cabin that sustained a torn outer wall during the first collision. After the steward initially stated that he reportedly had no physical injuries and was merely in a state of shock, he later felt pain in one knee, as well as in his head and neck.

Figure 13: Damage to the outer wall of a cabin

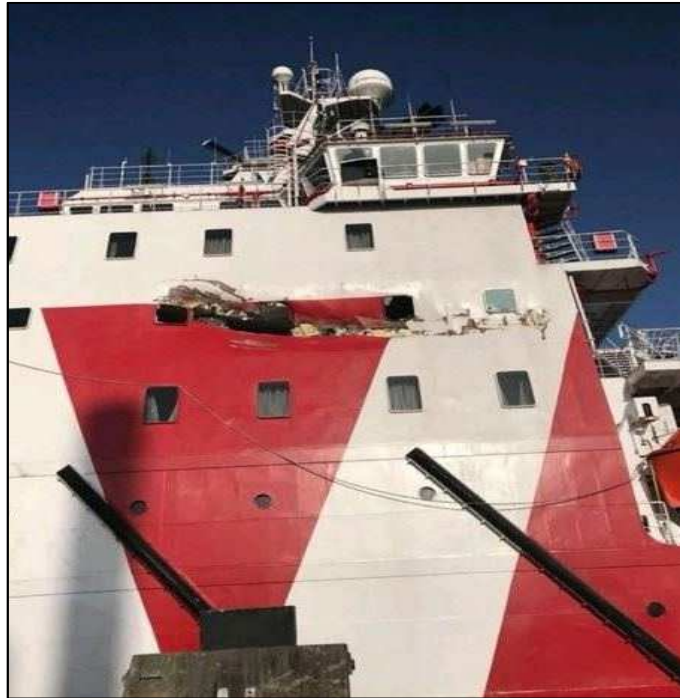
Figure 14: Damage to the superstructure

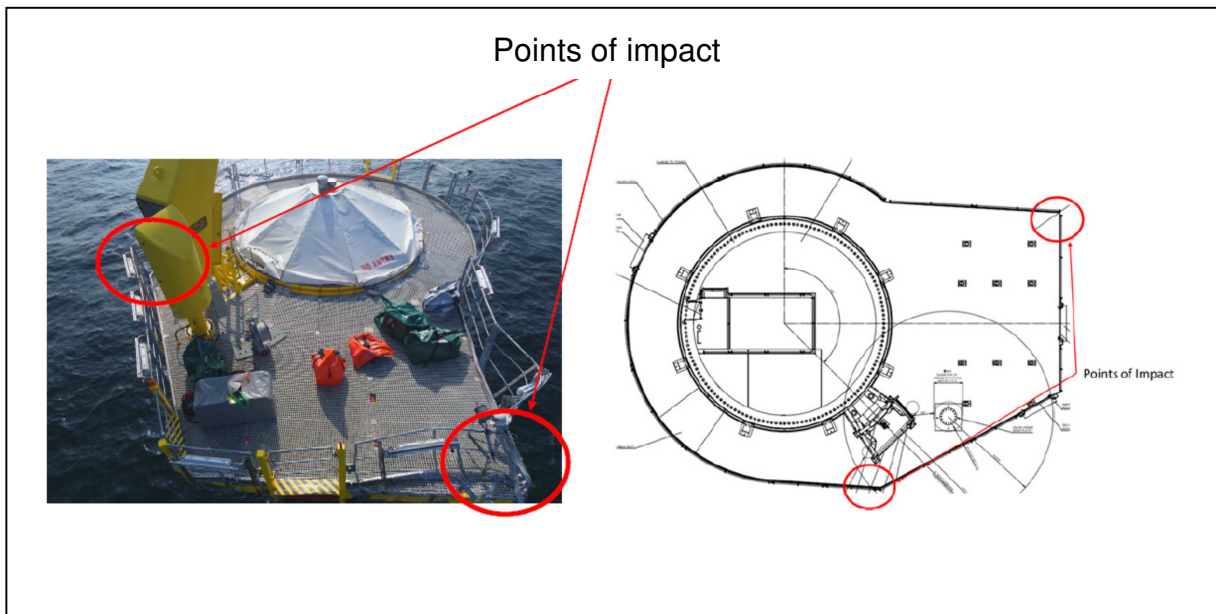
Figure 15: Points of impact on the platform

- 1102 VOS STONE's first allision (port side) with TP AB01 at about 2.1 kts (see Figure 15).

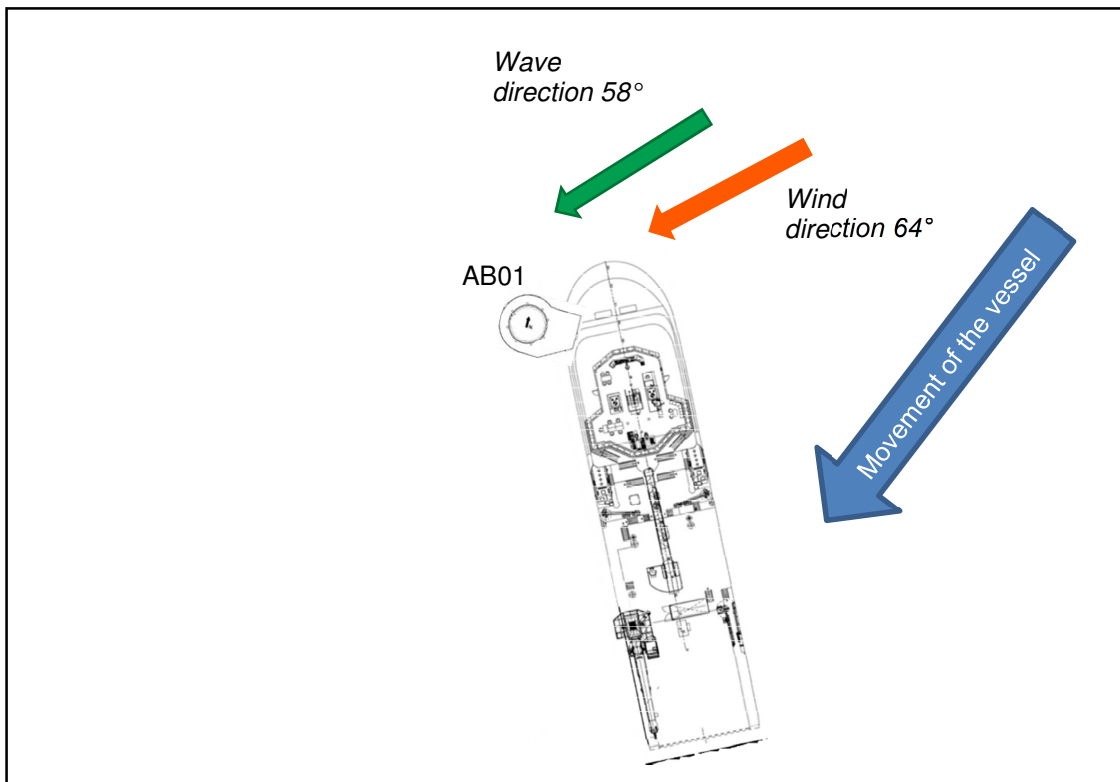
Figure 16 shows the ship's first allision (port side level with the cabins) with the TP. Although the thrusters had just been reenabled at this point, they did not have any effect. The VOS STONE's ahead speed was about 2.6 kts. The allision caused the platform to rotate about 90° anticlockwise.

Figure 16: First allision

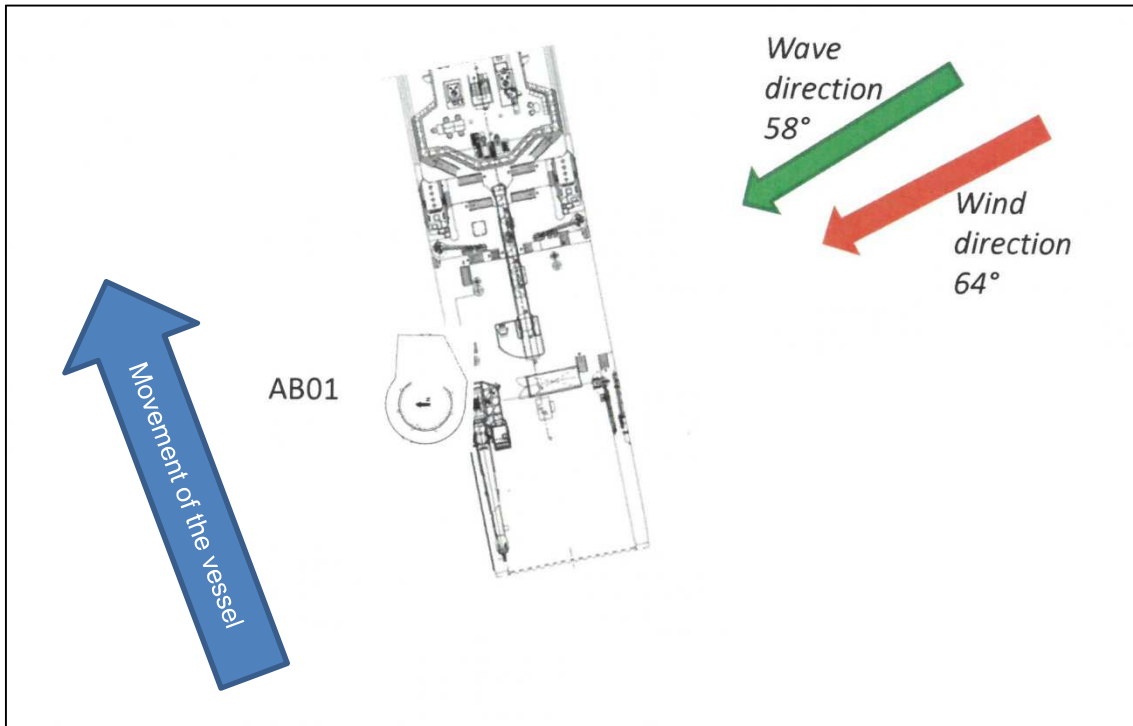
The impact caused TP AB01's external platform to rotate further by about 40° anticlockwise. The ship maintained her course and sailed out of the area.

Figure 17 shows the second allision when the shipboard crane struck the TP at a speed of about 2.7 kts. Control of the thrusters had been regained shortly beforehand. This allision caused the platform to rotate a further 40° anticlockwise.

Figure 17: Second allision
