## **Investigation Report 168/16**

### **Very Serious Marine Casualty**

**Fatal person-overboard accident involving a  
crew member of the fishing vessel  
PESORSA CUATRO  
150 nm west of Ireland  
on 17 May 2016**

18 February 2019

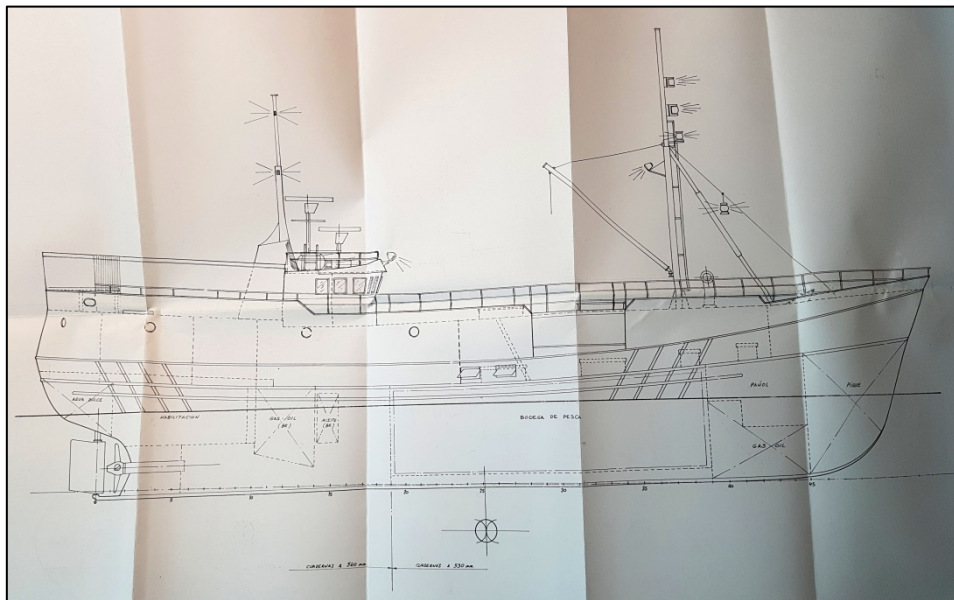
Figure 8: Vessel after the height of the aft superstructure was increased in 1994

However, the drawings available at the DNV GL classification society do not accurately reflect the actual situation (Figure 8), as the existing guard rail is not shown there.

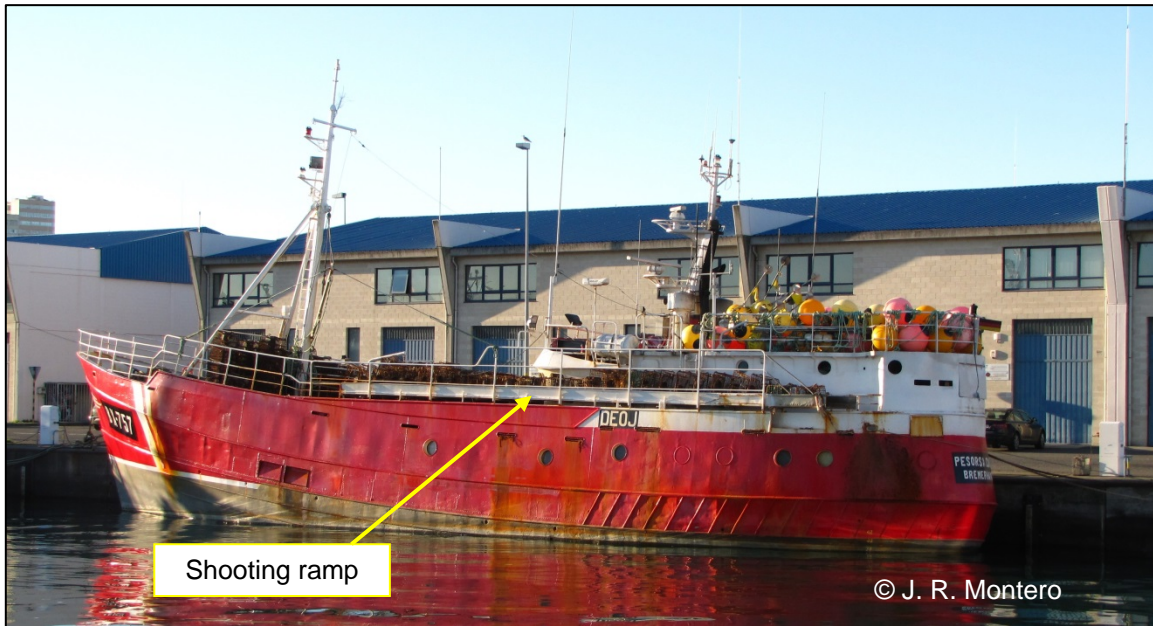
Figure 9: The PESORSA CUATRO after conversion in 1994

The existing drawings did not show the shooting ramp on the port side of the superstructure (see Figure 9). This was used for shooting the pots. The Federal Office for Agriculture and Food (BLE) was asked for information in order to determine the period in which the shooting ramp was installed. The BLE provided an overview of the fishing gear used and fish species caught by the PESORSA CUATRO. This shows that she fished with pots, among other things, from 2002 onwards. She then fished only for deep-water crab with pots from 2006 onwards. It can be deduced from this that the vessel was retrofitted in 2006 at the latest and the shooting ramp was mounted on the port side in this context.

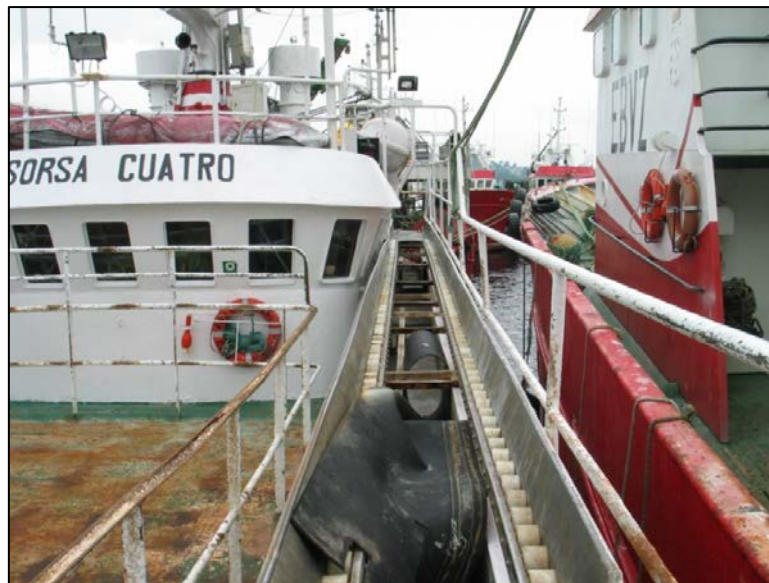
Figure 13: Shooting ramp for the pots

The shooting ramp provided the only means of access to the observation deck at the time of the accident, as the hatch on the observation deck was difficult to open because of its size and was also stowed over. To reach the observation deck, at least the rear half of the slipway had to be walked on when climbing onto the shooting ramp at the leading edge of the superstructure. Since the rollers attached to the sides did not provide a safe footing when walked on, the cross members had to be used. The upper edge of the cross members was about 65 cm above the deck. The gap between cross members was irregular with the larger gaps being between 129 cm and 157 cm. Therefore, safe footing was not provided.

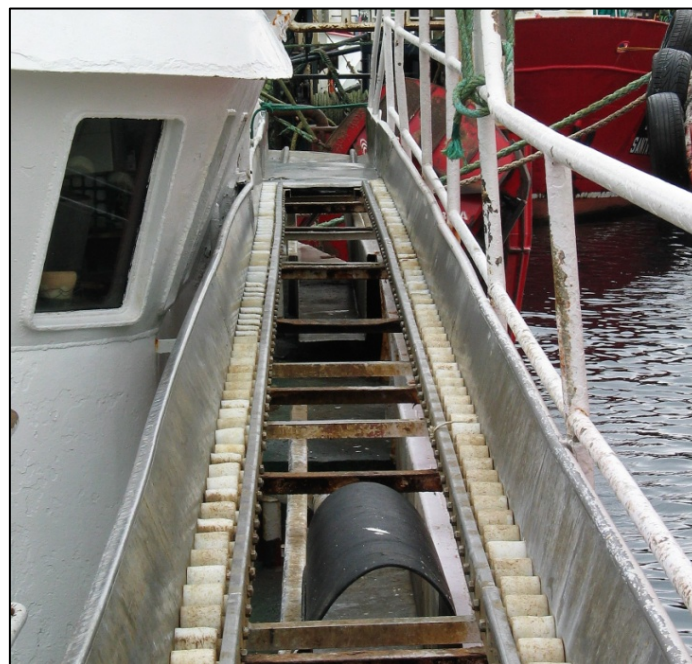
Figure 14: Shooting ramp, detailed view looking aft with rollers and cross members

The PESORSA CUATRO had been converted for catching crabs. A shooting ramp used to transport pots into the water from the stern had been installed on the superstructure's port side. To ensure effective transportation of the pots via this trough-shaped shooting ramp, it was equipped with rollers on the sides. Cross members were attached to the underside of the shooting ramp at irregular intervals to stabilise the structure.

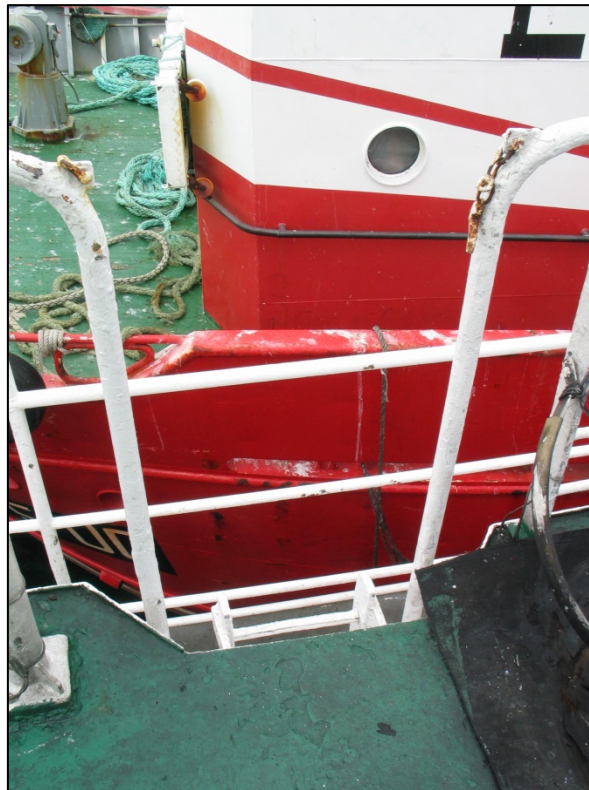
Only remnants of the chain that was supposed to secure the 56 cm-wide opening in the guard rail were present at the top of the ladder's handrail. Accordingly, it was no longer possible to close the opening in the guard rail (Figure 16).

Figure 16: Opening between ladder and observation deck without securing chain

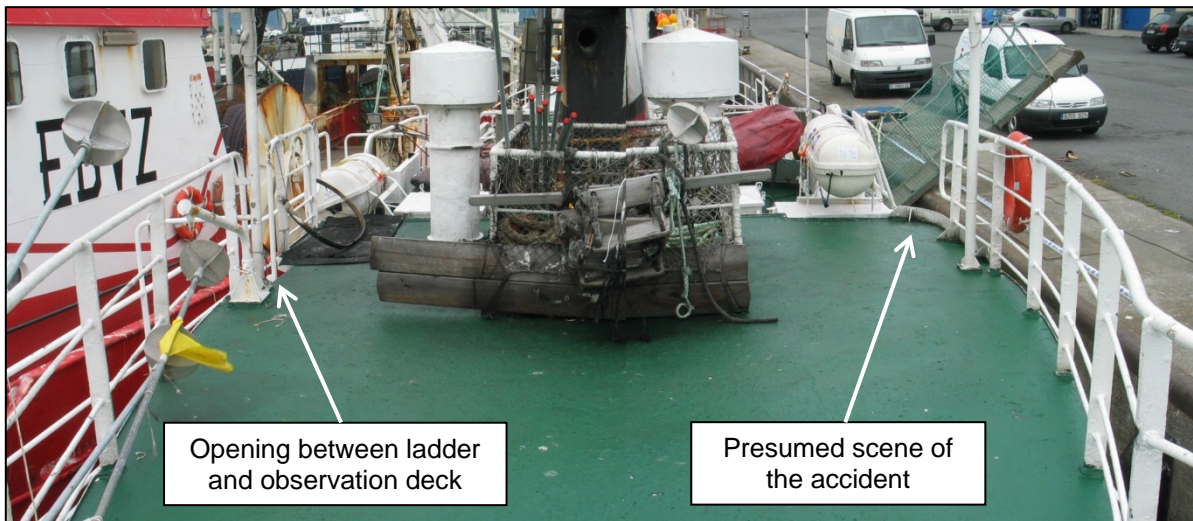
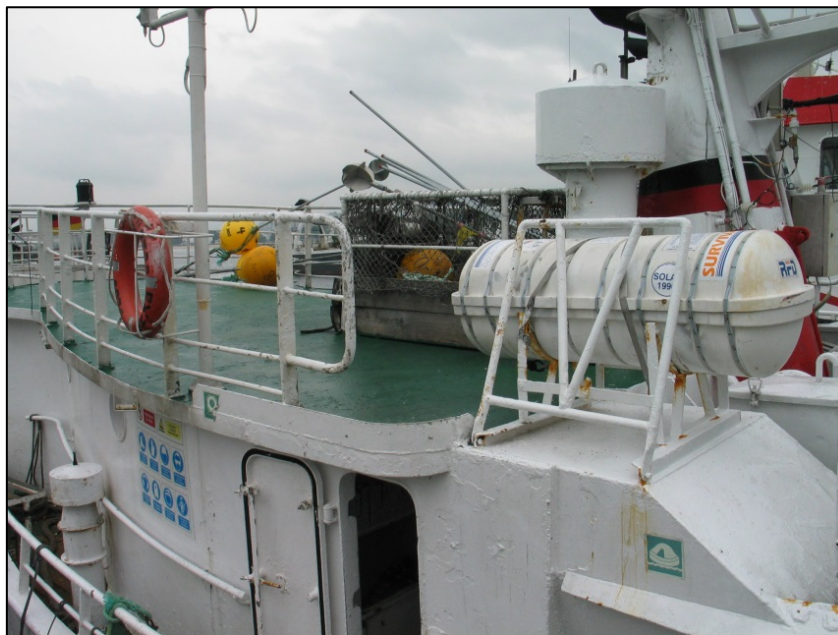
The extension of the superstructure in 1994 resulted in the loss of booby hatch access to the upper deck. The survey report stated that this was replaced by an access hatch with cover. This means of accessing the observation deck was no longer provided during the BSU's survey. Only a larger closed hatch immediately behind the aft mast could be found. Given its size, this hatch was neither intended nor suitable for use as a means of usual access. The hatch was completely enclosed by a guard rail. The enclosed space above the hatch was used as a stowage area (see also Figures 19 and 20).

The upper level was largely free at the time of the survey. Only one storage space was located there directly behind the mast. It had been constructed with a guard rail and was used for stowing fenders and other bulky objects. However, photographs available on the Internet also show that the entire area of the aft observation deck is used for stowing net buoys and others (see also section 3.2.3).

Figure 19: View forward over the aft observation deck  
 The stowage space is located in the middle.

Figure 20: View to the upper level of the observation deck from starboard

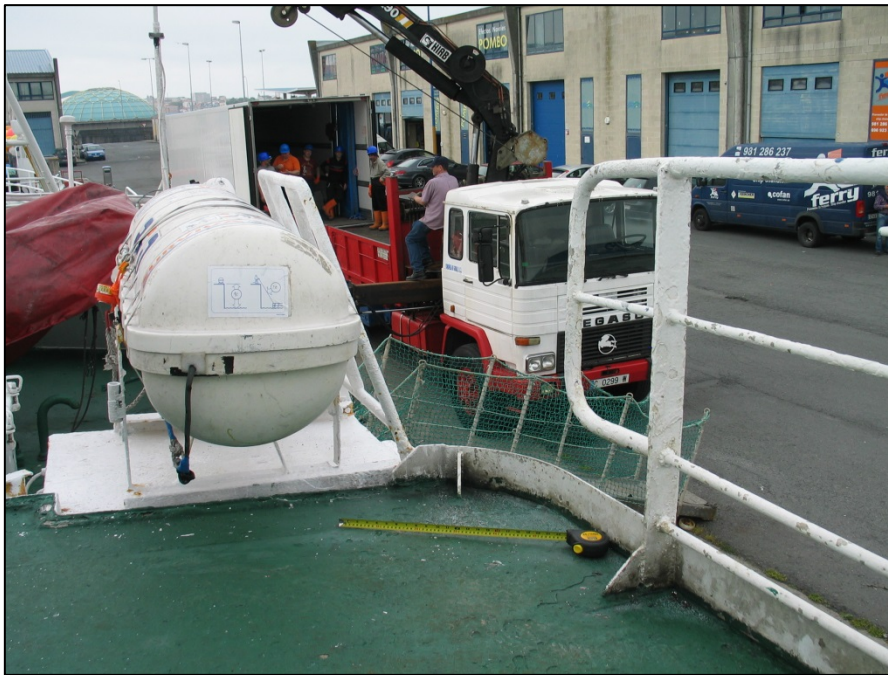
The observation deck was almost completely enclosed by a guard rail of 96.5 cm in height. For the most part, the guard rail consisted of four cross members. Apart from the ladder on port side, the only opening was on the starboard side in the immediate vicinity of the liferaft stowed there (Figures 20 and 21). This involved a gap of 50 cm, which could not be closed by a movable barrier. The investigators believe the casualty went overboard at this point.

Figure 21: Unsecured area next to the liferaft

The accident occurred during the fishing process. The subsequent casualty climbed onto the observation deck with a group of crew members to look for the next marker buoy from there. The BSU investigators assume that it was difficult to identify the marker buoy with radar alone because of the size of the radar reflector, its relatively low height above the water surface and the prevailing swell. As there was no other means of accessing the observation deck, the pot shooting ramp on the port side of the superstructure was used to climb up to it. The investigators believe that the casualty intended to adopt a lookout position on the starboard side. While moving to the starboard side, the subsequent casualty had to pass the stowage container in the middle of the deck, which was enclosed by a guard rail and offered a limited opportunity to hold on. Another guard rail then followed on the starboard side, providing a handhold. However, there was a gap of 50 cm in this guard rail near the starboard liferaft.

None of the other crew members on the observation deck saw the actual course of the accident. However, the investigators believe that the accident was caused by the opening in the guard rail.

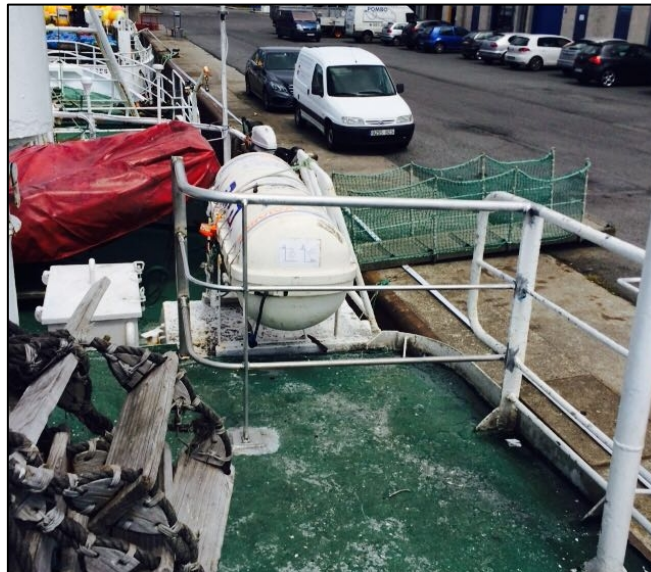
Figure 22: Additional guard rail next to the liferaft

The crew or the owner dealt with the issues found by the BSU in the course of its survey of the PESORSA CUATRO during the days that followed. For example, an additional guard rail was installed in the area of the starboard liferaft. Moreover, a means of access to the observation deck from the superstructure was established via the existing hatch cover. In addition, two chains were attached to the opening between ladder and observation deck on the port side to secure the opening.

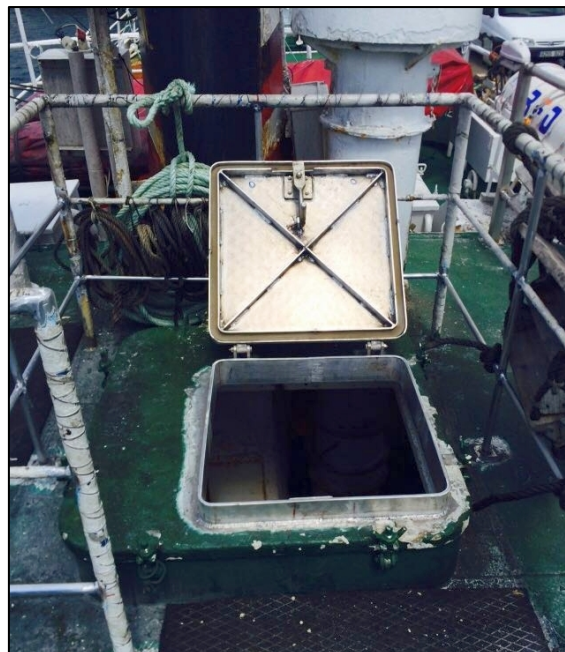
Figure 23: New means of accessing the observation deck

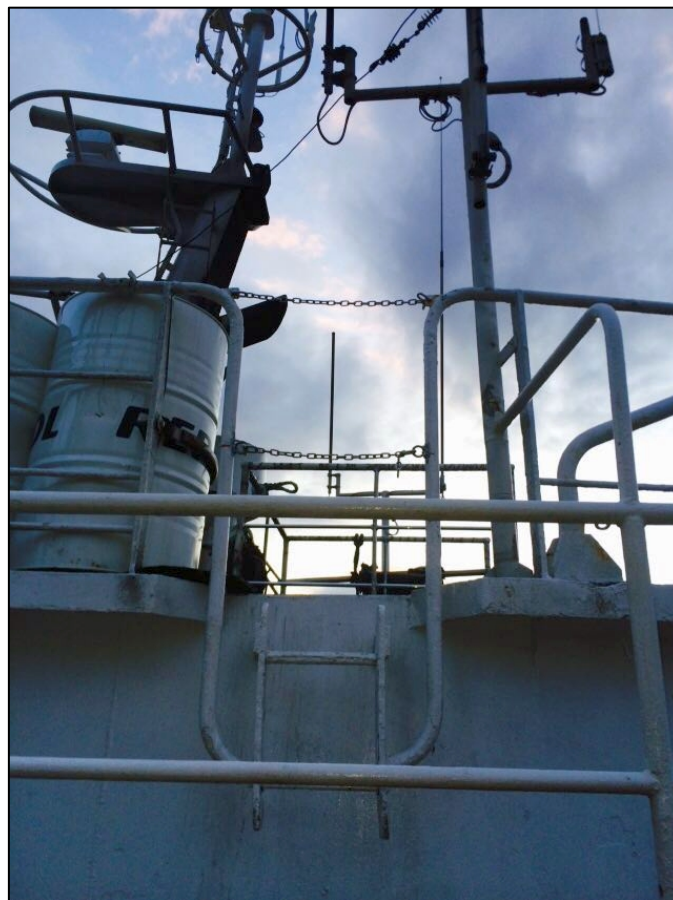
Figure 25: Ladder to observation deck with safety chains
