Bundesstelle für Seeunfalluntersuchung
Federal Bureau of Maritime Casualty Investigation
Federal Higher Authority subordinated to the Ministry
of Transport and Digital Infrastructure

Summary Investigation Report 20/17

**Failure of the main engine with subsequent
emergency anchor manoeuvre on the bulk carrier
MV CAPE LEONIDAS on 17 January 2017 in the area
of Kolmar on the River Elbe**

6 November 2019

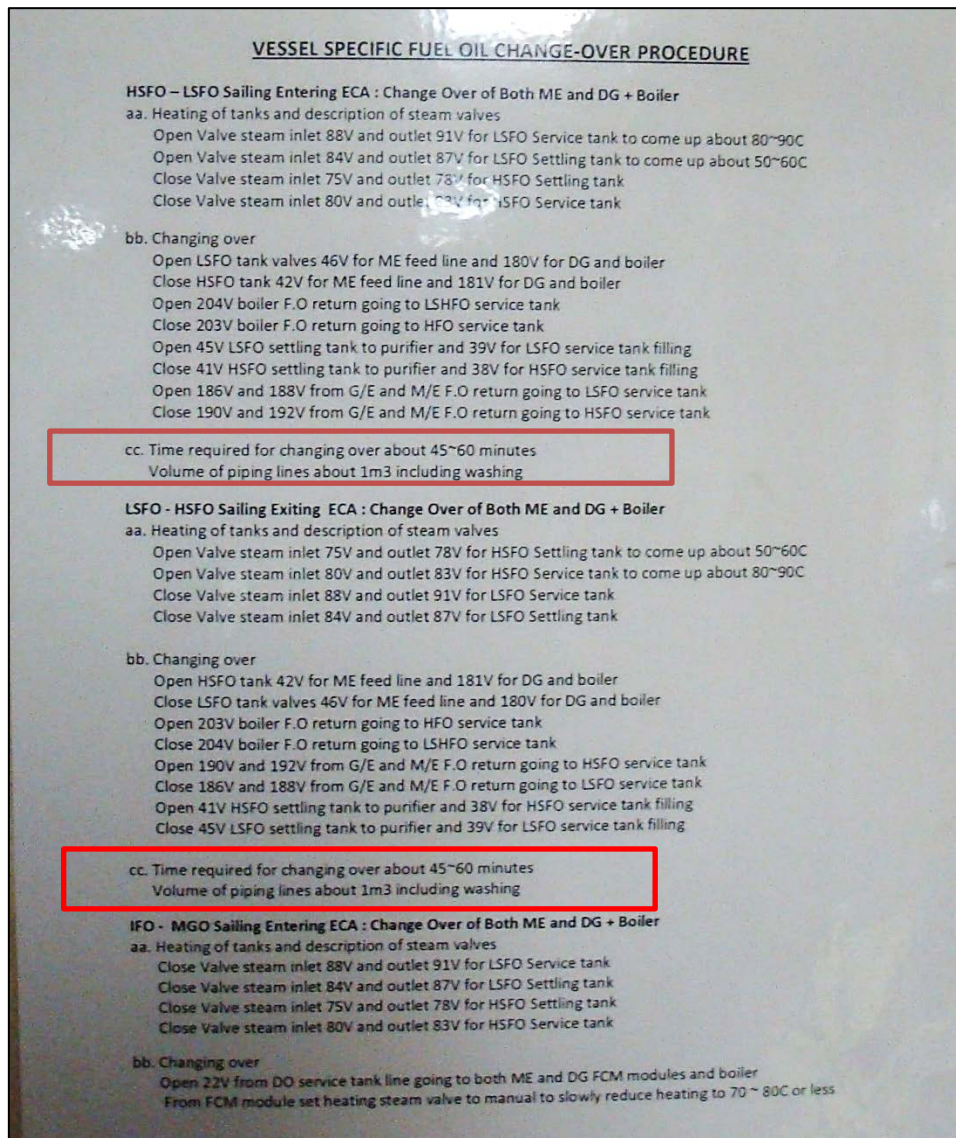
Figure 8: Fuel changeover notice in the CAPE LEONIDAS's ECR (extract)⁹

*The latter of the two procedures was found on the CAPE LEONIDAS in the form of a laminated multi-page printout (see **Figure 8** below) attached to the wall of the engine control room (ECR). It contains the following advice in several places (and regardless of the direction of the changeover): "Time required for changing over about 45-60 minutes."*

The expert believes that the wording of the fuel changeover instructions posted in the ECR, according to which the changeover should take 'about' 45-60 minutes, is open to misinterpretation. Individuals without in-depth knowledge of the technical facts may interpret the wording in question such that this information is to be understood as a maximum period. In fact, it is to be understood as a minimum period, however. With that in mind, it is recommended that the word 'about' be replaced by the phrase 'at least'.

In the expert's view, which the BSU agrees with unreservedly, the ambiguous or unclear wording in the operating instructions for the changeover procedure, which states that the changeover 'requires' a period of 'about' 45-60 minutes, may have played a decisive role in the changeover being executed too quickly. Although individuals without in-depth knowledge of the physical effects arising from temporary fuel mixing may interpret the wording in question such that this information is to be understood as a maximum period, it is actually the minimum period that must be observed in order to rule out adverse consequences for the functioning of the fuel system and thus for the main engine as a whole. With that in mind, the phrase 'at least' should be used rather than the word 'about'.

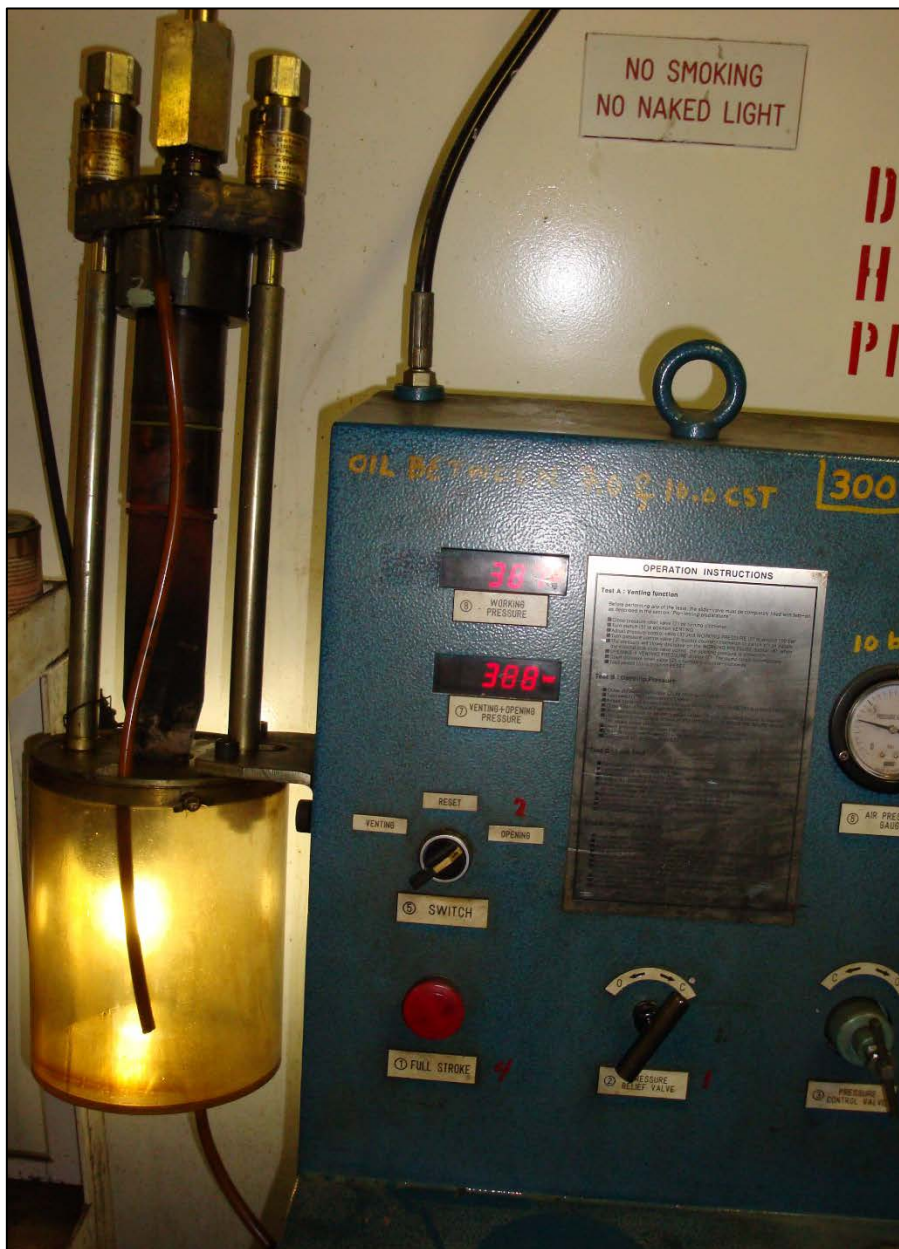
Figure 9: Rig for pressure testing injectors in the CAPE LEONIDAS's ECR

The pressure at which the nozzles should open/inject according to specifications (label on the test rig and the expert's experience) stands at 200-280 bar. The first of the two nozzles injected at a test pressure of about 270 bar in accordance with the specifications. On the other hand, the second nozzle did not inject after being subjected to increasing pressure up to 388 bar (see **Figure 9** below)! A further increase in the test pressure was dispensed with in the interest of the safety of those present and the test was aborted. The removed injectors were secured as evidence and examined in a laboratory subsequently.

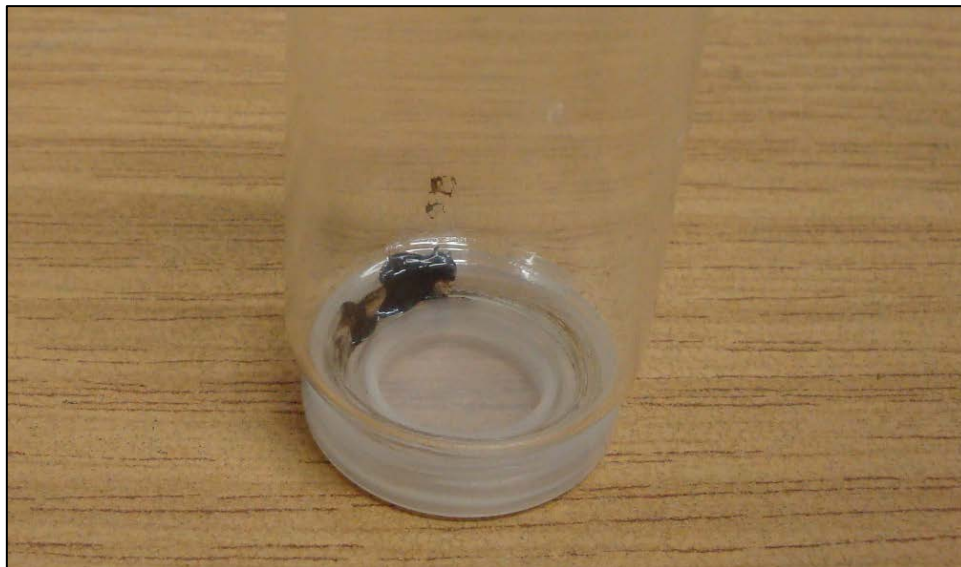
Figure 11: Secured residues from the fuel inlet of the defective injector

*The expert also tried to scrape a sample of a solid black substance out of the faulty injector, which was at the top of the fuel inlet (see **Figure 11** below). The sample acquired was insufficient for later analysis, however.*

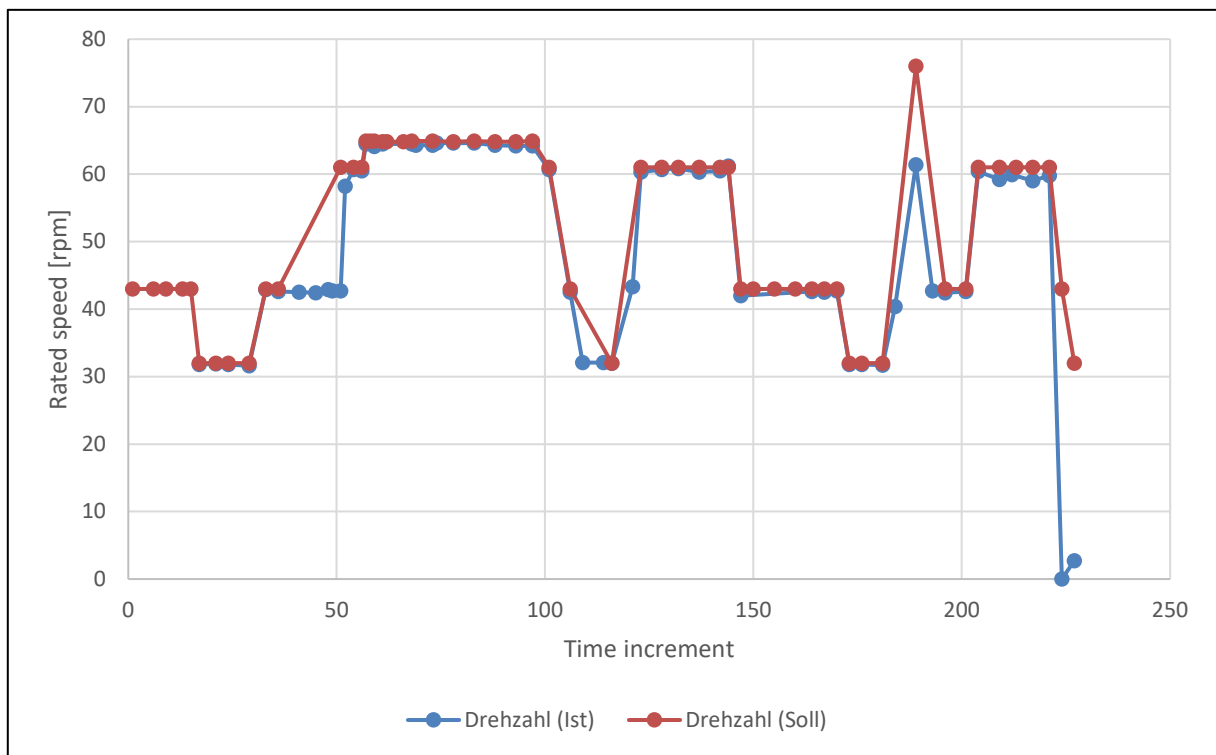
Figure 14: Rated speed curve from 2254 on 16/01 up until the incident (5-minute grid)

The display starts at 2254 on 16/01 and ends at 0419 on 17/01 (time increment 230). The penultimate time increment is 0414. At this point, the actual rated speed dropped to zero, even though the setpoint is 43 rpm. This point in time can be interpreted as the time of the failure. Various changes in rated speed are visible in the previous hour, where the rated speed setpoint is increased to some 76 rpm at about time increment 190. This is followed by an increase in actual rated speed to only 62 rpm. This increase is followed by a reduction in the rated speed, then another increase to 62 rpm and finally the shutdown of the engine at time increment 229, even though the rated speed setpoint still stands at 43 rpm.

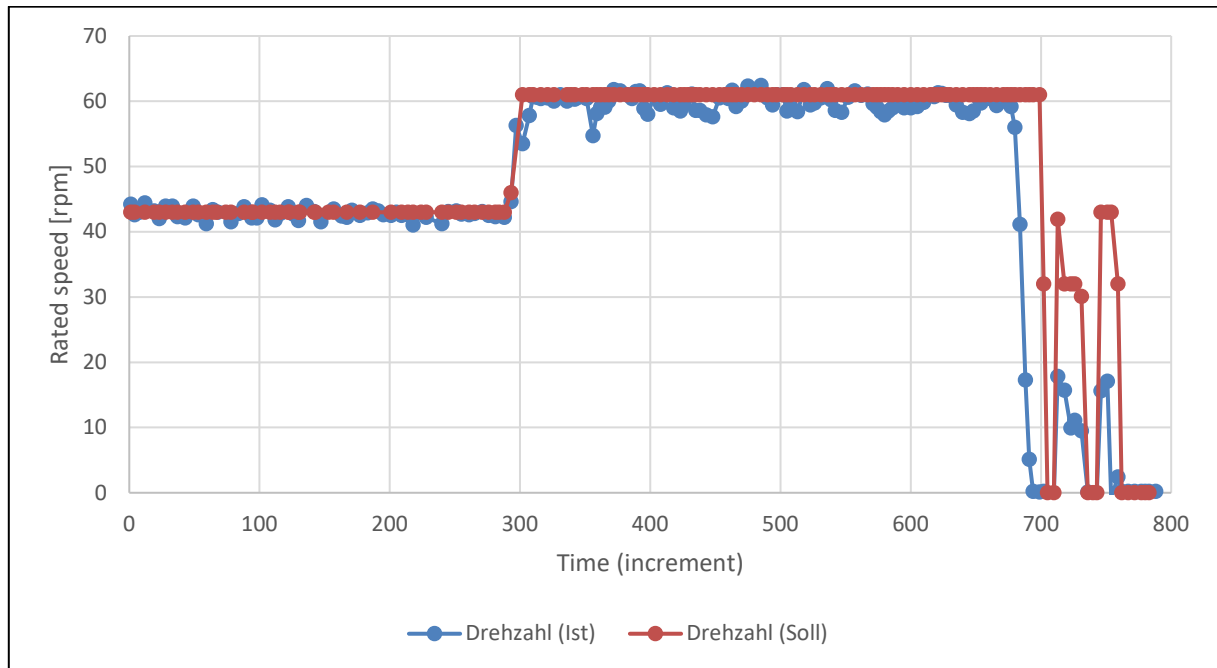
Figure 15: Rated speed curve from 0330 on 17/01 up until the incident (1-second grid)

Figure 15 shows that after a stable rated speed level of 43 rpm (setpoint = actual), the rated speed has also risen to a stable level of about 61 rpm (setpoint = actual). However, the rated speed drops to zero at time increment 680, despite the constant setpoint of 61 rpm. The setpoint reacts shortly after and is also set at zero. This is followed by several setpoints of 43 rpm, each followed by a short increase in rated speed to about 18 rpm, until both setpoint and actual stop at zero. The latter operations can be interpreted as start attempts. The automated system specifies a setpoint which leads to activation of the start-up air system. As a result, the actual rated speed increases (but not beyond the pneumatic actuation speed), at which the start-up attempt is aborted in each case.

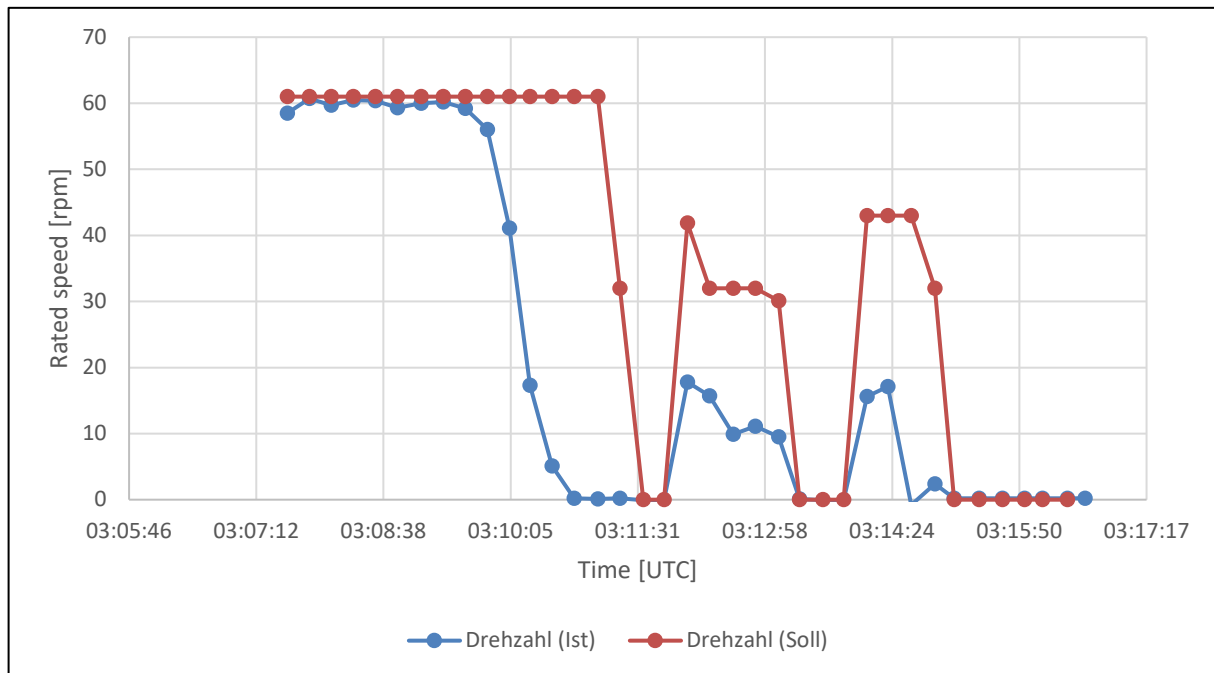
Figure 16: Rated speed curve (close-up) at the moment the incident occurred

Figure 16 shows this operation in magnified resolution. After the engine failed at 0409 (actual rated speed drops to zero, rated speed setpoint remains at 61 rpm), the automated system responds twice with rated speed setpoints of 43 rpm, which the engine cannot adhere to, however. The time at 0414 can be interpreted as meaning that the start-up attempts were abandoned either due to the automated system or manual intervention.

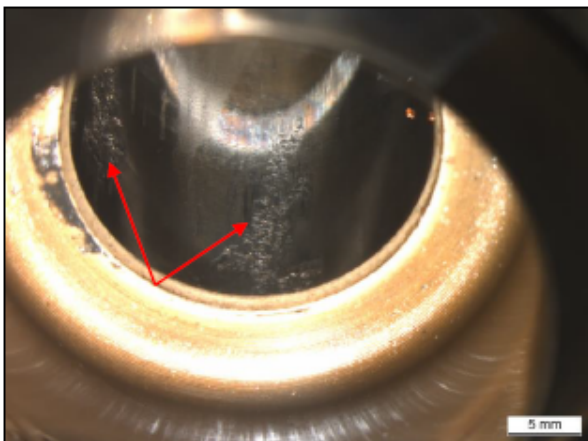
Ansicht A

Die Innenbohrung weist in vier Bereichen Oberflächenbeschädigungen auf.

Oberflächenbeschädigungen, siehe Pfeilmarkierungen

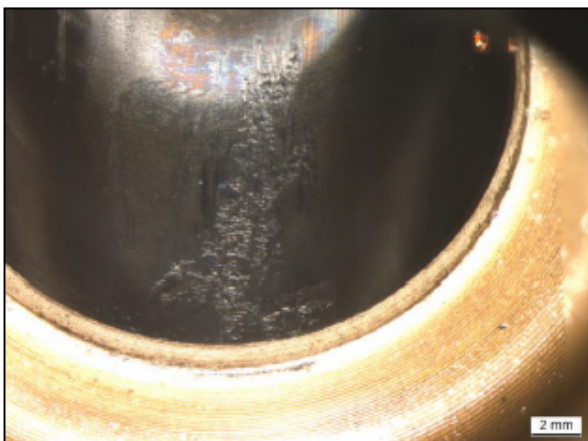
Detailvergrößerung

Oberflächenbeschädigungen

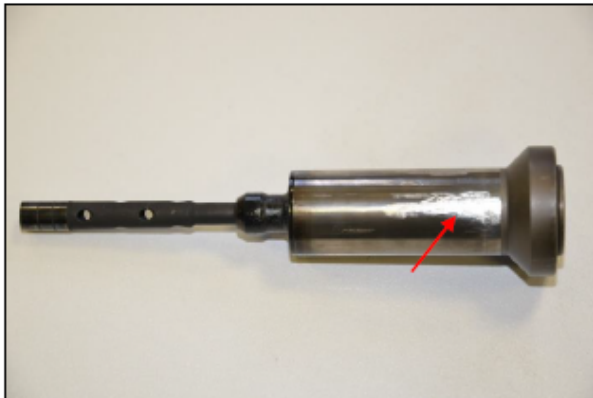
Weitere Ansicht

Die Mantelfläche weist in vier Bereichen Oberflächenbeschädigungen auf.

Oberflächenbeschädigungen, siehe Pfeilmarkierungen

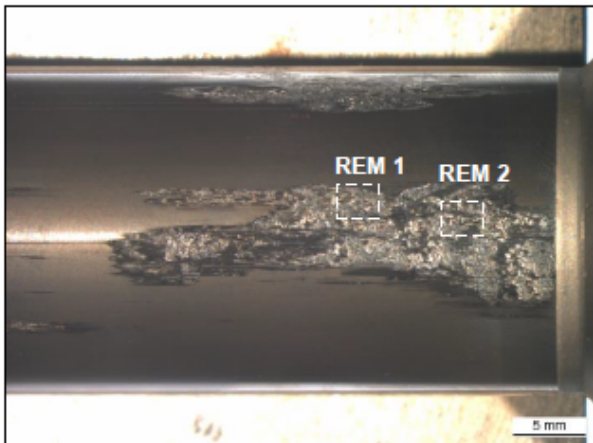
Detailvergrößerung

Oberflächenbeschädigungen

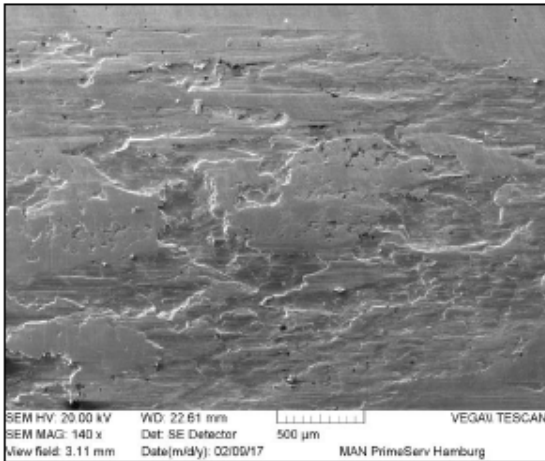
REM 1

Die Mantelfläche weist in diesem Bereich Fressspuren auf.

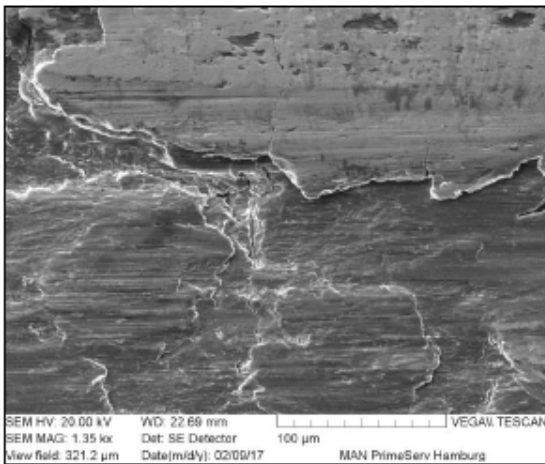
Weitere Detailvergrößerung

Ausgebrochenes Material

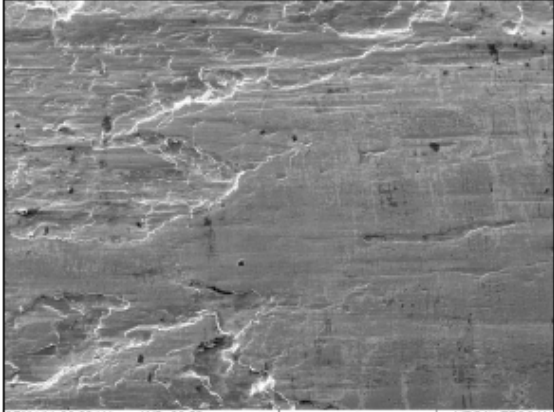
<p>SEM HV: 20.00 kV WD: 22.52 mm VEGAII TESCAN SEM MAG: 249 x Det: SE Detector 500 µm View field: 1.75 mm Date(m/d/y): 02/09/17 MAN PrimeServ Hamburg</p> <p style="text-align: center;">Labor_2017.02.01_D115</p>		<p>REM-Untersuchung der Oberflächenbeschädigungen</p> <p><u>REM 2</u></p> <p>Die Mantelfläche weist in diesem Bereich Fressspuren auf.</p>

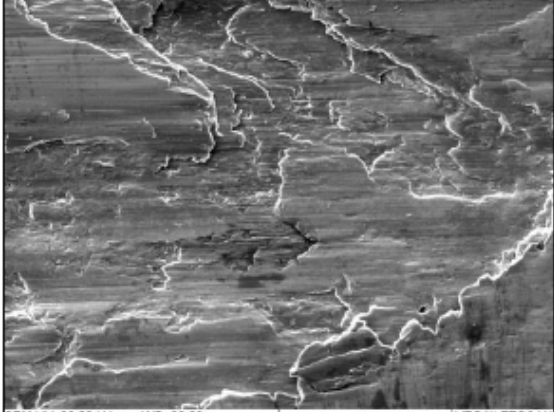
<p>SEM HV: 20.00 kV WD: 22.69 mm VEGAII TESCAN SEM MAG: 1.37 kx Det: SE Detector 100 µm View field: 317.4 µm Date(m/d/y): 02/09/17 MAN PrimeServ Hamburg</p> <p style="text-align: center;">Labor_2017.02.01_D117</p>		<p>Weitere Detailvergrößerung</p> <p>Ausgebrochenes Material</p> <p>Durch das Klemmen der Düsennadel im Düsenkörper und dem anschließenden Heraustreiben (Demontage der Komponenten) der Düsennadel aus dem Düsenkörper hervorgerufene Materialausbrüche.</p> <p>Abrasive Fremdpartikel auf der Mantelfläche wurden nicht festgestellt.</p>
