## Investigation Report 258/18

**Very Serious Marine Casualty**

# **Capsize of survey boat GEO PROFILER in the Wadden Sea off Büsum on 17 July 2018**

2 May 2019

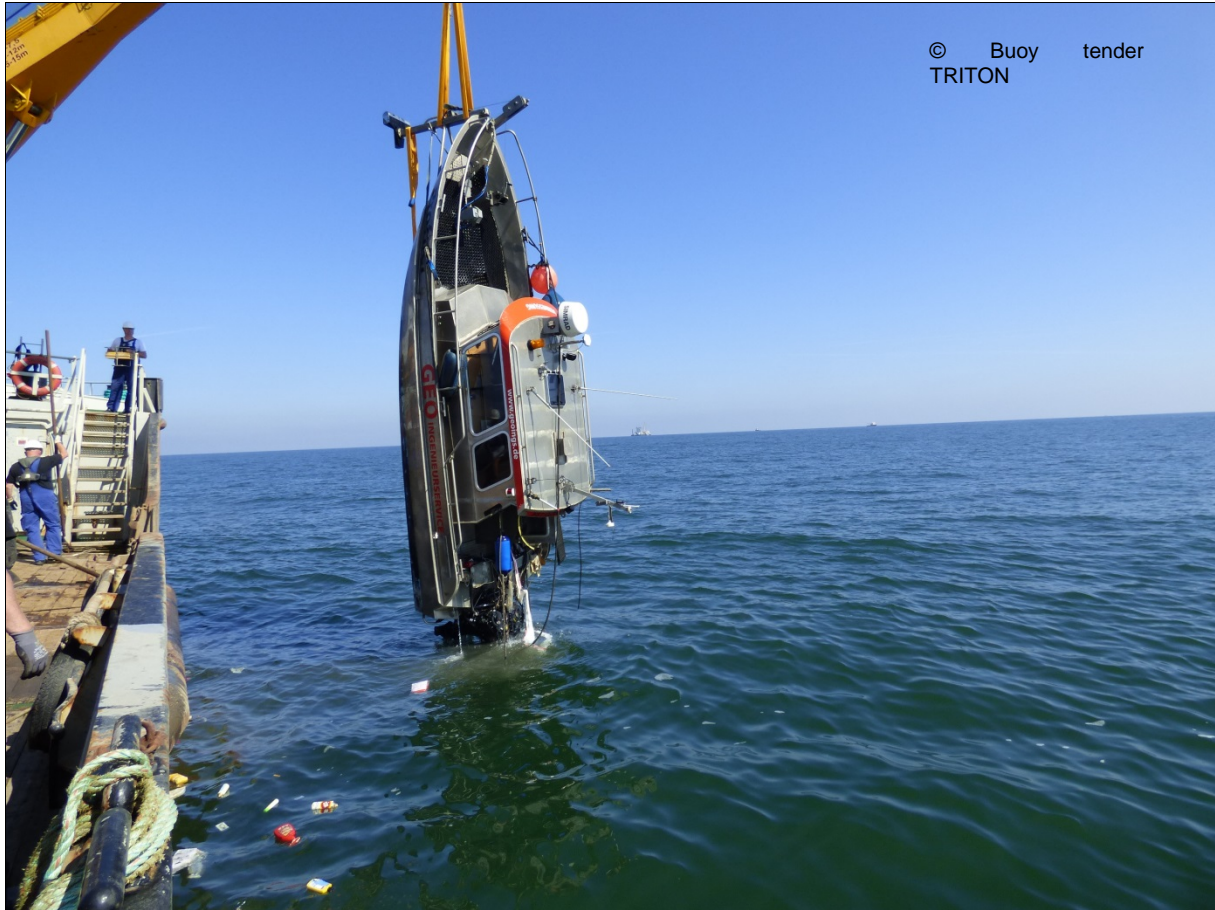
Figure 3: Salvaging the GEO PROFILER

On the afternoon of 23 July 2018, the buoy tender TRITON sighted the GEO PROFILER capsized with her bow visible on the surface at the position 54°09.3' N 008°30.5' E and salvaged her.

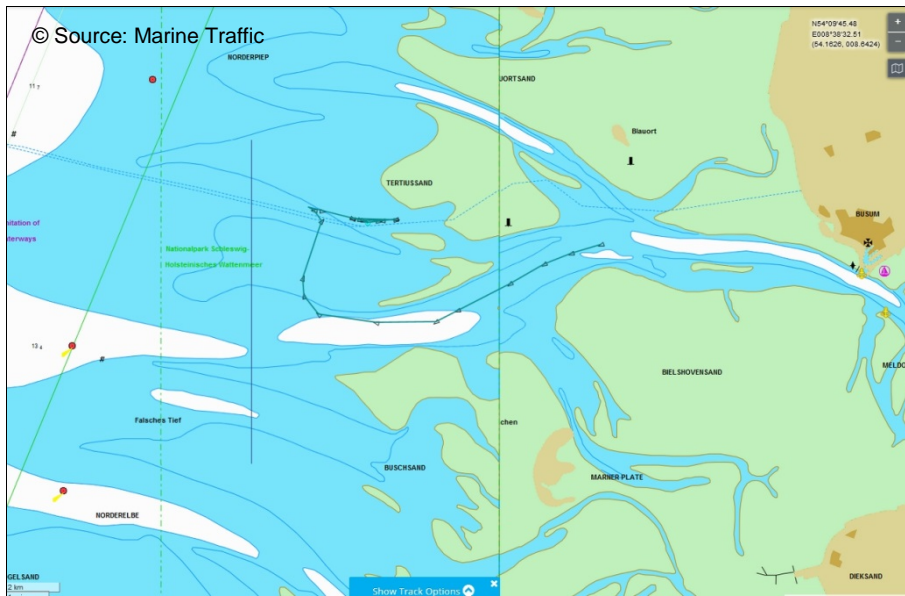
Figure 4: AIS track – BÜSUM

On 25 July 2018, the BSU surveyed and took measurements of the GEO PROFILER on the grounds of the Büsum buoy store for the investigation. The GEO PROFILER's last recorded AIS data and the weather reports of Germany's National Meteorological Service (DWD) analysed were used to reconstruct the course of the accident. The survey voyages were carried out south-west of Tertius sand. The last AIS signal was received at 1942. It was no longer possible for the crew to establish watertight integrity on the GEO PROFILER at this point due to the strong wind and waves. Twisted and disordered lines/cables are visible on the aft deck, making it impossible to lock the door in good time.<sup>5</sup> This caused the boat to take on water until she finally capsized stern first.

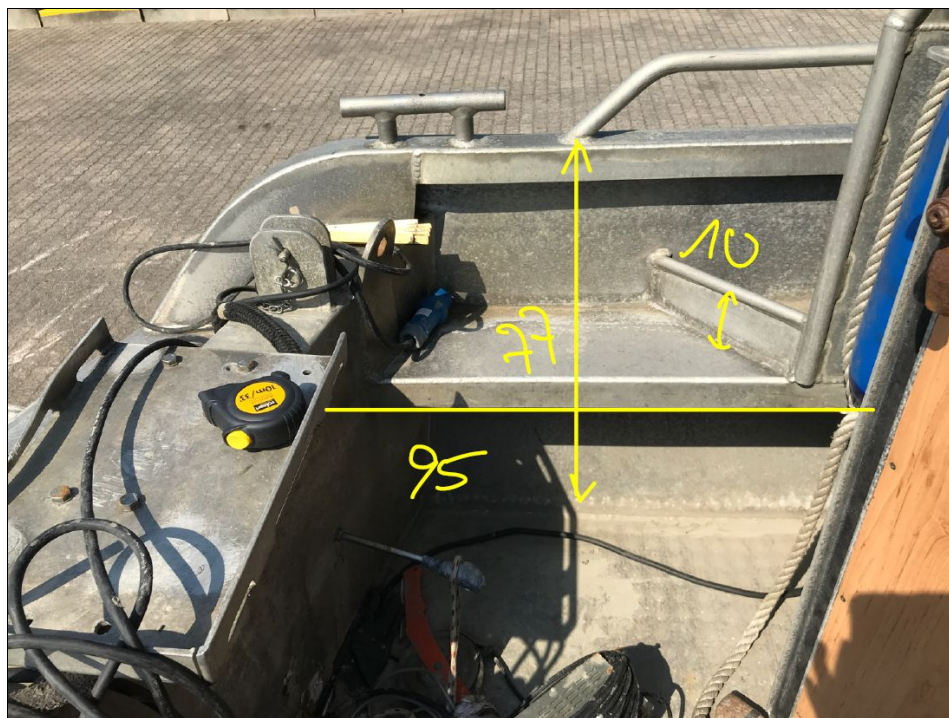
Figure 9: Bulwark

2. *Despite the covered design (with a weatherproof and closable wheelhouse), the boat should basically be regarded as an open boat and therefore used with appropriate caution. From the moment the bulwark immerses and water flows onto the deck in any noteworthy extent, stability is lost, possibly leading to the boat capsizing and ultimately foundering.*

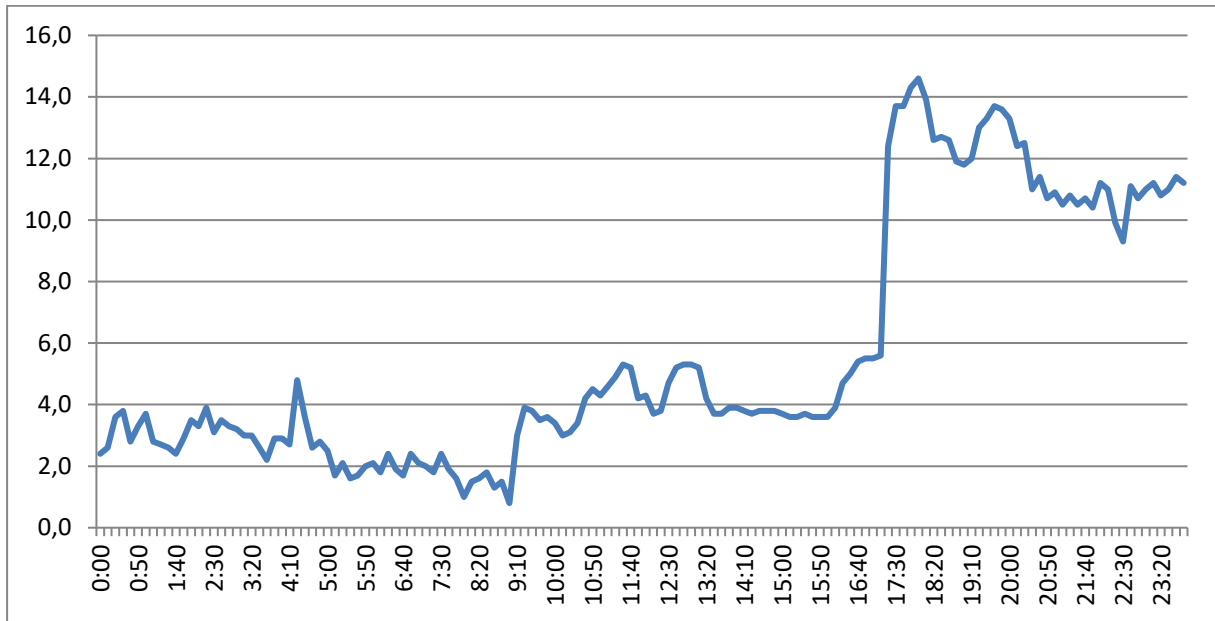
Graph 1: Wind force [m/s] for Büsum on 17 July 2018<sup>6</sup>

High tide was at 1650 at the scene of the accident (reference: Blauort). The receding water ran in the opposite direction to the wind. Wave heights of up to 3 m are probable due to interference.

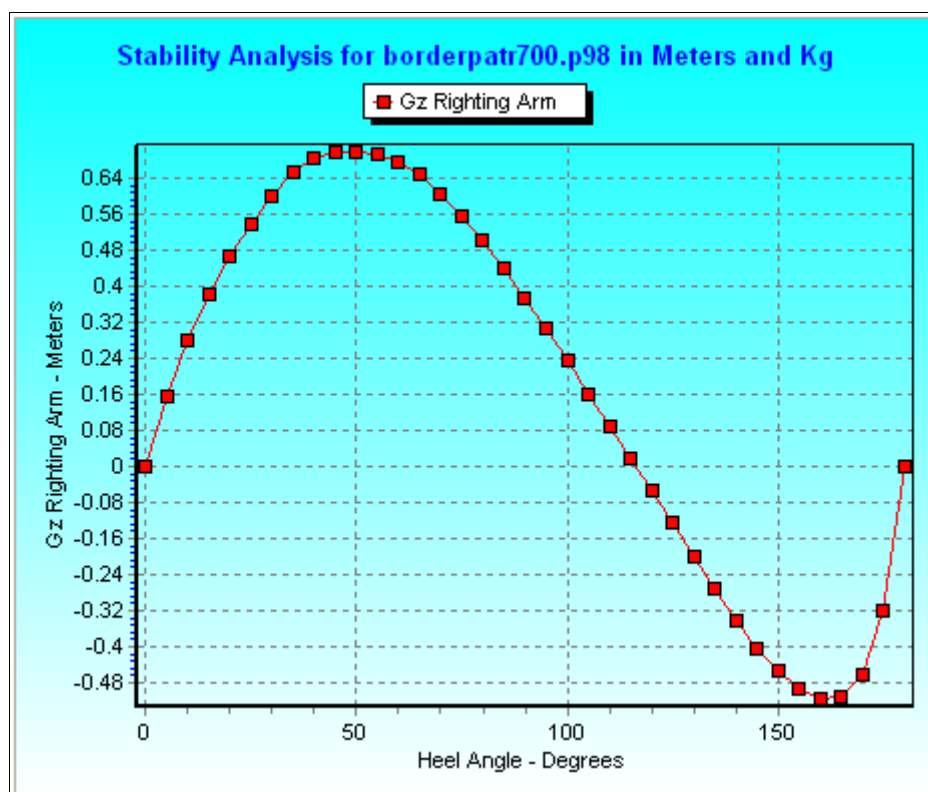
Figure 10: Stability curve for the bare hull

The range of stability is 115°. It is reasonable to assume that the structure was taken into account in the closed state, otherwise this relatively high value would not have been achieved.

7.4.3 The Federal Bureau of Maritime Casualty Investigation recommends that the owner or operator obtain a declaration of conformity from the shipyard in accordance with the certified module Aa, in which a stability calculation is required, for the Coenenboat CKB700 type of boat.

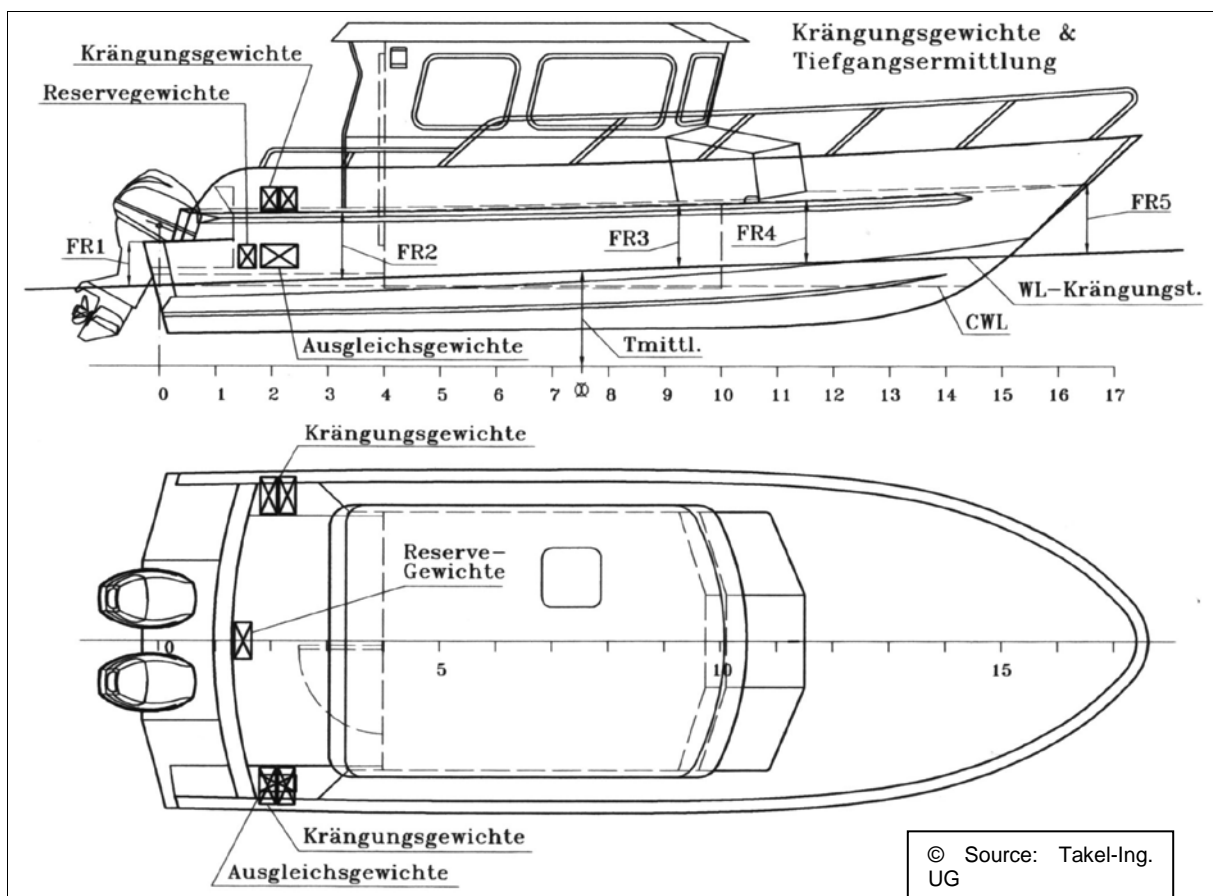
Figure 11: Inclining test

Light ship weight	2.15 t
Weight centre of gravity lcg	2.74 m
vcg	1.26 m
tcg	-0.02 m

The inclining test delivered a light ship weight of 2.15 t for the boat ready for use with her current equipment (bridge equipment, survey computer, multi-beam echo sounder, generator, fenders and lines, two 60 hp outboard engines but without people, effects and diesel on board). The initial stability GM was determined as 0.89 m. This value is within the normal range for smaller boats and confirms the safe feeling one has upon entering one. The light ship data are required as input variables in the load case calculations.

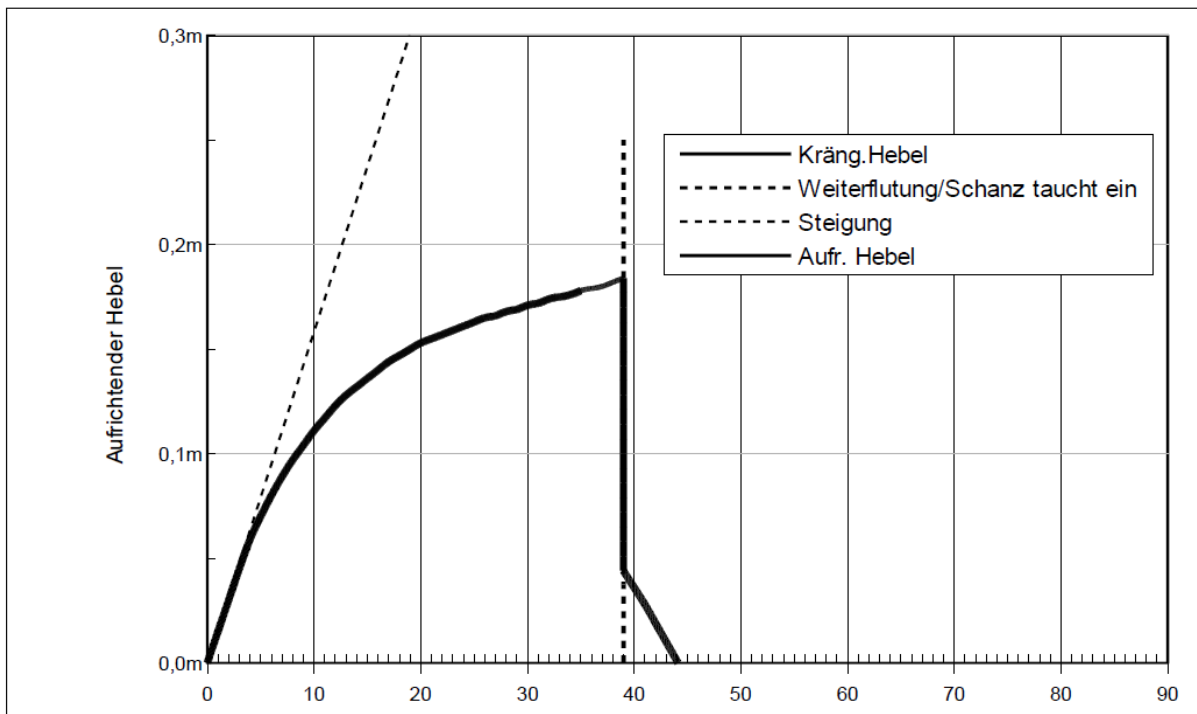
Figure 12: Load case 1 stability curve

Although initial stability is good, the maximum righting lever arm is too low (for the criteria of the IS Code, which do not have to be met here). The lever arm curve clearly demonstrates that the righting lever arm continues to rise up to a heel of 39°. However, stability is lost from the moment the bulwark is immersed and the deck floods. A 'remaining' lever arm still exists but it is too small to right the ship. In practise, this means that the boat will capsize and probably founder as soon as the bulwark is immersed. Accordingly, it should basically be regarded as an open (uncovered) boat.

The mean draught stood at 0.67 m with a displacement of 2.36 t. The freeboard was 0.46 m (0.2 m was required).

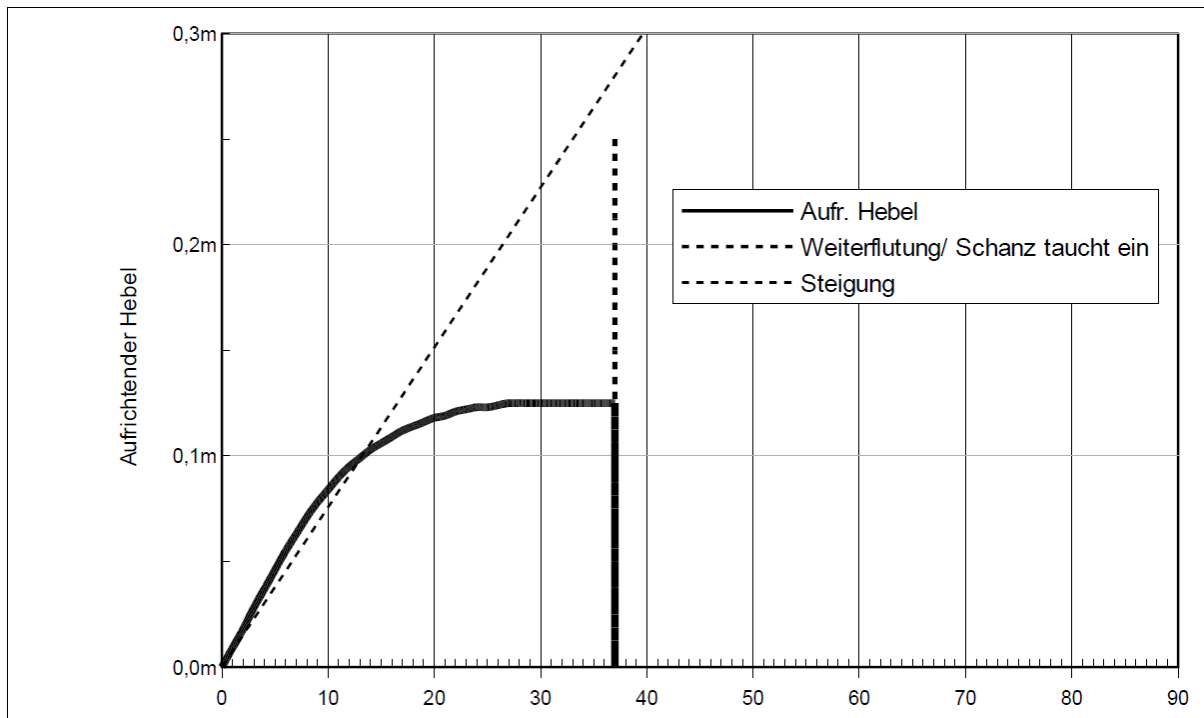
Figure 13: Load case 2 stability curve

The effect of a flooded cockpit on stability is considered in this load case. Stability deteriorates considerably due to the additional weight of the water and especially its free surface. The bulwark immerses at a heel of 37°, which then leads to capsizing. In practise, this means that the opportunity to drain the (slowly self-draining) cockpit through a cautious sailing style remains despite reduced stability if the cockpit floods but the wheelhouse remains dry to begin with.

The mean draught stood at 0.71 m with a displacement of 2.87 t. The freeboard was 0.42 m (0.2 m was required).

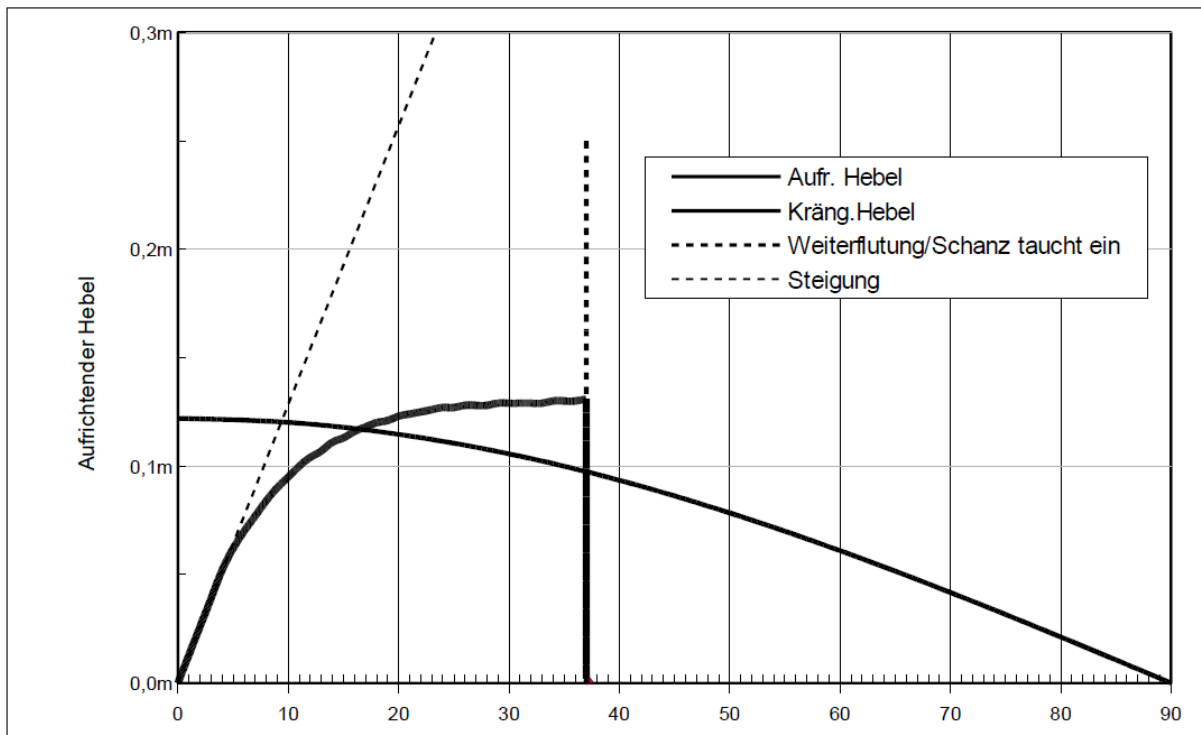
Figure 14: Load case 3 stability curve

CE criterion 6.2 (offset load, see table on following page) was checked in this load case. The boat meets the CE criteria for category C in her current state. The static heel angle (17°) is calculated from the intersection of the heeling and righting lever arm curves when four people (the permissible number of people) are standing on the side. The other relevant CE criteria are also shown here but do not refer exclusively to this offset load case.
