Investigation Report 408/17

Serious Marine Casualty

**Grounding of the bulk carrier
MV GLORY AMSTERDAM
on 29 October 2017 about 1.6 nm north of the
North Sea island of Langeoog**

6 March 2019

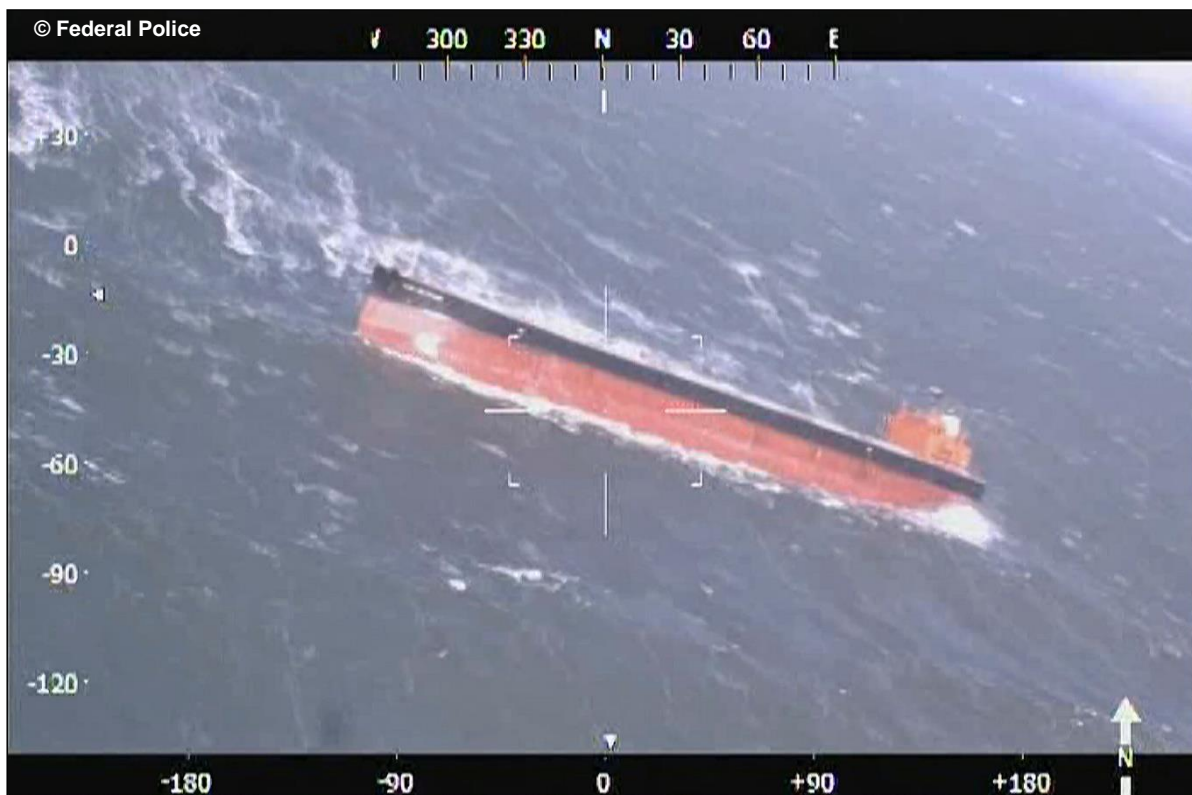
Figure 3: Aerial view of the GLORY AMSTERDAM heeling heavily to starboard at this moment

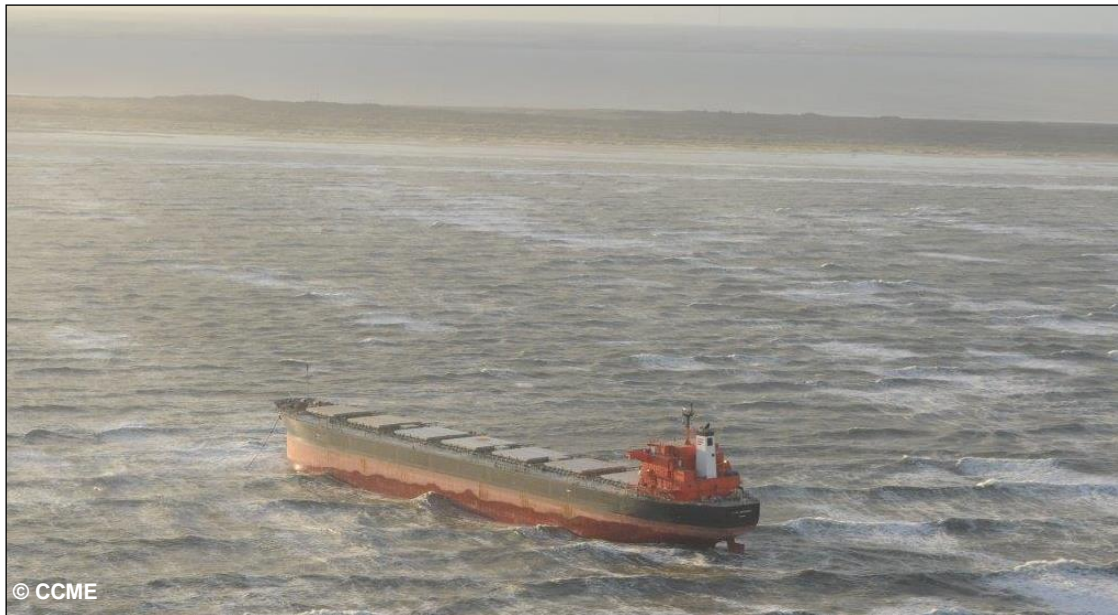
Figure 7: The GLORY AMSTERDAM after she ran aground off Langeoog

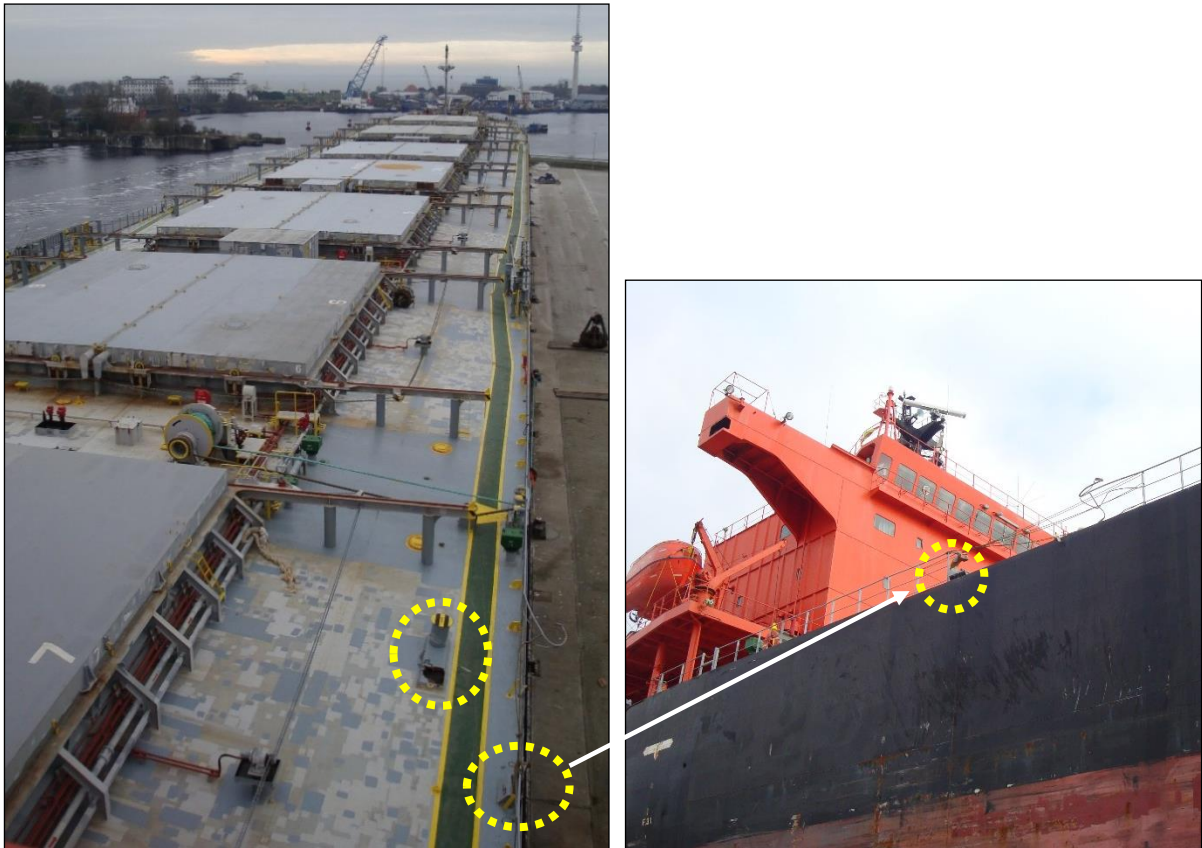
As a result of the double bollard (designed for maximum loads of 866 kN) on the starboard side level with the leading edge of the bridge used by the distressed vessel's crew to fasten the towline being excessively overloaded, it broke out of its anchorage. The nearby hawsehole used to feed the towline, which is designed for maximum loads of 208 kN, also broke open due to the heavy pulling forces (see **Figures 10 ff.**).

Figure 10: Positions of the destroyed bollard and broken hawsehole

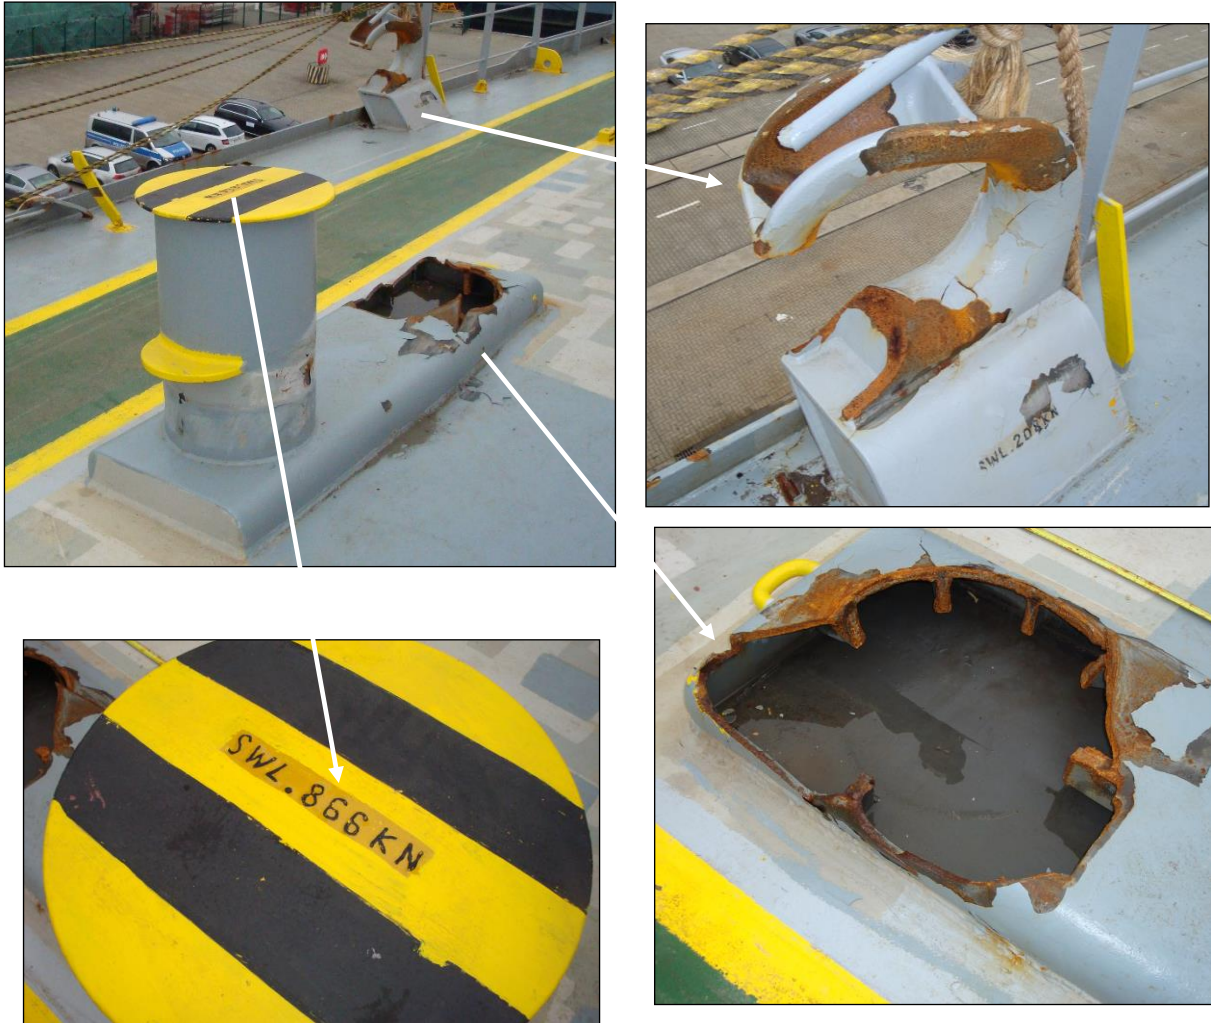
Figure 11: Close-ups of the destroyed bollard and broken hawsehole

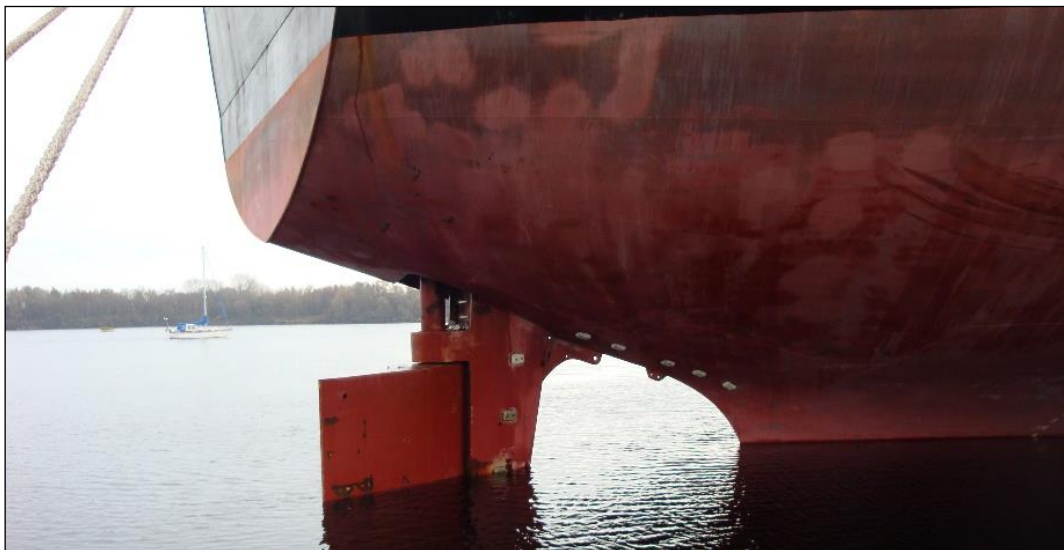
Figure 12: Rudder blade of the GLORY AMSTERDAM (damage not visible)

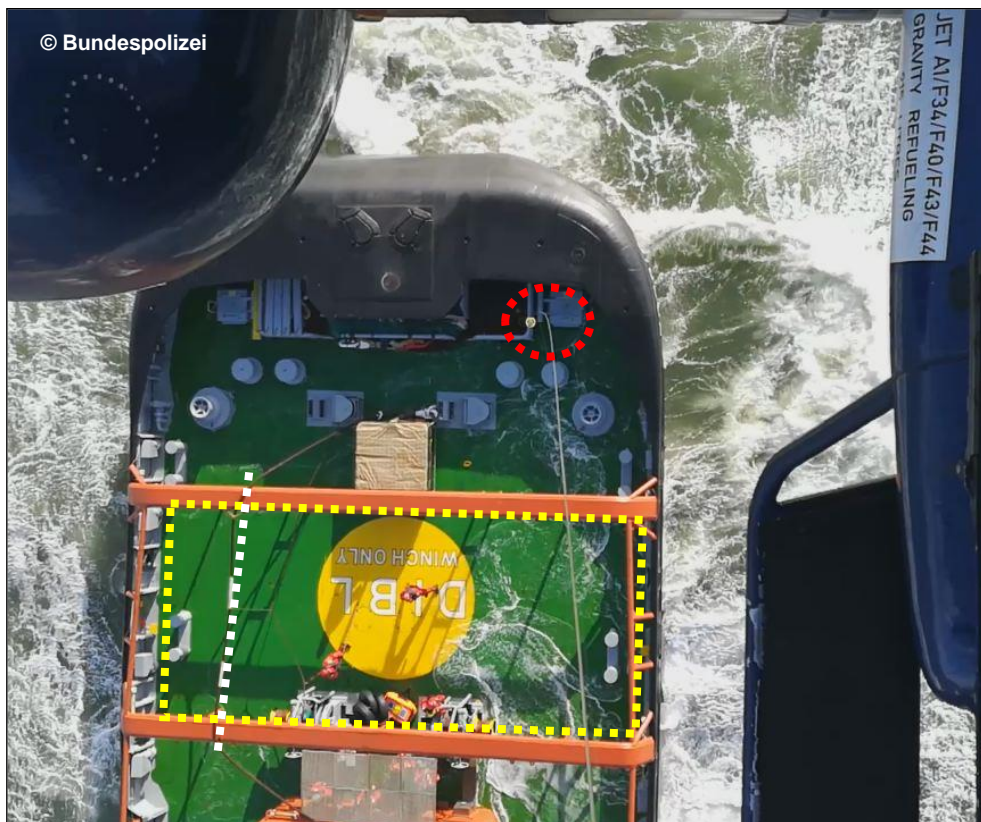
Figure 32: Attempt to lower the winch hook at the day of the accident

In addition to that was the particular danger that a person hanging from the hook could have been hurled against the above obstacles while being winched up from the NORDIC, which was rolling and pitching violently in the swell, before reaching an uncritical height above the vessel.

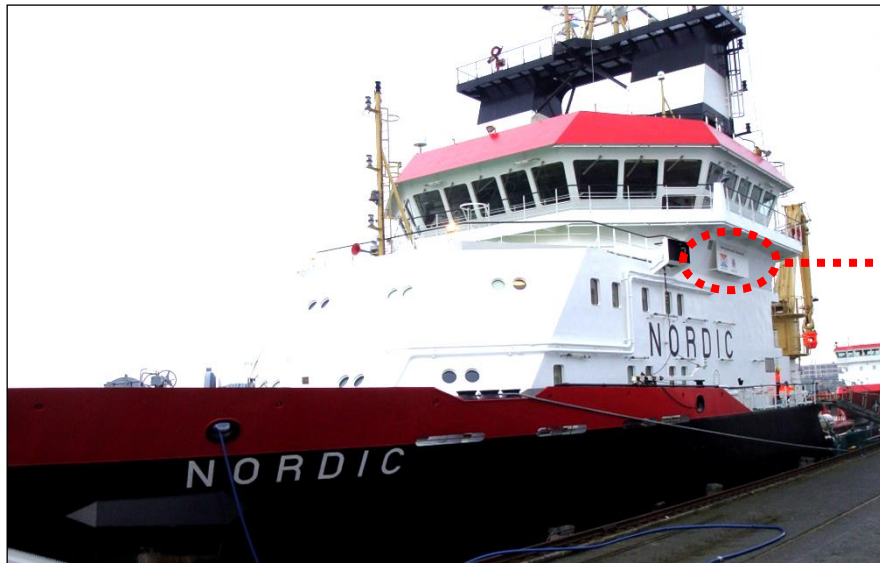
Although signs bearing the lettering 'Arbeitsgemeinschaft Küstenschutz' [coastal protection working group] and the logos of the owners Bugsier and Fairplay Towage (see **figures 37 f.** below) are mounted underneath the bridge deck on each side of the NORDIC, these signs are – especially because of the logos of the two owners – not a suitable means of illustrating that the vessel is operating on behalf of the authorities, but rather imply that she is a private salvage tug operating with commercial objectives.

Figure 37: ETV NORDIC – no clear marking identifying her as a vessel acting on behalf of the authorities

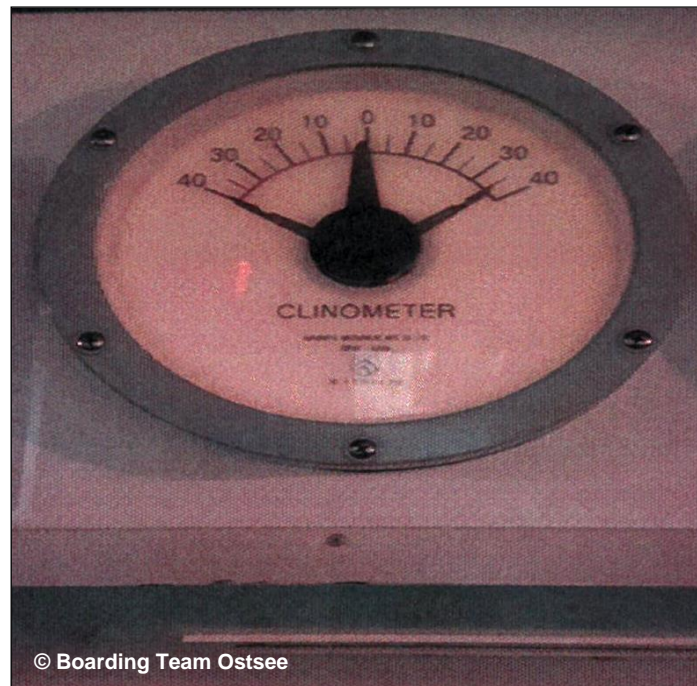
Figure 42: The GLORY AMSTERDAM's inclinometer on the day of the accident

*The external conditions (wind/swell) on the day of the accident were by no means such that the establishment of a towing connection was a routine matter. Rather, with regard to the helicopter transfers and the establishment of the line connection, it is important to stress that the weather was extremely poor and that the risks (including for the crew of the NORDIC, which pushed the limits of what was possible) were extremely high for all involved. The inclinometer on board the GA displayed the maximum value (40° heel!) when the BT appeared on the bridge (see **Figure 42** below).*

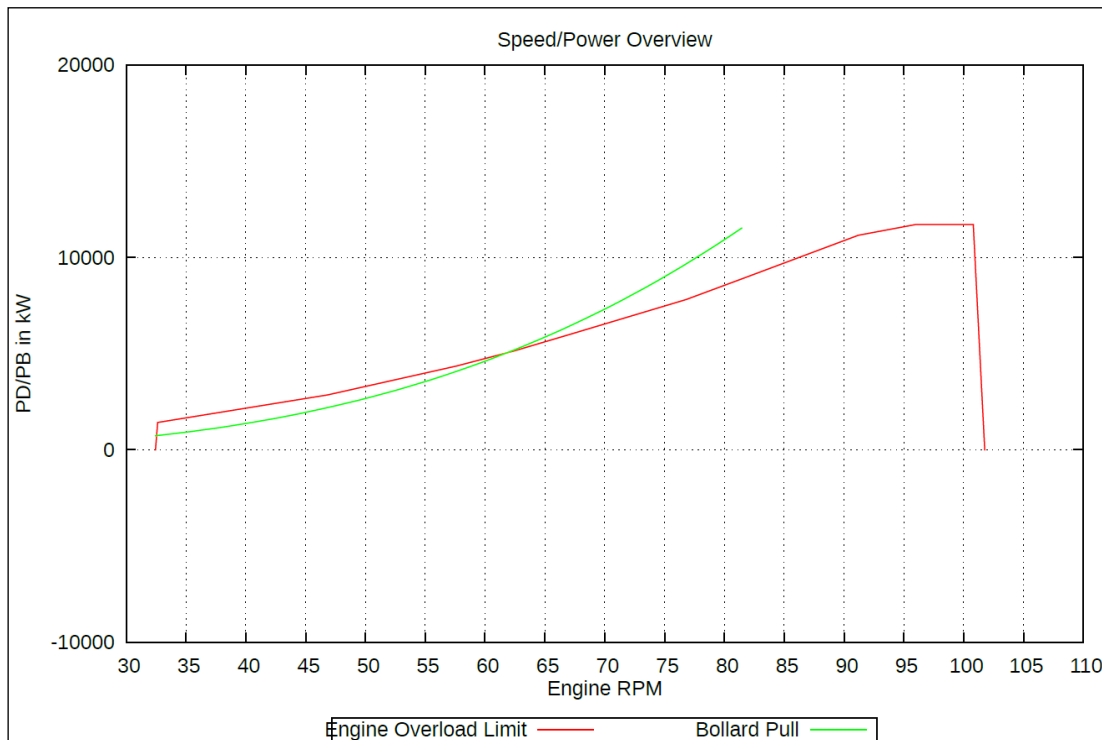
Figure 44: The GLORY AMSTERDAM's propeller curve

The diagram at **Figure 44** below shows that the propeller curve intersects the engine curve at approximately 60 RPM. At this rated speed, the propeller then produces about 1,022 kts of thrust. Since, as explained above, the additional resistance of the ship calculated due to wind and swell is about 1,113 kts, the propeller alone could no longer hold the ship.

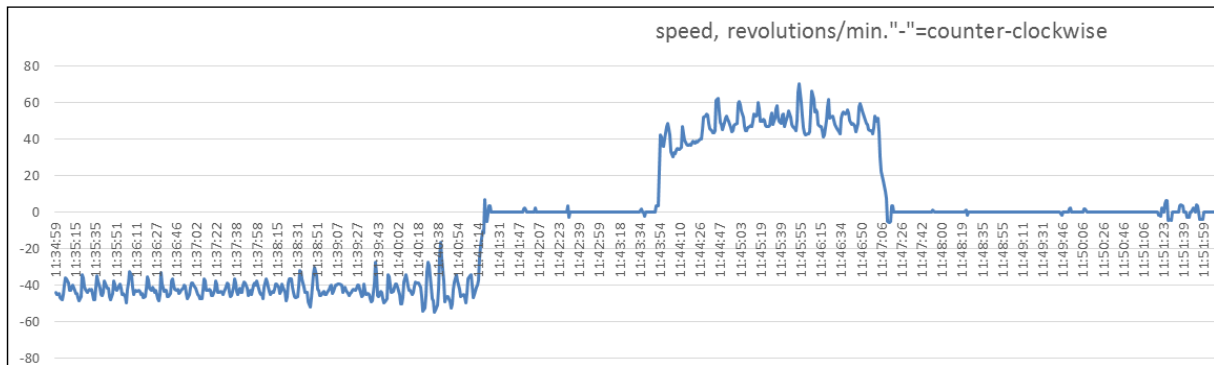
Figure 45: Fluctuations in the rated speed

Figure 45 below shows an example of the discussed drop in rated speed from 60 to 45 RPM for the period 1135 to 1200 UTC, for example, based on the relevant recordings on the GLORY AMSTERDAM's VDR. The graph illustrates that this effect occurred during both the full ahead manoeuvre (1135 to 1141 UTC) and the full astern manoeuvre (1144 to 1147 UTC).

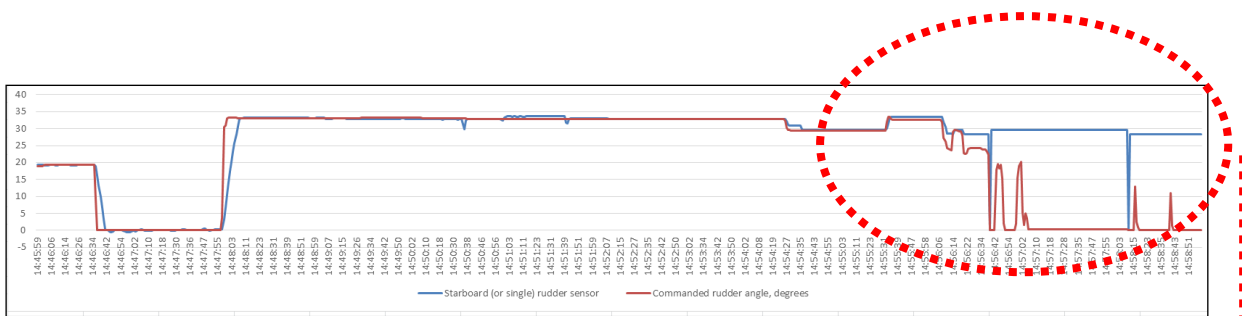
Figure 46: Functioning of the rudder in the period 1445 to 1459 UTC

The statement that the GLORY AMSTERDAM's steering gear actually did fail at precisely the moment or period when she was ordered to slip her anchors was confirmed in the relevant VDR recordings of the distressed vessel. The following **Figures 46 f.** provide a graphic representation of the actual rudder angles (blue curve) and helm commands (red curve) during the period **1545 to 1559**.

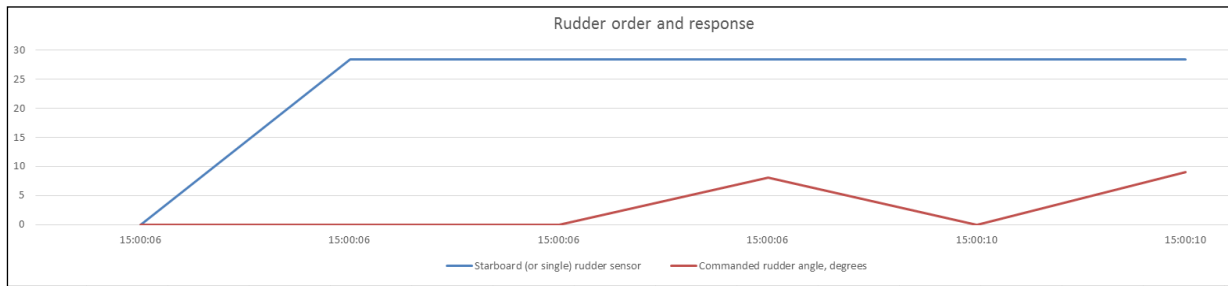
problem is not continuously illustrated by the other VDR recordings concerning the rudder because the corresponding VDR sensors were evidently also affected by the steering gear's technical problems. However, the rudder information recorded only sporadically by the VDR during the rest of the day (see **Figures 48 f.** below) suggests that the distressed vessel's steering gear no longer operated reliably after **1556**.

Figure 48: Indication of steering gear failure at 1500 UTC

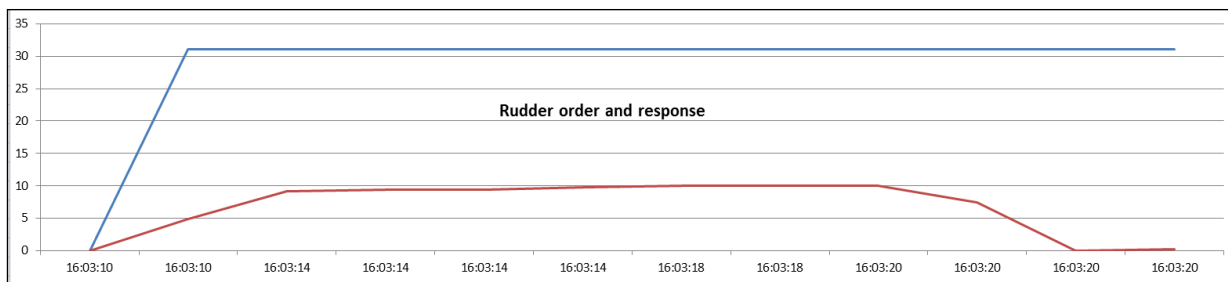
Figure 49: Indication of steering gear failure at 1603 UTC
