Bundesstelle für Seeunfalluntersuchung
Federal Bureau of Maritime Casualty Investigation
Federal Higher Authority subordinated to the Ministry of Transport
of Transport and Digital Infrastructure

Investigation Report 496/15

**Fire in the cargo hold of the
multipurpose ship VENTURA
off the canal locks
at Kiel-Holtenau
on 18 December 2015**

29 November 2019

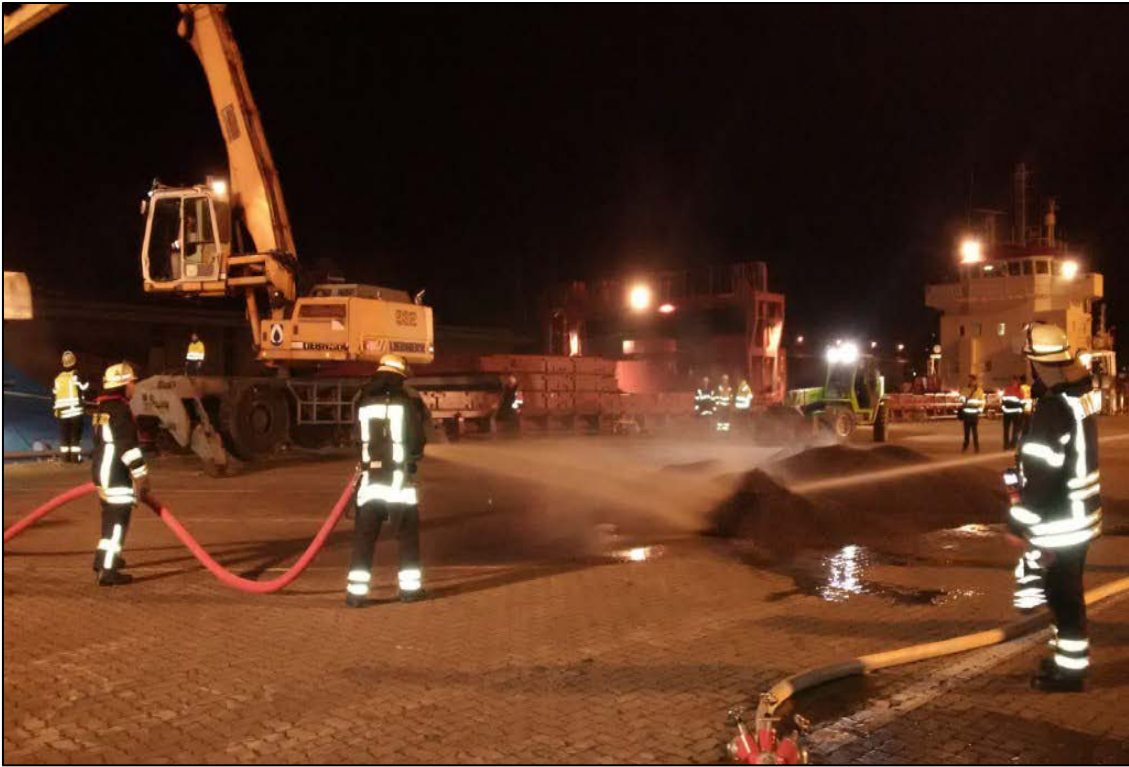
Figure 4: Fire service fighting the fire

In the meantime, all necessary preparations were made for unloading and extinguishing the affected cargo at the berth. The crew opened the hatch with the help of the ship's gantry crane. The smouldering cargo was then unloaded directly onto the pier by means of a grab crane, where it was extinguished by the fire service. The operation was reported as completed at about midnight.

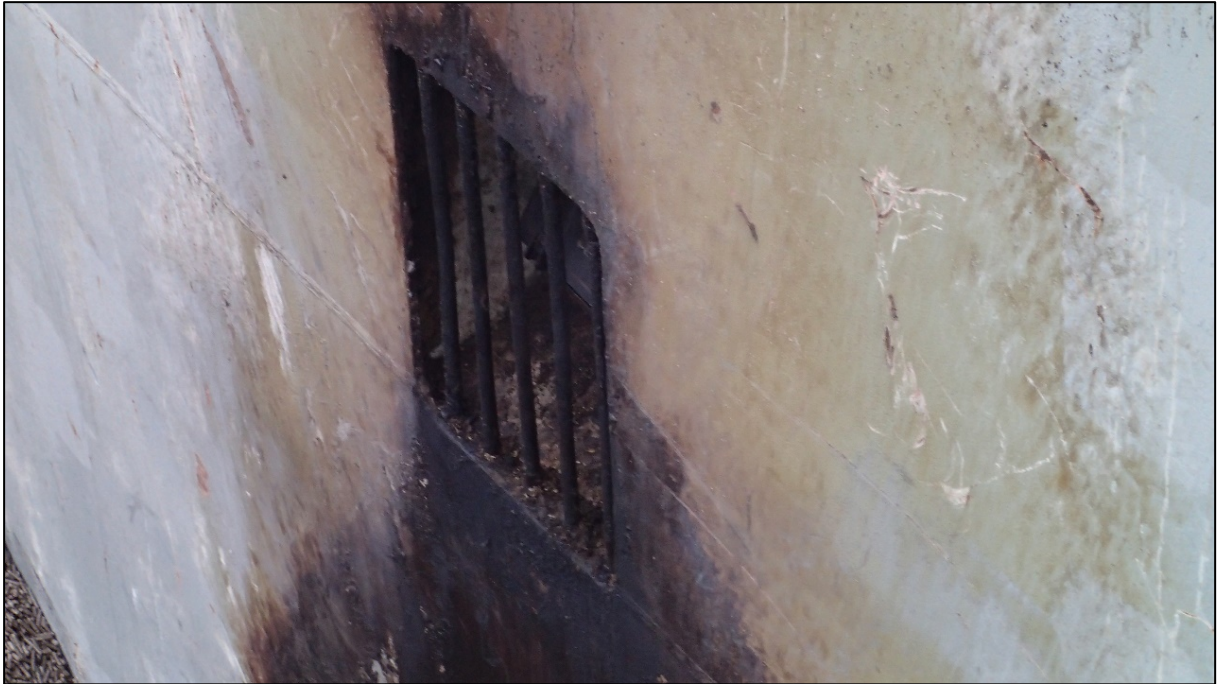
Figure 6: Fire damage on the starboard leading edge of cargo hold 1

When considering the severity of the damage, it is evident that there are areas on the leading edge of cargo hold hatch 1 which have been more strongly affected by the effects of the fire and adjacent areas which are either affected less or not at all. The following figures document the aforementioned facts:

Fire damage can be seen below and on the starboard hatch lighting's protective grating.

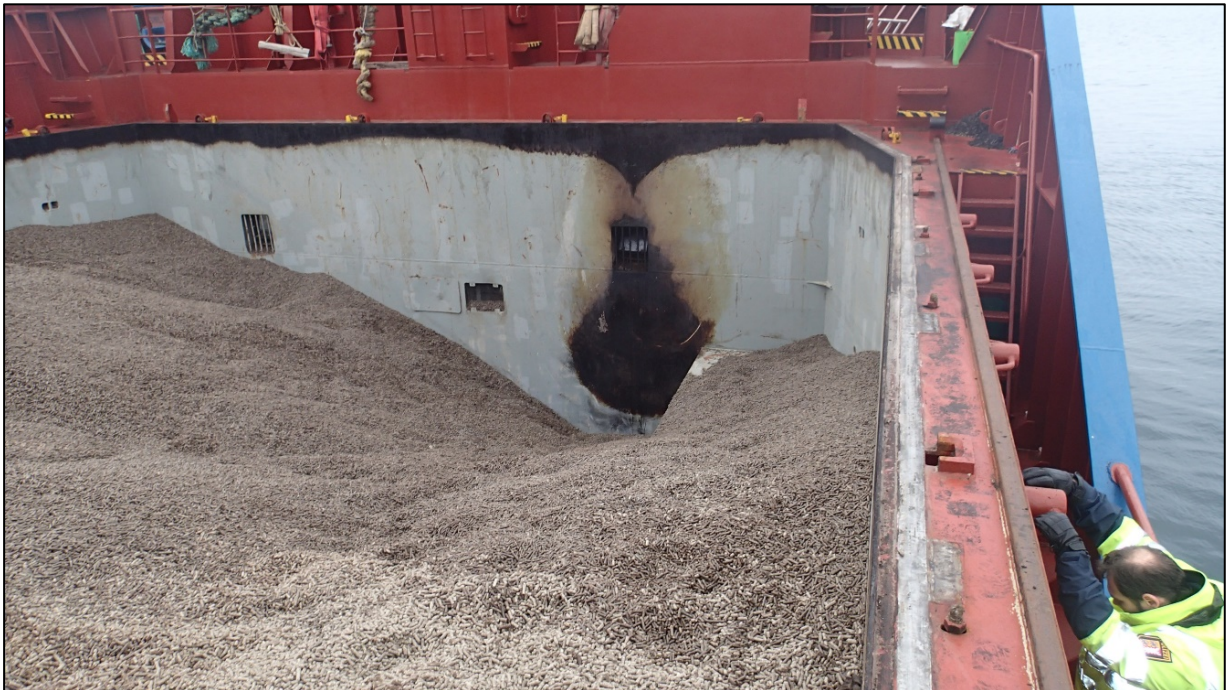
Figure 7: Area fouled by soot above the cargo and hotspot on the wing tank

It is worth noting that the smouldering fire was limited to a relatively small part of the cargo. Accordingly, the conditions prior to ignition may have developed over an extended period. It seems that the smouldering fire was only starting to develop when the increase in temperature (or smoke development) was detected. For example, the 50 °C found at the cargo hold hatch corresponds to the self-heating temperature of organic materials. The assumed spontaneous ignition and ensuing smouldering fire has a temperature of 250-270 °C in the case of sugar beet pulp. These temperatures also correlate with the damage patterns on the cargo hold walls.

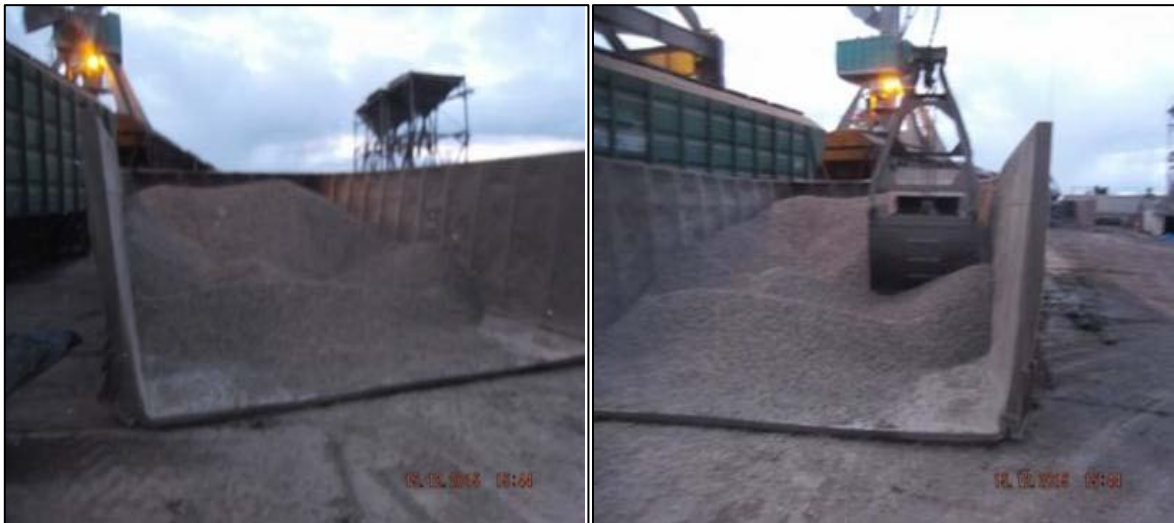
Figure 10: Photographs of the cargo taken at 1544 local time on 15 December 2015

The cargo's moisture content is another factor that supports the assumption of spontaneous ignition. According to the cargo documents or the 'Form for Cargo Information for Solid Bulk Cargoes', the cargo's moisture content was 11.3%. The maximum moisture limit for this cargo is specified at 12%. This certificate is dated 14 December 2015. No other samples of the cargo, in particular that from the open troughs, were taken after it stopped raining. However, it is reasonable to assume that there was higher moisture ingress into parts of the cargo.

The transportable moisture limit has been specified as 12% for this cargo and means that this is the maximum moisture content of the cargo that is considered safe for transportation on ships. If it is found that the cargo has a higher moisture content, then it is strongly recommended that the cargo only be transported if the ship is specially built or equipped. The ultimate decision as to whether cargo may be loaded and transported always rests with the master. In the case of the VENTURA, the cargo's moisture content was 11.3%. According to the cargo documents, this value was certified on 14 December 2015 and applies to the entire cargo at that time. No further samples were taken during the loading operation, in particular after precipitation.

The Federal Bureau of Maritime Casualty Investigation recommends that the owner, Erwin Strahlmann GmbH & Co. KG, advise its ship's command to the effect that if solid bulk cargo is loaded from open troughs or the like, which are not protected ashore from any type of precipitation, new samples must be taken in respect of the moisture content and that parts of the cargo must be excluded from loading if required limit values are not met.

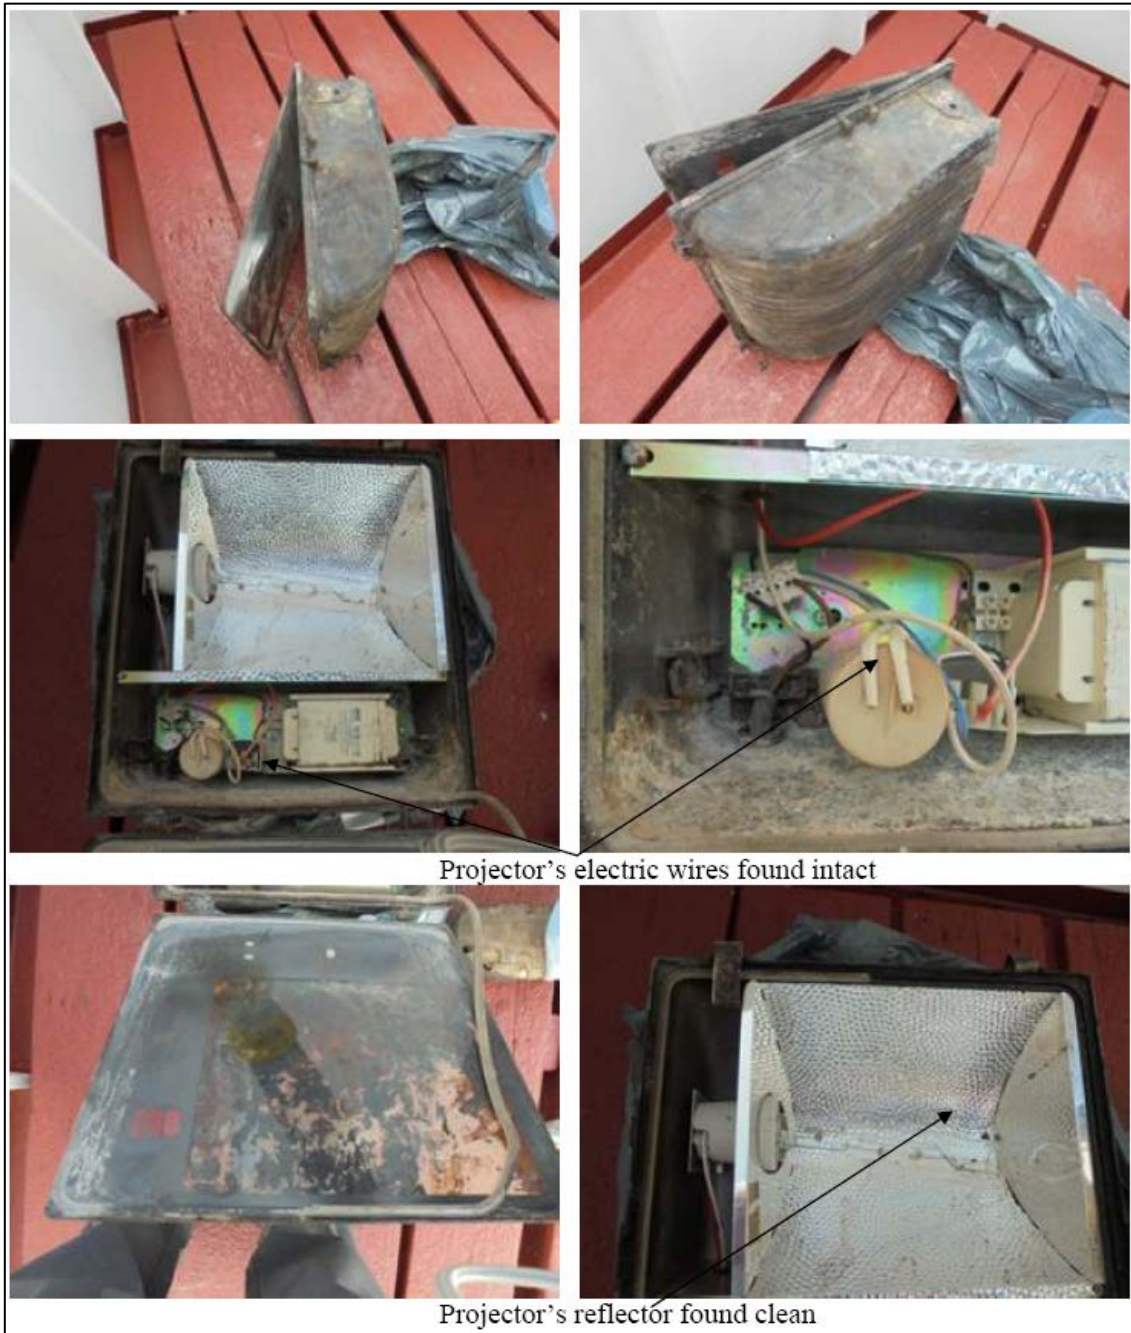
Figure 13: Starboard cargo hold lights

The cargo hold light located above the hot spot on the forward starboard side of cargo hold 1, which is one possible cause of the fire, was examined thoroughly. Although this was within the range of the highest thermal load, the cargo hold light was still fully functional. There was no damage to the reflector, glass or cables. The cargo hold light pair could be switched on and off. This means that a defective cargo hold light can be ruled out as the cause of the fire with certainty.

After completion of the investigations the BSU was able to rule out the assumption that the starboard cargo hold light triggered the fire as a direct source of ignition. The cargo hold light and bulb installed in it were clearly not defective.

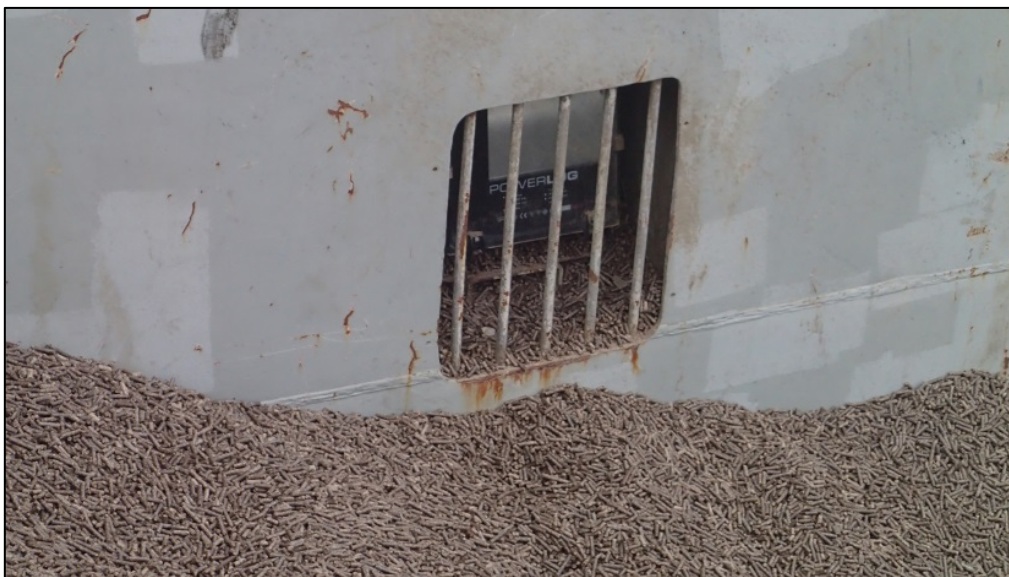
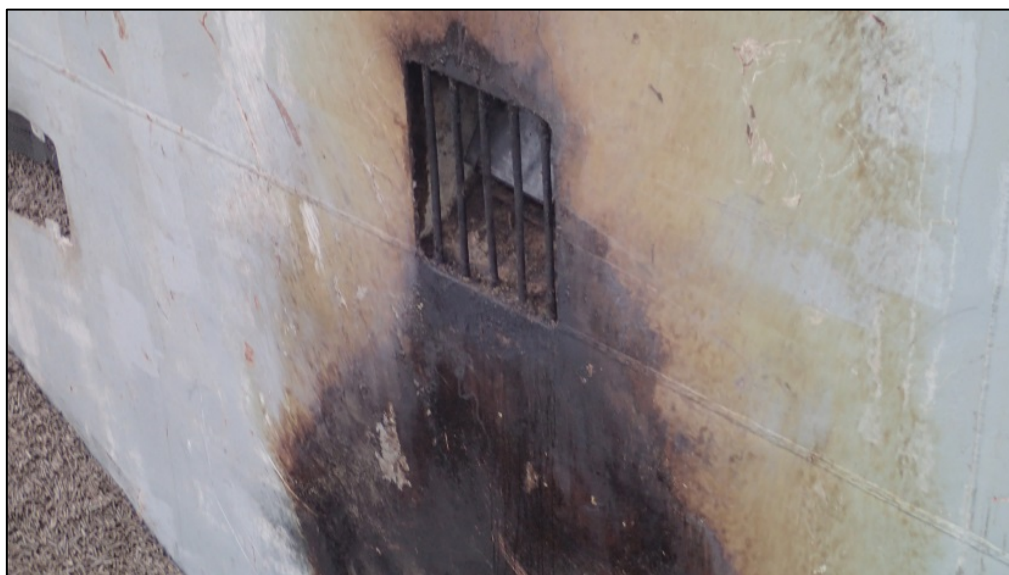
As already discussed, only two cargo hold light pairs can be switched on or off at the same time. However, the overall damage pattern indicates that the fire started on the starboard side below the forward cargo hold light. Another assumption is that this cargo hold light constitutes an indirect source of ignition. According to the report commissioned by the BSU, the Powerplug halogen spotlights installed (output: 400 W) reach a surface temperature of 400-500 °C during operation, which is also the cargo's ignition temperature. The crew stated that the cargo hold lights were not in operation, however. It has not been possible to clarify whether they were switched off during the entire loading operation or only shortly before the relevant cargo depth was reached.

The Federal Bureau of Maritime Casualty Investigation recommends that the owner, Erwin Strahlmann GmbH & Co. KG, advise its ship's command that the niches in which cargo hold lights are located should be sealed when solid bulk cargo is loaded above them so that it cannot pass through their protective grating and come into direct contact with the lights. This would rule out the possibility of a direct or indirect source of ignition originating from cargo hold lights that were not switched off or defective.
