Bundesstelle für Seeunfalluntersuchung
Federal Bureau of Maritime Casualty Investigation
Federal Higher Authority subordinated to the Ministry
of Transport and Digital Infrastructure

Investigation Report 52/18

Serious Marine Casualty

**Allision of the container ship AKACIA
with a lock gate on the Kiel Canal in Kiel-Holtenau
on 19 February 2018**

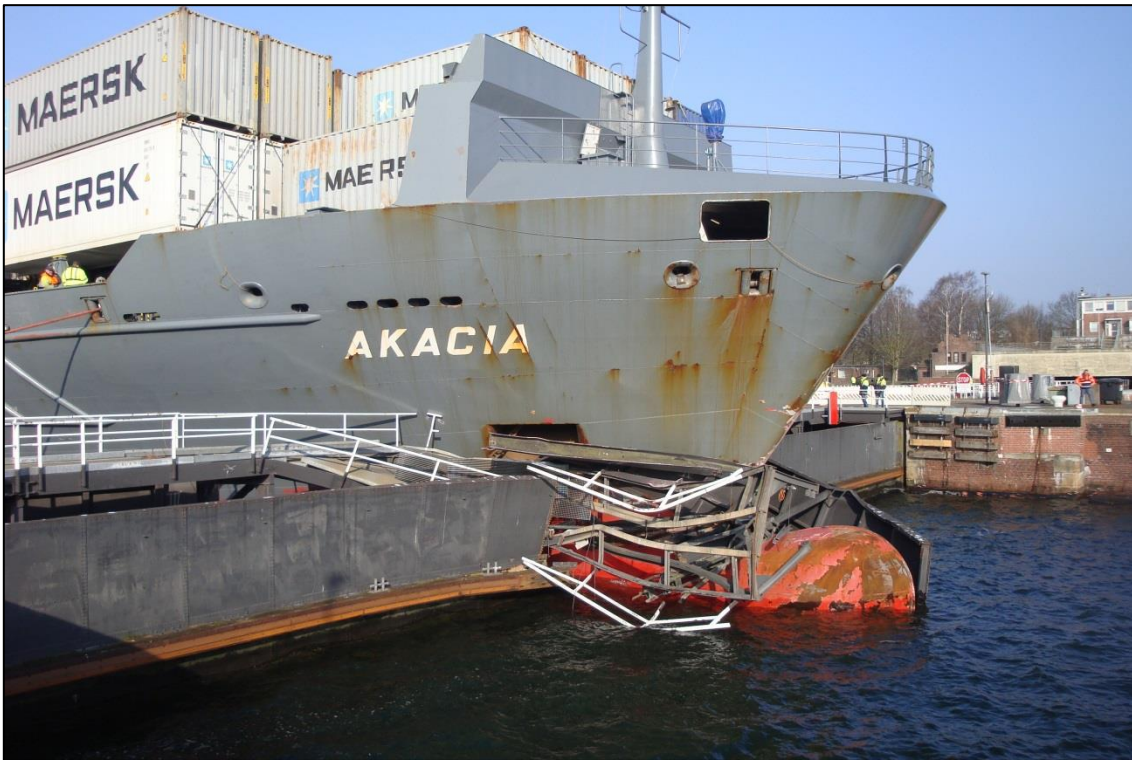
All other measures of the ship's command, such as an emergency anchoring manoeuvre with both anchors and a main engine emergency stop failed to lead to a significant reduction in speed. Consequently, the lock gate was hit at 2354² at high speed. Part of the ship's fore section broke through the gate, her bow sustaining heavy damage in the process.

Figure 4: The AKACIA and the damaged lock gate

After the allision, crew members were sent to the fore section to check the extent of the damage. It was found that the bow thruster room was filled with water. The forepeak was also affected and slowly filling up.

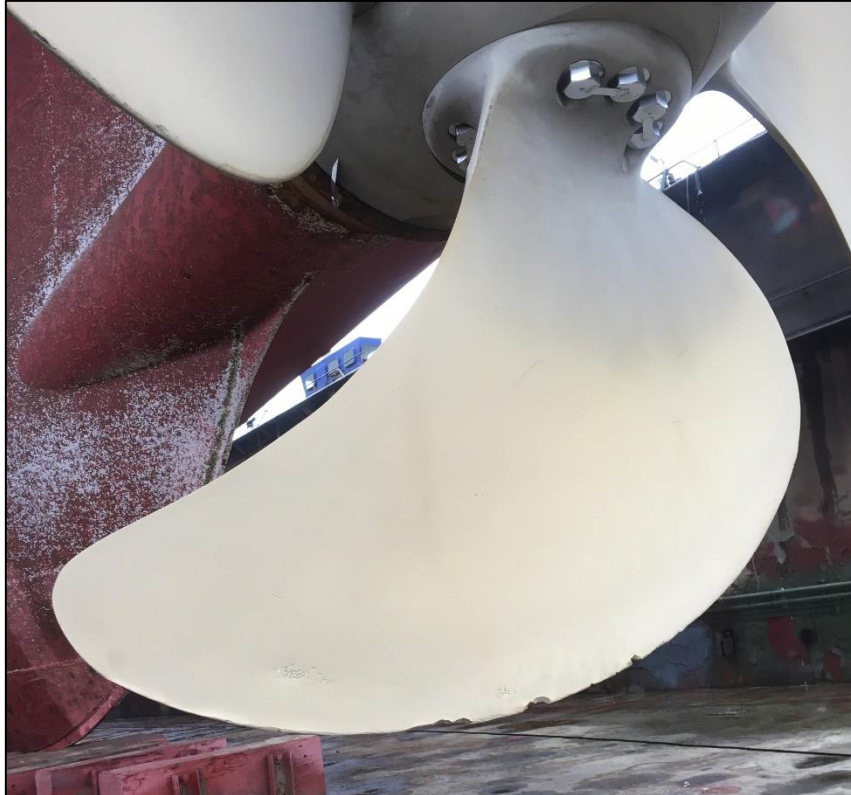
Damage caused by an earlier contact with a solid object was found on the propeller blades and inside the propeller hub during the investigation. Resulting fragments were then transported through the CPP system's hydraulics. The investigators believe one of the fragments blocked the valve needed to adjust the pitch at the time the system failed.

The AKACIA was surveyed on 12 March 2018, by which time she had been moved to Hamburg and dried in a floating dock at the Norderwerft shipyard. Damage to the propeller blades was found during the survey of the hull and propeller in the dock.

Figure 36: Damage to one of the propeller blades

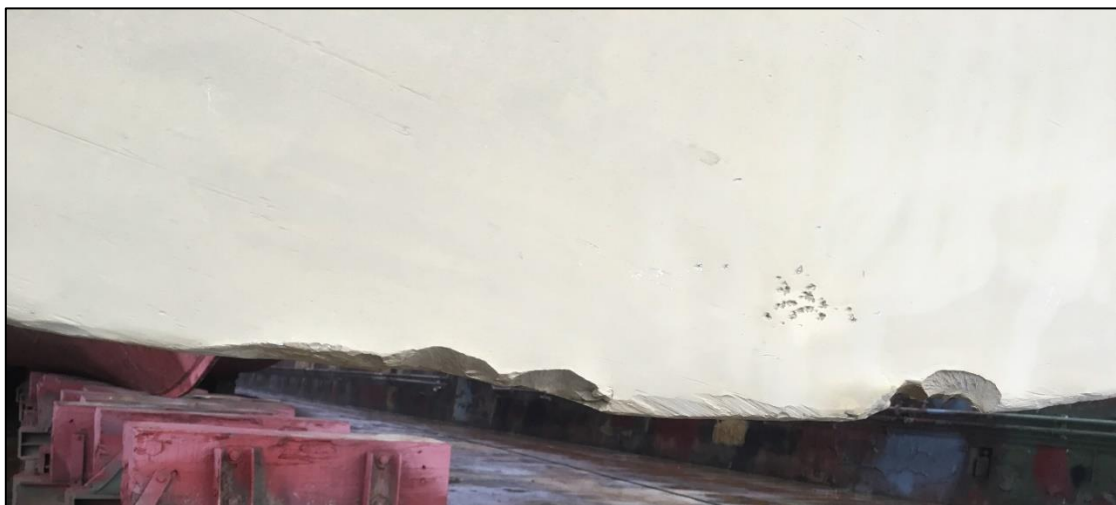
Figure 37: Close-up of the damage

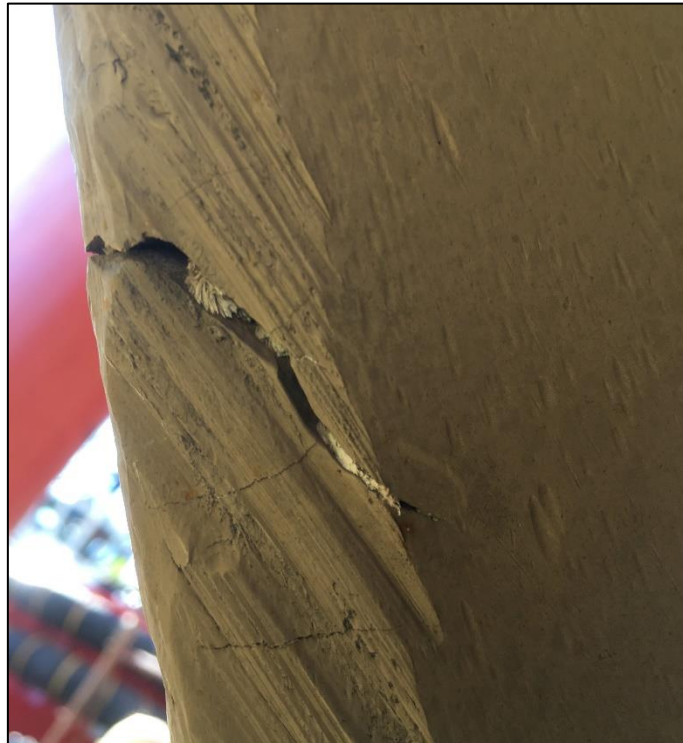
The damage to the propeller blades was re-examined on 19 March 2018 and remnants of line were found in cracks in one of the accessible propeller blades.

Figure 38: Crack in one of the propeller blades
Remnants of line were found in the crack.

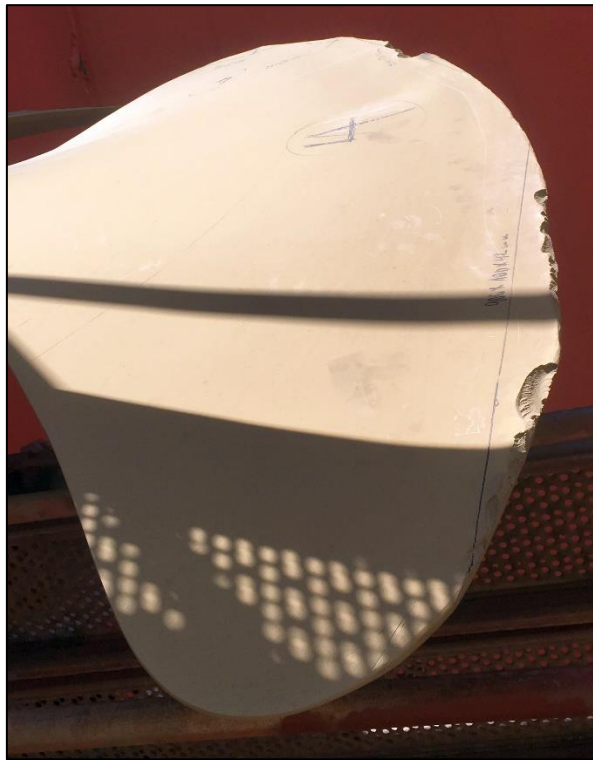
Figure 39: More damage on another blade

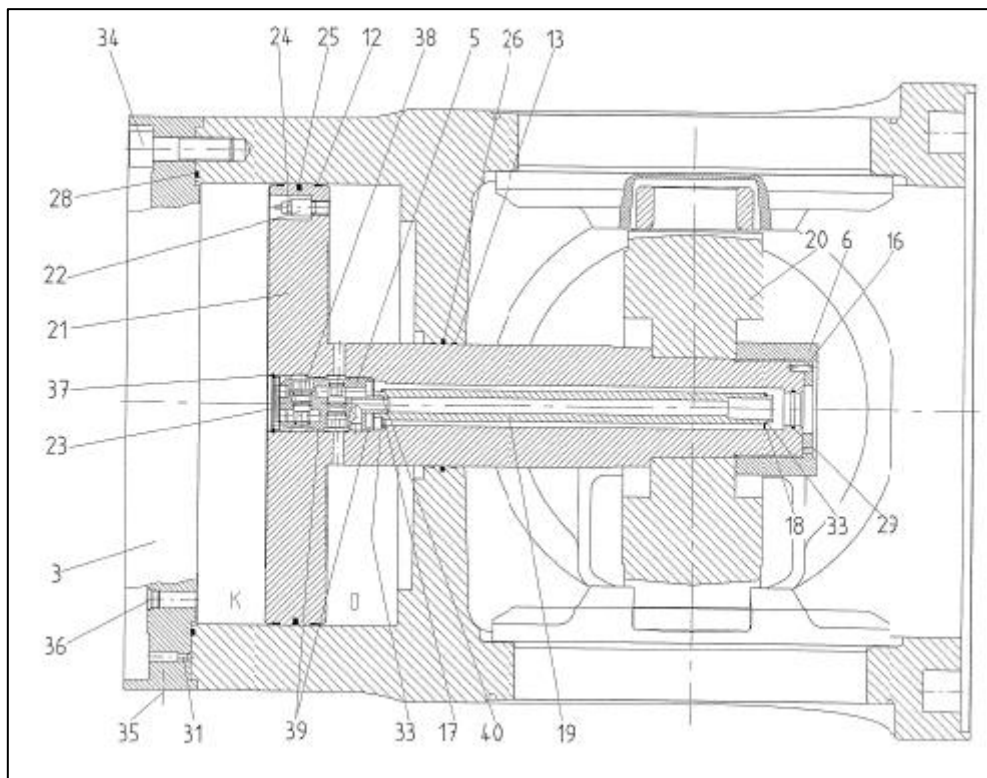
In the late afternoon of 21 March 2018, staff of SCHOTTEL had opened the propeller hub far enough for the valve body (Figure 40: 5) to be pulled out of the hub. It was found that the seal ring/O-ring at the front in the direction of travel (Figure 40: 39) was torn. In addition, it was noted that a support plate (Figure 40: 17) and a retaining ring²³ (Figure 40: 33) were not in their place.

Figure 40: Propeller hub

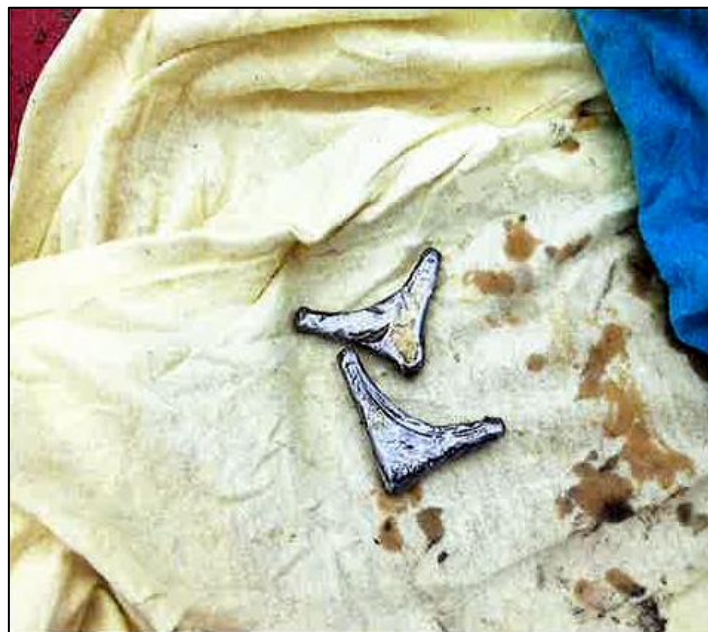
When the CPP system was further dismantled in the shipyard, the service technician found fragments of the support plate in the system.

Figure 42: Fragments of the support plate found²⁶

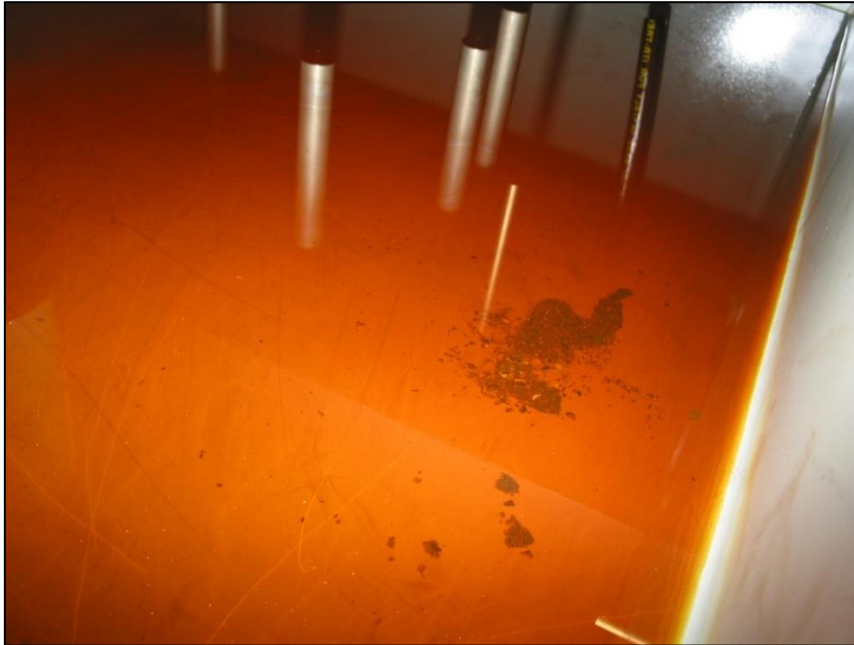
Due to the findings made on the day before, another survey on board was carried out on 22 March 2018. Particles were clearly visible at the bottom of the tank, which was now almost empty. In addition to metal particles, plastic particles were also found (Figures 43 and 44).

Figure 43: Deposits in the tank of the hydraulic power unit

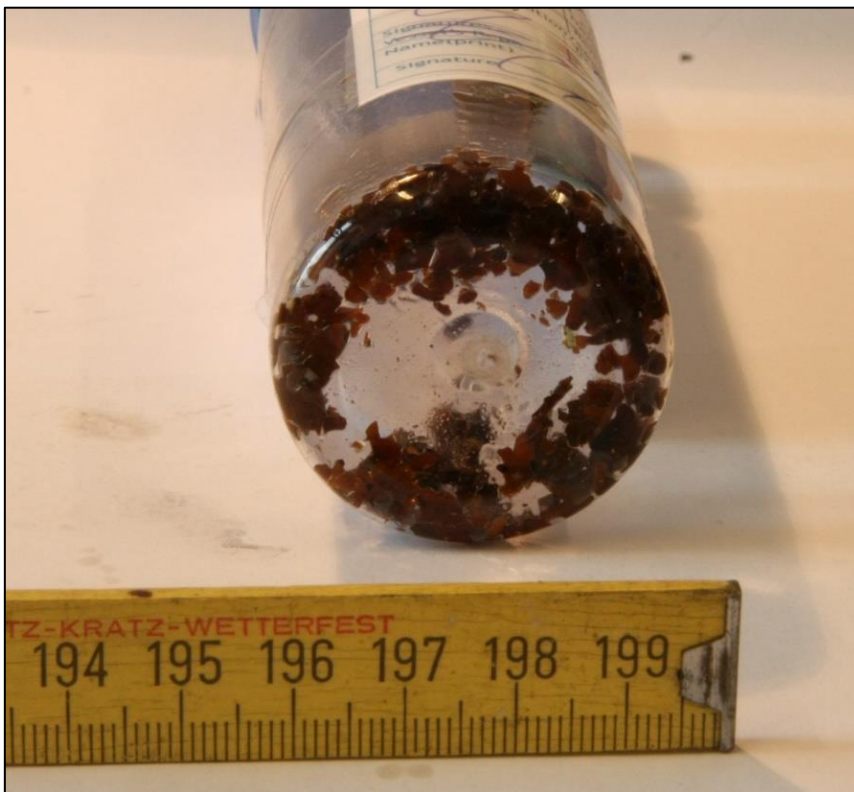
Figure 44: Sample of particles found in the tank

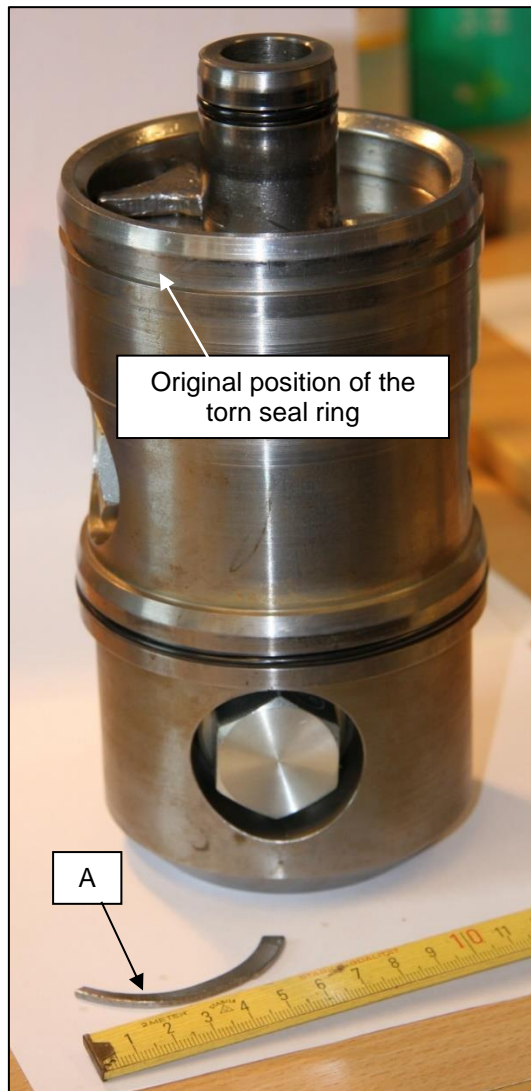
Re 1.: It was found that a metal foreign body was caught in the valve body and that there was damage in the form of a dent on the forward edge of the valve body. The foreign body was removed.

Figure 45: Valve body and removed foreign body (A)²⁷

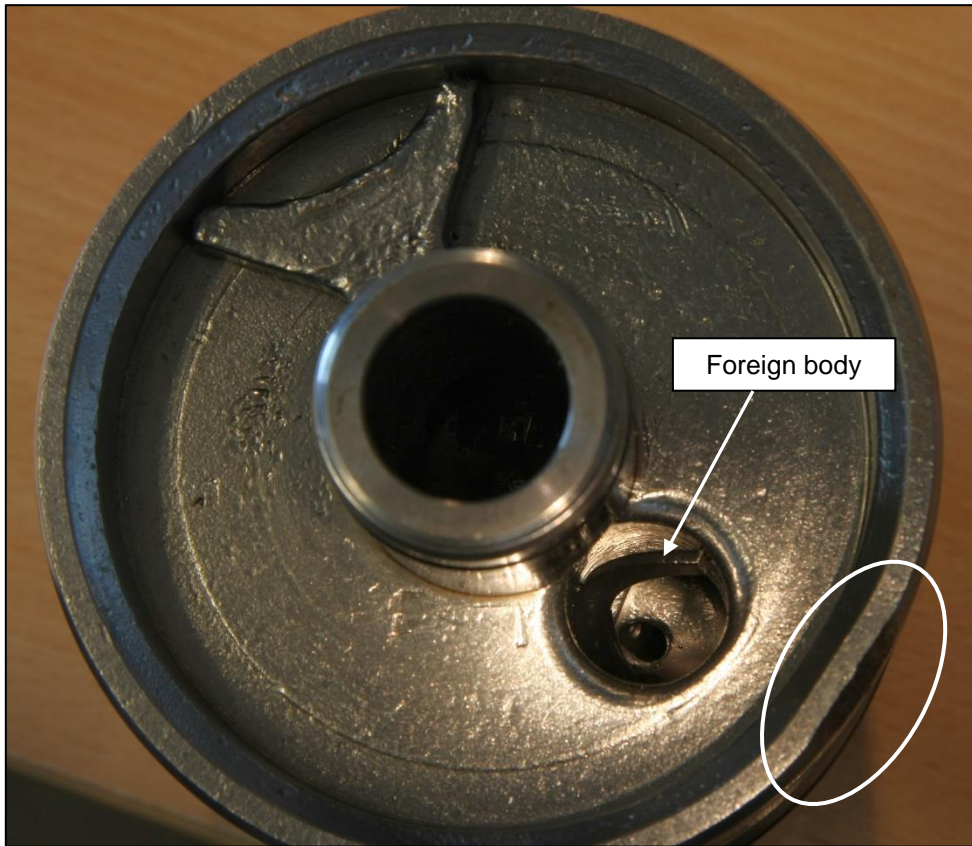
Figure 46: Valve body belonging to the hydraulic cylinder in the propeller hub
Top view with foreign body before removal and the damage in the form of a dent shown here.

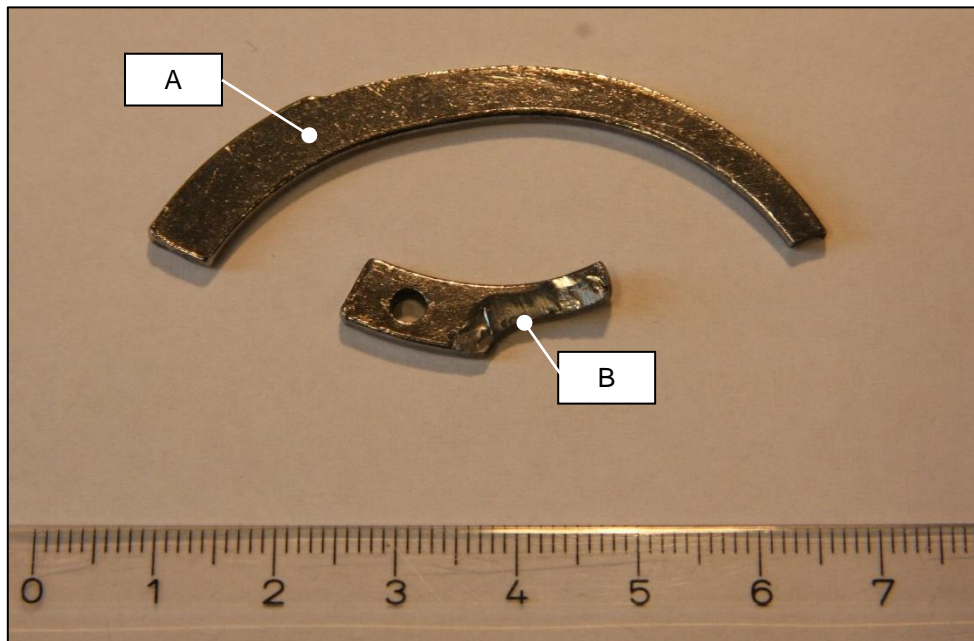
Figure 47: Removed foreign bodies
A: foreign body from the valve body; B: foreign body from the non-return valve

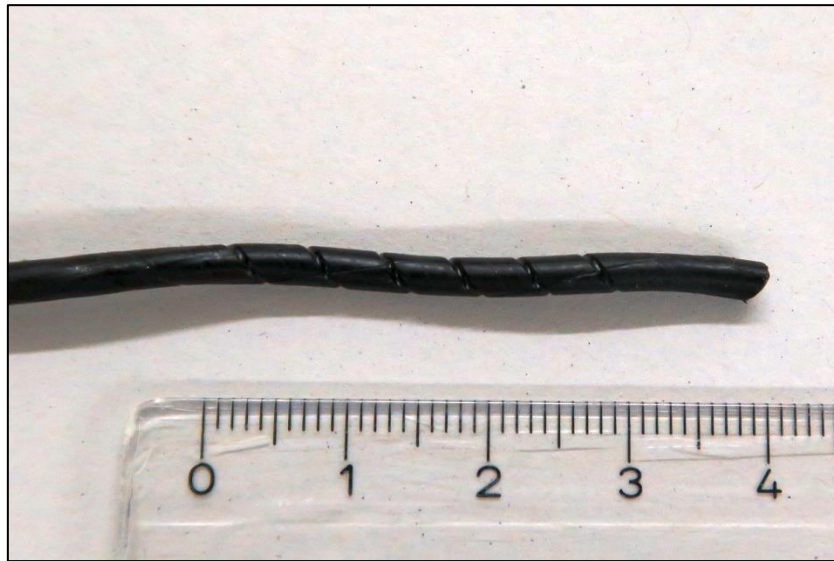
Figure 48: Torn seal ring with notches

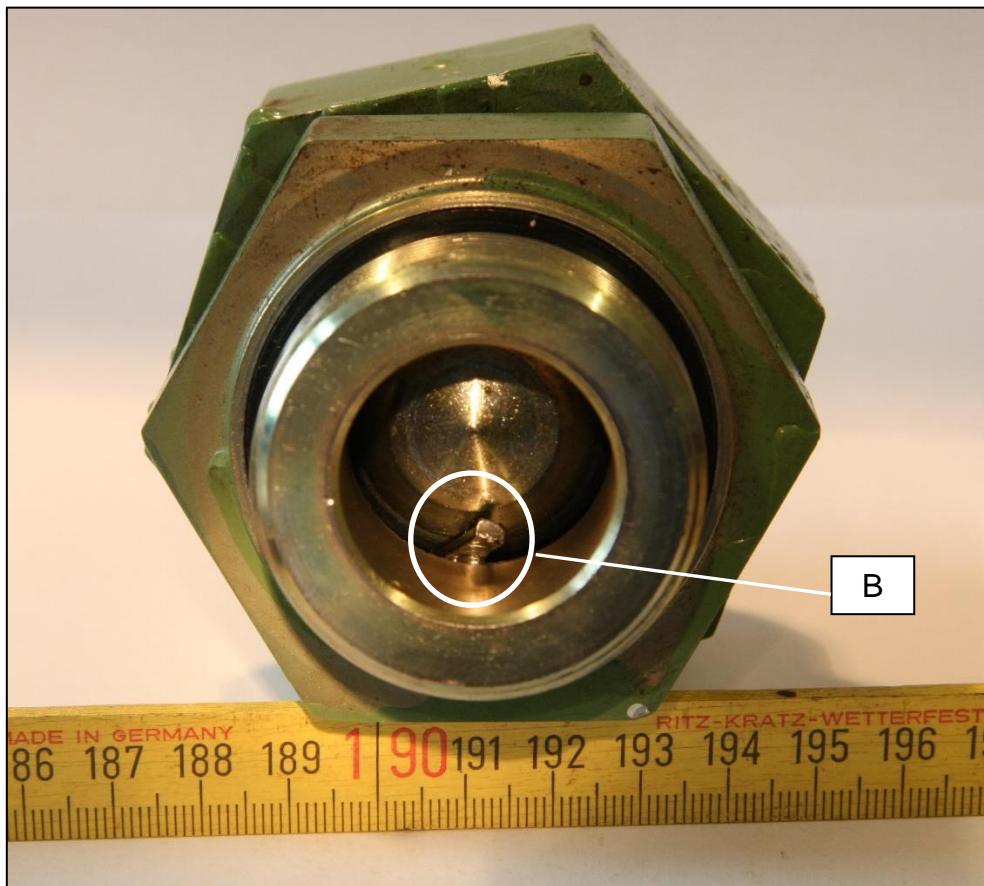
Figure 49: Non-return valve with foreign body (B)²⁸

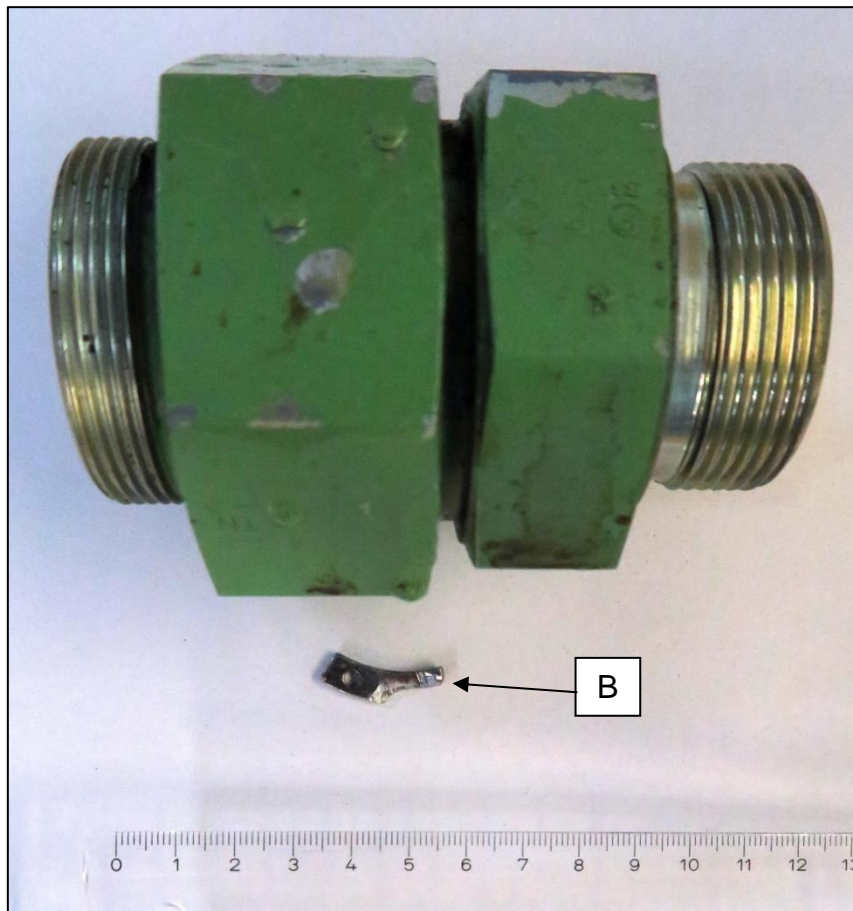
Figure 50: Non-return valve and removed foreign body

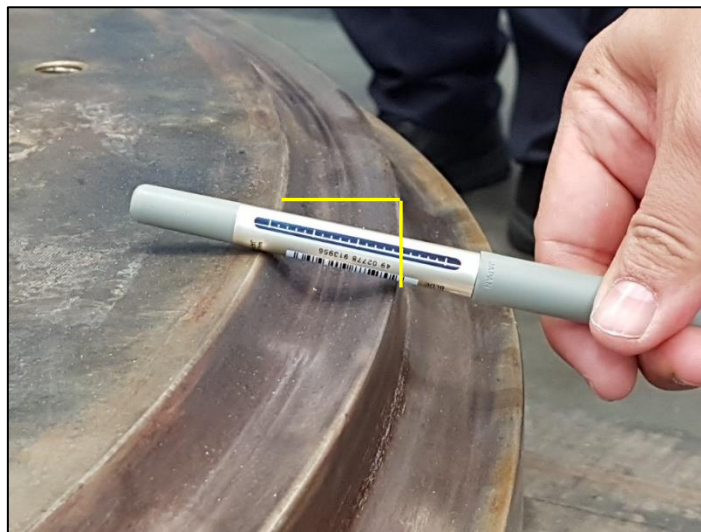
On 12 April 2018, the investigating police officers and the BSU were able to survey the disassembled CPP system in Wismar in one of the manufacturer's workshops, during which other damage to the system was presented. For example, there was substantial abrasion on the cover flange²⁹ which possibly not be related to the cause of the damage inside the propeller hub. The investigators believe this is the result of abrasion caused by the rope guard.

Figure 52: Material removal on cover flange
Original condition of the component marked in yellow.

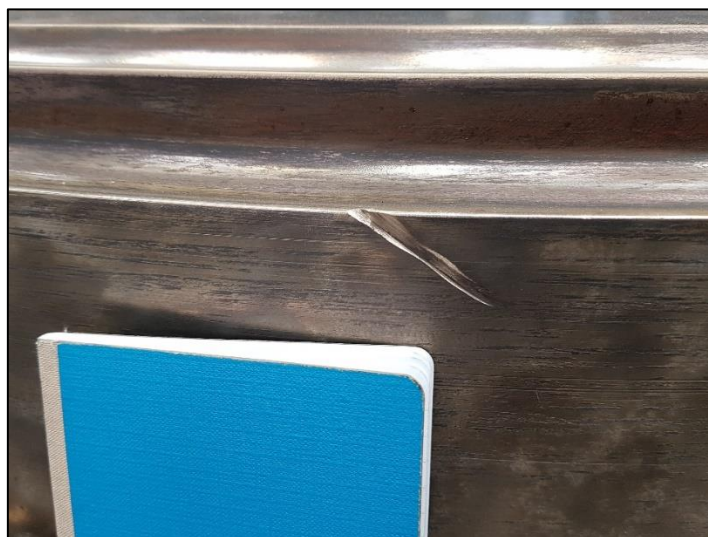
Figure 53: Notch on the bearing plate

During the survey, SCHOTTEL employees expressed the opinion that contact between the propeller blades and a floating line or fishing net reportedly did not cause the breakage of the parts in the propeller hub. The energy required for this could reportedly

only have been generated by contact with a solid object, i.e. a rock or floating container. The contact reportedly led to a sudden and substantial force being applied in a linear direction in the system. As a result, the broken component parts were reportedly also moved in the direction ahead and destroyed, as they are not designed for such loads.

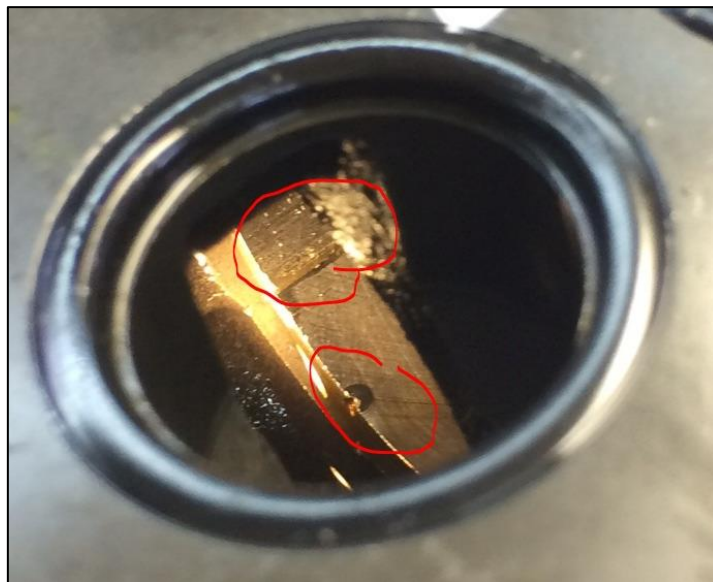
It was found during the assessment that the piston had jammed in the housing. The control edge of the connection from A to T on the piston had been damaged by a foreign body, which was no longer in the valve. Scores had formed on the control edge. The jammed foreign body led to the failure, as the piston was no longer controllable.

Figure 54: Damage to the control edge of the piston³⁰

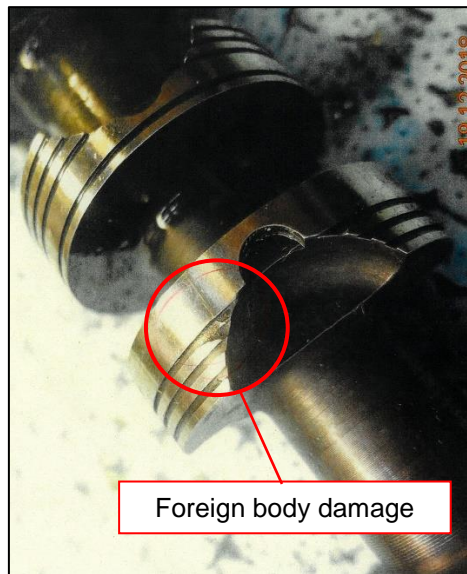
Figure 55: Damage to the piston of the proportional valve³¹

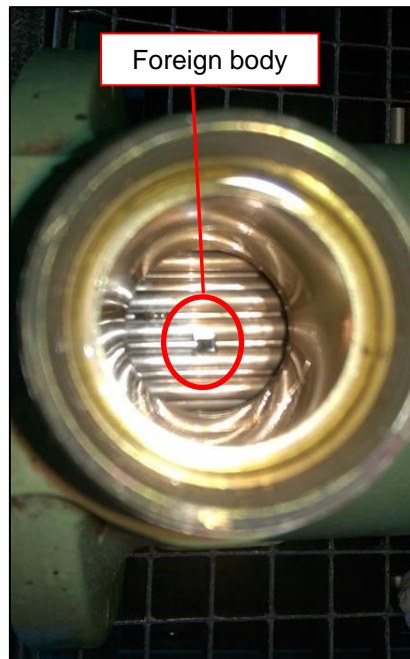
As part of the damage assessment and repair of the CPP system and hydraulics, Schlie Hydraulik Service GmbH dismantled, assessed, restored and flushed the hydraulic system in the AKACIA's engine room. During the assessment of the shell-and-tube cooler (oil cooler – see also Figure 27 for the position of the oil cooler in the hydraulic system), a foreign body was found inside the cooler. No other components, such as pumps or pressure limiters, exhibited any particular anomalies.

Figure 56: View into the shell-and-tube cooler³²

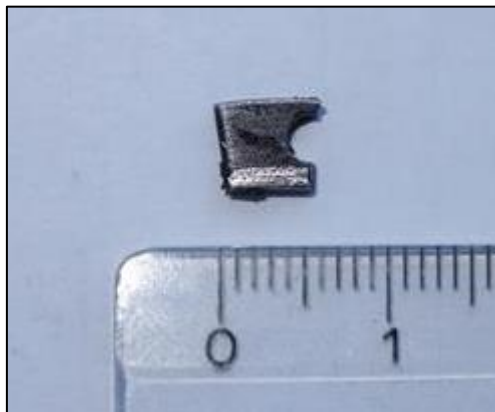
Figure 57: Identified foreign body³³

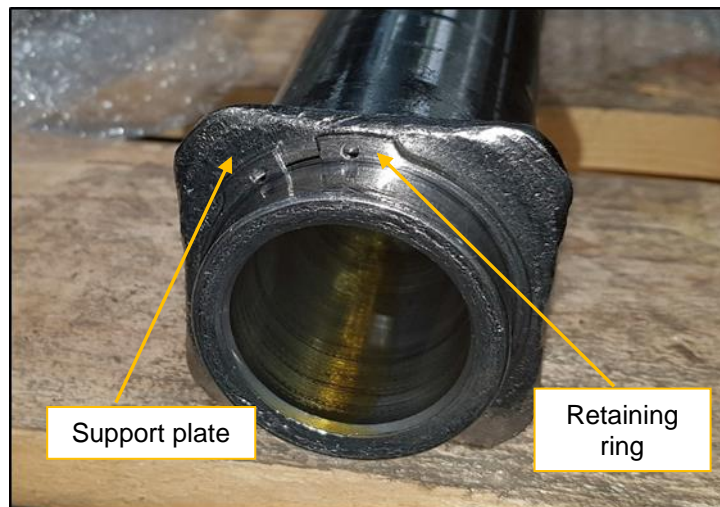
During the surveys in the course of the investigation and gradual dismantling of the system, other damage was discovered in addition to that on the propeller blades. For example, fragments of a retaining ring were found in the valve body and in a non-return valve upstream of the oil cooler and in the actual oil cooler. In addition, larger fragments of a support plate were found in the area of the adjoining pipelines after the valve body was dismantled. The retaining ring and support plate were not among the system's moving parts. Neither were designed to absorb greater forces acting in the longitudinal direction of the ship. Therefore, the harmful event destroyed them to such an extent that their fragments could enter the system.

Figure 59: Hydraulic oil pipe with support plate and circlip
