## **Investigation Report 71/17**

### **Very Serious Marine Casualty**

**Collision between the FV JAN MARIA and a fishing  
boat in the Mauritanian EEZ  
on 21 March 2017**

20 September 2019

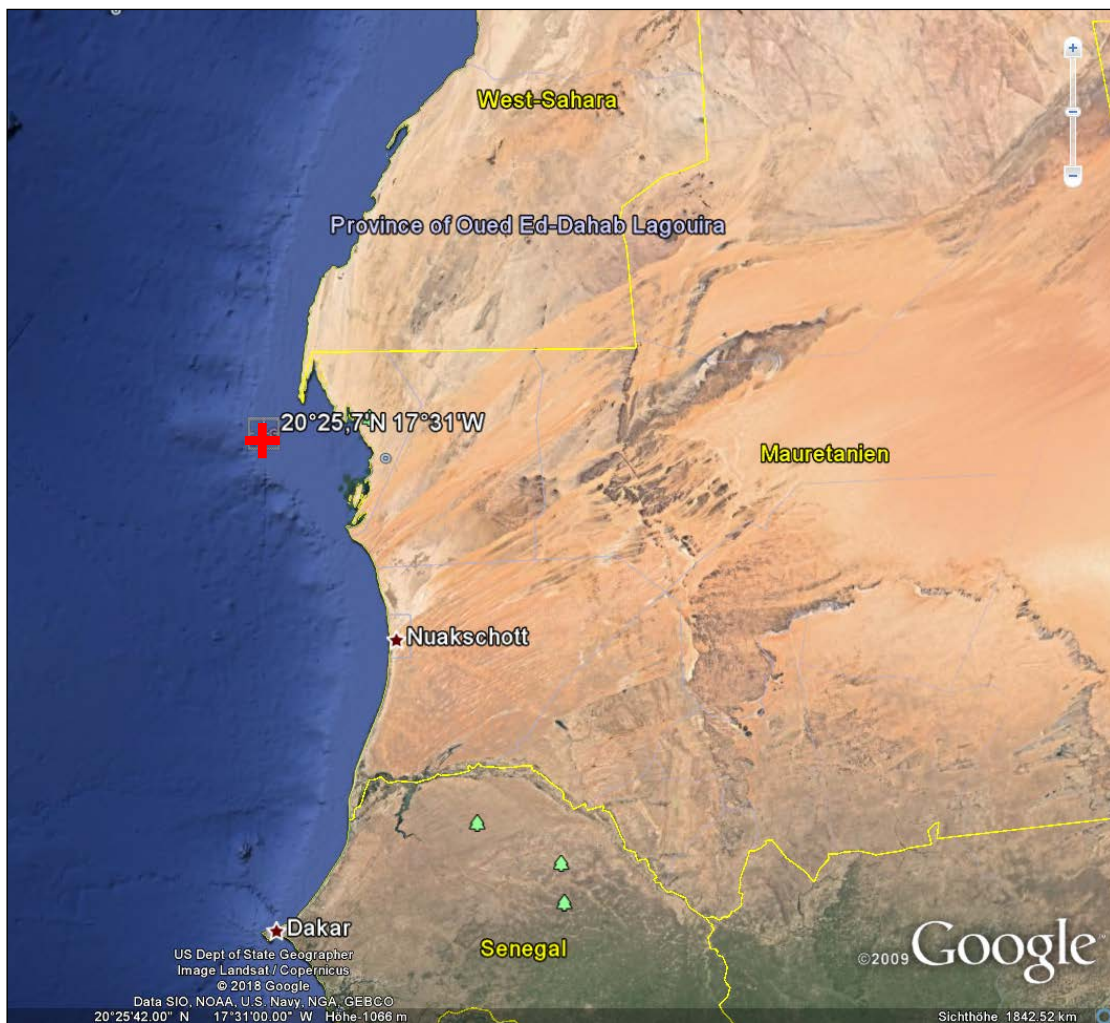
Figure 3: Scene of the accident

Type of accident: Very serious marine casualty  
Date, time: 21/03/2017 at about 0113  
Location: Atlantic; Mauritanian EEZ  
Latitude/Longitude: Approximately  $\varphi$  20°25.7'N  $\lambda$  017°31.0'W  
Ship operation and voyage segment: JAN MARIA: Preparing to fish (searching for fish)  
Fishing boat: Laid up  
Consequences: Fishing boat foundered; three of the fishing boat's crew members deceased

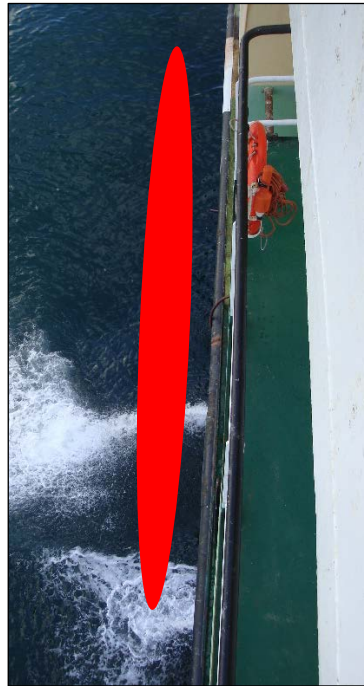
Figure 8: View from starboard wing to fishing boat (red ellipse symbolises boat, not to scale)

**Figures 6 ff.** show the position outside the bridge where the officer in charge of the navigational watch and the seaman (who reported the collision with the fishing boat) met, the position in the starboard wing from where they then looked for the object with which they had collided and the view from the position in question toward this object.

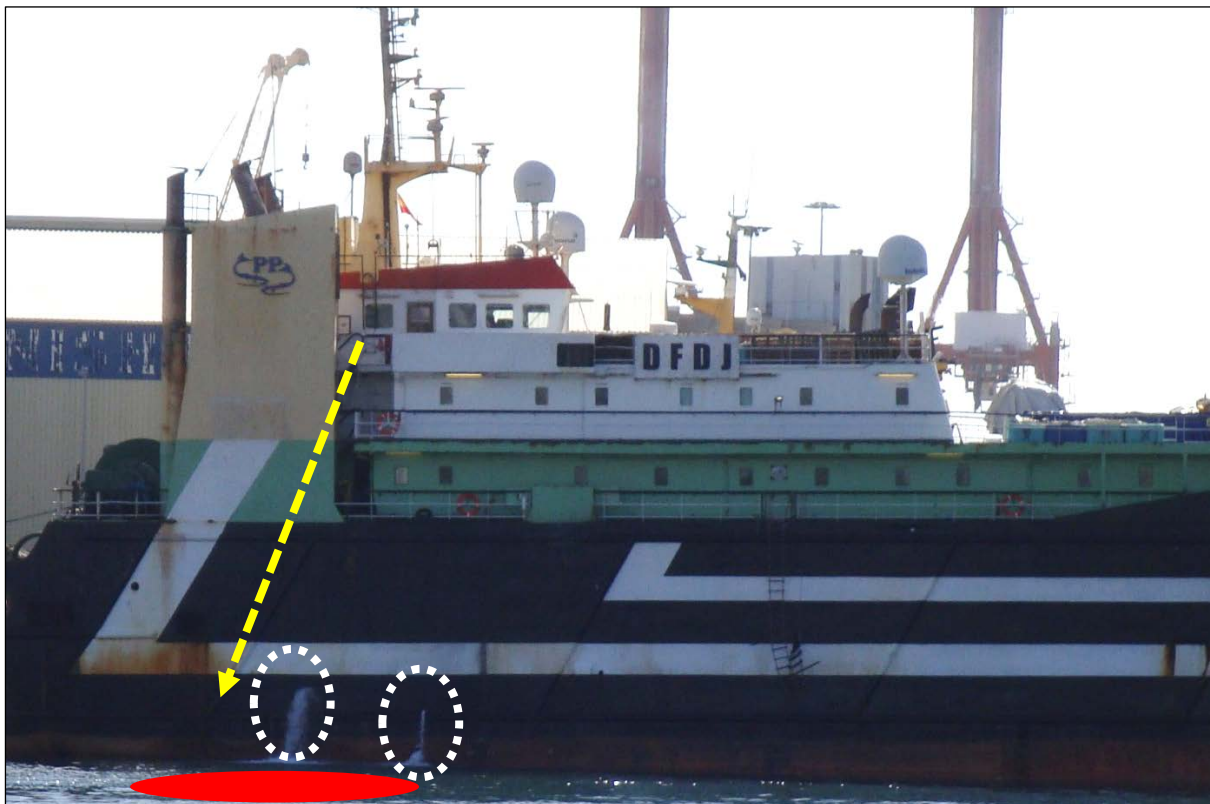
Figure 9: Starboard side of the JAN MARIA with schematic illustration of the position at which she and the fishing boat collided; direction of view from the wing to the boat (yellow arrow); cooling water discharge outlets (marked white)

**Figure 9** above shows that the JAN MARIA's hull has two cooling water discharge outlets directly above the area in which the two vessels collided. As with the time at which the photographs were taken, cooling water from the cooling water circuit belonging to the ship's air conditioning and cooling system also – and as per design – flowed out of these outlets when the accident occurred. At least one powerful water jet identical with those in **Figures 9 f.** flowed directly and continuously into the open fishing boat unchecked.

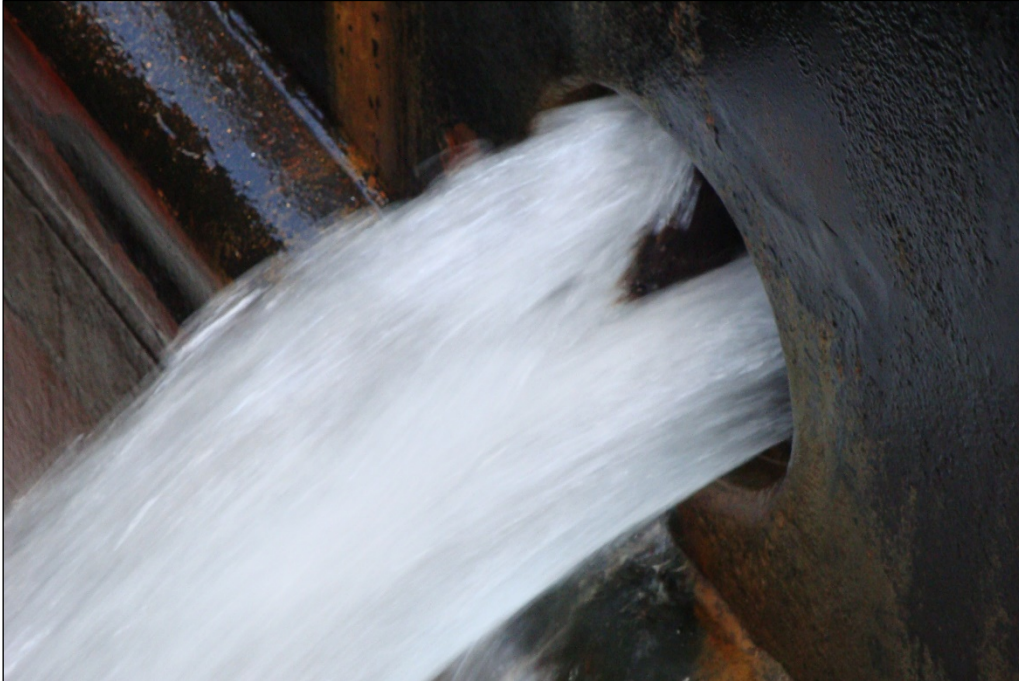
Figure 10: Cooling water discharge outlet (close-up)

The officer in charge of the navigational watch had already contacted the engineer on watch in the engine room by phone and asked him to shut off the cooling water discharge outlets before the master had arrived on the bridge. The engineer stated that it was reportedly not possible to shut them off immediately for technical reasons.

Following the BSU's investigation it is reasonable to assume that the officer in charge of the navigational watch immediately called the engine room personnel to arrange for the water outlet to be shut off as quickly as possible after noticing that the cooling water was flowing into the fishing boat. The engineer on watch advised the officer in charge of the navigational watch that it was not possible to shut it off immediately. Accordingly, the cooling water continued to flow into the fishing boat unchecked in the minutes that followed until she was completely flooded and foundered.

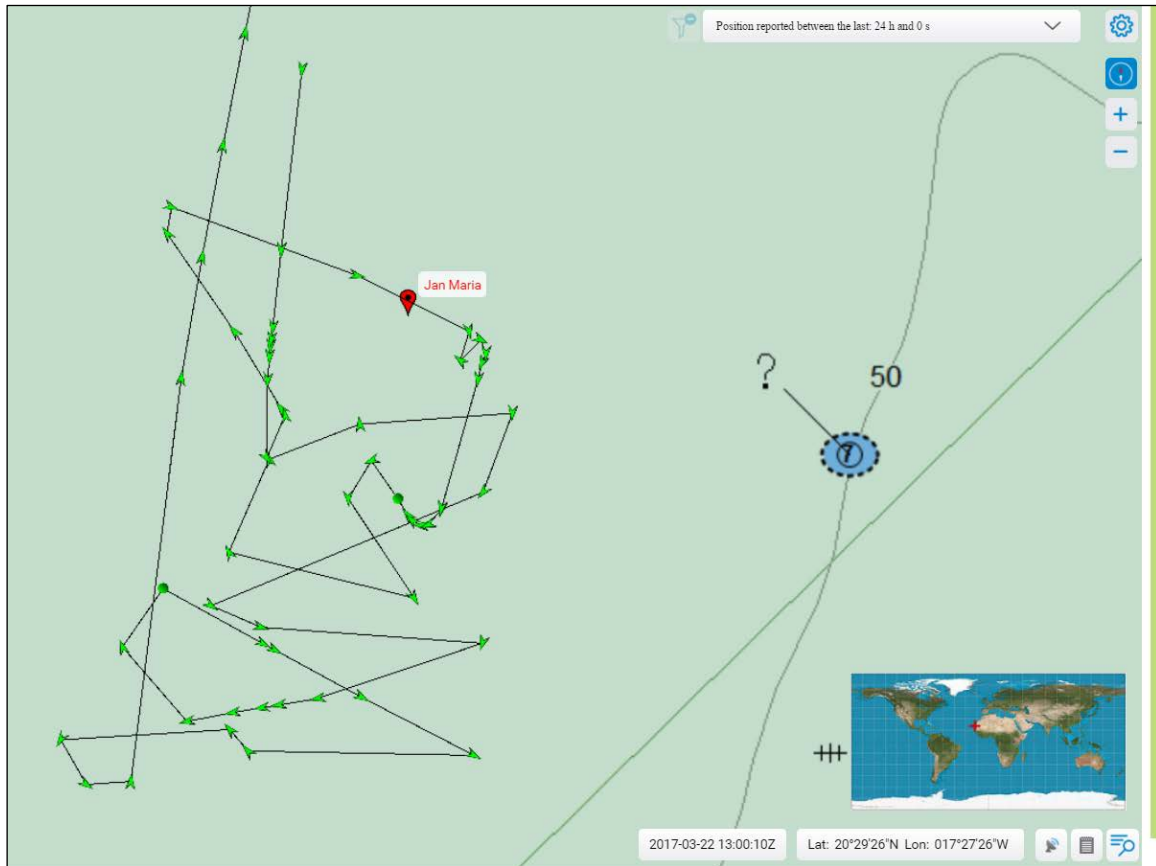
Figure 13: The JAN MARIA's SAT-AIS data on 20/21 March 2017 (accident/search area)

**Figure 13** below and an analysis of all the AIS data retrieved illustrate that after the accident the ship's command of the JAN MARIA made every effort to search the accident area systematically for the missing fishermen through frequently changing courses.

It should be noted that the ship positions displayed or their connecting lines can only give an approximate impression of the JAN MARIA's actual course. Due to the system, the underlying AIS data were not recorded continuously or at a constant interval. Instead, depending on the satellite constellation, there were distances of up to 35 minutes between two recorded positions during the period under consideration. It is also important to consider that the JAN MARIA only proceeded at an average speed of some 3 kts before and after the accident. Due to the system, this low speed additionally limits the reliability of the course lines calculated.

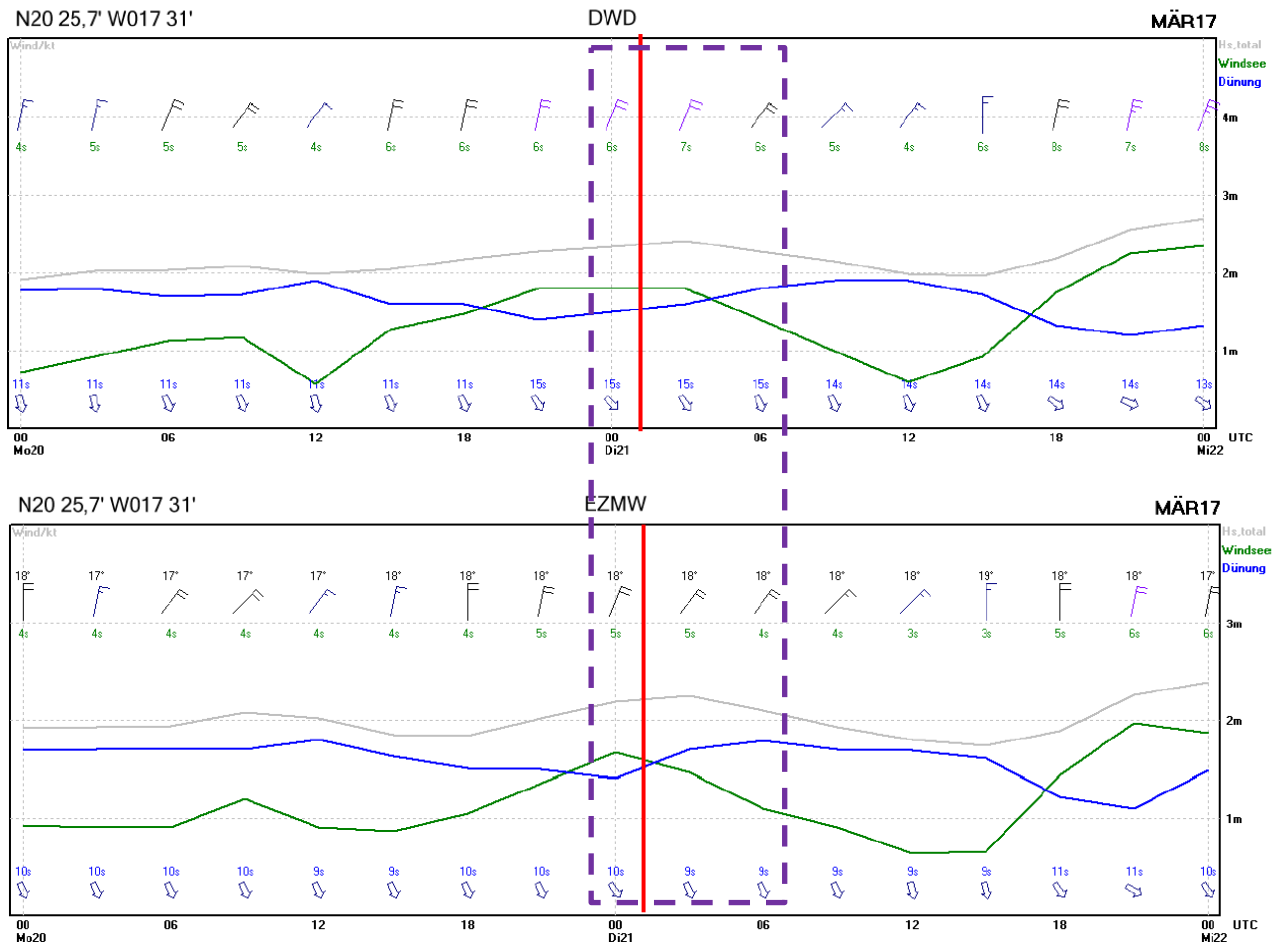
Figure 14: Development of wind and swell at the scene of the accident (red line: time of accident)

To describe the wind and swell conditions, the DWD referred to its own prediction model and additionally to that of the European Centre for Medium-Range Weather Forecasts (ECMW) in Reading, England. **Figure 14** shows the development of wind and swell from **20-22 March 2017** interpolated to the accident position and based on the analyses and forecasts of the DWD and ECMW [EZMW in below Figure]. The green curve shows the wind sea's proportion of the total significant wave height (grey) and blue indicates the swell's proportion, the direction of propagation and period of which are each shown at the bottom of the charts. Accordingly, the significant wave height was probably less than 2.5 m at the time of the accident. A force 5 (18-21 kts) north-east wind prevailed.

No serious weather deterioration in the hours after the accident was indicated at the scene of the accident, which was under the influence of a broad subtropical high. The two prediction models are both in agreement – at least with regard to the swell – and confirm the statements of the ship's command that the swell increased in the hours immediately after the accident (see area marked purple in **Figure 14**).

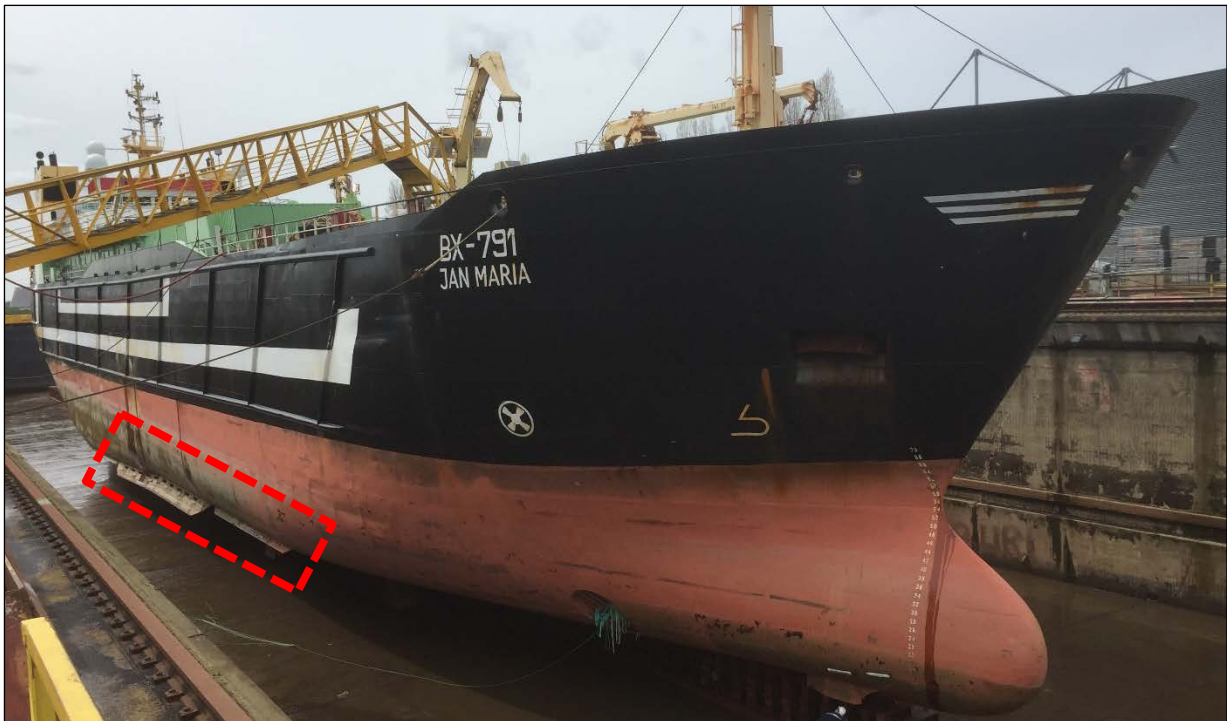
Figure 15: The JAN MARIA in dock (bilge keel marked red)<sup>18</sup>

In all likelihood, the anchor line caught on the JAN MARIA's bilge keel.<sup>17</sup> The boat was dragged to the JAN MARIA's hull and unable to free herself from this helpless situation without assistance.

The fact that the fishing boat and the fishing vessel collided directly beneath two cooling water discharge outlets in the latter's shell plating proved to be fatal and the primary cause of the accident. The exceptionally large inflow of cooling water in relation to the size of the open fishing boat resulted in her flooding and foundering extremely quickly. The temperature of the water was less than 30 °C, meaning that viewed in isolation it was of no relevance to the accident.
