**Bundesstelle für Seeunfalluntersuchung**  
**Federal Bureau of Maritime Casualty Investigation**  
Federal Higher Authority subordinated to the Federal Ministry  
of Transport and Digital Infrastructure

## **Interim Investigation Report**

**Very Serious Marine Casualty 452/19**

**Accident with subsequent loss of life  
on board the SAJIR  
in the roadstead off Ningbo (China)  
on 19 December 2019**

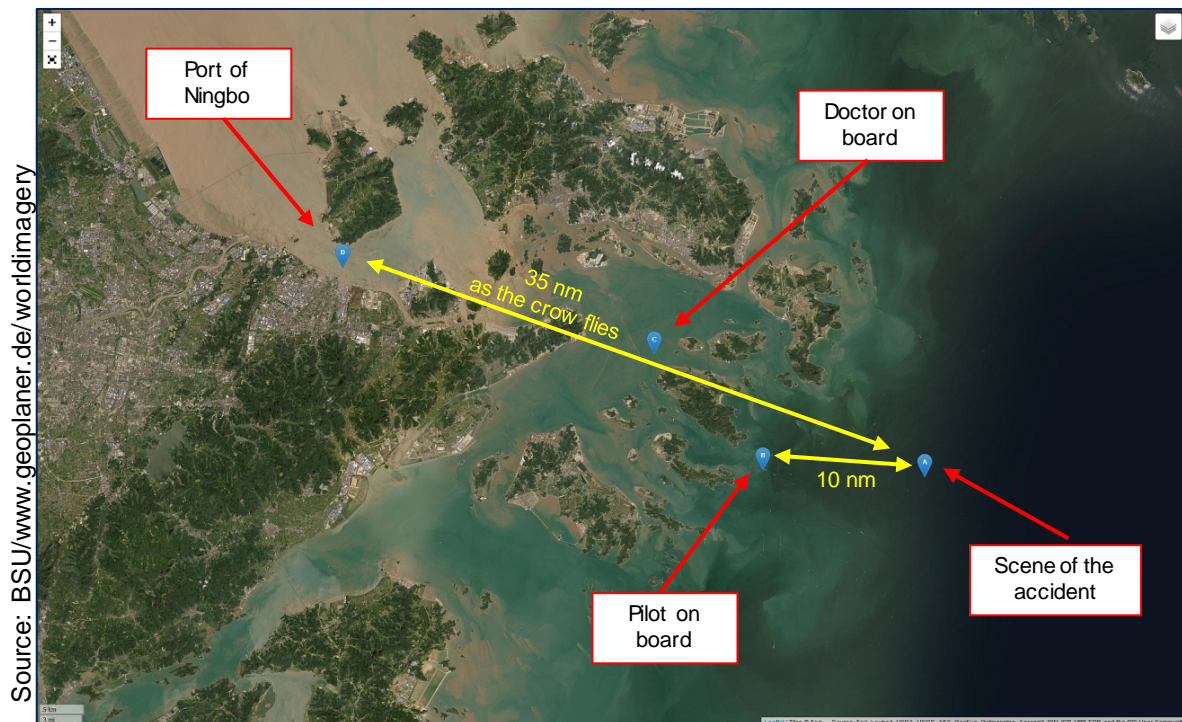
Figure 2: Scene of the accident and distances

A bosun and two deck ratings inspected the empty cargo holds and removed any objects that could cause an obstruction when loading containers. At about 1700<sup>4</sup>, the bosun was in cargo hold 9 and fell some 8 m from the enclosure of part of the engine room onto the floor of the cargo hold, suffering life-threatening injuries due to the impact.

The fall from a height was caused by an unsecured access point to an unlit cargo hold. However, as with comparable ships, a risk of falling from a height does prevail there for reasons of ship design.

The ship's operator analysed the accident. As a result, all areas of the SAJIR and other ships in the fleet where a comparable risk of falling from a height prevailed and no markings or barriers previously existed were secured accordingly.
