**Bundesstelle für Seeunfalluntersuchung**  
**Federal Bureau of Maritime Casualty Investigation**  
Federal Higher Authority subordinated to the Ministry  
of Transport and Digital Infrastructure

## **Investigation Report 12/16**

### **Serious Marine Casualty**

**Collision between the Rendsburg transporter bridge  
and freighter EVERT PRAHM with  
subsequent grounding  
of the EVERT PRAHM  
on 8 January 2016**

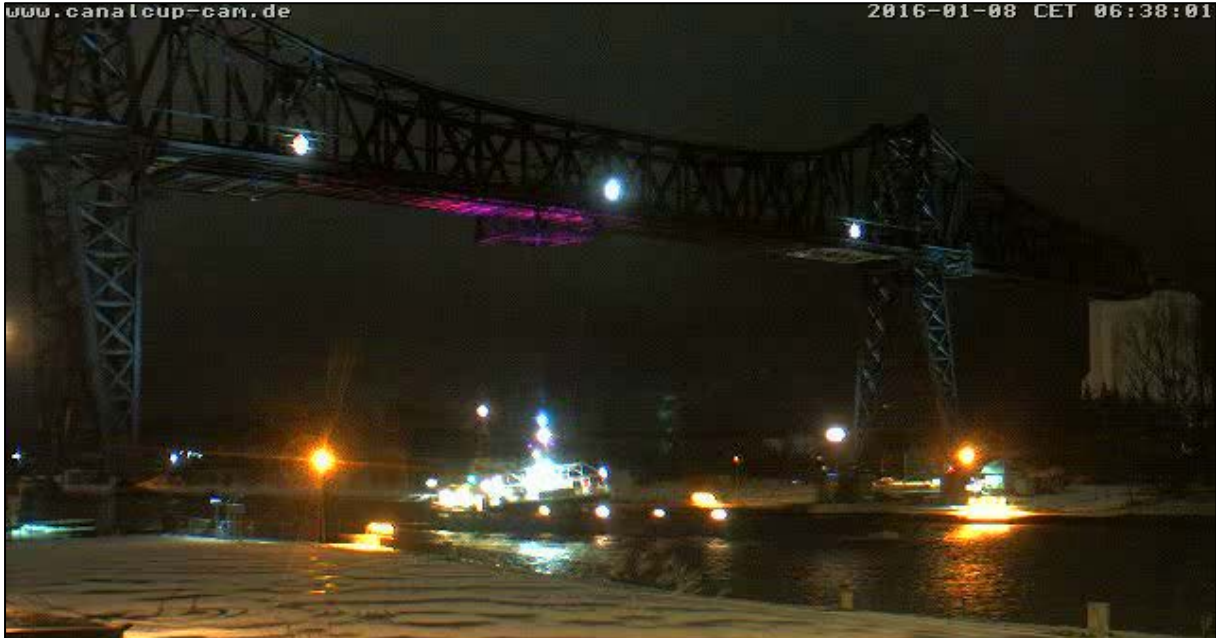
The transporter bridge struck the hatch of the EVERT PRAHM amidships (see Figure 9), snagged briefly on the hatch, rotated, was dragged over the hatch cover and then released.

Figure 9: Collision (08/01/2016, 0638)

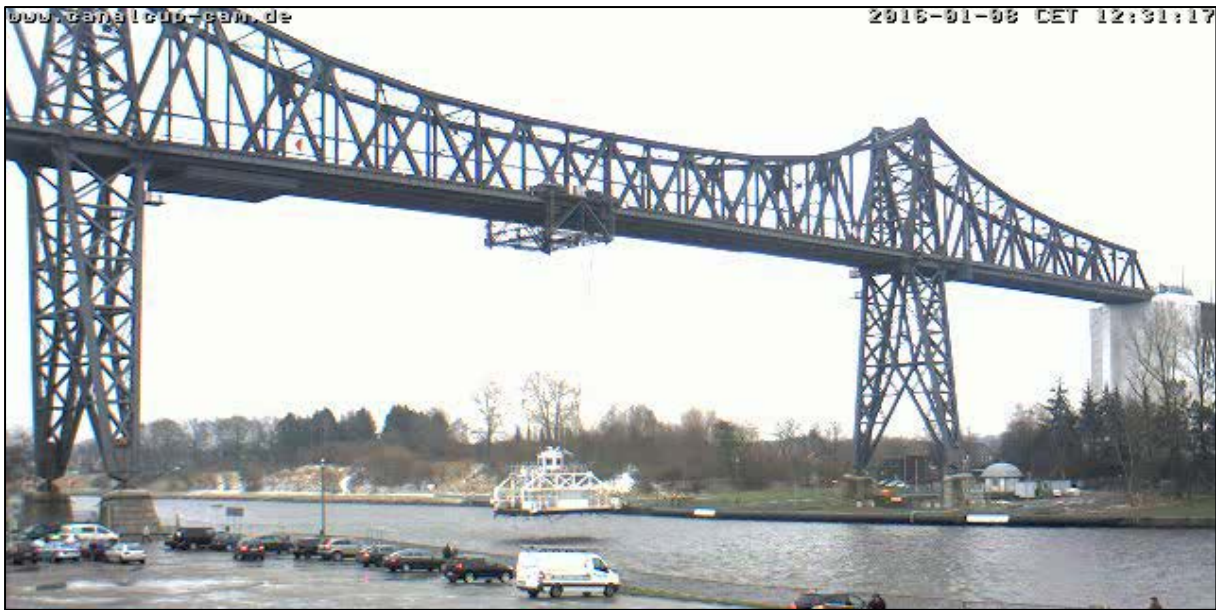
The transporter bridge was severely damaged due to the collision and partially torn out of the rail track. It was stuck over the middle of the Kiel Canal (see Figure 20).

Figure 20: Position of the transporter bridge in daylight after the accident

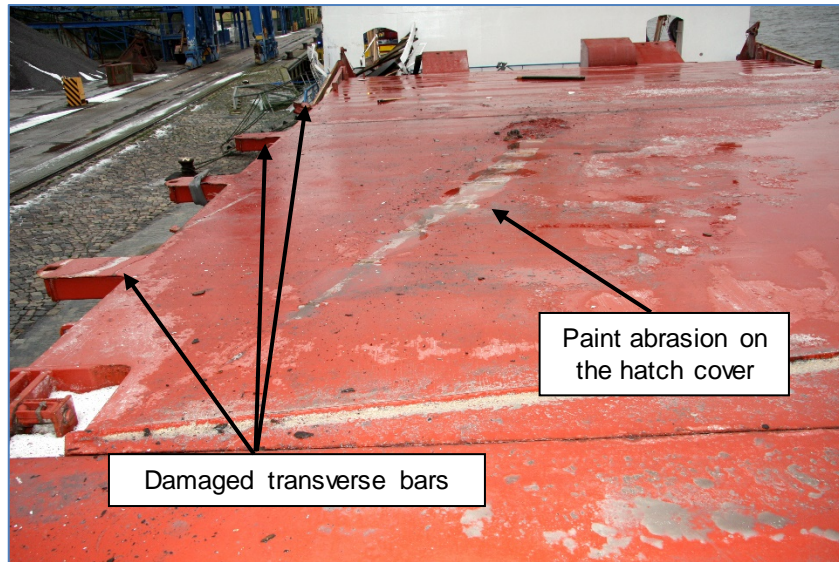
The EVERT PRAHM was heavily damaged during the accident. The transporter bridge struck the hatch cover amidships, resulting in deformations and paint abrasion (see Figure 26).

Figure 26: Damage to the EVERT PRAHM's hatch cover

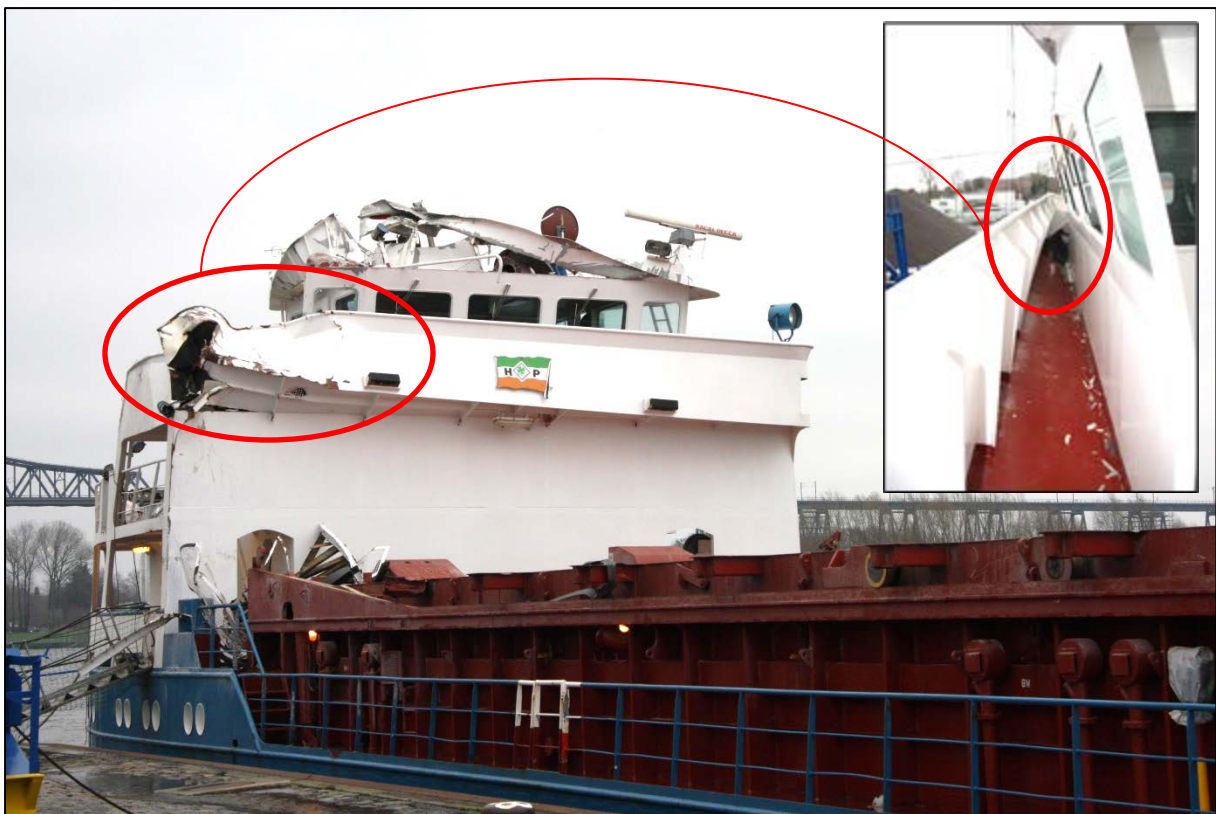
The starboard bridge wing was severely buckled inwards and similar to the wheelhouse generally deformed (see Figures 27 and 28).

Figure 27: Overview – damage to the EVERT PRAHM's superstructure

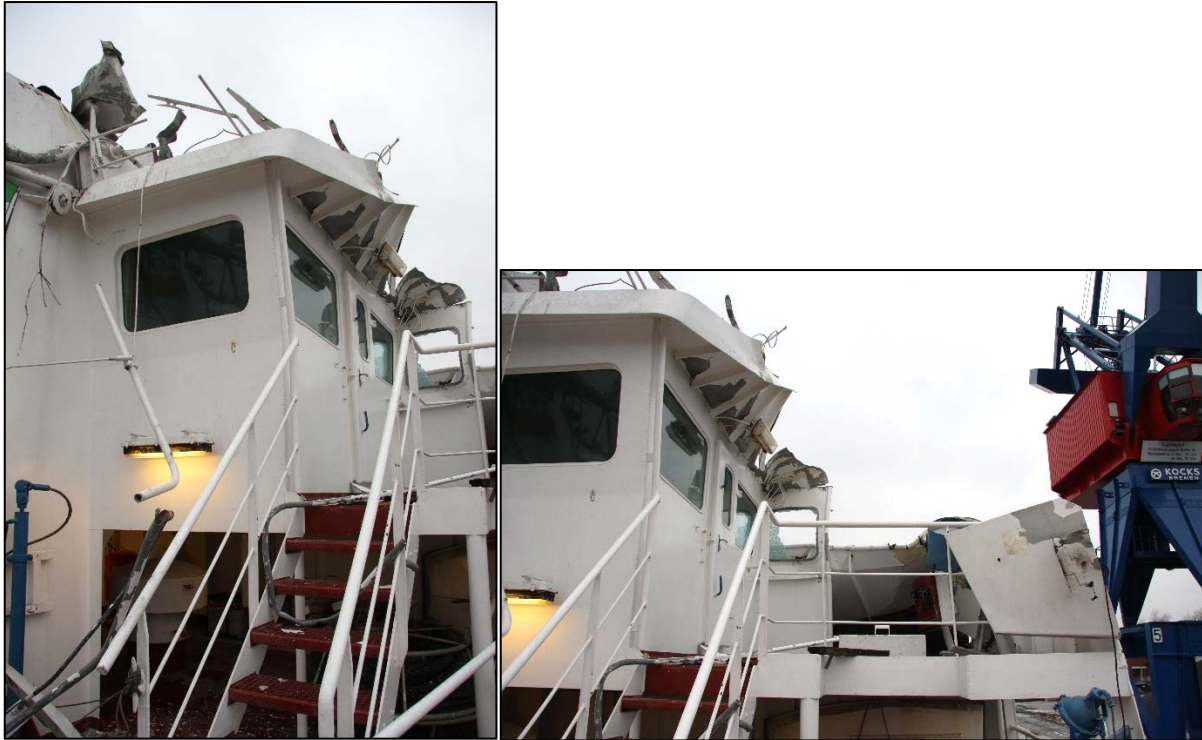
Figure 28: Damaged starboard wing on the EVERT PRAHM

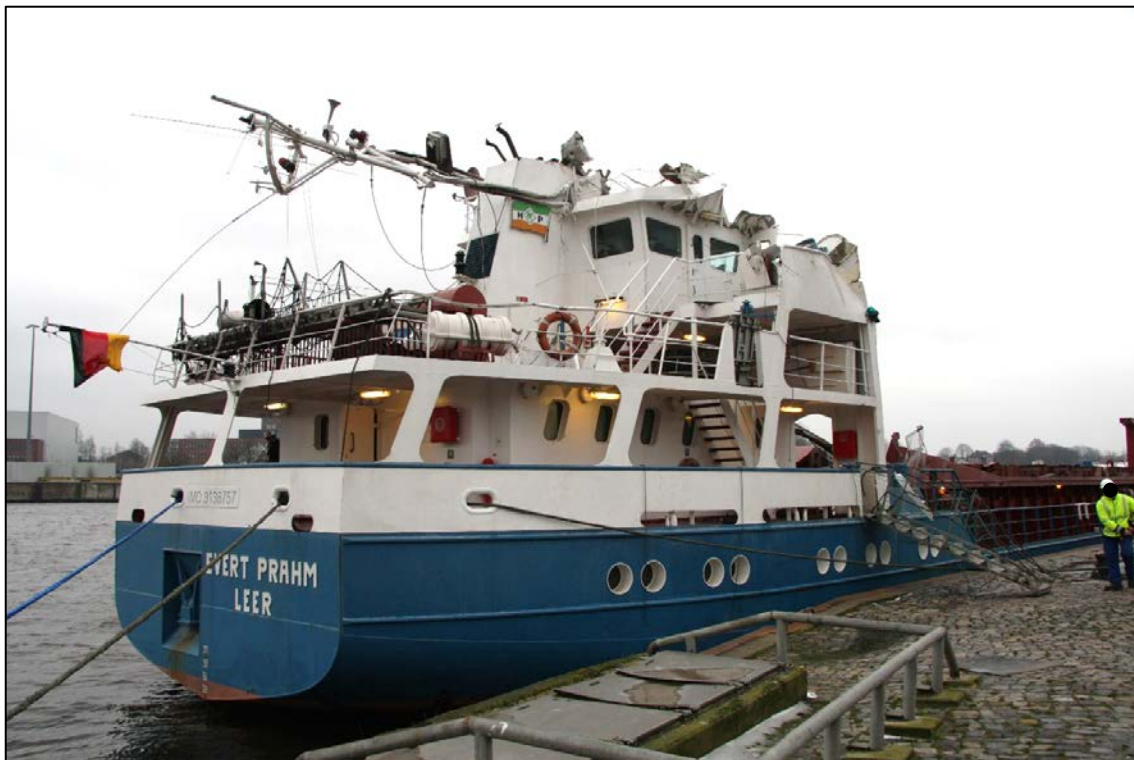
The lighting was partially defective. Due to the impact and the transporter bridge snagging on the wheelhouse, the stern mast had been knocked down and several antennas on the observation deck (including the X-band radar antenna, GPS and AIS) were damaged (see Figure 29).

Figure 29: Damage to the EVERT PRAHM's superstructure, view from astern

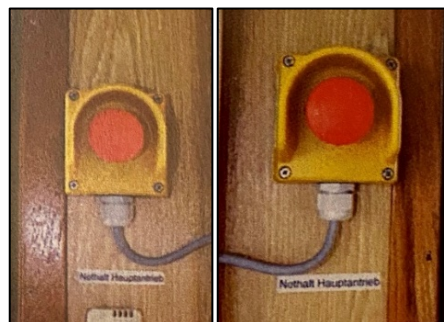
Emergency stop buttons (functioning described in the operating manual) for the main drive were located on the side next to the respective control panel for a crossing to the northern or to the southern bank (see Figure 36).

Figure 36: Emergency stop button in the transporter bridge operator's cabin

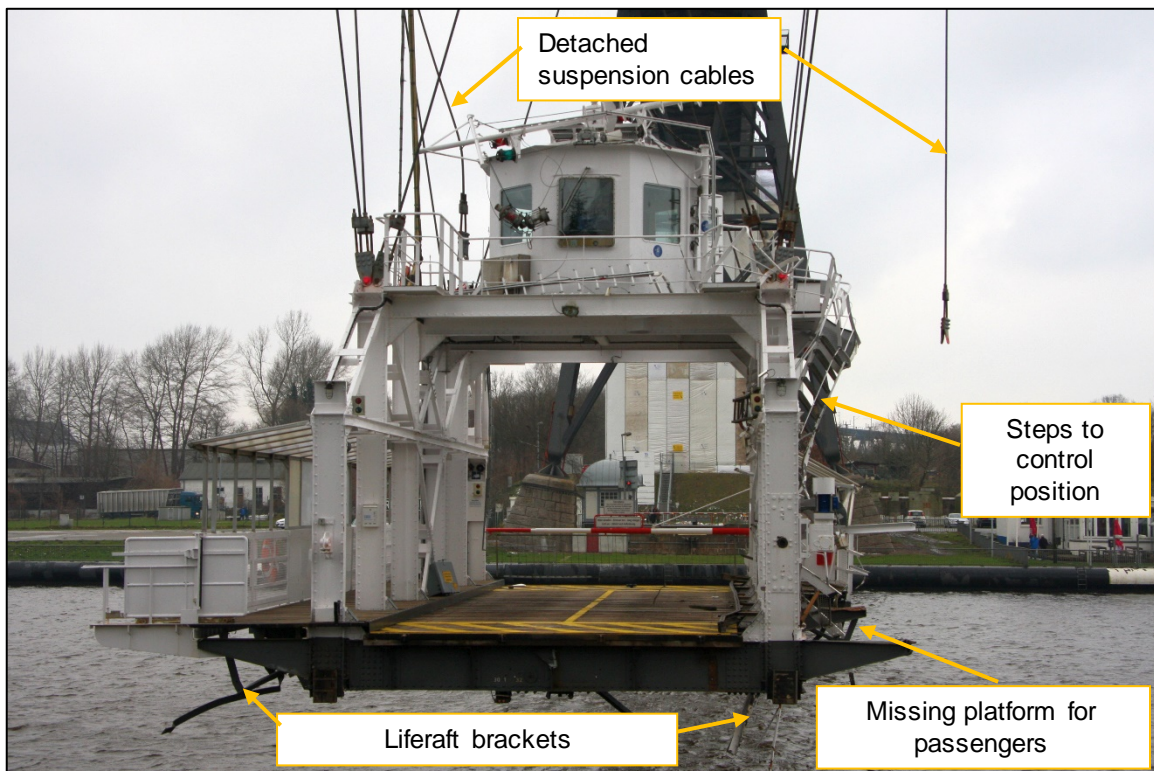
Figure 38: Transporter bridge viewed from the southern side

A rough description of the damage to the transporter bridge (see Figures 38 to 43) follows:

- the platform for the passengers and its roof was almost completely destroyed on the side of impact (eastern side);
- the steps to the control position were destroyed on the eastern side;
- the signal mast was broken;
- the transporter bridge's barrier on the southern side was destroyed, and
- the solid liferaft brackets below the platform were destroyed.

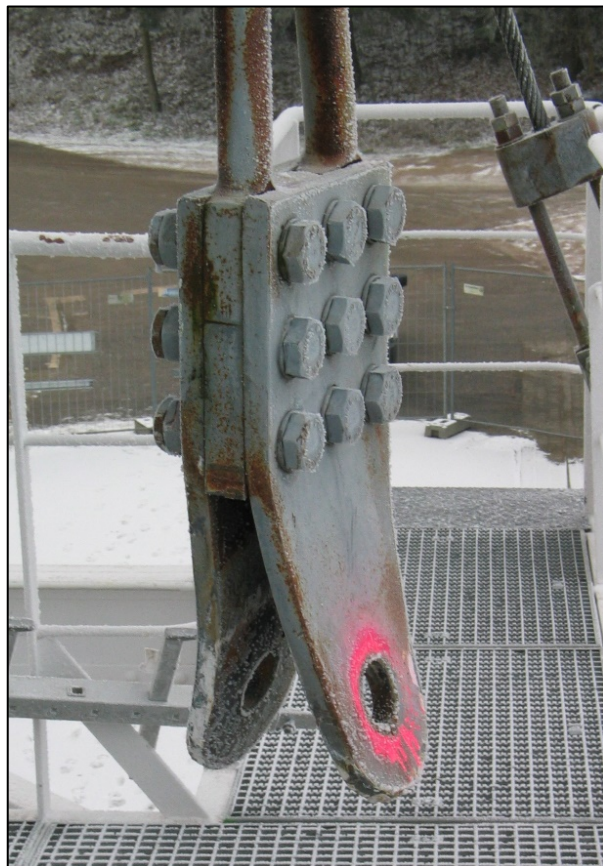
Figure 42: Broken suspension from the north-western side

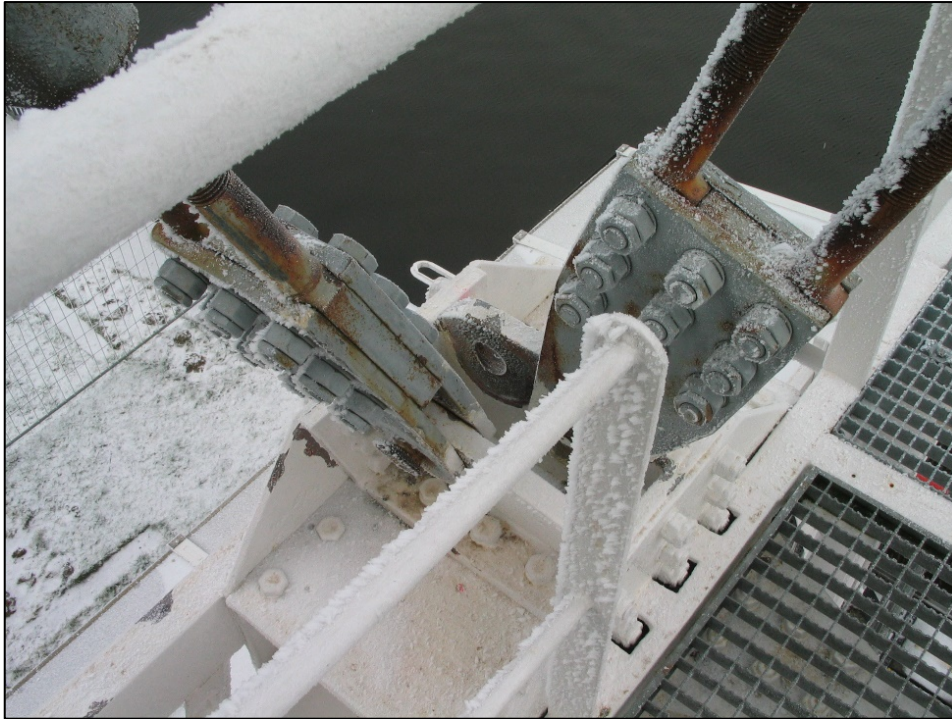
Figure 43: Cable attachment point on the north-western side

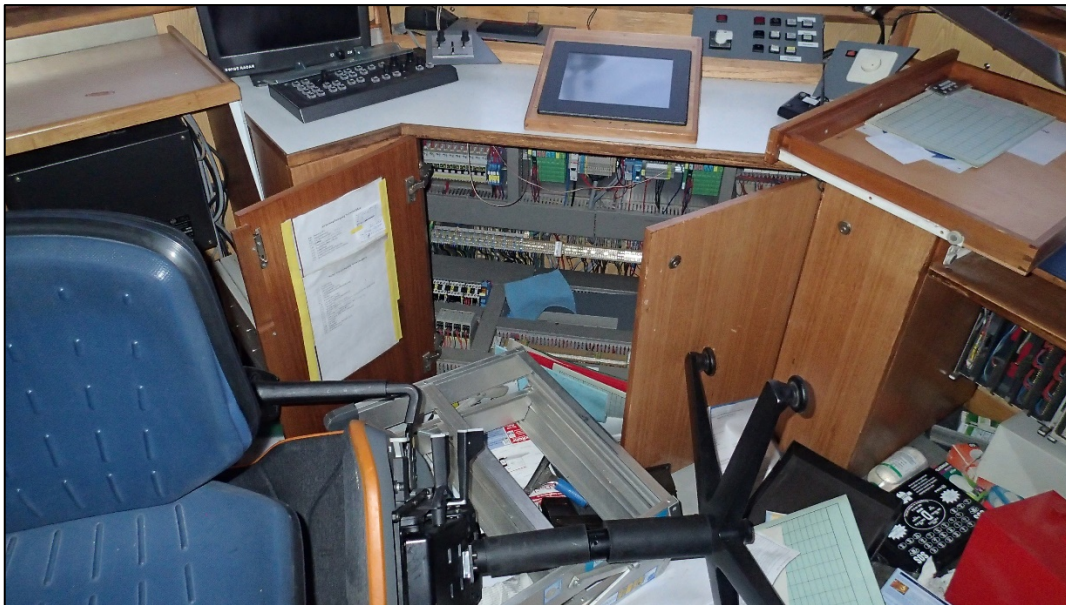
The control position was severely affected (see Figure 44).

Figure 44: View into the control position from the door

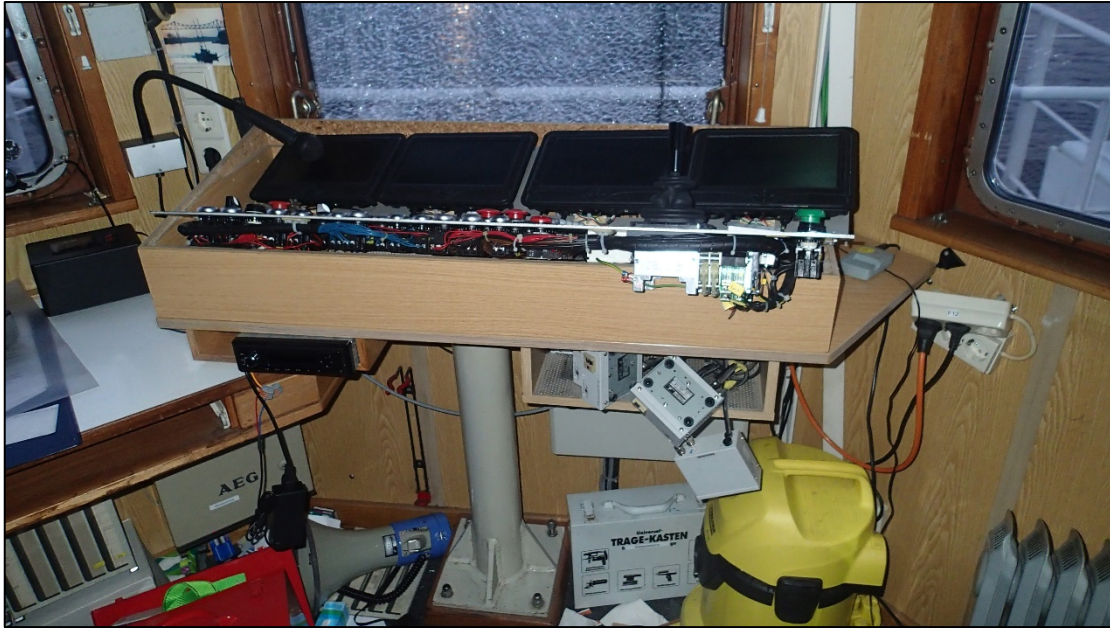
The window on the northern side of the transporter bridge's control position was shattered (see Figure 45). The window to the southern side was intact but the sunblind was rolled down.

Figure 45: View of the control panel on the northern side

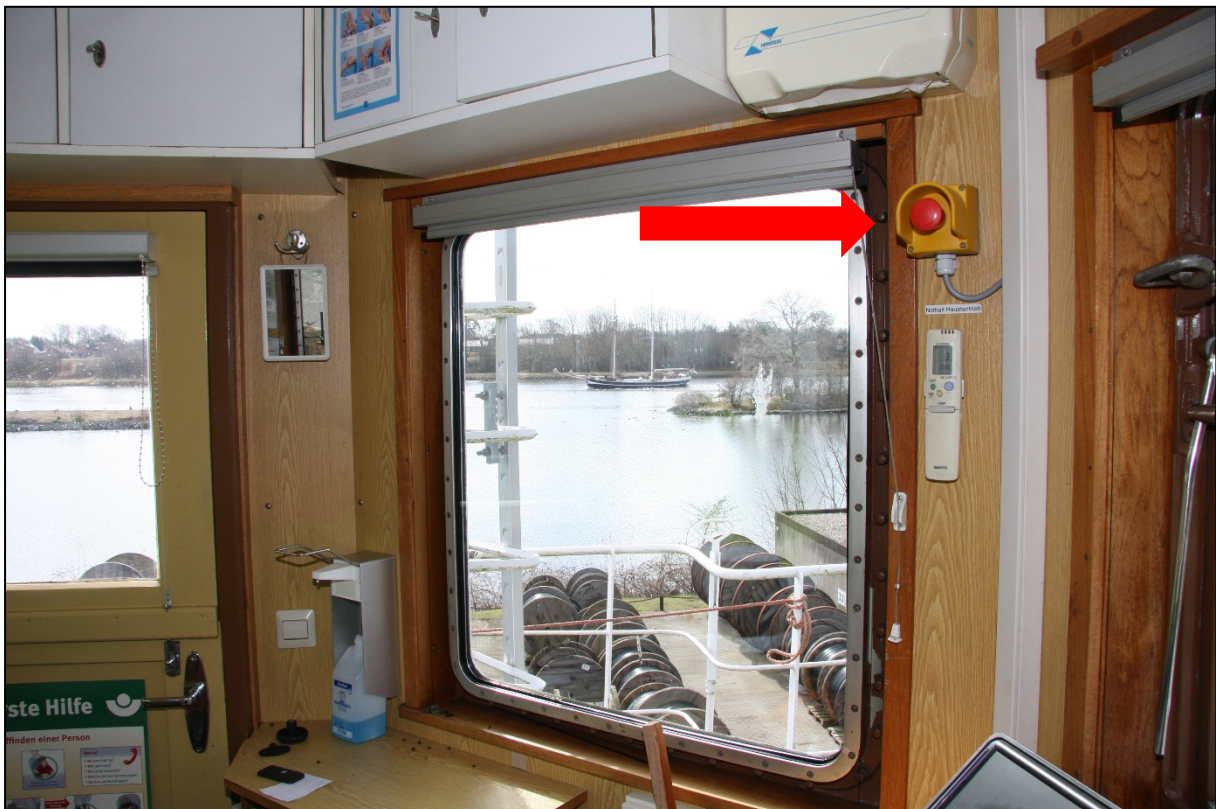
An emergency stop switch above the control panel had not been engaged and was therefore not operated. WSP Kiel pressed the switch for test purposes, at which it engaged. In the event that the emergency stop switch above the southern control panel had not been operable on the day of the accident, there was also an emergency stop button on the opposite control panel. This was also found to be unengaged.

On 22 January 2016 the BSU's investigation team surveyed the transporter bridge in Osterrönfeld at the southern docking area. The survey was carried out jointly with representatives of WSP Kiel and technical experts from DNV GL, which Kiel Public Prosecutor's Office had commissioned. The experts inspected the cabling, including that of the emergency stop buttons. The normal emergency stop position and the active position were noted so as to allow for a comparison with recordings made on the day of the accident. The superstructure was without power on the day this survey was carried out, meaning that the functionality of the emergency stop could not be tested. The position of the emergency stop buttons for the southern (for crossing to the southern bank) and northern (opposite direction) control panels was noted (see Figure 46).

Figure 46: Position of the emergency stop button to the left above the southern control panel
