Bundesstelle für Seeunfalluntersuchung
Federal Bureau of Maritime Casualty Investigation
Federal Higher Authority subordinated to the Ministry
of Transport and Digital Infrastructure

Investigation Report 15/19

Serious Marine Casualty

**Fire in the area of the deck cargo
on board the container ship
YANTIAN EXPRESS
in the Atlantic Ocean
on 3 January 2019**

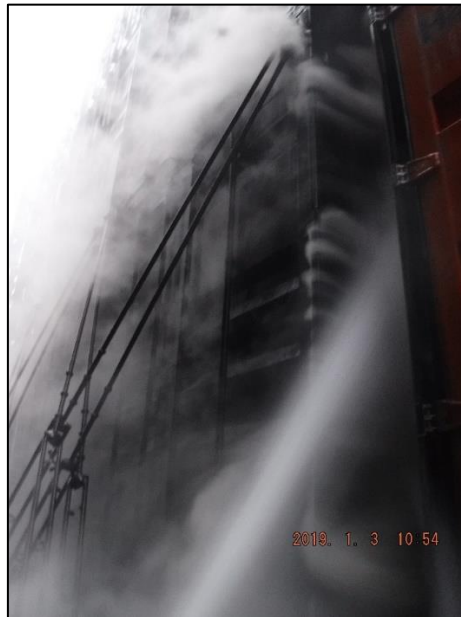
Figure 8: Firefighting at bay 12; row 03 in the middle of the image

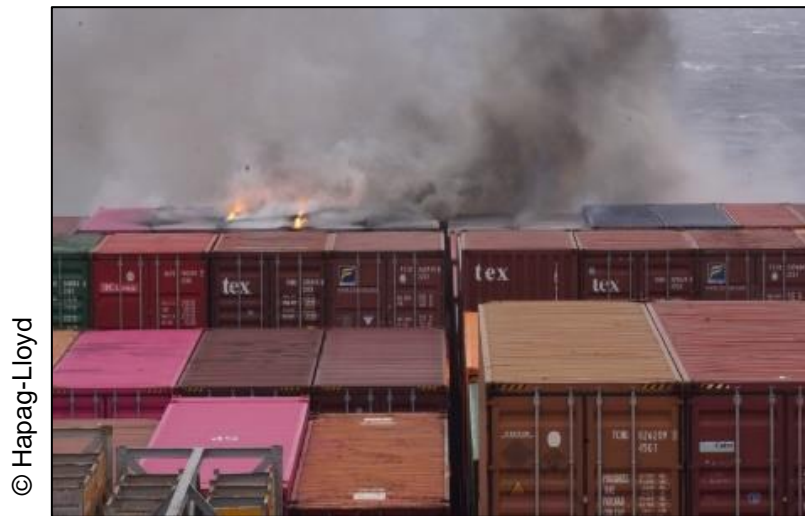
Figure 11: Bay 12 on fire

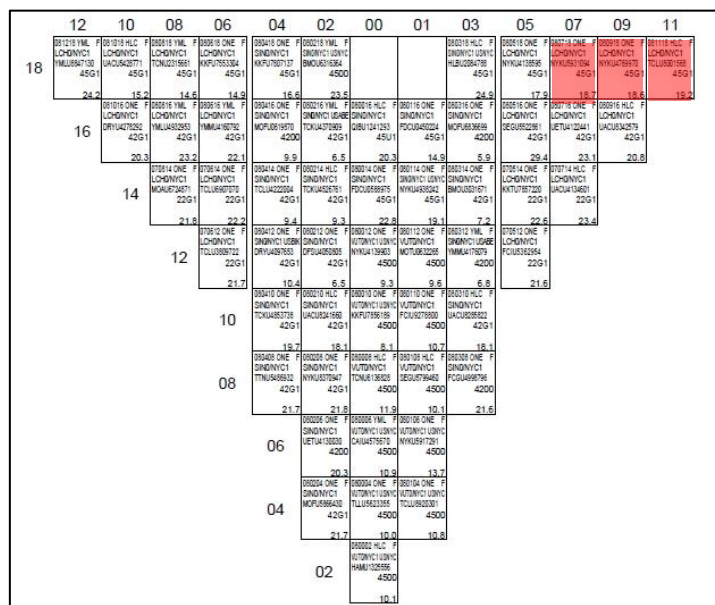
The container at slot 080718 now also exhibited an increase in temperature. 190 °C was measured at slot 080918. All three containers were further cooled from the outside. To fight the smouldering fires, the containers in positions 080918 and 080718 were opened and nozzles positioned.

Figure 17: Containers on fire in cargo hold 1, bay 7

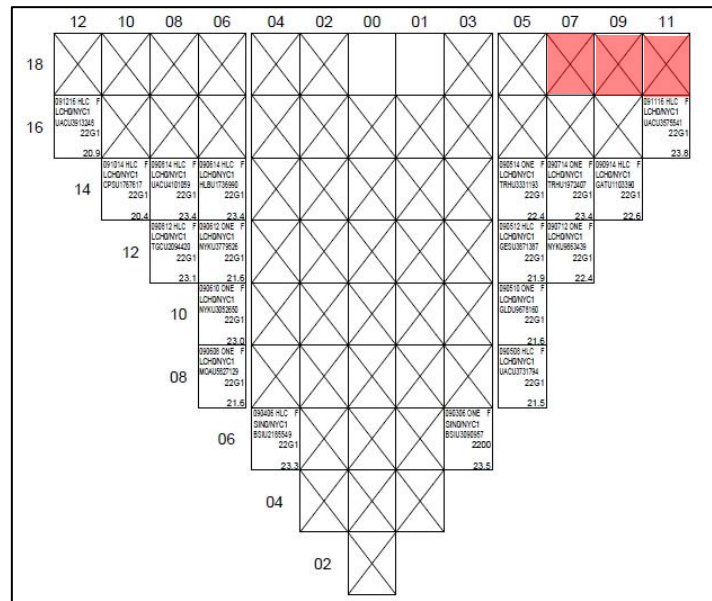
Figure 18: Containers on fire in cargo hold 1, bay 9

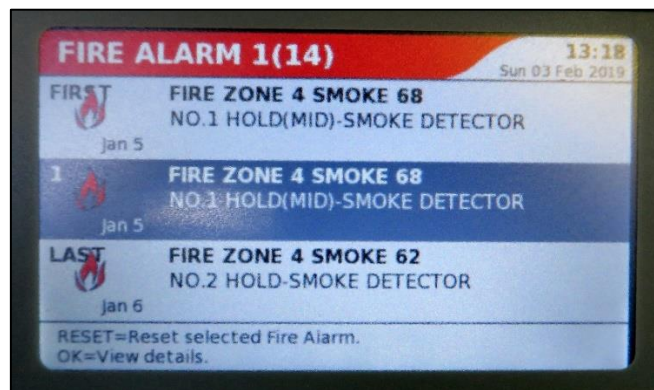
The fire alarm system on the bridge of the YANTIAN EXPRESS displayed various alarms on the integrated monitor (see Figure 24). A comprehensive evaluation was later carried out using the system's log data (see subsection 3.2.8)

Figure 24: Fire alarm system display

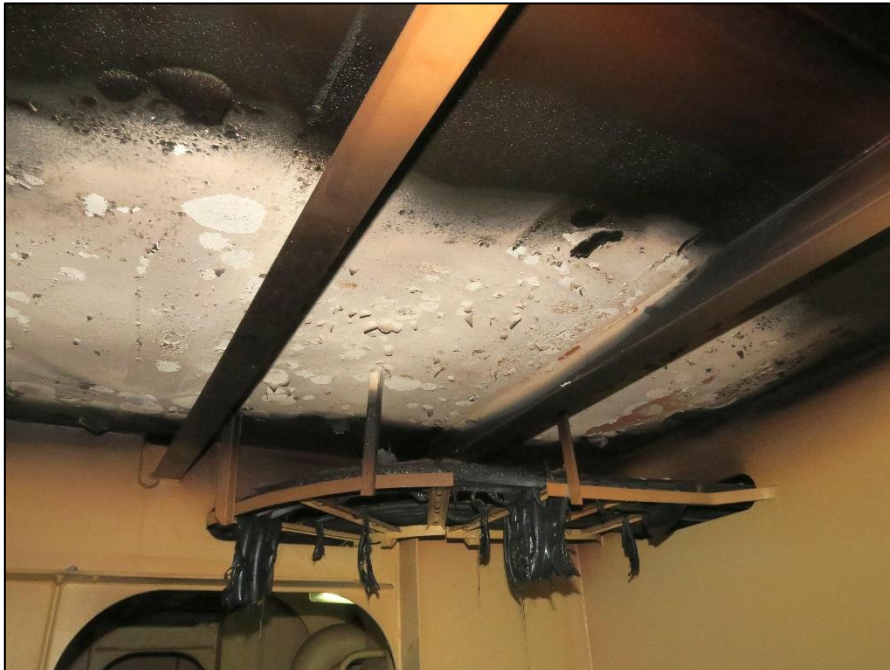
During the inspection of the passageways, major damage to the ceiling of the corridor and to the equipment and cable looms located there could only be identified on the starboard side in the area of cargo hold 1.

Figure 25: Thermal damage in the starboard passageway adjacent to bay 3

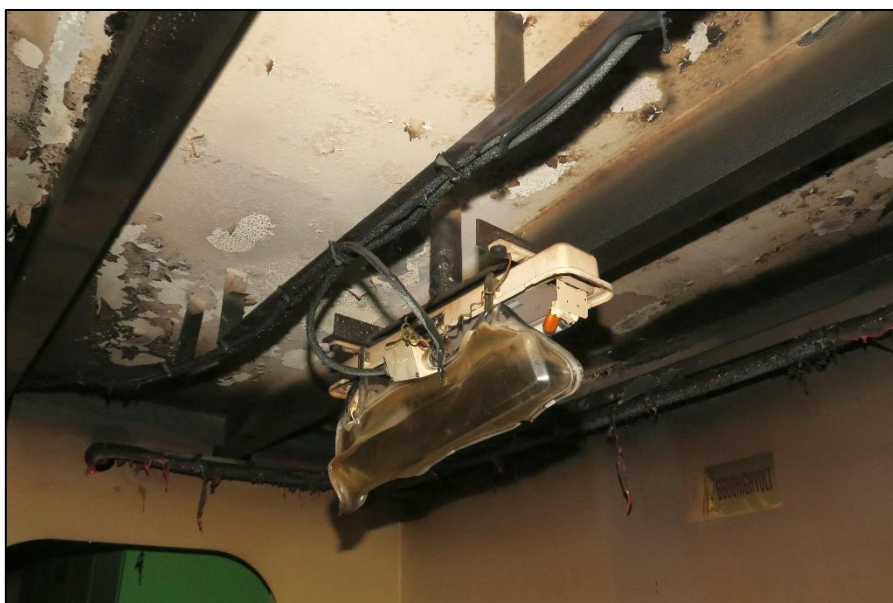
Figure 26: Thermal damage in the starboard passageway adjacent to bay 5

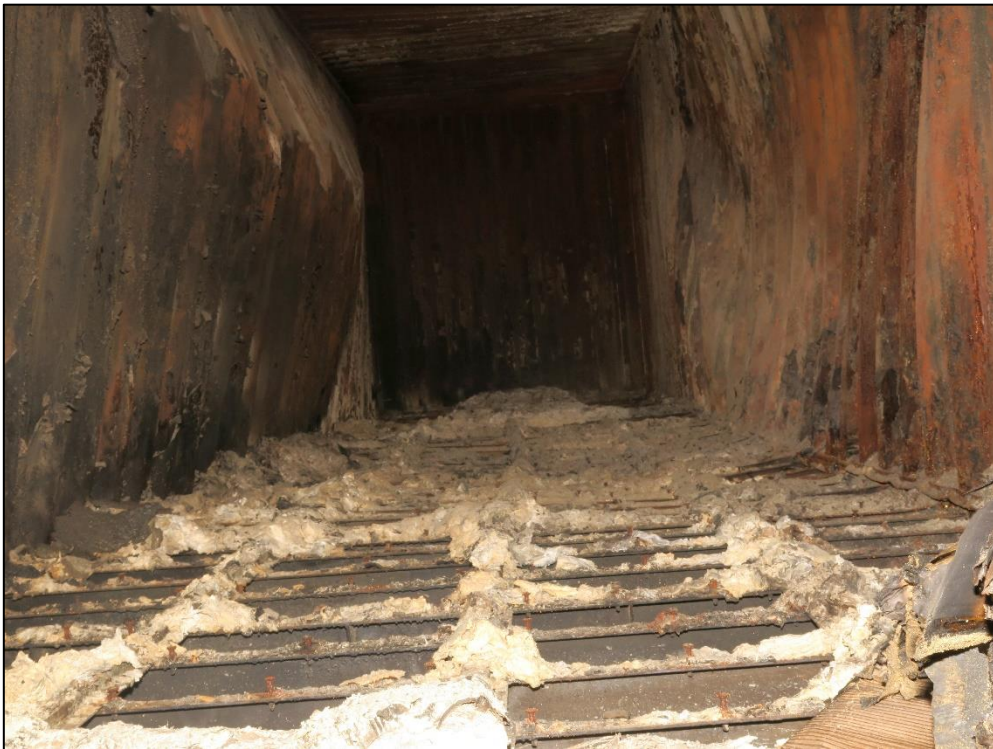
- the container at slot 120382, which according to the cargo documents originally contained knitted or crocheted baby garments, was completely burnt out:

Figure 29: View into the container at slot 120382

Only a small amount of fire debris; floor completely burnt.

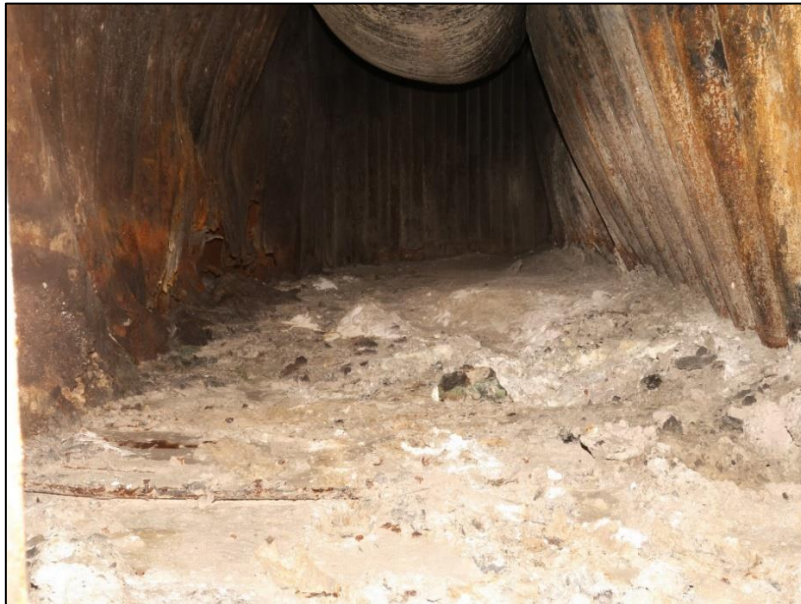
- the container at slot 120582, loaded with polypropylene woven shopping bags, was also completely burnt out:

Figure 30: View into the container at slot 120582
Small amount of fire debris; floor completely burnt.

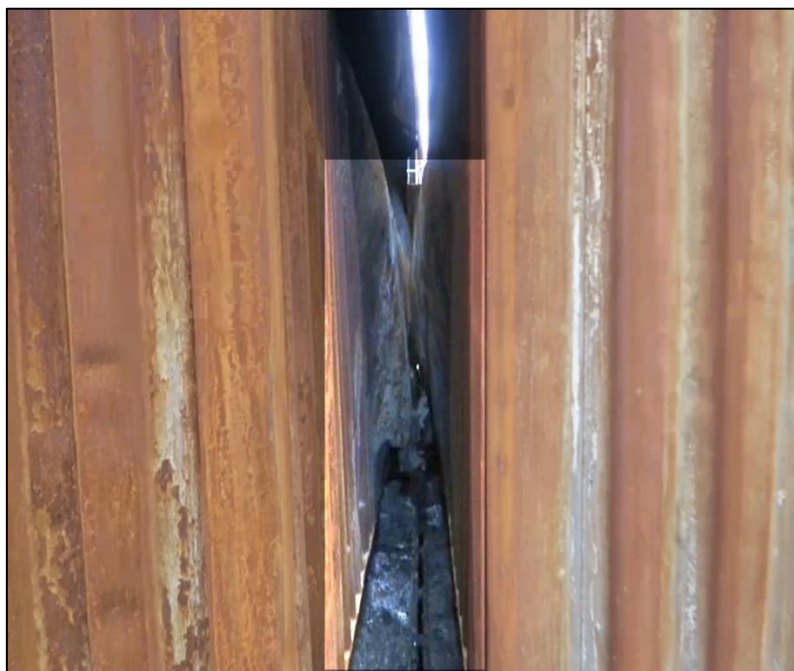
Figure 31: Gap between the containers at slots 120382 and 120582
The two containers are touching due to the effect of the heat. Middle of image brightened.

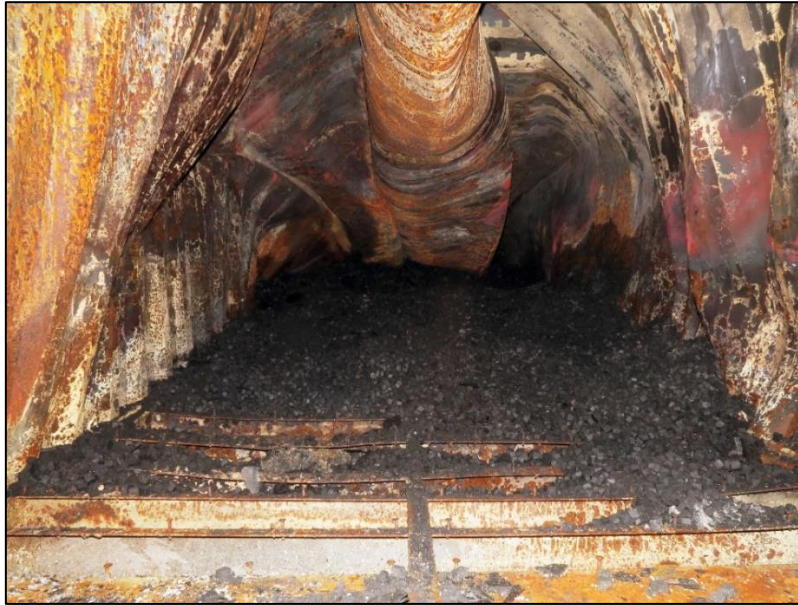
- the container at slot 120782, which according to the cargo documents was loaded with coconut pellets, still contained the remnants of a coconut pellet load. The pellets, made of a compressed material, were cuboid with an edge length of 2.3 cm x 2.3 cm x 1.5 cm:

Figure 32: View into the container at slot 120782

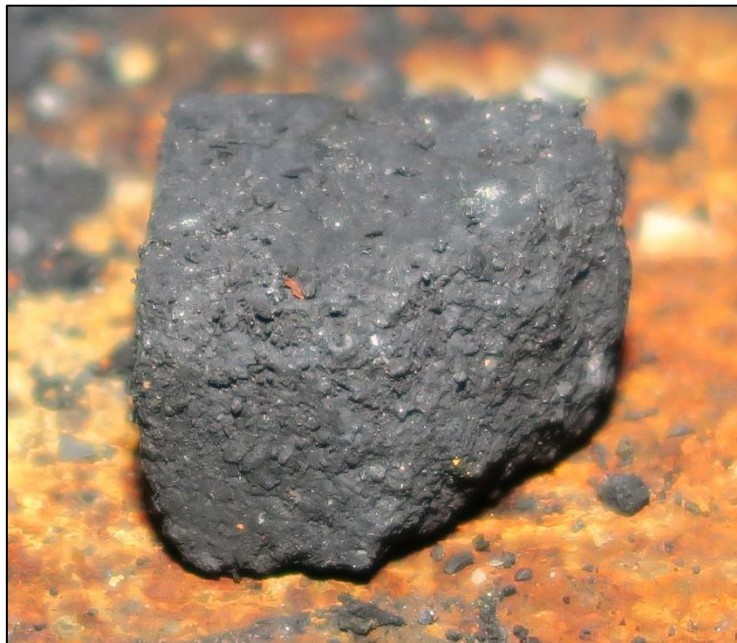
Figure 33: Close-up of a coconut charcoal cube

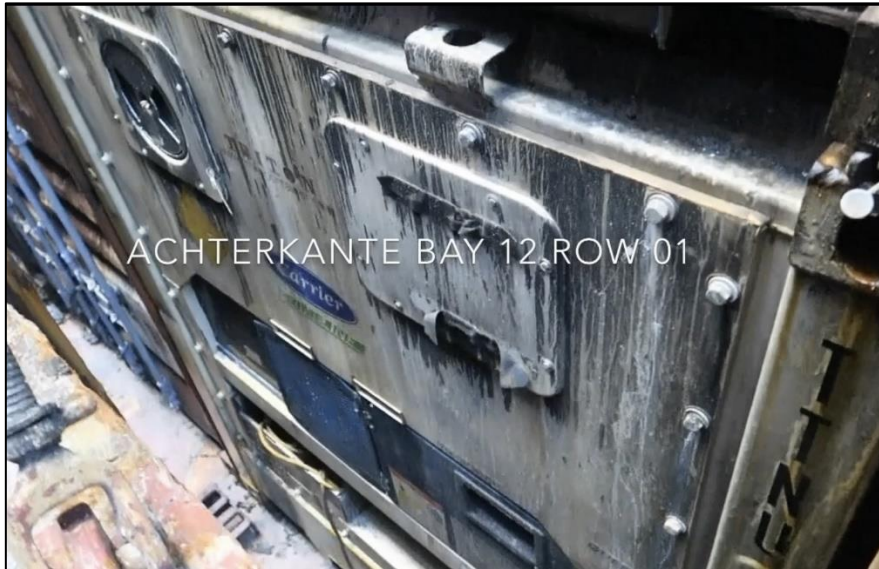
During the inspection, the refrigerated container at slot 120182 was also viewed. No effects of fire could be found on the refrigerating unit side located on the aft edge of bay 12 (see also Figure 34).

Figure 34: Undamaged refrigerated container at slot 120182

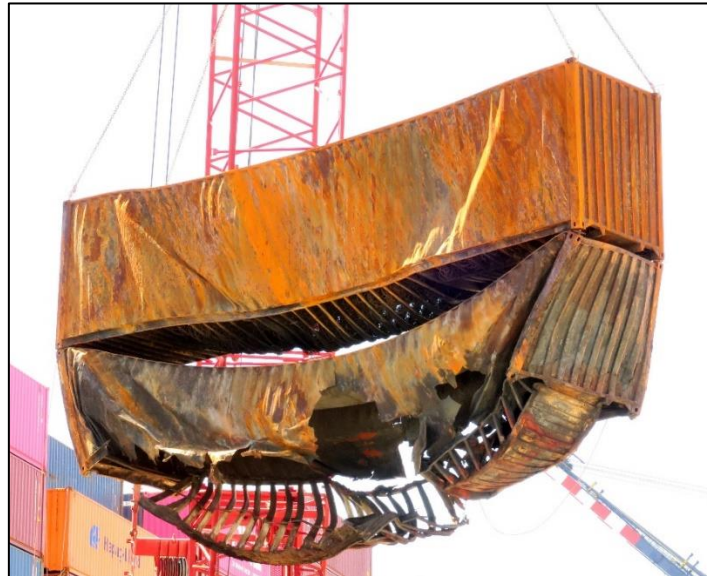
Figure 38: Containers at slots 120788 (top) and 120786

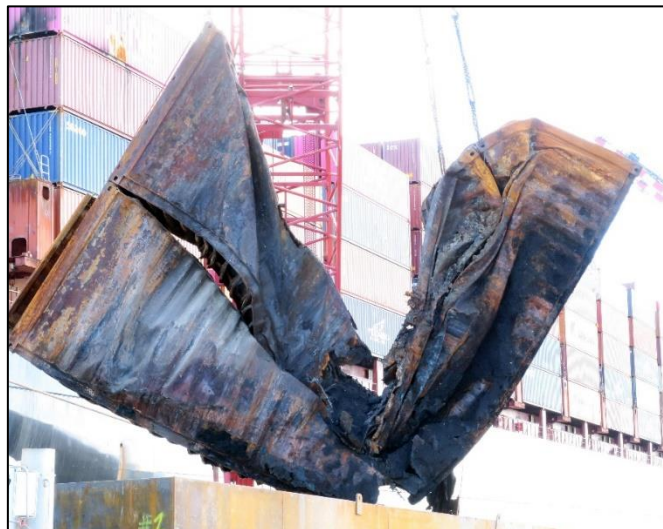
Figure 39: Containers at slots 120784 (top) and 120782

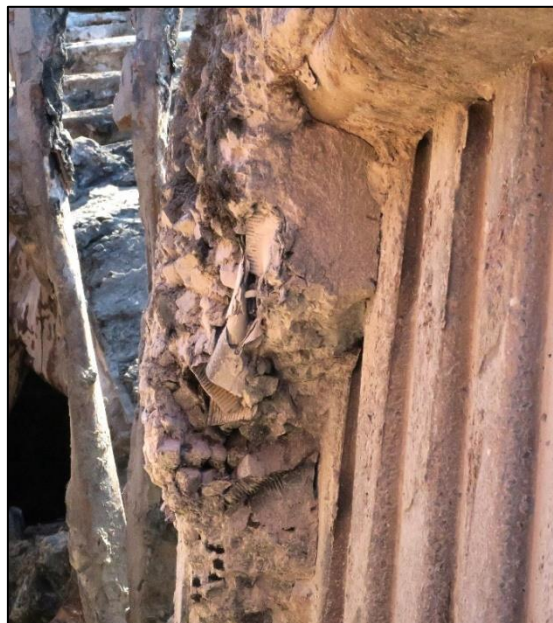
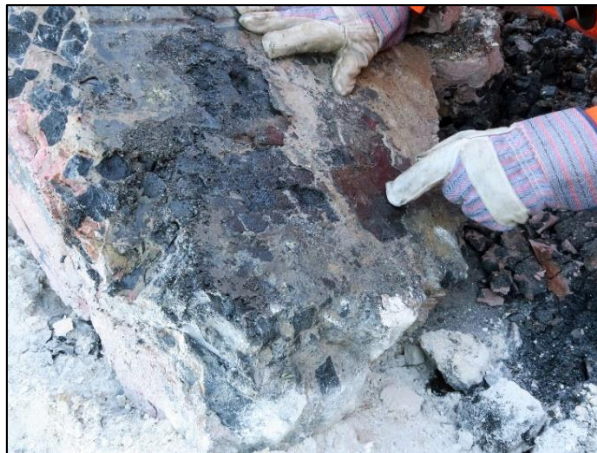
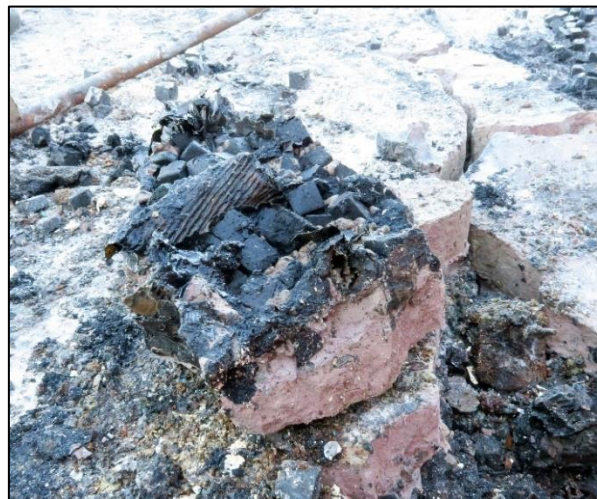
After the container had been unloaded from slot 102582, this area was examined. It was found in the process that parts of the charcoal load had also been under this container. Some of the pyrochar (in its cardboard packaging unit) was baked into the fire debris of the polypropylene shopping bags (see Figures 43 to 45).

Figure 43: Underside of container from slot 120582

Figure 44: Packed pyrochar at slot 120572

Figure 45: Packed pyrochar at slot 120572

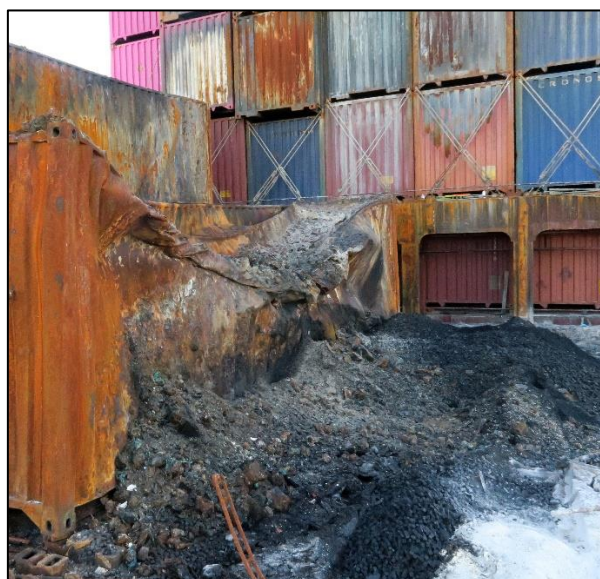
Figure 46: Slot 120782, unburnt pyrochar
The contents spilled out when lifting.

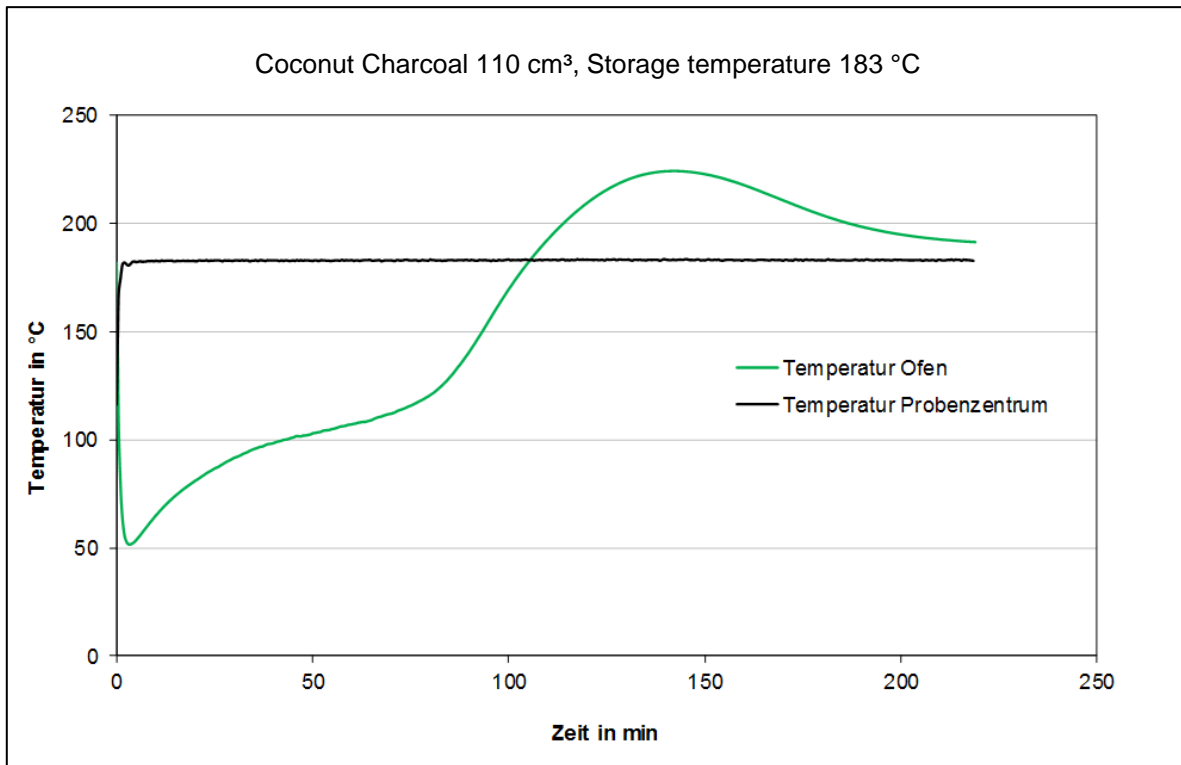
Figure 47: Isoperibol test with cocolut charcoal (110 cm³) at 183 °C

The examinations allow for the conclusion that the fire could have been caused by self-igniting of the coconut charcoal.

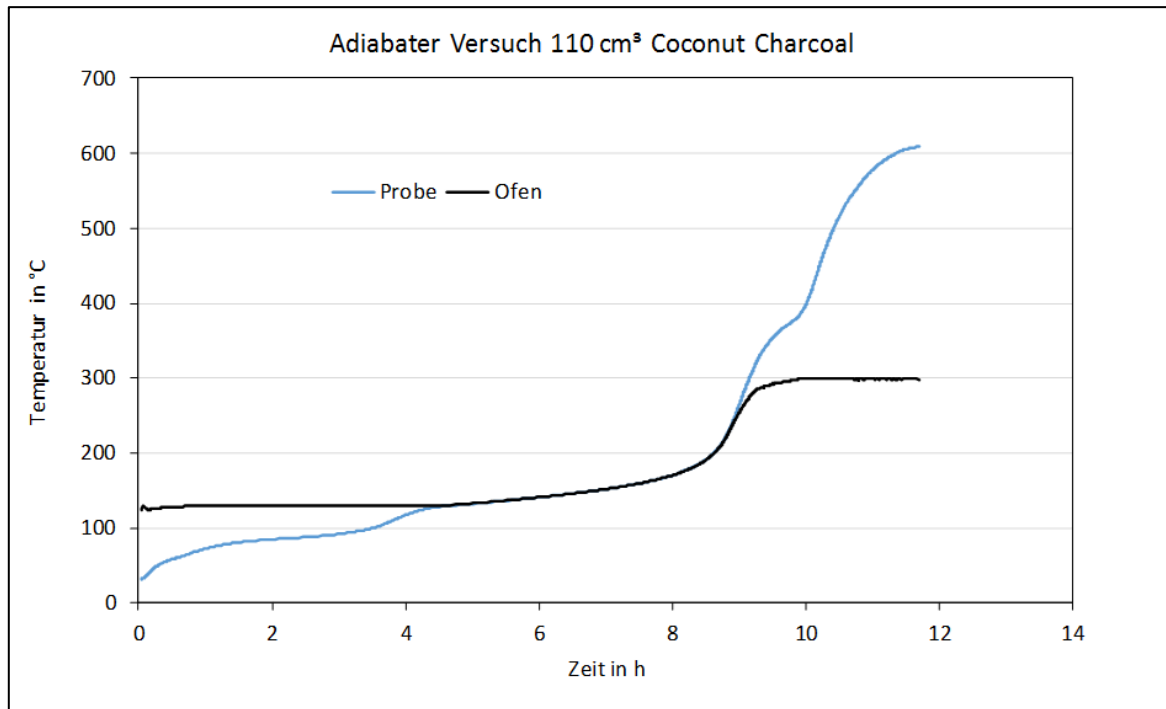
Figure 48: Adiabatic test with coconut charcoal (110 cm³)

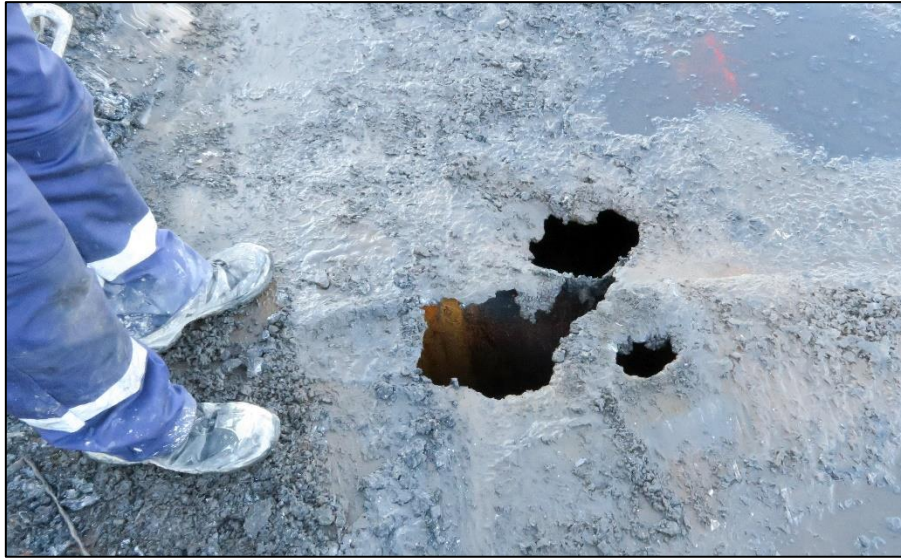
In the area of the container loaded with nitrocellulose in slot 080782, a hole was later found in the hatch cover. In the opinion of the firefighters commissioned by the salvage company, it was caused by the combustion of the nitrocellulose. The fire then developed via this hole into hold 1 and led to the ignition of the containers loaded with tires in slots 080718, 080918 and 081118.

Figure 50: Comparable hole on position 080182

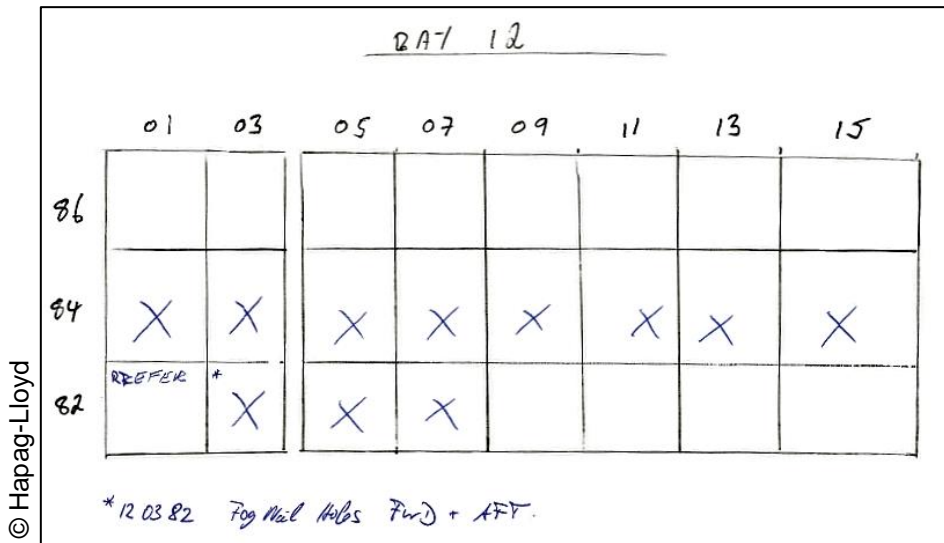
Figure 51: Holes created by the crew for the water lances

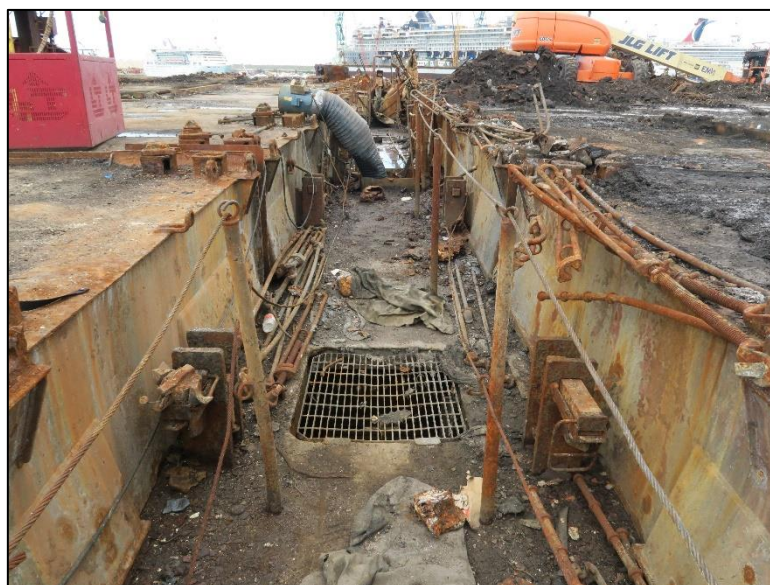
Figure 54: Grill over port ventilation opening in the transverse corridor between bays 4 and 8

It was found here that the flap of the ventilation opening under the grill was not locked. Access to the flap was not possible because the grill was secured by a chain and lock.

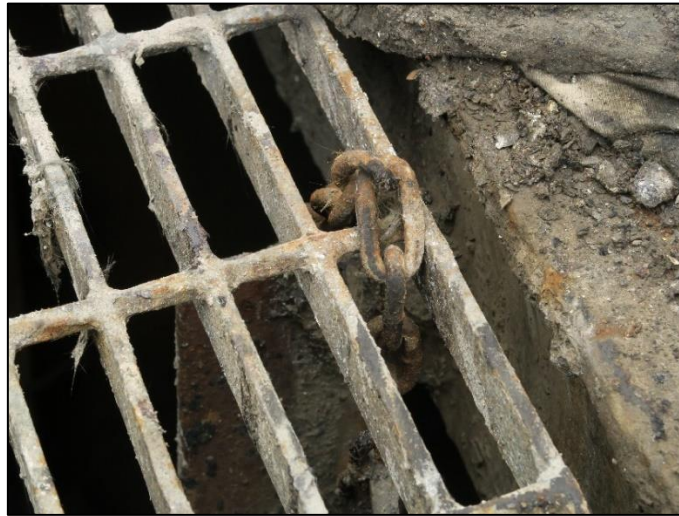
Figure 55: Grill over ventilation opening secured by chain and lock

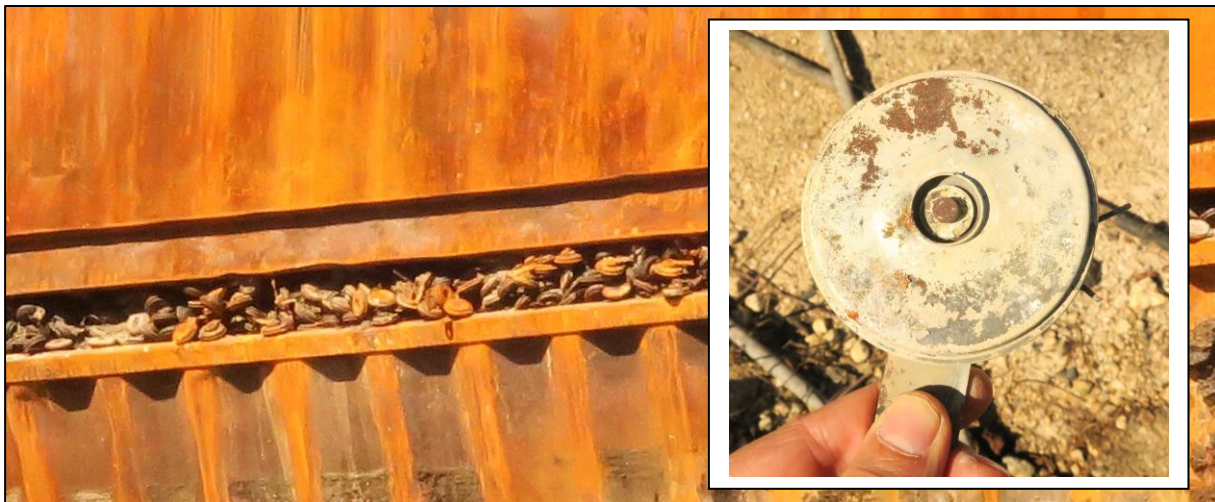
Figure 59: Horn from container at slot 120384

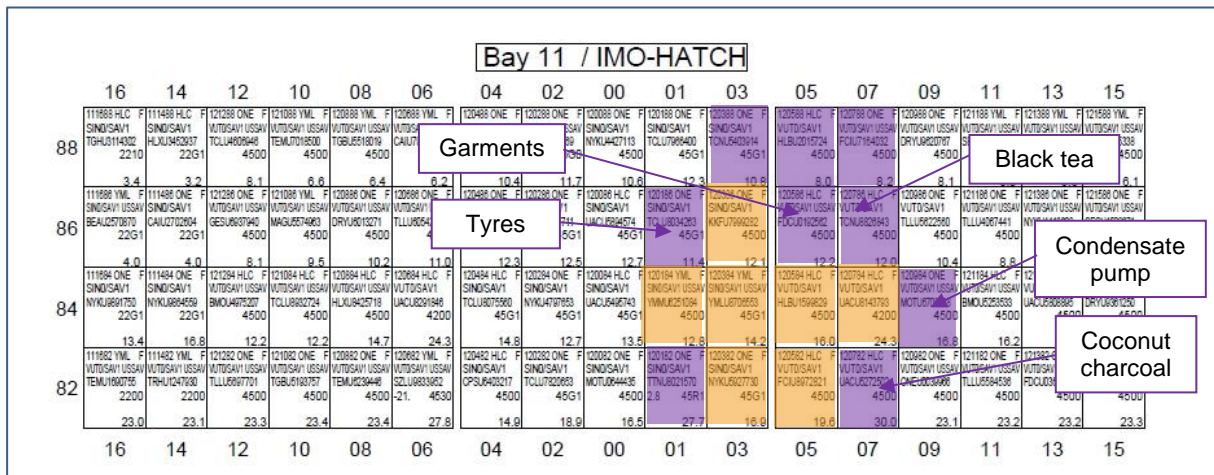
Figure 60: Containers emitting smoke at 1116 on 3 January 2019
