Bundesstelle für Seeunfalluntersuchung
Federal Bureau of Maritime Casualty Investigation
Federal Higher Authority subordinated to the Federal Ministry
of Transport and Digital Infrastructure

Investigation Report 19/19

Less Serious Marine Casualty

**Accident involving a person
on the multi-purpose vessel MARFAAM
at the Rüsterbergen pilot station
on the Kiel Canal (NOK)
on 13 January 2019**

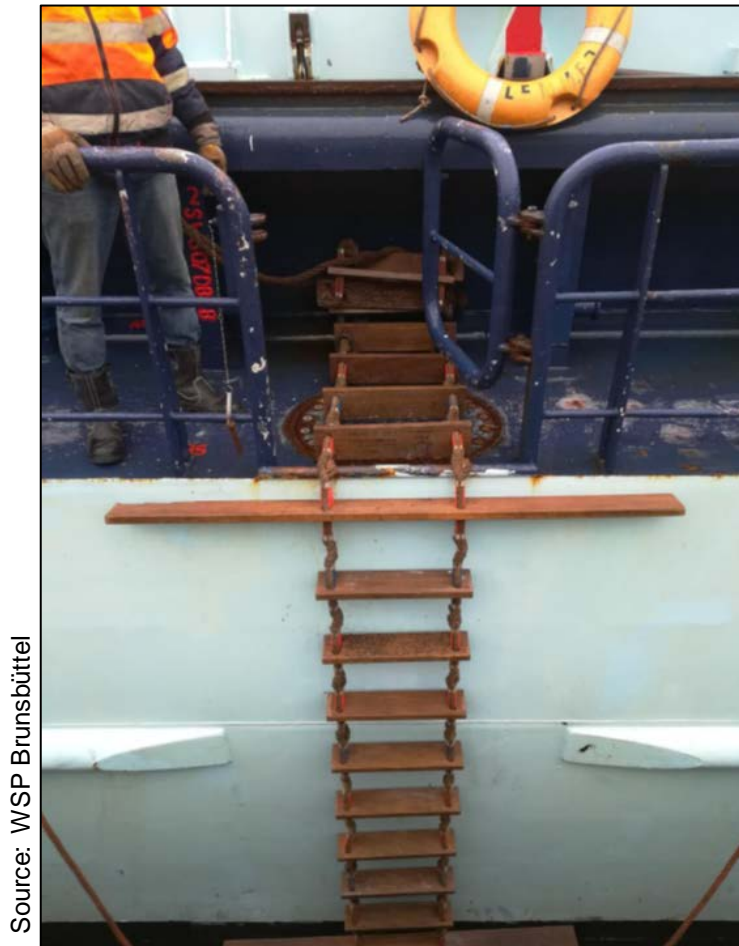
Figure 4: The MARFAAM's pilot embarkation point on the day of the accident

The Dutch-flagged multi-purpose vessel MARFAAM sailed westbound on the NOK during her voyage from Ventspils in Latvia to Ghent in Belgium. Apart from the crew, a pilot and a canal helmsman⁶ were on board. The pilot and the canal helmsman from the eastern section were scheduled for replacement when she was about half way down the canal at the Rüterbergen pilot transfer station (NOK km 55). The MARFAAM reached the pilot station at about 0650 on 13 January 2019. The freeboard was about 4.50 m when the accident happened.

From his point of view, the accident was caused by a lack of handholds and/or a suitable stanchions that can be gripped safely with one hand.

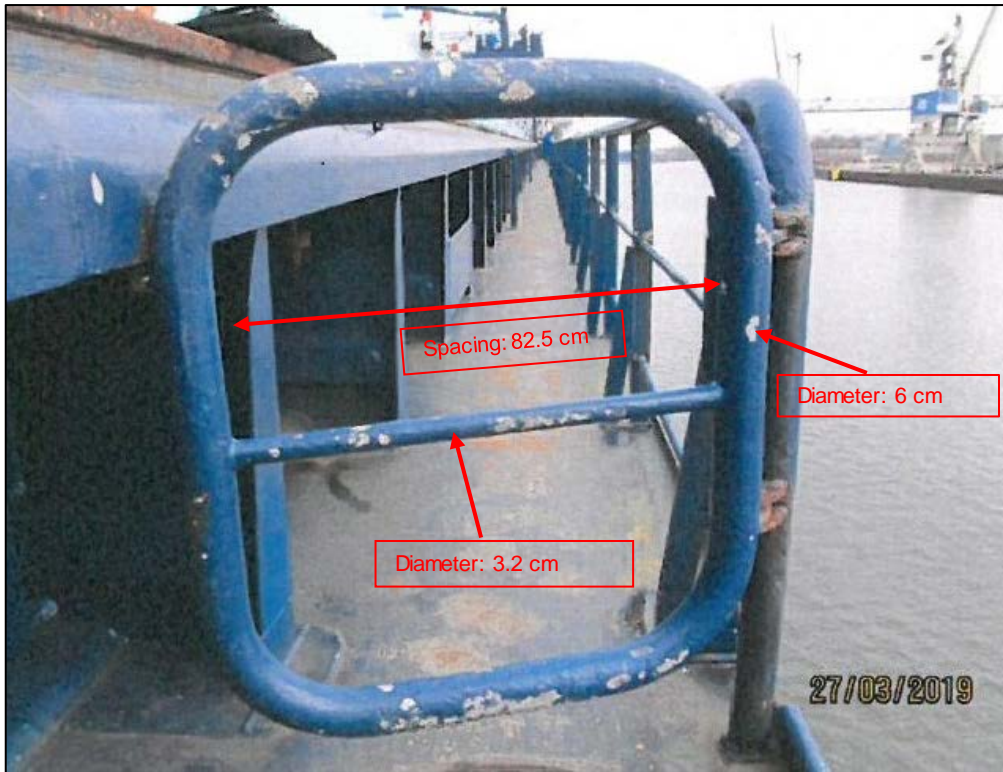
Figure 5: Open gateway

It was found that the pilot gateway is not mounted on a stanchion, but rather on the handrail of the rails, which continues down to the deck in this area. The handrail has a diameter of 6 cm and circumference of 19.7 cm there. The middle cross bars on the rails, which the injured canal helmsman had tried to take hold of inevitable and unsuccessfully, have a diameter of 3.2 cm.

It is not possible to completely open the gateway 90° because the leaf hits the hatch coaming first. There is no way of fixing or locking the gateway leaf in position when it is open, either.

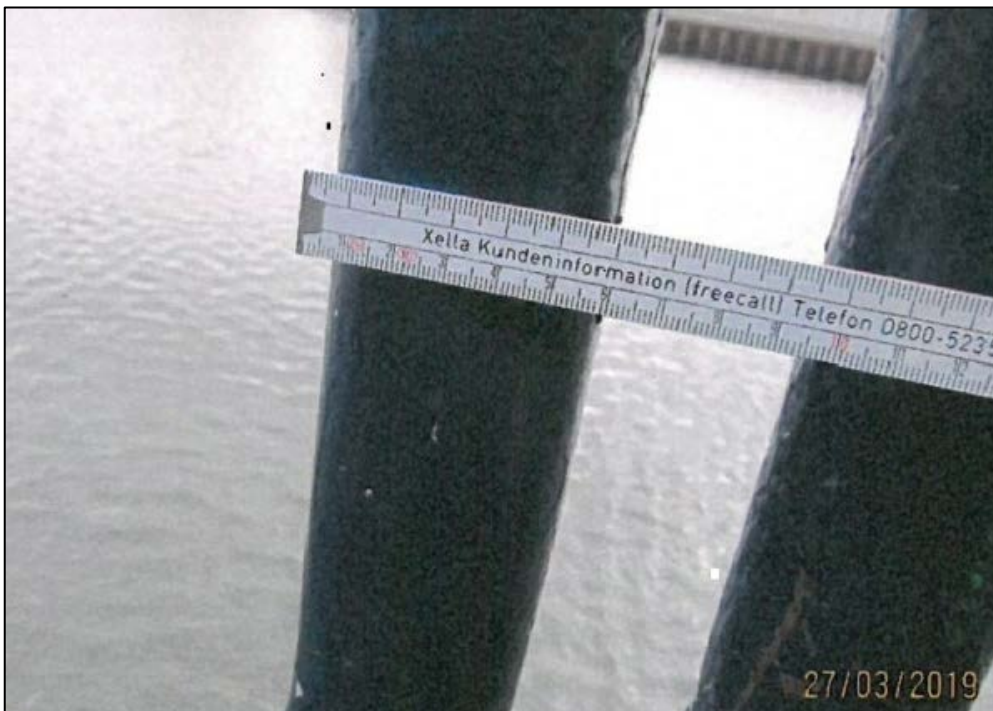
Figure 6: 6 cm diameter handrail

There were no handholds on the MARFAAM at the time of the accident. At the gateway the handrails continued down to the deck. Their diameter was about 60 mm, making it difficult for a hand to grasp them.

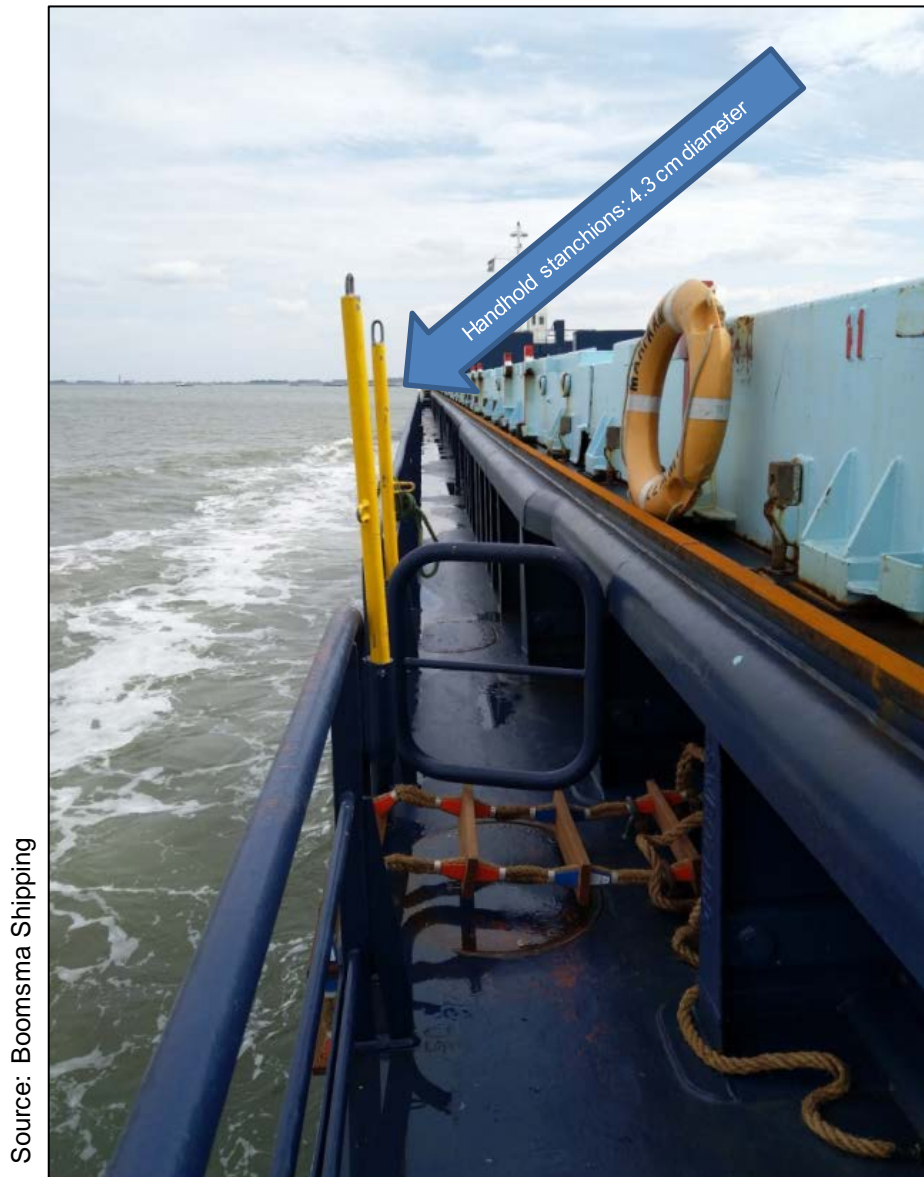
Figure 7: The MARFAAM's embarkation point up until September 2019

A photograph of the ship operator shows handhold stanchions mounted above the rails. According to the accident reports and statements, the crew dispensed with mounting these supports on the day of the accident.

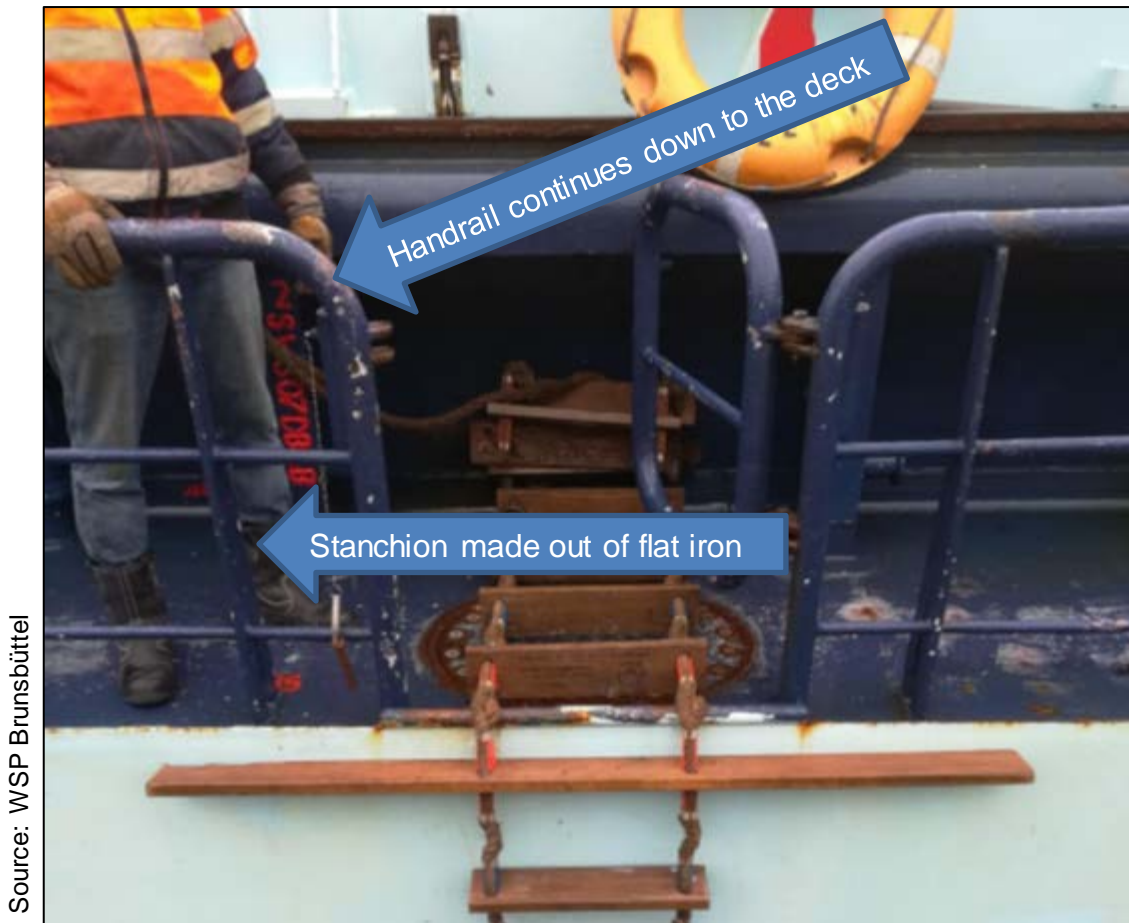
Figure 10: Handrail continues down to the deck

According to LR, for reasons of ship design and in the absence of a design for handholds, the handrails on the MARFAAM were continued down to the deck and regarded as handholds (see Figure 10).

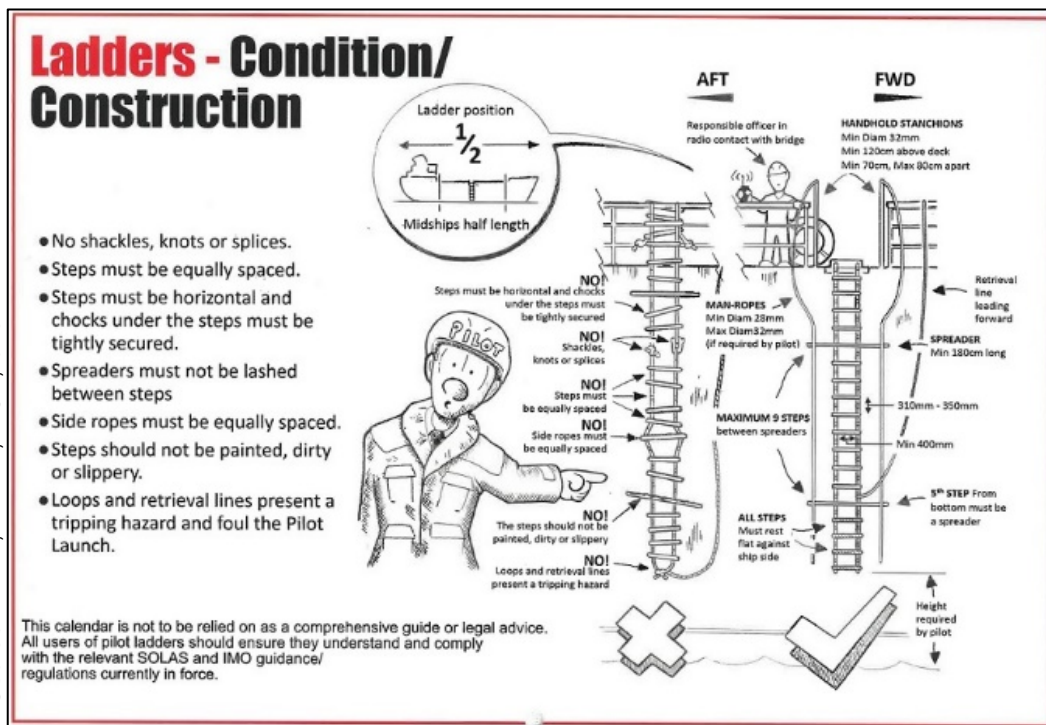
Figure 12: From the IMPA calendar for 2020

This drawing also takes into account access via a gateway, which is not included in the diagrams adopted by the Maritime Safety Committee. Handhold stanchions are erroneously drawn, which are intended for access via a bulwark ladder. Handholds similar to those required for access via a gateway should actually be provided (see Regulation 23, paragraph 4, Chapter V SOLAS). Handhold stanchions should only be used if they can be mounted freely and where a hand reaching for one is not obstructed by other components.

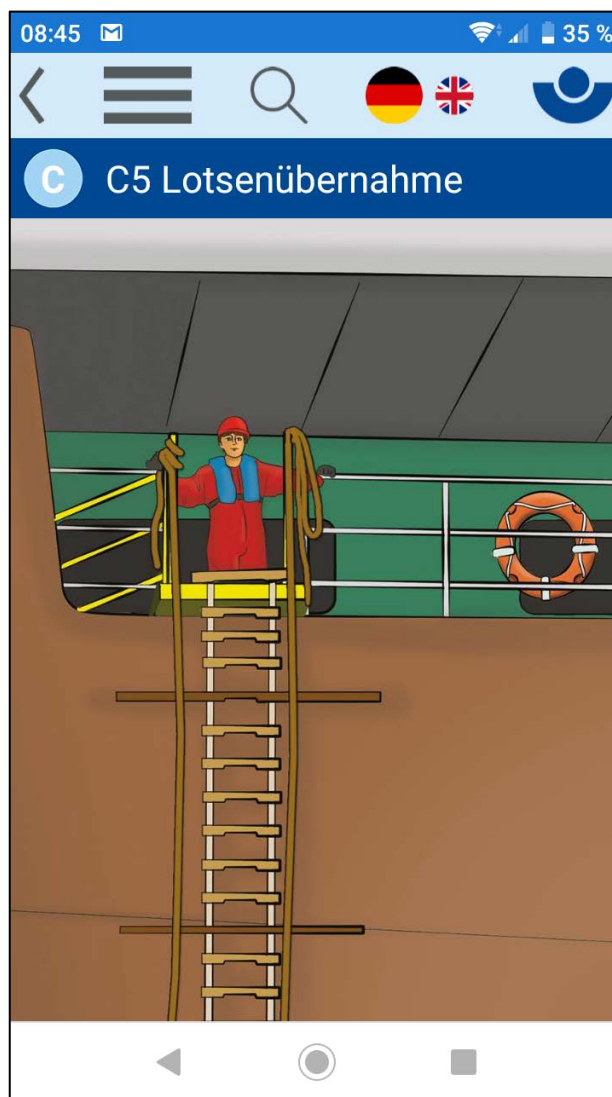
Figure 13: Screenshot from the Seafarer's Compendium application

The BSU is of the opinion that the depiction of the following points is erroneous: Handhold stanchions are visible instead of adequate handholds. The handhold stanchions are mounted inside the gateway and as such can make the entrance narrower. People embarking could also encounter access problems if the gap between the handhold stanchion and rails is too narrow. Regardless of the fundamental problems, people embarking will have difficulty using the handhold stanchions, as manropes are hanging in front of them.

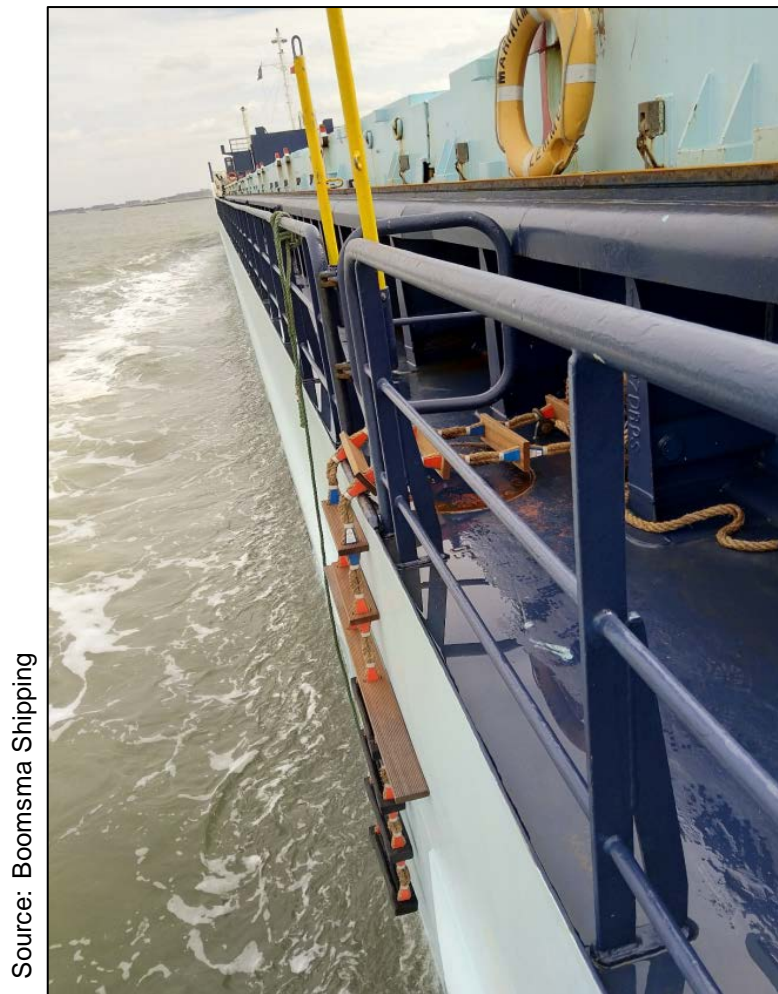
Figure 15: Handhold stanchions out of reach

Handhold stanchions can be mounted above the rails (see Figure 15) on the MARFAAM. However, these handhold stanchions are not adequate, as personnel embarking can only grasp them when at deck level. To reach the deck of the MARFAAM safely, it is necessary to reach for a handhold from the pilot ladder at deck level.
