Investigation Report 241/18

Serious Marine Casualty

Grounding of the motor tanker PAZIFIK off Indonesia on 9 July 2018

23 January 2020

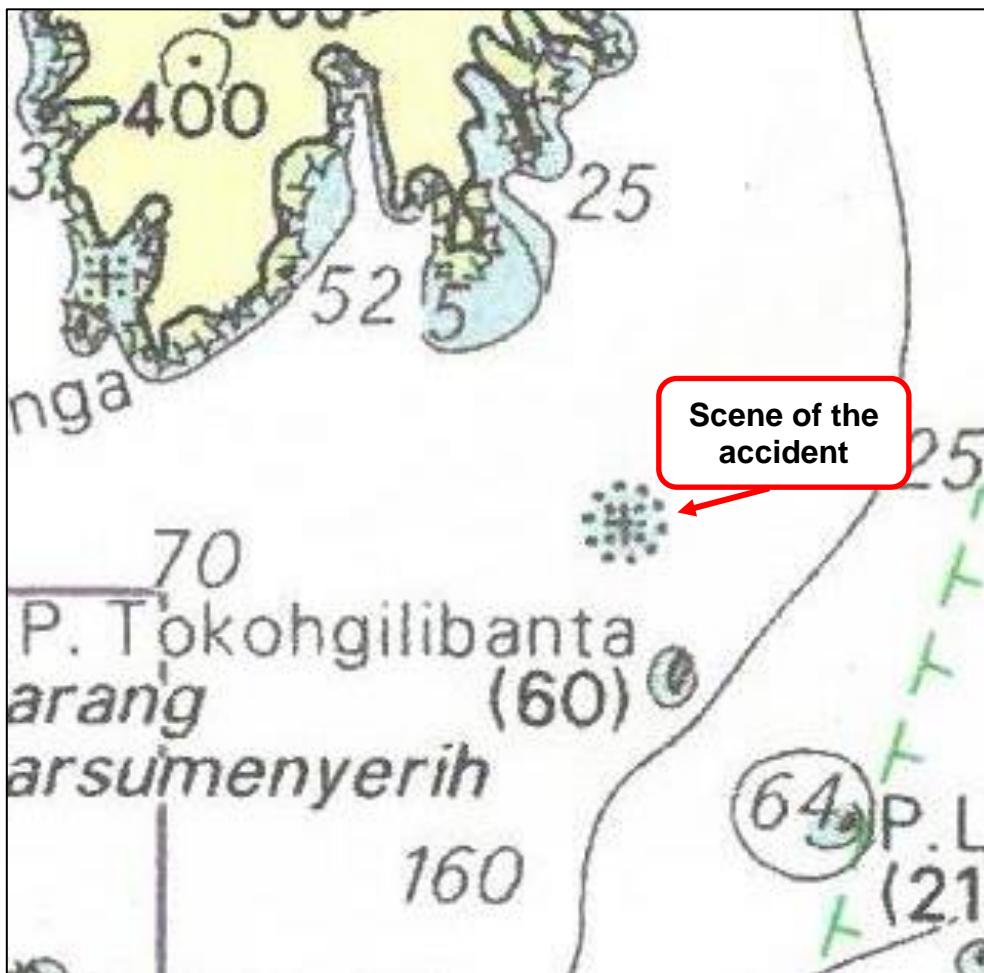
Figure 8: Navigational Chart BA 2910; scale: 1:500,000

Charts BA 2903 and BA 2910 (scale: 1:500,000) show the 'rock awash' symbol, i.e. a rock submerged temporarily or during high tide, at the scene of the accident.

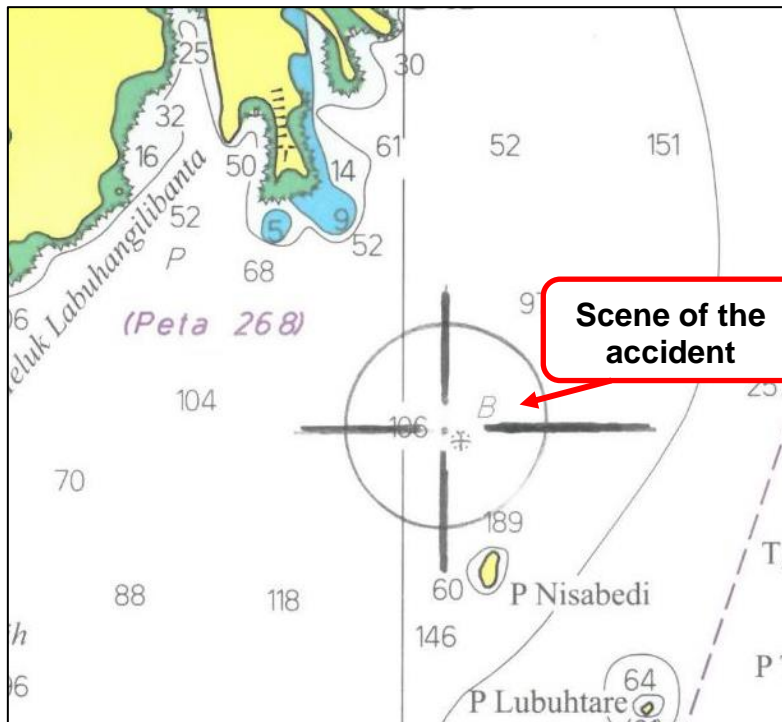
Figure 9: Indonesian Navigational Chart ID 295; scale: 1:200,000

The Indonesian Navigational Chart ID 295 (scale: 1:200,000) shows a rock symbol but it is not clear whether the rock is submerged from time to time. The Indonesian Navigational Chart ID 268-2 (scale: 1:50,000) does not show the 'rock awash' symbol but merely a shallow area with a water depth of 9 m.

According to the UKHO, the position of the rock shown on ENC-ID300295 is taken directly from the Indonesian Navigational Chart ID 295 at a scale of 1:200,000. This position differs with a 9 m shoal, which is plotted on the paper-based Navigational Chart ID 268-2 with a larger scale of 1:50,000. Although both Indonesian charts are compiled using the WGS 84 datum, there is a discrepancy between them in respect of position.

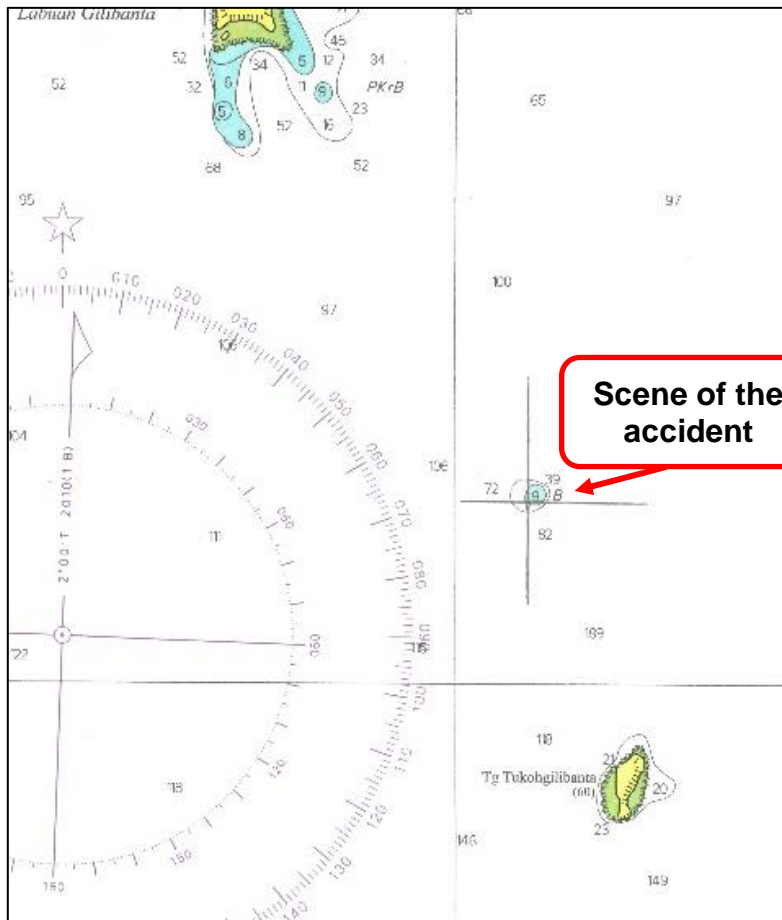
Figure 10: Navigational Chart ID 268-2; scale: 1:50,000

Chart ID 268-2 shows a depth of 9 m at this position. The chart indicates that this depth measurement dates back to 1904. Chart ID 295 – with a smaller scale – shows a rock in unknown depth in the form of a 'rock awash' symbol permanently submerged (depth: 0). It is likely that the rock symbol was consciously used in the small-scale charts for reasons of generalisation. The reason why one chart shows 'rock awash' and the other a permanently submerged rock ('underwater rock') is unclear. The UK charts use Indonesian charts as a basis but show the more dangerous scenario, 'rock awash'. The UKHO is not responsible for updating the ENCs of other nations but has forwarded the information to the Indonesian Hydrographic Office for review. Surveying of the area around the island of Komodo is planned for the near future and this will be used as an opportunity to map the position and minimum depth of these rocks precisely.

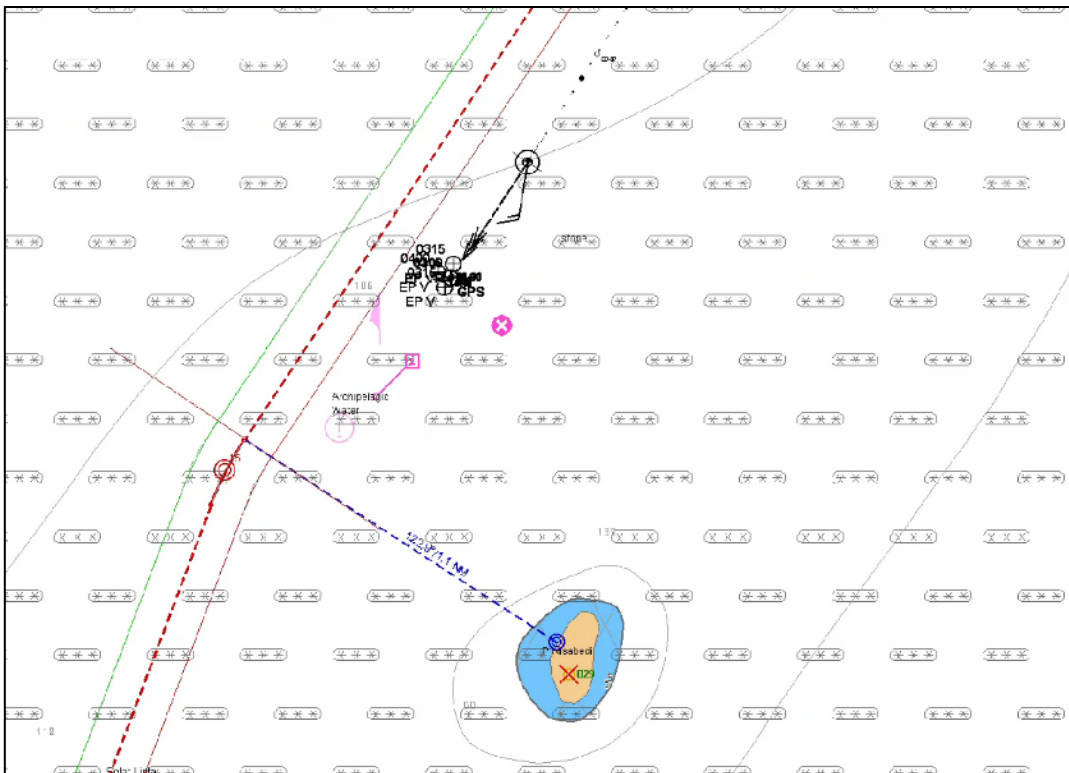
Figure 12: Deviation from route planning up until grounding

Using the information available on board, it was impossible for the crew to obtain accurate information about the actual navigational danger. When the passage was planned and executed, it was assumed that sailing through the plotted isolated danger did not entail any risk, especially since this isolated danger was shown to be permanently submerged. In view of the information from other sources, which did not have to be available on board, the information is insufficiently described in the latest ENC, i.e. the one used. The crew did not believe the plotted isolated danger posed a risk during the passage. On the planned route the isolated danger was passed at a distance of about 0.7 nm. The distance to the nearest shallow waters of the island of Banta was about 0.8 nm. The CATZOC (category zone of confidence) for this area is assigned a 'C', indicating a positional inaccuracy of +/- 500 m or 0.27 nm. This means that a safe CPA (closest point of approach) to the island of Banta and to the plotted isolated danger is reduced to 0.53 nm and to 0.43 nm, respectively, in the worst case.

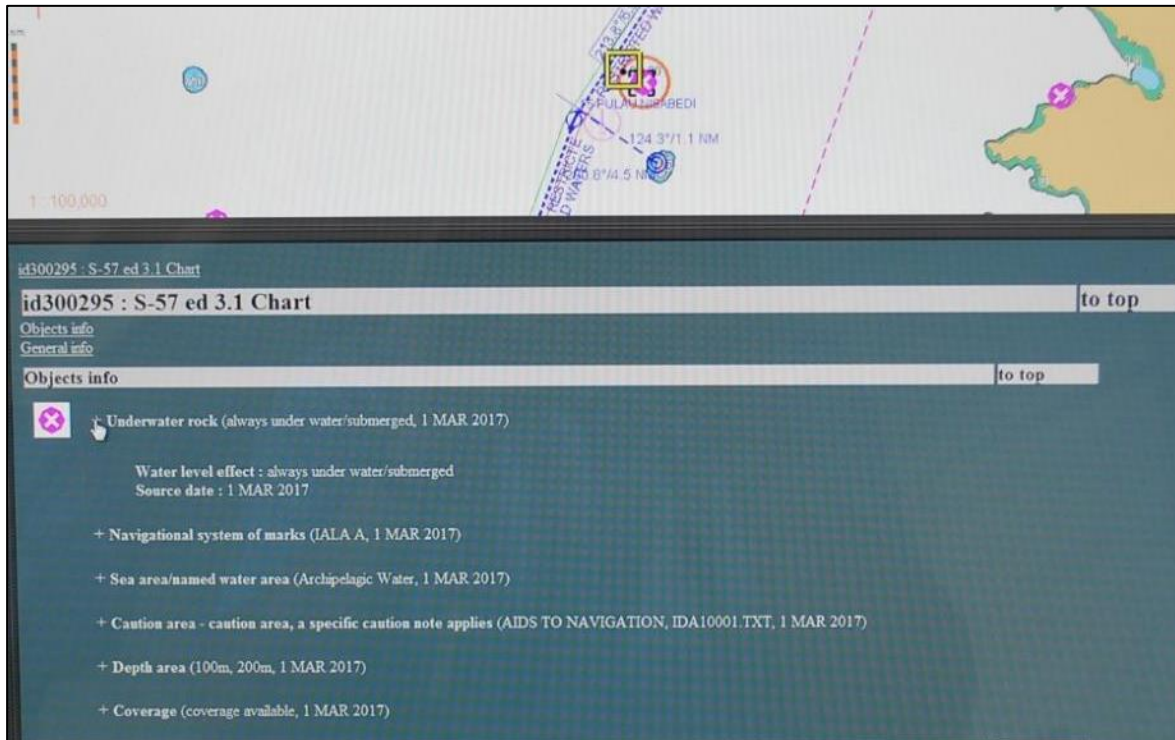
Figure 13: Information stored in the ENC

"Underwater rock (always under water/submerged 1 MAR 2017)"

There is no additional depth information or depth contours for or near the isolated danger area. The general water depth in the Selat Sape passage around the isolated danger is specified at about 100 m.

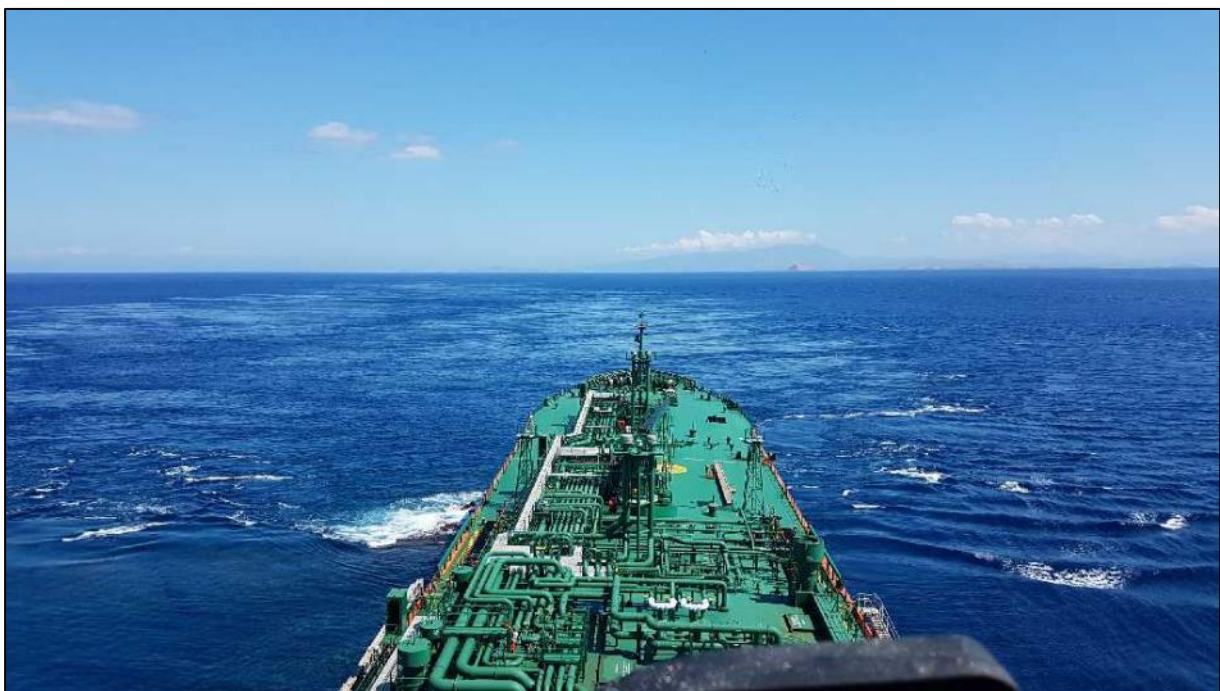
Figure 15: Waves breaking on rocks

"A drying rock, 1 mile farther NNW, is small and dangerous; the breakers on it being indistinguishable from the normal overfalls and sea conditions in the area."

This account corresponds entirely with the situation found at the place of grounding.
