## **Investigation Report 32/19**

### **Serious Marine Casualty**

# **Grounding of MV BORE BANK after steering gear failure level with buoy 18 in the Rostock sea channel on 17 January 2019**

16 January 2020

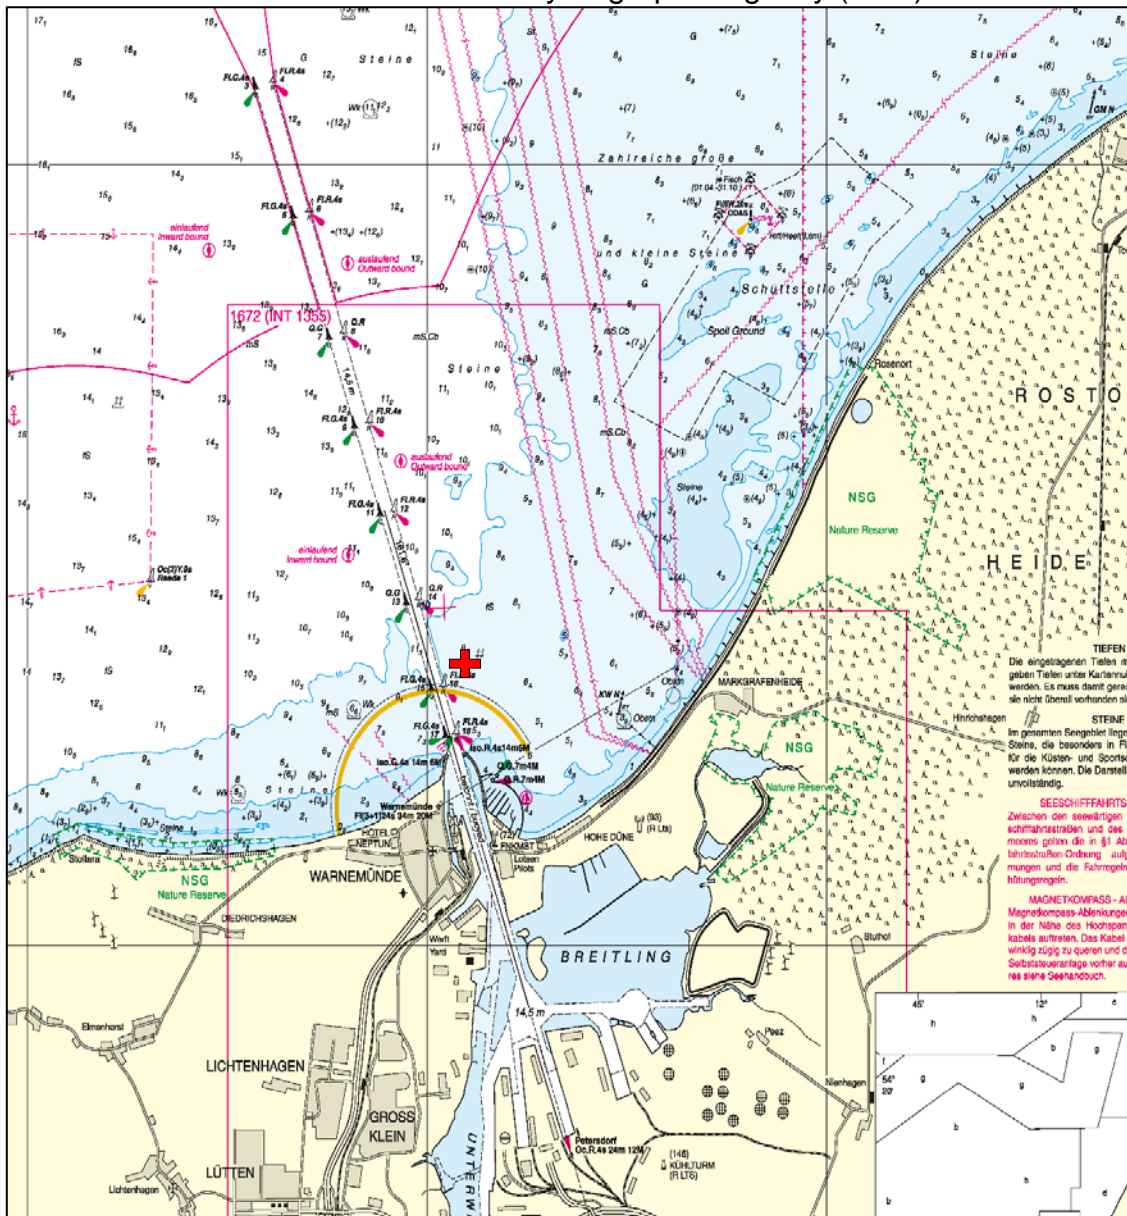
Figure 2: Scene of the accident

Type of marine casualty: Serious marine casualty/ran aground  
 Date, time: 17/01/2019, 0550  
 Location: Entrance to the port of Rostock  
 Latitude/Longitude:  $\phi 54^{\circ}11.270'N \lambda 012^{\circ}05.532'E$   
 Ship operation and voyage segment: Estuary trading  
 Place on board: Fore section  
 Human factors: No  
 Consequences: External assistance required; only paint abrasions on the underwater hull

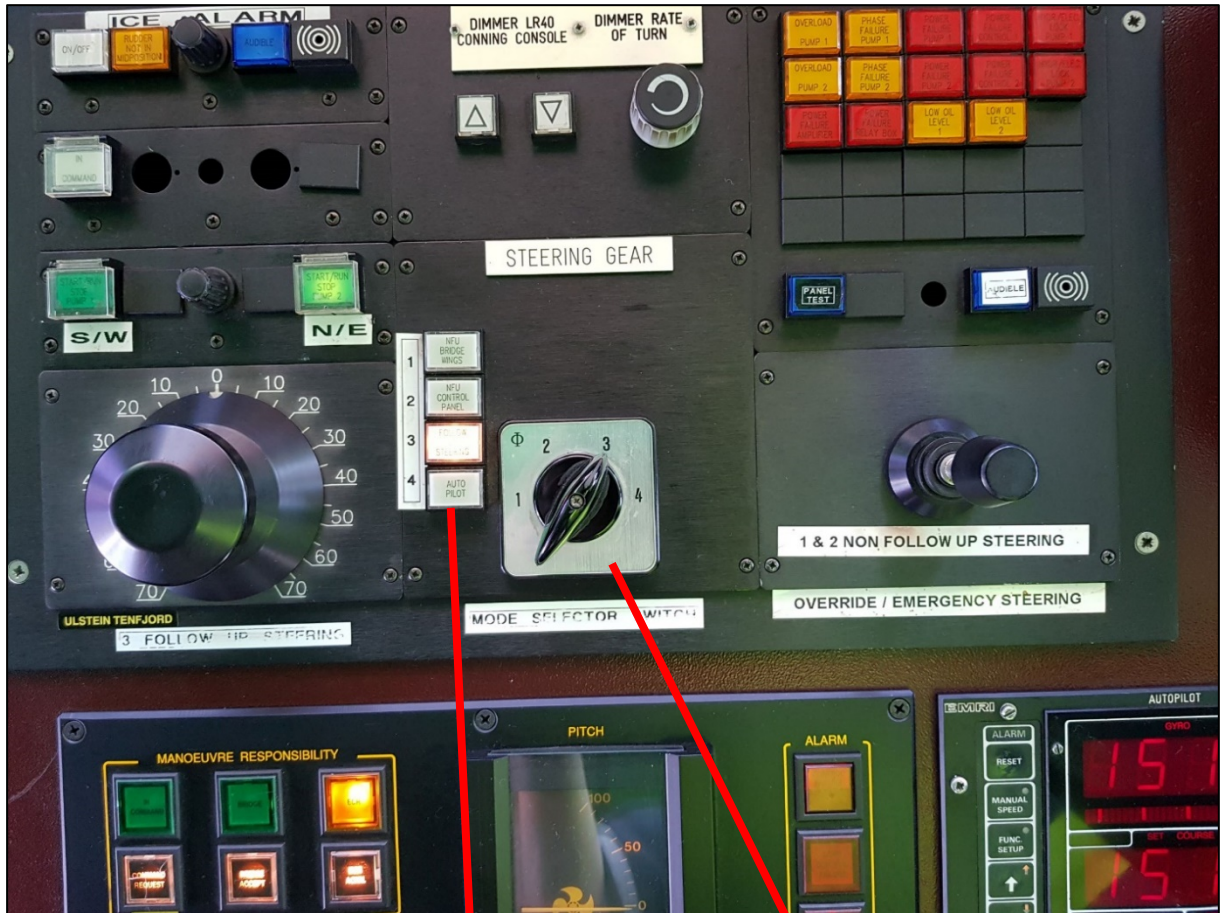
Figure 3: Steering gear control panel

The Finnish-flagged Ro-Ro/ship BORE BANK was en route from Kotka to Rostock on 17 January 2019. The pilot boarded in the morning at 0530 and the sea channel passage began. The bridge was manned by the pilot and the master at the starboard console and the third officer at the centre console. The ship was steered using autopilot and proceeding at about 7 kts. A strong easterly wind constantly pushed the BORE BANK to starboard. At 0547, the pilot noticed that he could no longer steer the ship using autopilot and asked the third officer to take over the manual steering. The third officer then switched over from autopilot to follow up steering but found that he could not steer the ship using that, either. The steering was evidently still operating on autopilot (see Figure 3 to Figure 5).

The master later said (amongst other things) that there must have been errors in the switching process. He seems to remember that the indicator did not switch to follow up steering, which would mean the autopilot was not switched off. The master claimed that the autopilot could only be switched off when the rudder was at ZERO degrees. It was also stated that the installed autopilot had reportedly never been adapted for the ship but had operated on default settings since the ship entered service. Moreover, it has reportedly caused several false alarms since then, too.

The BSU is in possession of internal information from the owner, which indicates that the switchover process is reportedly abnormally complicated and therefore only understood by the regular crew. The replacement crew operating on board was reportedly not in possession of this particular knowledge, however.

A nautical superintendent from the owner visited the ship on Monday 21 January 2019 in the next Finnish port to assess the situation. Following that, the autopilot's manufacturer was asked to visit the ship to carry out repairs and adjustments. A technician boarded on 18 February 2019 and carried out tests and adjustments on the system until 21 February 2019. After that, the steering gear reportedly operated properly. The cause of the steering gear failure was not determined, however.

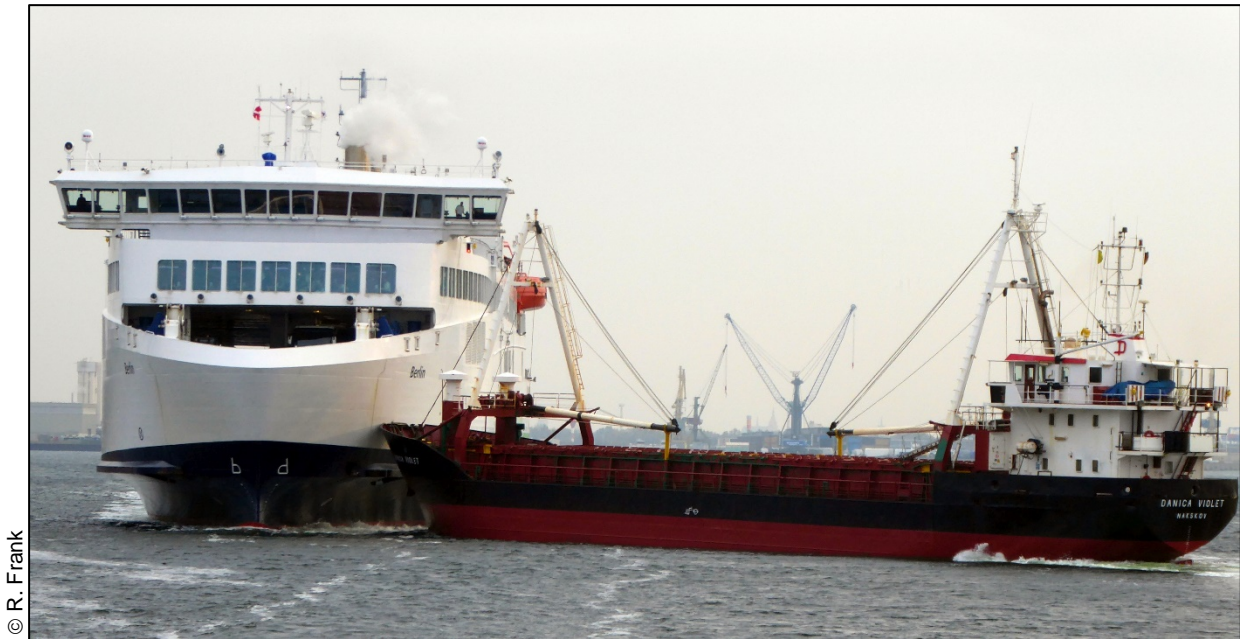
Figure 6: Collision of DANICA VIOLET with BERLIN

At about 1530 on Friday 1 November 2019, the DANICA VIOLET (Danish flagged) was sailing into the sea port of Rostock, when her steering gear failed causing her to turn to port level with the cruise terminal. The hard to starboard manoeuvre did not have any effect so that the engine (left-handed controllable pitch propeller) was set to full astern. However, this engine manoeuvre intensified the turn to port. Subsequently, DANICA VIOLET's bow collided with the port-forecastle of the outbound ferry BERLIN.

The results of the internal preliminary investigation carried out by the BSU revealed that DANICA VIOLET entered the sea channel using the autopilot. When the vessel all of a sudden was turning to port the vessels command attempted to operate the rudder manually, but did not succeed. Due to the age and dimension of the ship, the DANICA VIOLET does not have a VDR on board. However, a VDR does not record steering gear data. Immediately after the collision, the steering gear operated again enabling the DANICA VIOLET to berth without assistance. The service company called was unable to detect a cause, as was often the case with regard to such accidents. Once again, no technical recordings explaining the steering gear failure were available.
