## **Investigation Report 405/18**

### **Serious Marine Casualty**

**Destruction of the main engine's turbocharger  
with subsequent fire in the engine room  
of the BALTIC BREEZE  
in the North Sea  
on 14 October 2018**

21 July 2020

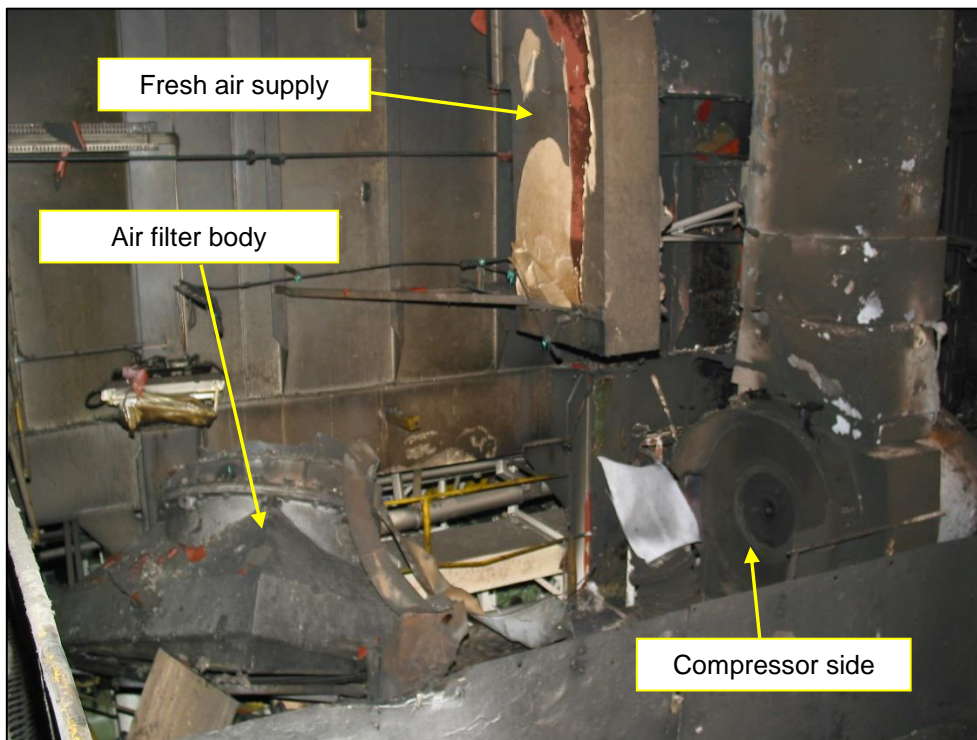
Figure 7: Main engine's destroyed turbocharger  
View of the compressor side.

*The existing damage pattern indicates that it was clearly caused by the compressor of the turbocharger. The damage in the area of the exhaust turbine is to be regarded as consequential.*

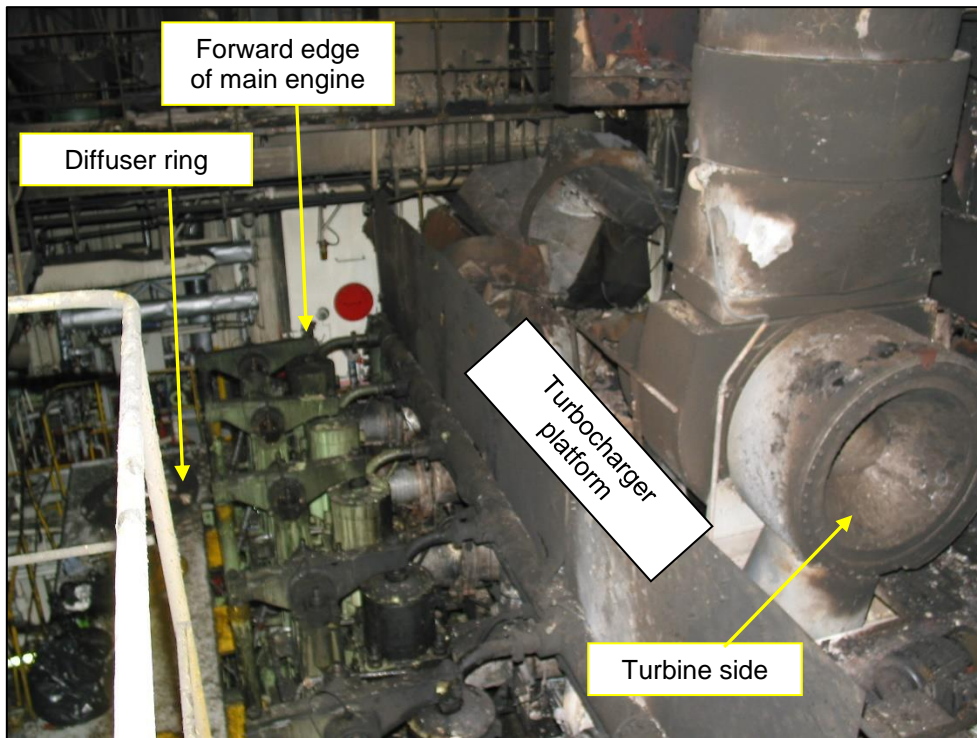
Figure 8: View of the main engine and turbocharger platform  
 Location of the diffuser ring to the left on the platform of the cylinder station.

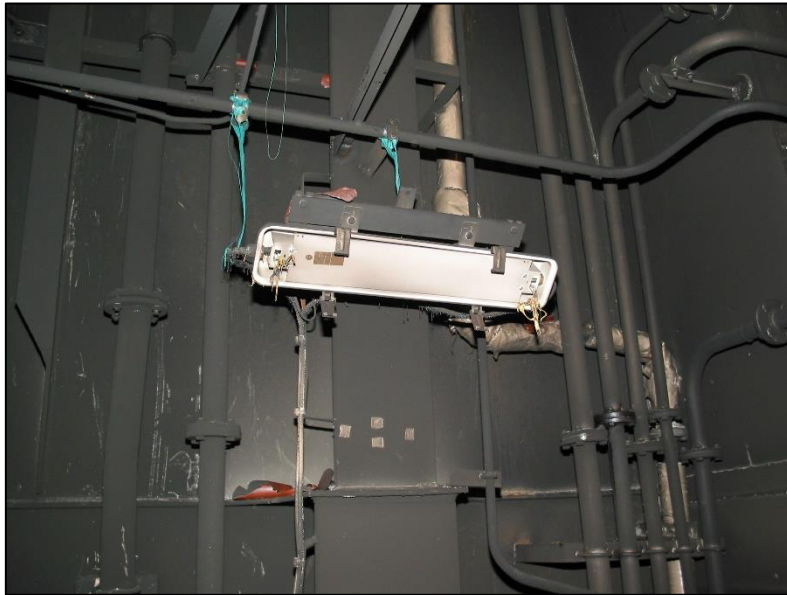
Figure 10: Damage to lights and cables

- the complete engine casing was heavily fouled by soot. Various wiring harnesses and lights had been exposed to heat stress (Figure 10);
- heat stress had caused paint to flake off on the outside of the engine casing (Figure 11).

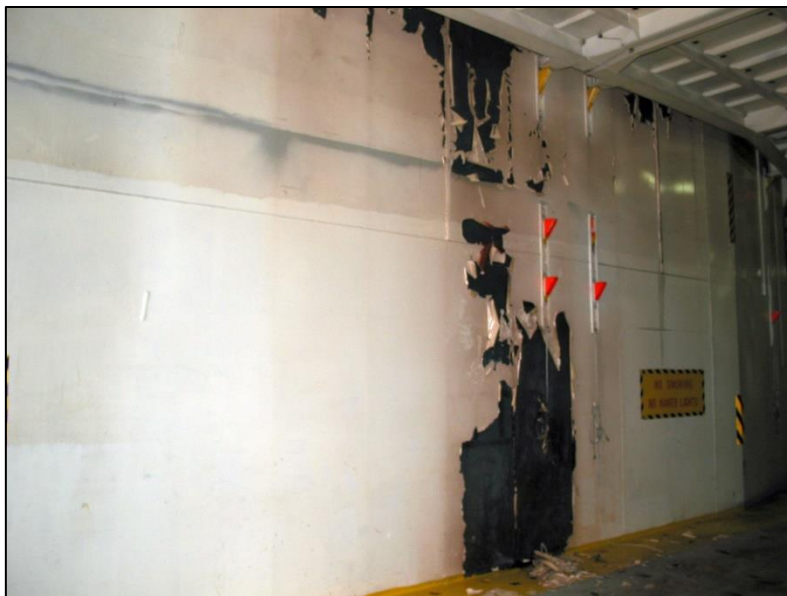
Figure 11: Damage to the paint coating

The outside of the engine casing on the starboard side of the freeboard deck is shown here.

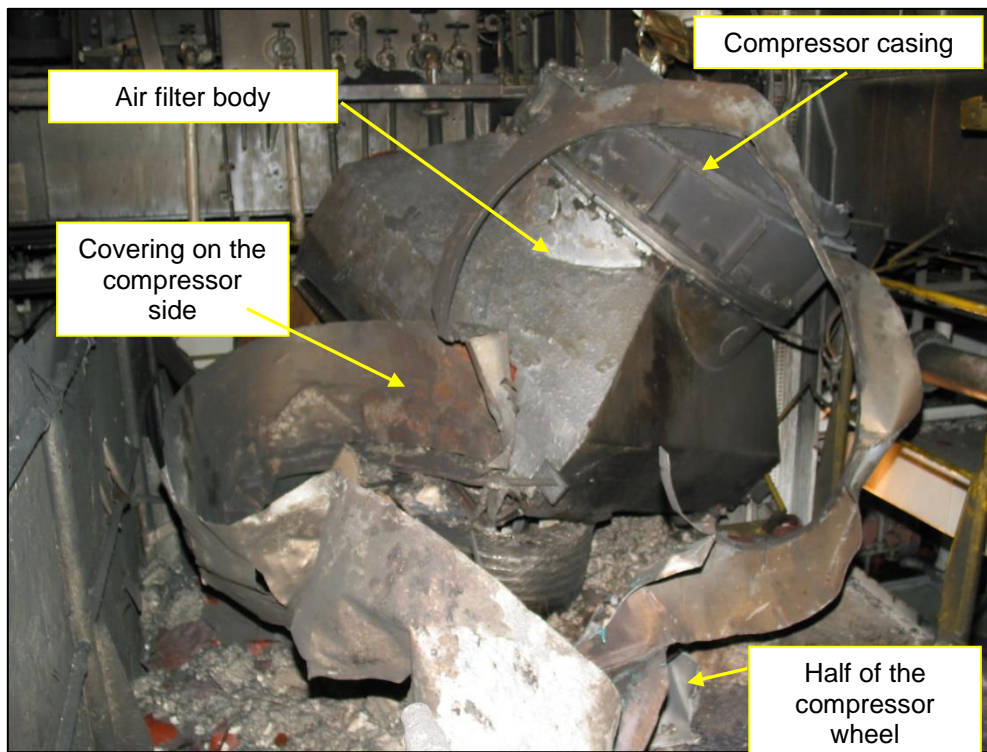
Figure 13: Turbocharger platform with air filter body

*"The entire compressor of the turbocharger was no longer on it. There were only small parts of the compressor's casing [...] and the air discharge nozzle from spiral to charging air cooler [...]. [...] half of the compressor wheel was located near the intake casing between the position of the turbocharger and the intake casing [Figure 13]."*

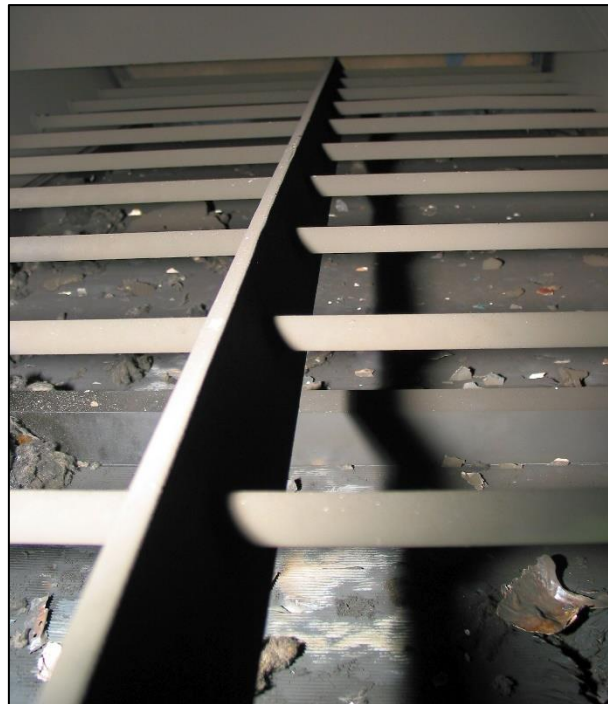
Figure 20: Compressor side of the charging air cooler

*The charging air cooler was also checked for damage or obstruction during the survey on 17 October 2018. This involved opening the hood of the charging air cooler on the turbocharger side. Parts of the charging air cooler were heavily fouled by oil, combustion residues and small pieces of debris that probably fell from above during the damage event and fire. The stator lamination from the charging air cooler was inspected after an access cover had been opened. A large number of small splinters were found on the stator lamination, which presumably come from the broken compressor wheel and broken compressor casing. However, no extensive obstruction, e.g. that may have caused the turbocharger to start surging, was detected [Figure 20]."<sup>14</sup>*

*No indications of a significant reduction in the flow of air through the compressor by subsequent throttling could be found. An inspection of the charging air cooler revealed that it was not obstructed in any significant way. Although debris was found on the stator lamination of the charging air cooler [Figure 20], it is unlikely to have resulted in a reduction in flow rate needed for surging.*

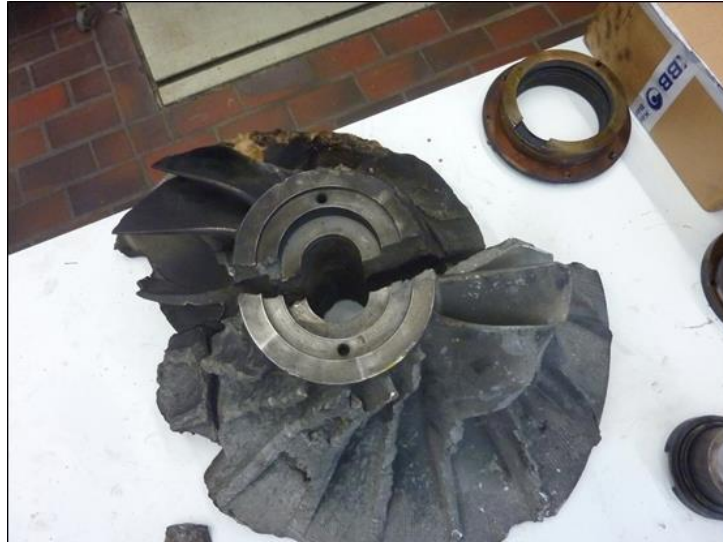
Figure 26: Split compressor wheel

*As described above, the compressor wheel is split into two parts. [...] The wheel has a straight split [Figure 26]. The crack runs perpendicular to the line of the two mounting holes for the dismantling tool. The crack also runs parallel to the bore for the turbocharger shaft. The blades are all damaged, some of them being worn down to the compressor wheel hub. These heavily worn areas are laterally reversed on the two wheel halves. The rear side of the wheel shows [Figure 27]. It can be seen here clearly that the protruding parts that engage in the claw sleeve for a positive joint have broken out in the middle of the wheel around the shaft bore and are completely absent. The sealing labyrinth on the outer radius of the back of the wheel is relatively heavily worn down but in those areas where the wheel disc is complete still relatively easy to see [...]."<sup>16</sup>*

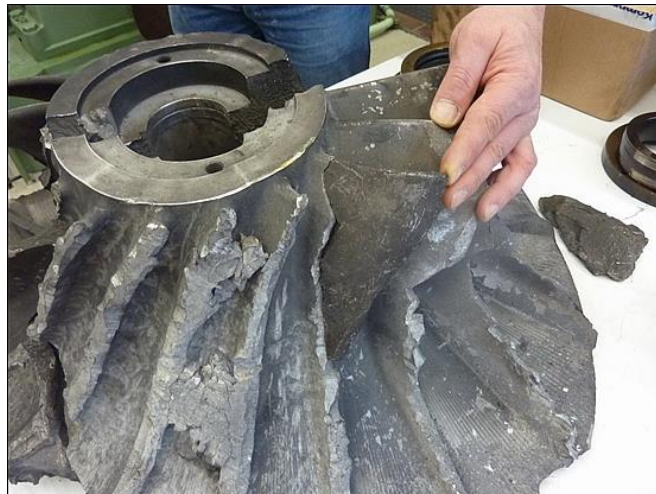
Figure 28: Deformed and broken compressor blades with material smearing

*"The extremely heavily damaged blades, which have been worn down to the hub, exhibit plastic deformation and warping of the material. This must have been caused by a transverse (in relation to the direction of the blades) movement, as indicated by the corresponding traces of movement on the materials [Figure 28]. It is reasonable to assume that this occurred after the wheel was split when punching through the diffuser and compressor casing.*

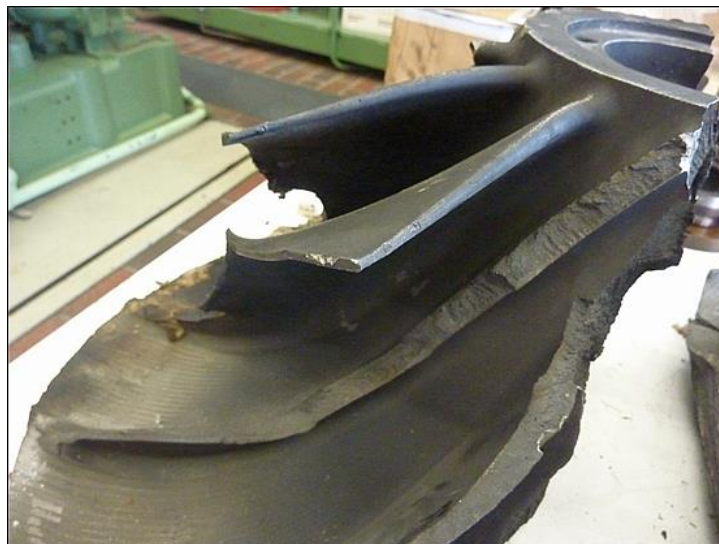
Figure 30: Extract from Figure 29

*It can be clearly seen here that the fracture characteristics on the first and second blade developed largely without deformation, while strong deformations in the direction of rotation with corresponding chips in the material can be seen on the third and fourth*

*blade after the fracture at the upper end, which may have been caused by parts that had broken off of the first and second blades.*

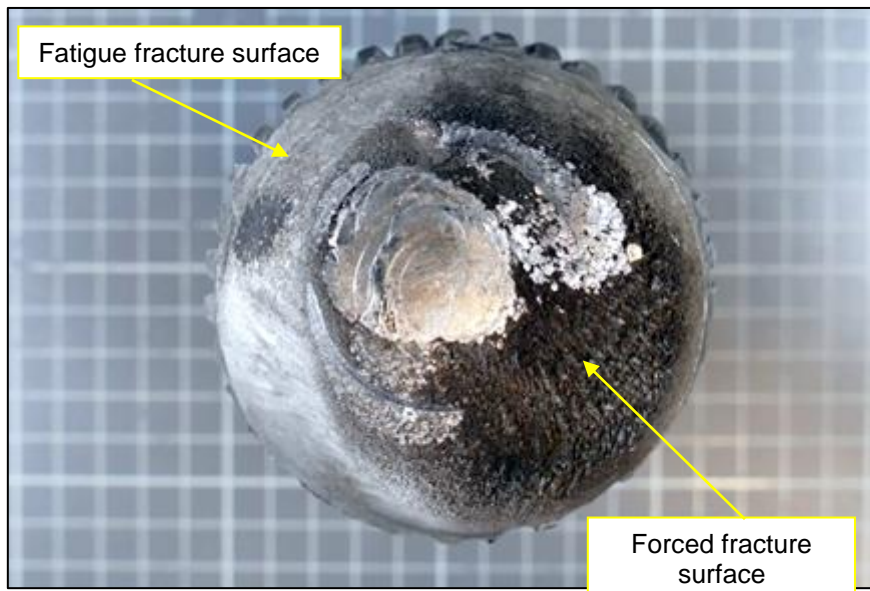
Figure 31: Fracture surface of the rotor shaft with fatigue and forced fractures<sup>21</sup>

*During the examination (Annexes 2 and 3) it was found that the fracture surface is located exactly at the end of the serration of the turbocharger's shaft on the compressor side. The exact origin of the fracture is at the end of the tapered part of the serration, where a minimal edge on the fragment on the shaft side is also visible. The fracture surface is thus parallel to the turning grooves, which are clearly visible in the area of the transition cone. On the two examined shaft ends it is clearly visible that on one side of the shaft there is a sickle-shaped fatigue fracture surface rotating through about 180°, which has already been hammered considerably. [See also Figure 31.] However, the remainder of the surface of the forced fracture is at least 2/3 of the total cross-sectional area of the shaft at the point of fracture. It is also evident that rather than opening when the shaft bent, the fatigue fracture actually closed.*

*It can therefore be assumed that the crack resulting from a fatigue fracture did not cause damage. Since the fatigue fracture surface has been subjected to strong hammering, it is no longer possible to detect the location of the start of the fracture.*

*As the examinations of the Laboratory for Materials Science at the Bremerhaven University of Applied Sciences show, the shaft had a crack in the form of a fatigue fracture, which was already smoothed on its surface, i.e. it must have been in operation for a long time.*

*However, it is highly unlikely that this crack was responsible for the fracture because the bend in the shaft caused the crack to close rather than open. The reduction in cross-sectional surface by about 30% near the fracture surface is likely to have facilitated a tearing off of the shaft end in the event of excessive loading due to the blocking of the compressor wheel, as the stresses in the shaft reached a critical level more quickly because of the reduction in cross-sectional surface. It is no longer possible to clearly determine the cause of the fatigue fracture retrospectively. The metallographic examinations show that the fracture occurred parallel to machining grooves on the shaft, i.e. it is possible that an increased notch effect could have occurred there due to insufficient surface quality during machining. The fracture on the shaft is indicative of rotating bending, which is a typical overload due to imbalance. It*
