Bundesstelle für Seeunfalluntersuchung
Federal Bureau of Maritime Casualty Investigation
Federal Higher Authority subordinated to the Ministry
of Transport and Digital Infrastructure

Investigation Report 421/18

Occupational accident on board the MV SVENJA at the pier in the port of Rostock on 31 October 2018

18. June 2020

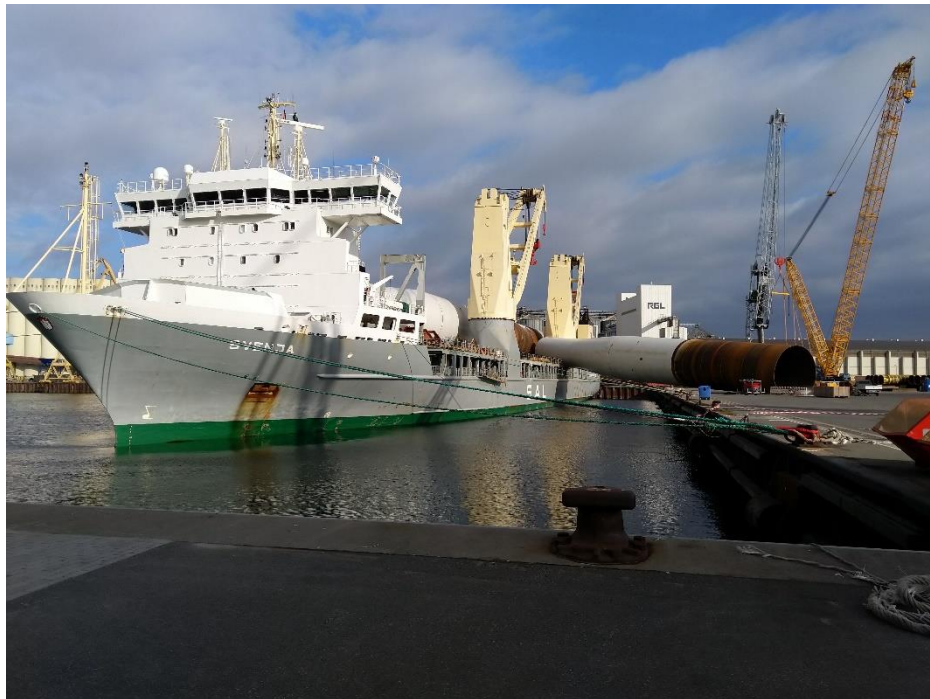
The BSU was notified of the accident at 1511 on 1 November 2018 and the first survey was made on 2 November 2018. During the survey one end of the MP lay on the pier and the other on the ship, which was moored at the bow with new lines. The cranes had been turned lengthwise, Crane 2's traverse was detached and the SPMT already removed. At the stern, the ship was wedged against the pier and additionally made fast with mooring lines/cables.

Figure 3: Scene of the accident on 2 November 2018

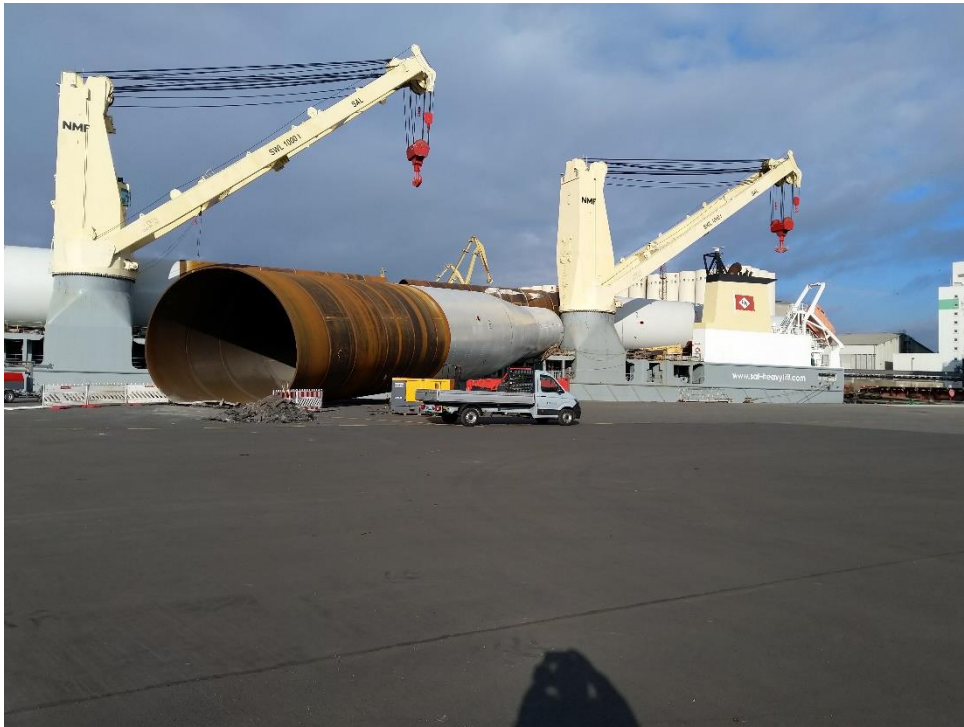
Figure 4: MP A28 seen from the pier

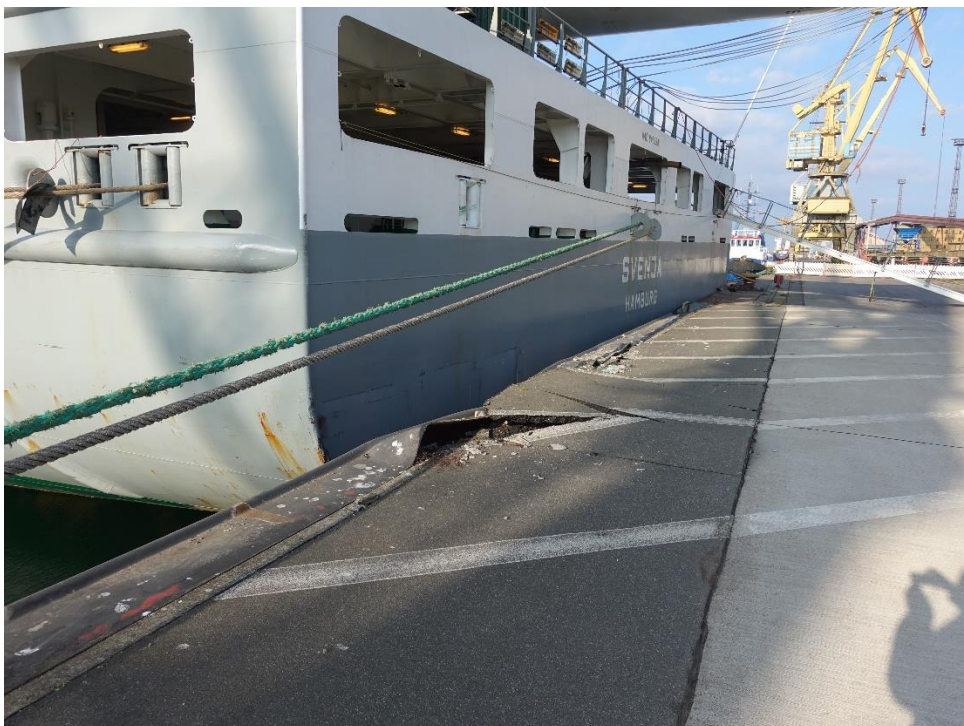
Figure 5: Ship wedged at the stern

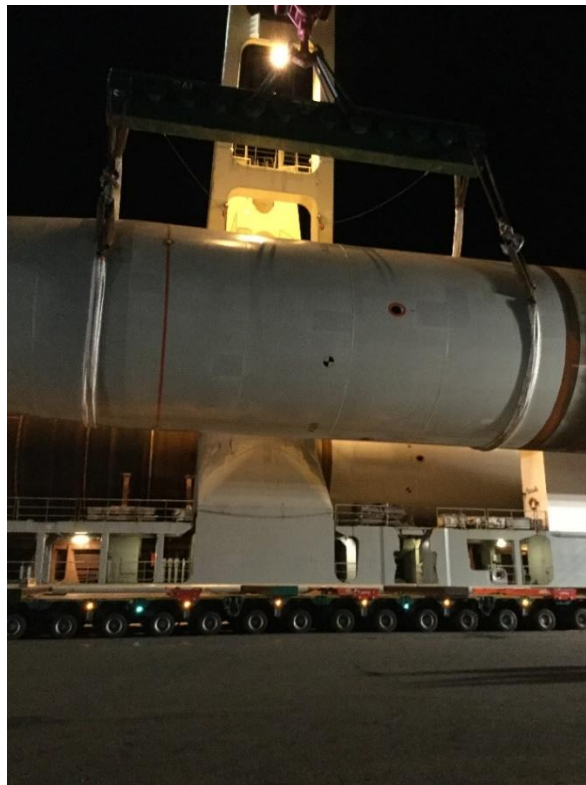
Figure 10: Lift before the swing operation

The photogrammetric analysis (measuring accuracy: ± 12 mm) showed that the centre of gravity (based on the owner's drawing) marking was off-centre by 12.3 cm toward the conical part. This centre of gravity marking was confirmed by KMR-Marine Surveyors GmbH's geometrical measurement of MP A28.

The distance from the slings to this marked centre of gravity is 8.189 m toward the conical part and 7.741 m toward the cylindrical part. The analysis of the two photographs revealed that from the lift (Figure 10) to the crane being turned by 90° (Figure 11), there was no displacement of the slings.

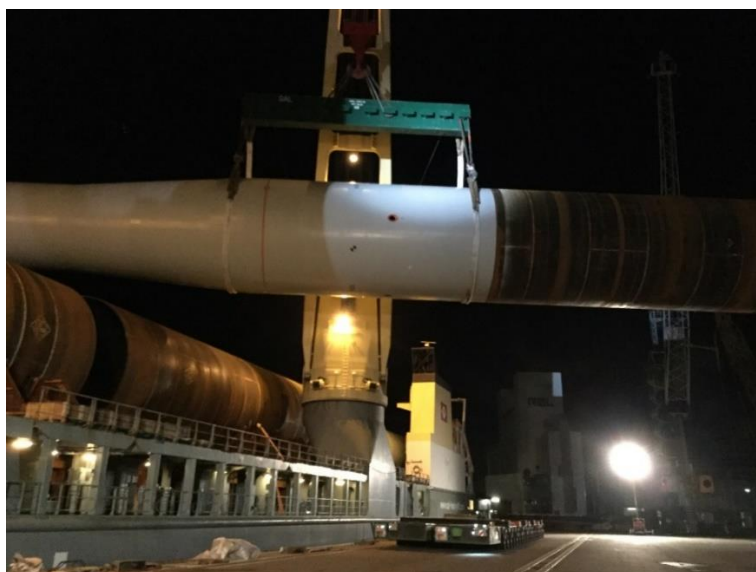
Figure 11: The swing operation

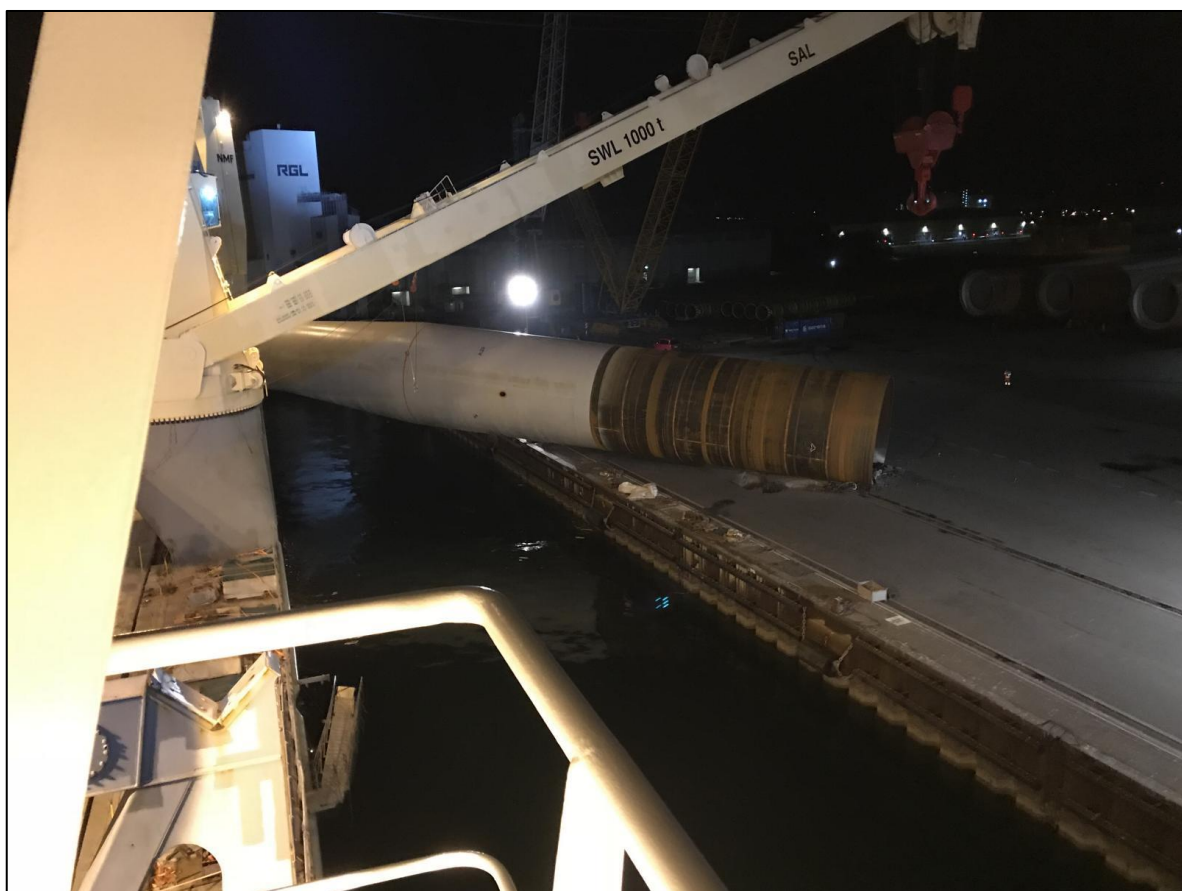
The ship was almost upright and the raised cargo swung clear of the MPs already on board. At about 1932, MP A28's cylindrical part began to tilt toward the bank about half way between the quay and the ship when Crane 2 had turned about 45° over the ship. At this point the chief officer was situated starboard in the aft section of the hatch near the planned stowage position and the second officer was on the main deck in front of Crane 2's pedestal operating the tigger winches. It was noticed that the sling in the conical part first started to slip, that a stream of water was released under the MP and that the cylindrical end approached the crane's cabin. The MP slipped out of the slings toward the bank. When the MP dropped down, it first struck MP E24, which was already loaded, then it slipped toward the quay side and pushed the ship away from the quay. Apart from one head line, all the mooring lines at the bow parted and the gangway fell into the water at the front. Only a spring line parted at the stern and the ship became wedged against the quay wall aft.

Figure 12: Final position after the MP slipped

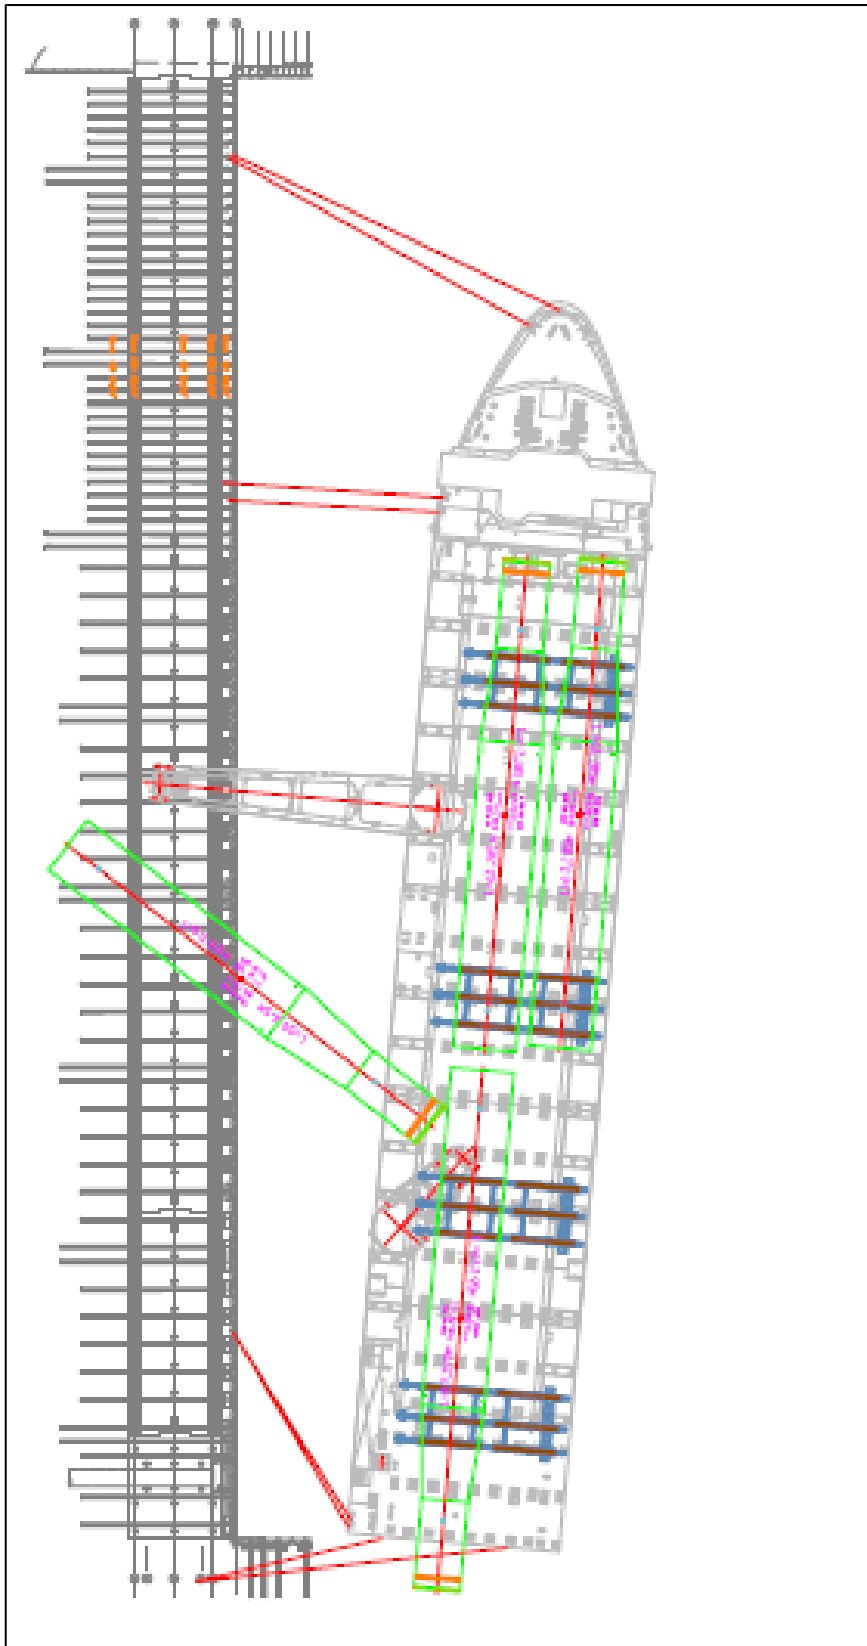
Figure 13: Final position of the ship and MP A28

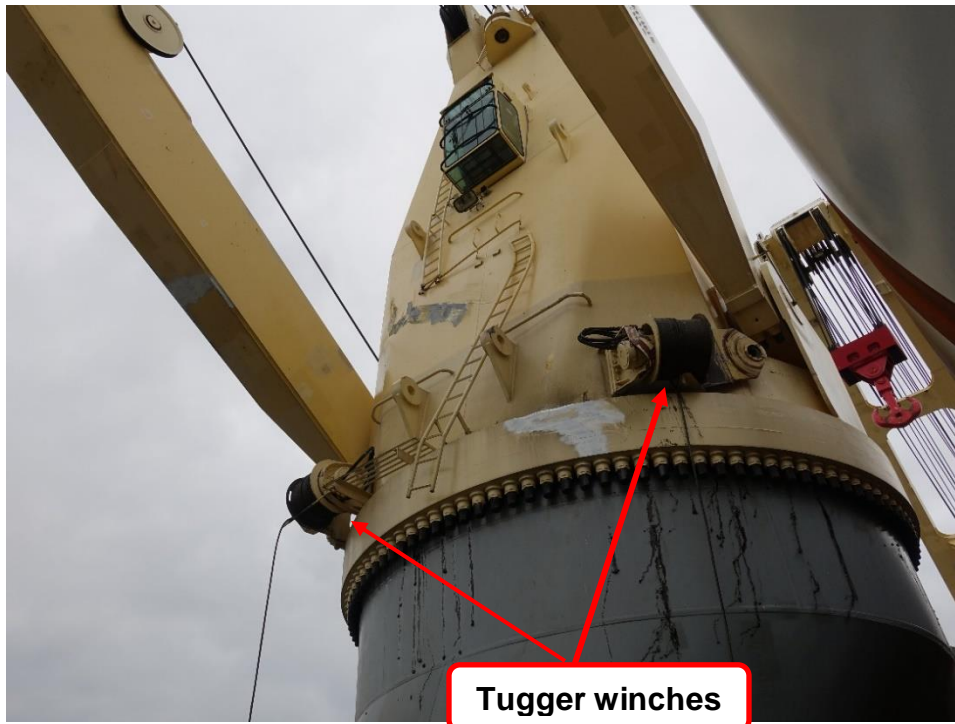
Figure 14: Damage to Crane 2

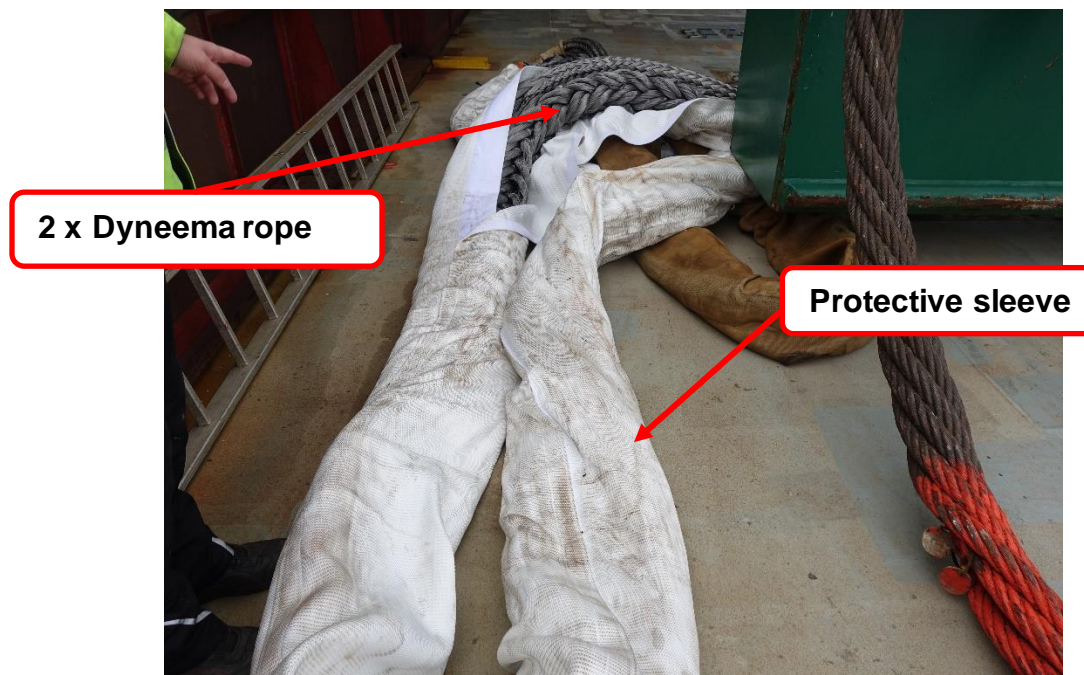
Figure 15: Lifting sling from the conical part of the MP

The lifting sling attached to the conical part of the MP exhibited no tearing. However, fusion with the protective sleeve, which was no longer at its original position, and traces of wear were visible.

The lifting sling in the cylindrical part exhibited complete and partial tearing, as well as complete and partial fusing of strands. The protective sleeve was completely severed and exhibited other cuts and wear. The above damage can be explained by the sling slipping over the bulge of the earthing brackets on the MP.

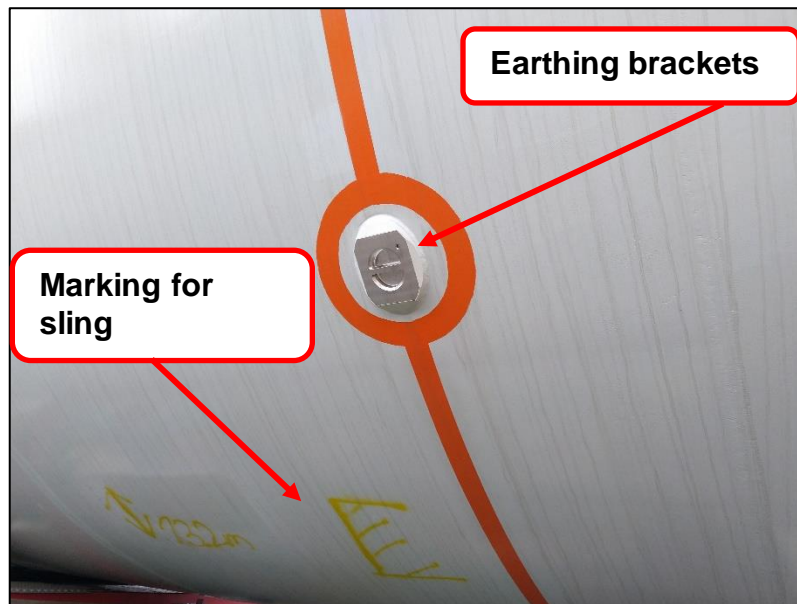
The complete arrangement of the lifting traverse and lifting slings is shown in Figure 9. One ring on the 27.5 m-long lifting sling made by GeoGleistein is hung directly into the traverse, while the other ring is attached to an extension bracket, which is also hung directly on the traverse, by means of a shackle. The spacing between the slings on the crane traverse for single-crane operation can vary between 11.8 m and 16.0 m. The 16.0 m spacing for this lift was required for structural reasons due to the bulge of the earthing brackets on the MP, as well as due to the bearing blocks on the SPMT and the deck.

Figure 16: Position of lifting slings and earthing bracket (other lift)

- 1.) In contrast to previous lifting operations, a lifting sling may no longer be attached to the conical part of the MP in this project.
- 2.) A distance of at least 400 mm from the earthing brackets must be maintained.
- 3.) A crane deployment report must be prepared in accordance with a form for each lift of a MP in single-crane operation.
- 4.) The maximum inclination of a MP when being lifted in single-crane operation, where both lifting slings may only be placed on the cylindrical part, is 1°.
- 5.) The specified inclination is measured during a lift using a digital spirit level attached to the MP with magnets. The master can read the current value by means of remote indication on a mobile phone.

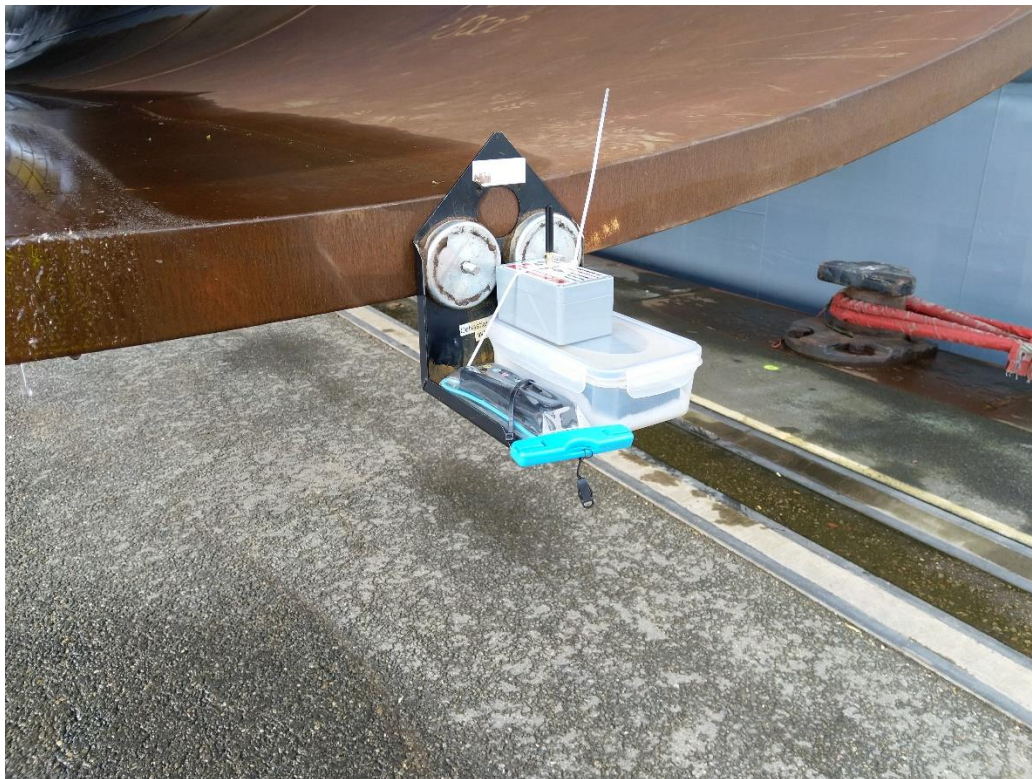
Figure 191: Inclinator on a MP
