# Loss of containers overboard from MSC ZOE

1-2 January 2019

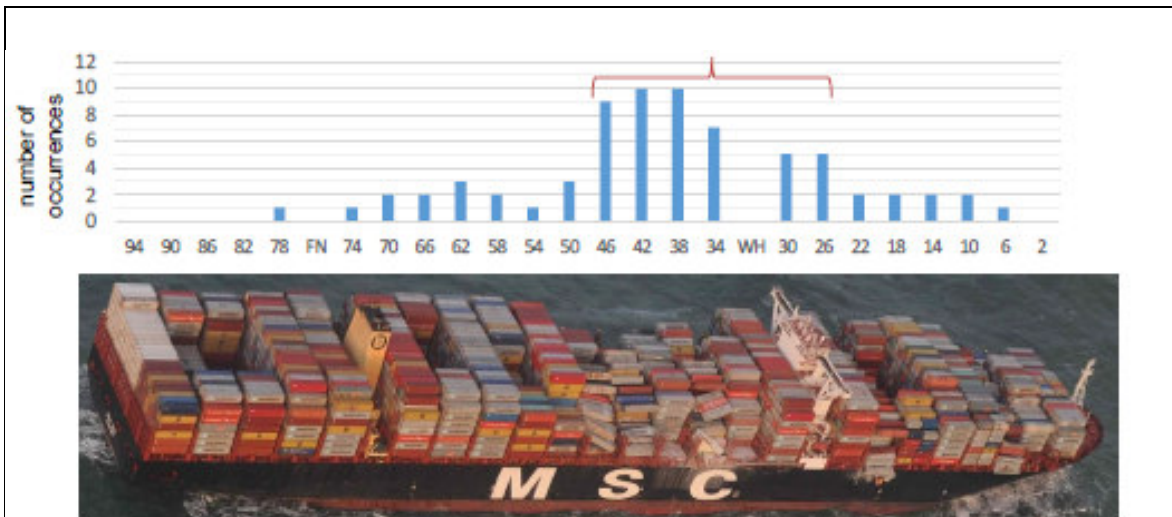
Figure 4-40: Spatial distribution of green water events as observed during three tests at zero speed, compared with the damaged container stacks of the MSC Zoe (view from starboard side)

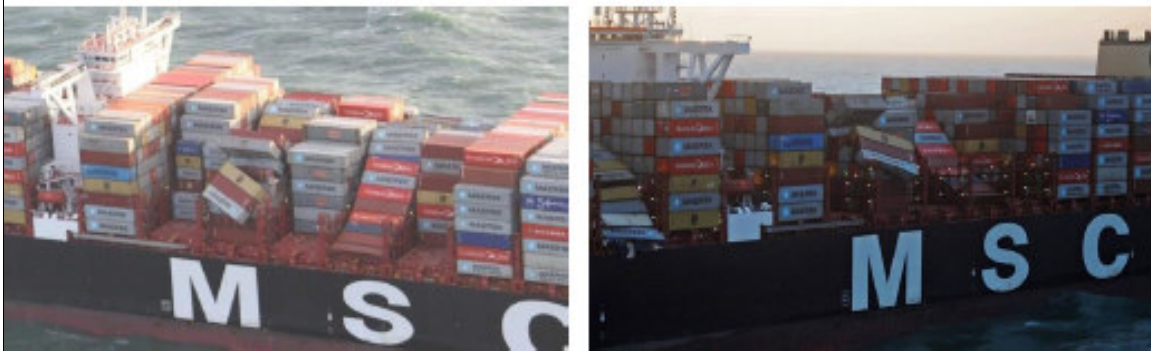
Figure 4-41: Loss of containers on the wave (port) side of the MSC Zoe, in the area where during the model tests the largest number of green water events was observed (view for port side).
