Bundesstelle für Seeunfalluntersuchung
Federal Bureau of Maritime Casualty Investigation
Federal Higher Authority subordinated to the Ministry
of Transport and Digital Infrastructure

Summary Investigation Report 129/20

**Allision with lock gate
by motor vessel (MV) RIMINI
in the Alte Nordschleuse lock at Brunsbüttel
on 17 May 2020**

6 October 2020

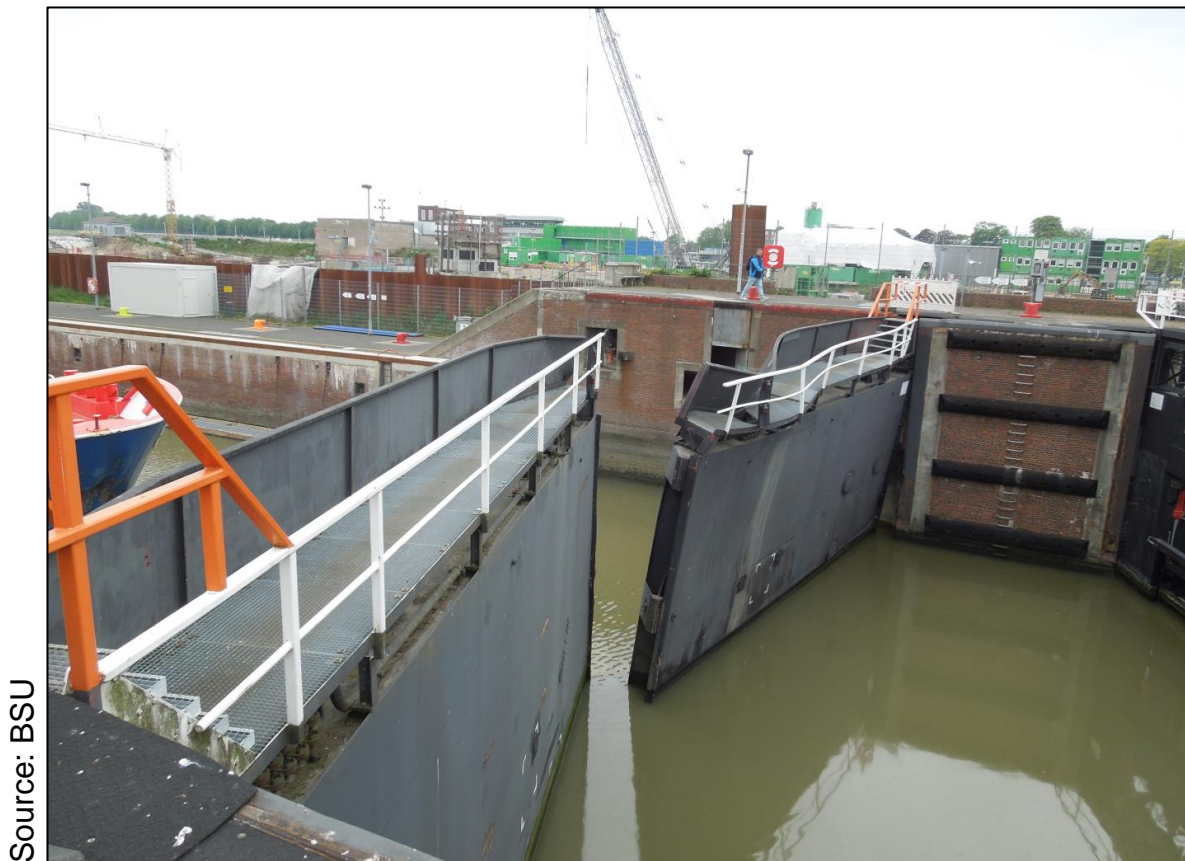
The lock gate was severely dented and thus unusable because it could no longer close tightly.

Figure 3: Dented lock gate

A light oil film – presumably from the lock gate's damaged hydraulics – was visible on the water in the immediate vicinity of the lock gate. This was subsequently contained by a single oil boom.

The damaged lock gate is to be salvaged by the end of June. At the time this report was being written, the German Federal Waterways and Shipping Agency (WSV) assumes that the damage will amount to an estimated EUR 1,100,000 and that repair works will probably continue until the autumn of 2020.

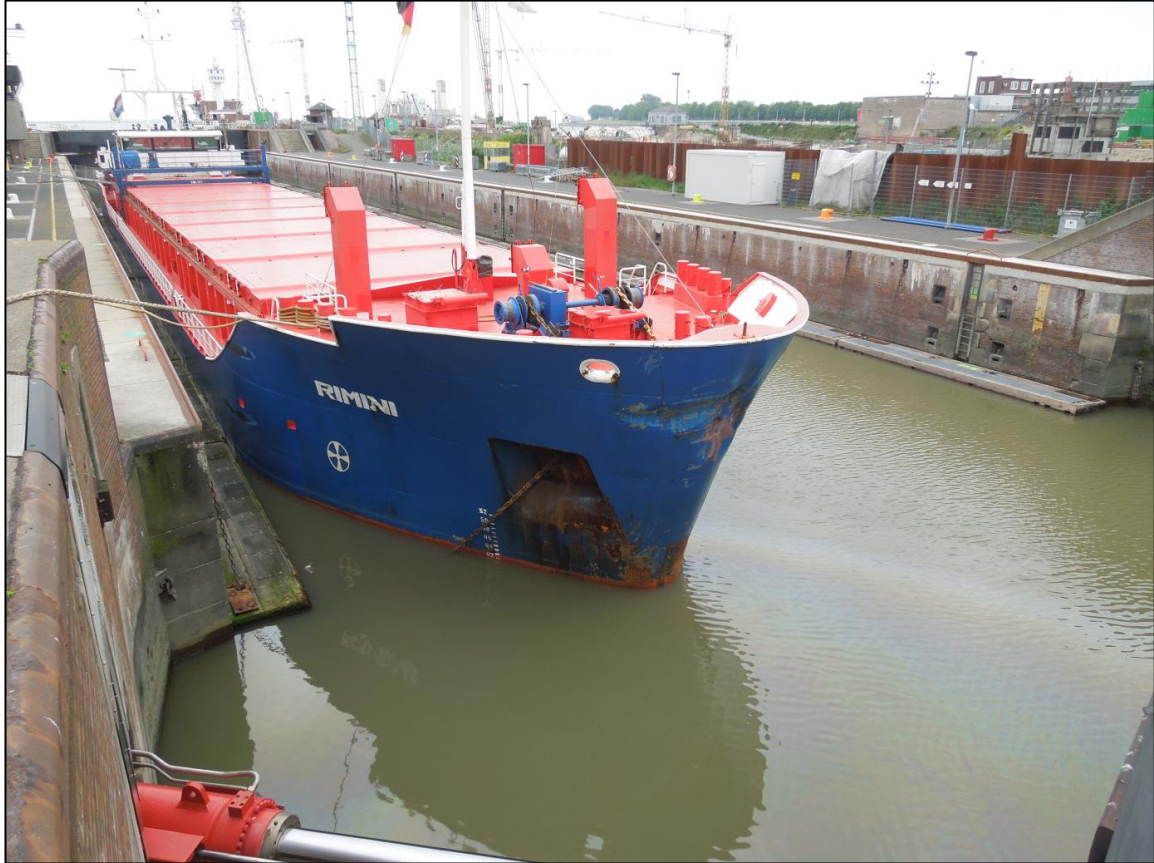
Figure 4: The RIMINI with damaged stem and light oil film

The shell plating on the bow of the RIMINI was severely dented, and the deck plating was pushed upward on the forecastle deck. No leakage of, or other damage to, any of the RIMINI's tanks was found.

Also, emergency repairs to the bow and the forecastle deck were carried out by Adolf Cornels GmbH while the vessel was still in Brunsbüttel.

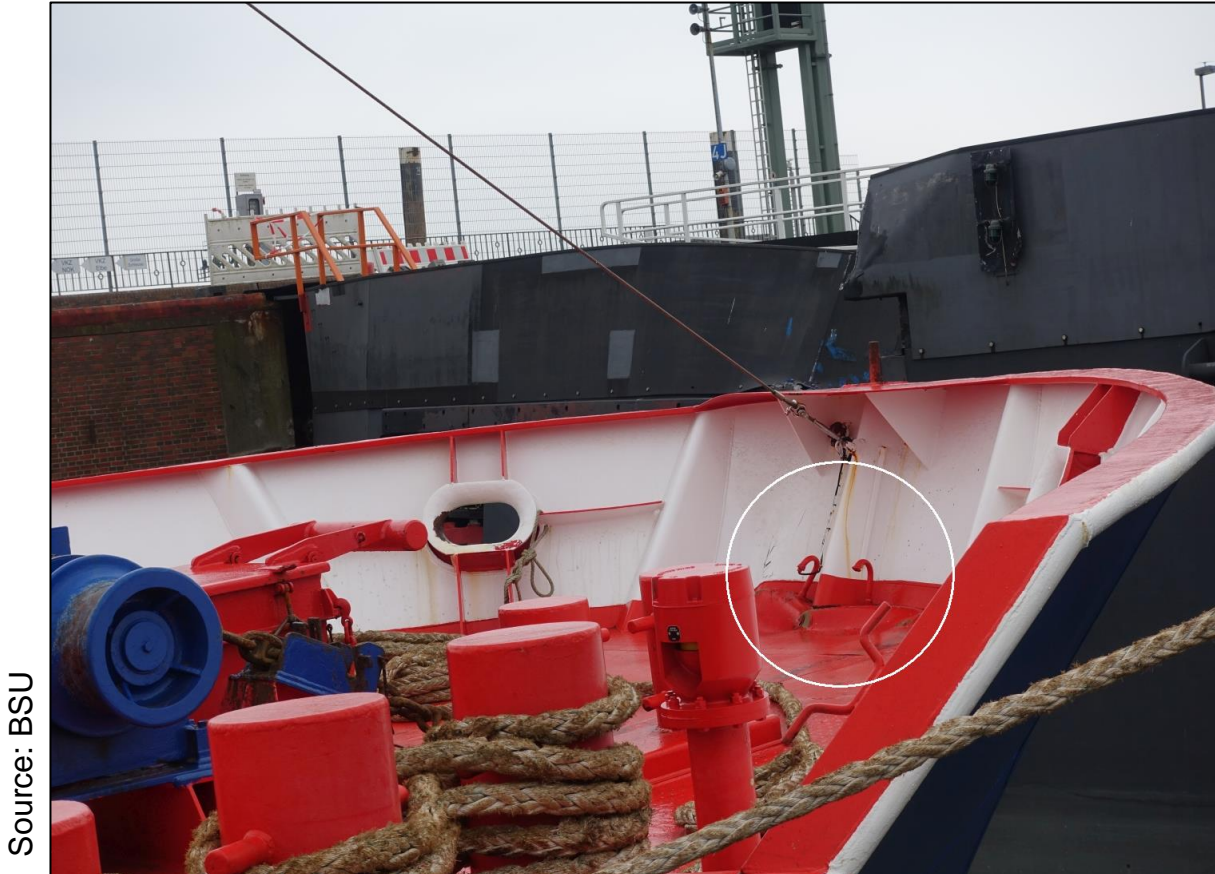
Figure 5: Deformed deck plating in way of forecastle

Welders from Adolf Cornels GmbH ground and welded the cracks on deck. Below deck the cracks were exposed, welded together, and reinforced with a doubling plate. The area's plate stiffness was almost restored using profiles, according to the service report.

The one Recommendation that was issued was that the damage to the bow must be repaired definitely within a specified period, which ends on 29 January 2021.
