Summary Investigation Report 182/20

Less Serious Marine Casualty

**Deflagration
on the
Danish sail training ship DANMARK
off Fehmarn
on 30 June 2020**

9 December 2020

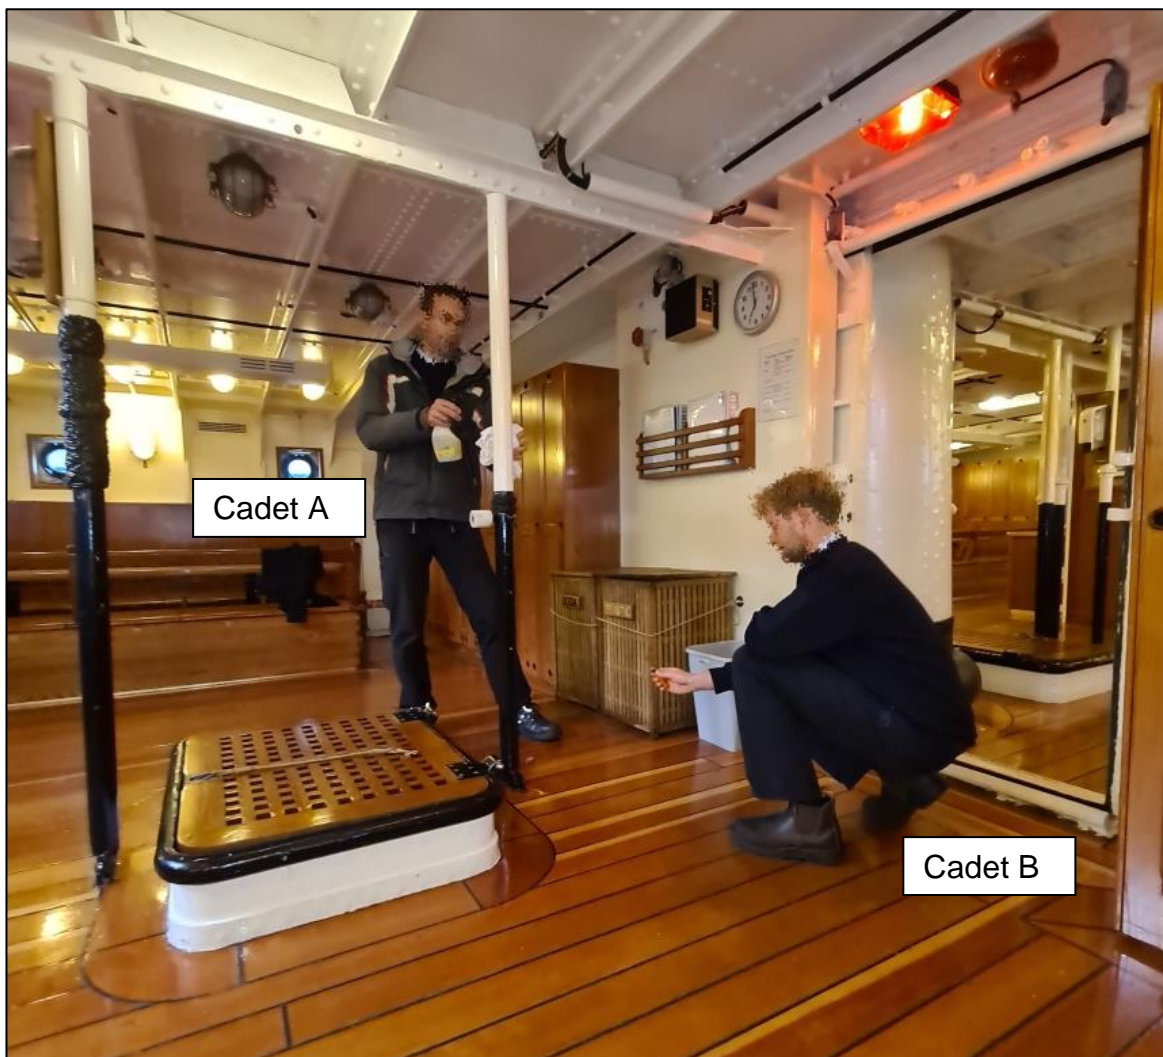
Figure 3: Simulated accident scene

At about 0950, the two cadets on cleaning duty were near the room's waste bin. Cadet B wanted to throw something away and noticed a lighter lying on the floor next to the bin. Reportedly, he decided to test it to see whether it was broken and should also be thrown away. Cadet A claimed he told Cadet B that this was not a good idea in the vicinity of the ethanol, but the latter failed to respond (possibly did not hear him) and ignited the lighter.

Cadet A was standing directly next to him when this happened, having just sprayed ethanol onto his cloth. The spray mist in the air directly in front of his face (or the gas-aerosol mixture in the room, see also p. 13) caught fire immediately, causing a short but violent deflagration. Describing the deflagration as a "fireball around my field of view", Cadet A dropped his cleaning equipment and rapidly covered his face with his hands; his pullover and belt had also caught fire.

In this particular case, a single source of ignition was sufficient to cause a short but violent deflagration, whereby the people involved apparently did not anticipate the sheer quantity of flammable mixture present in the air. The fact that the injured person did not lose any hair or eyebrows, despite suffering severe burns to the face, is an indication of the short duration of the deflagration.

The BSU concludes that this inadequate incorporation into the SMS was the main cause of the accident. It meant that no one could develop the appropriate hazard awareness, and this fact was partly responsible for the ignition of the lighter (no matter how ill-judged – and forbidden – this act may have been in the first place), which ultimately triggered the deflagration.

Immediately after the hazardous materials accident, the DANMARK's Safety Committee¹⁸ came together in order to draw conclusions for the operation of the vessel and to avoid similar incidents in the future. Decisions were made to switch from spray bottles to pump dispensers, to scale back the additional hygiene measures (and thus the use of ethanol) after 14 days of isolation at sea, to obtain white cloths (which are to be rinsed thoroughly with water after use) for work with ethanol only, and to mark ethanol containers (spray bottles and later pump dispensers) with larger hazard pictograms.

When the accident was processed, however (which, as mentioned, worked extremely well), this error was recognised and rectified. Ethanol has been incorporated into the system in a manner that fully accounts for its dangerous nature (it is no longer used as a cleaning agent), and it is reasonable to expect that an incident of this nature will not be repeated on board the DANMARK, nor within MARTEC's sphere of responsibility.
