Summary Investigation Report 283/16

Less Serious Marine Casualty

**Water ingress in the RoPax ferry BERLIN's forepeak
after an allision with the fender system in the port of
Gedser (DK) on 30 July 2016**

11 December 2020

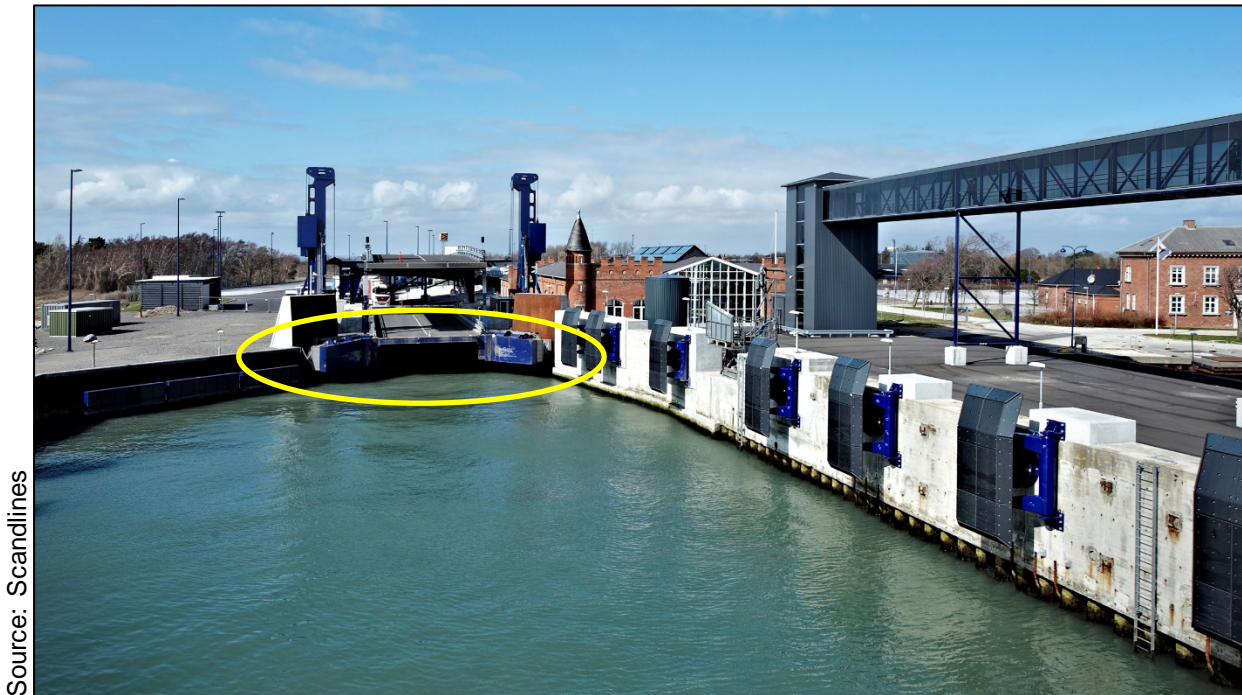
Figure 6: Ferry terminal in Gedser

The second officer communicated the distances to the quay from the port wing. At 0755, the ship struck the diagonal fender at about 2.5 kts.

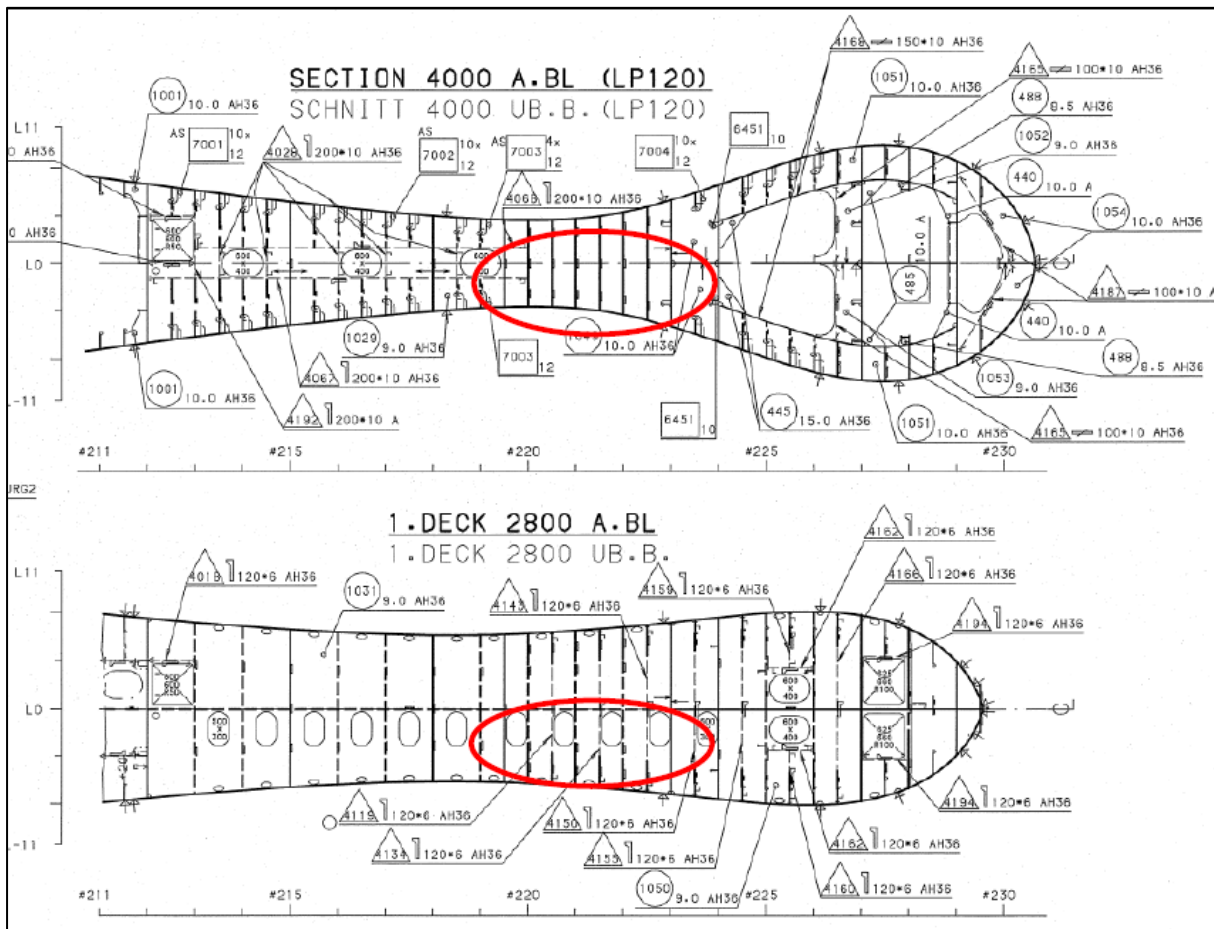
Figure 7: Bulbous bow (longitudinal section)

The indentation on the port side of the bulbous bow had a diameter of about 1.65 m in the area of frames 229/230 and a maximum penetration of 35 cm. The bulbous bow was bent about 2-3° to starboard when viewed from the longitudinal axis. On the starboard side there was buckling at a height of about 4 m in the area of frame 220. Two other cracks also found there were provisionally welded from the outside. This damage pattern resulted in the following repair area: the damage to the ship was limited in the area of the bulbous bow, frame 219.5-223 level with the keel to stringer 1.5.

- damage on the starboard side between frame 220 and 220.5; above and below stringer 1;
- damage on the starboard side between frame 220 and 220.5; above stringer 1.5;
- stringer 1 deformed between frame 219.5 and 221.5, and
- stringer 1.5 deformed with longitudinal stiffener between frame 219.5 and 221.5.
