## **Summary Investigation Report 310/16**

### **Less Serious Marine Casualty**

**Fire in the vicinity of the combined boiler  
with two injured crew members  
on board the tanker WEICHSELSTERN  
in the Neue Weser Nord Reede roadstead  
on 19 August 2016**

30 July 2020

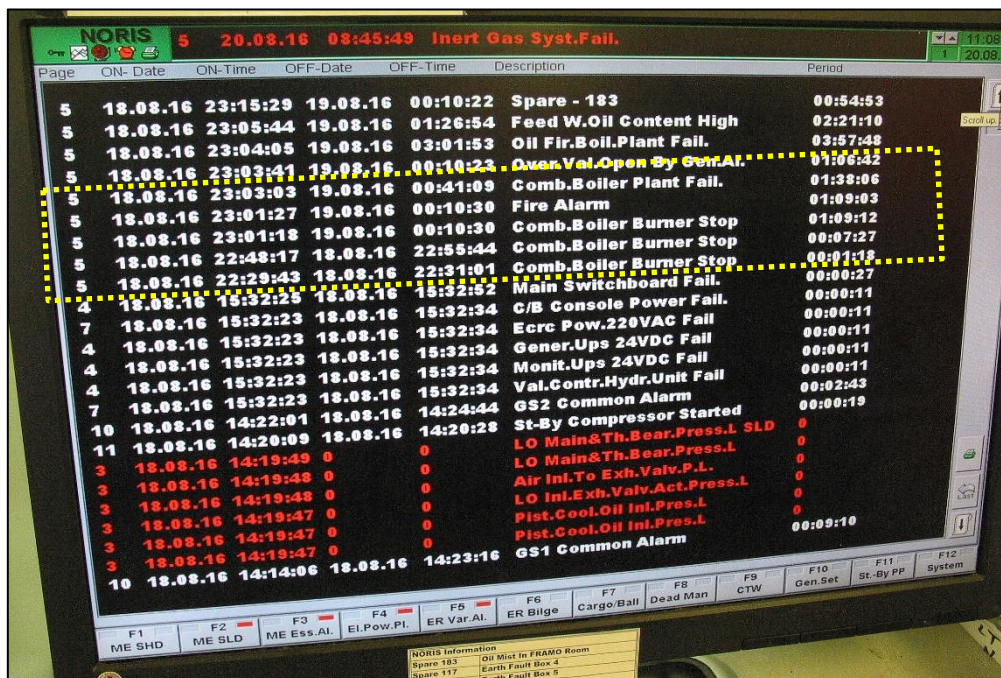
Figure 3: Alarms displayed for the combined boiler

The monitoring system registered the alarm as **Comb. Boiler Burner Stop 222943 (ON-Time)** (see Figure 3). A signal light on the switch cabinet was triggered and identified this alarm as a *Flame Failure*. The 2nd Eng acknowledged the alarm at **223101 (OFF-Time)**, when he pressed the reset button. This reset the boiler's control system and cleared all alarms (Figure 6). A system restart would not have been possible before this happened. The 2<sup>nd</sup> Eng then went to the boiler to check the condition there. A flame was not visible anymore through the boiler room's sight glass. He then returned to the engine control room (ECR) and phoned the 3<sup>rd</sup> Eng to ask about the boiler's last service because the boilers fell within the latter's area of responsibility. The 3<sup>rd</sup> Eng was also asked to go to the ECR.

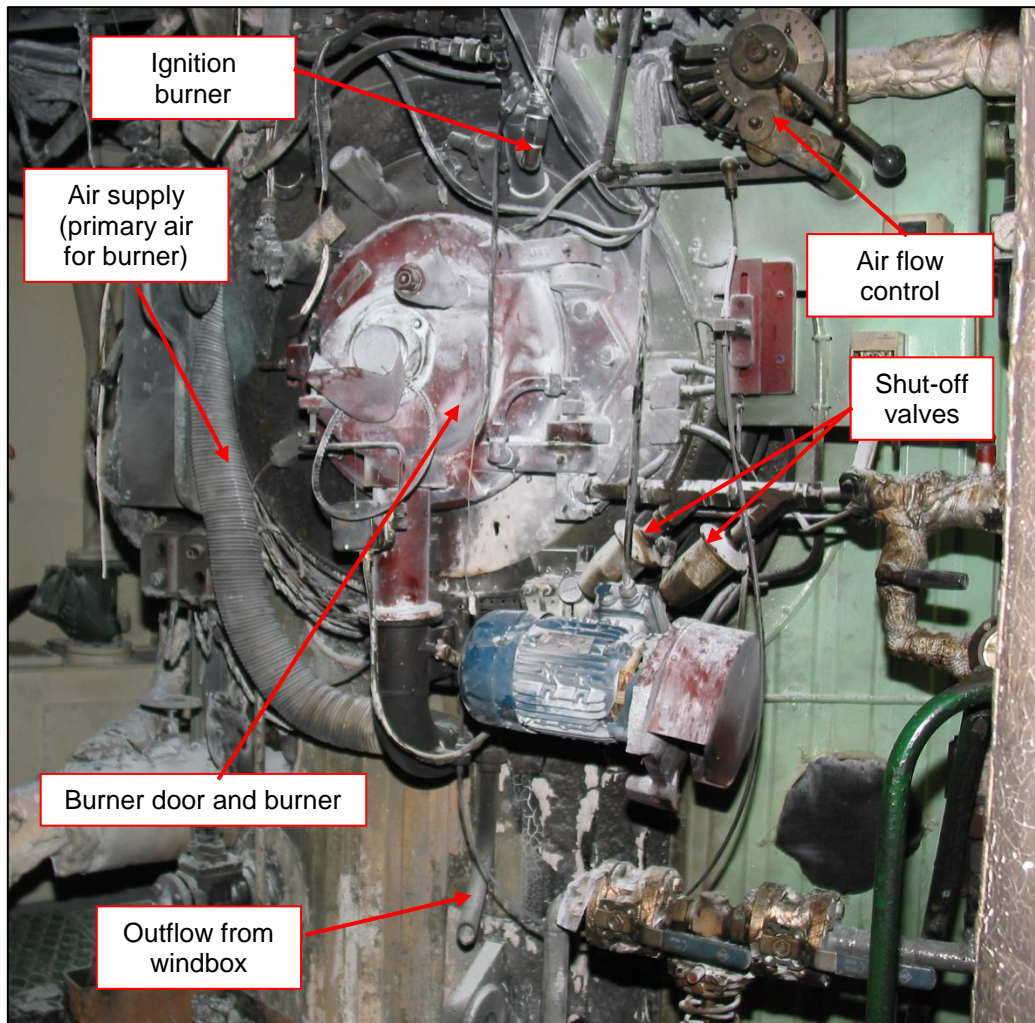
Figure 9: Combined boiler and its burner

The electric motor for driving the rotary atomiser burner is torn off and hanging in front of the burner door on a cable.

The BSU's investigators assume that the burner door flew open with some force. This can be inferred from the electric motor for driving the rotary atomiser burner breaking off (see Figure 9). The combustion chamber's excess pressure is usually in the range of 8-20 mbar. Higher pressures may occur for a short period during the burner's ignition process. The manufacturer has no measurements for this, however.

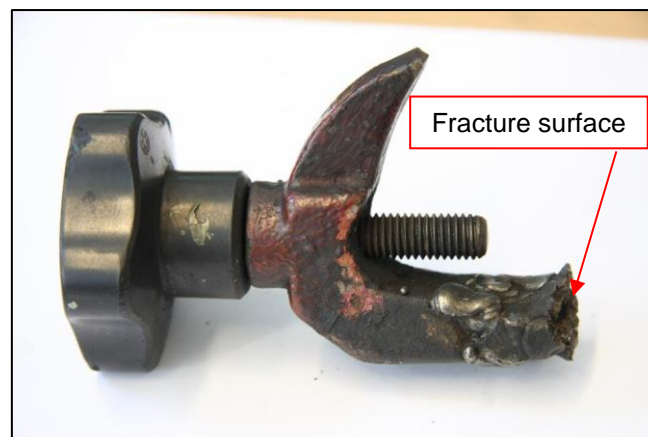
Figure 12: Broken hook from the door's locking mechanism

It was found during the investigation that the burner door's locking mechanism was broken. "*The burner door is locked mechanically by a rotatable hook mounted on the boiler, which includes a bolt in the burner door [Figure 14]. The hook also comprises a locking screw with hand wheel, which creates a frictional connection between the hook and bolt.*"<sup>12</sup> The fragment of the door's locking mechanism was found. The BSU secured the entire door locking mechanism. As can be seen in Figure 12, the hook had been welded.

- a) *"A welded joint can be found in the connecting piece between the pivot joint and hook. There is a clear difference between the colour of the weld metal and that of the base material, indicating that the filler metal is dissimilar. The fracture is located at the edge of the welded joint. The crack edges show no macroscopic evidence (e.g. vibration grooves) of a vibration fracture. Rather, the macroscopic formation of the crack edges indicates a forced fracture, [...], where it becomes clear that the filler metal surrounds the base material in a ring shape."*<sup>14</sup>

- b) *"If these criteria are used for the assessment [...], then the welded joint does not satisfy even the lowest requirements of this standard.<sup>15</sup> As Figure [...] shows, filler metal has been deposited on the head of the pivot joint during welding, supporting the assumption that it was installed when the weld was applied."*<sup>16</sup>

- e) *"Figures [...] show the crack edge fracture surfaces. The crack surface clearly shows the pattern of a violent fracture. No evidence of vibration cracking could be found. Moreover, it is clear that the weld metal surrounds the base material as a ring. In some places a thin layer forms between the filler metal and base material [...] and in other places slag inclusions have collected in this area [...]."*<sup>19</sup>

*As the micrographs indicate, brittle structures (ledeburite, martensite, hardness levels in excess of 550 HV) have formed in the seam transition area as a result of the thermal conditions under the selected welding conditions. This means that the heat-induced stresses cannot be compensated for when the welded joint cools down, causing cracks to form.*

*On the other hand, hot cracks have formed in the nickel filler metal, which are caused firstly by low-melting eutectics that form on the grain boundaries of these materials and secondly by the heat-induced tensile stresses.*

*The improperly welded joint must be regarded as the cause of the component's failure. In addition to substantial external irregularities, it also exhibits internal defects (hardening structure with cracks, stress-induced hot cracks). Moreover, nickel alloys have lower strengths than the base material, cast iron.*

*Accordingly, it is reasonable to assume that when viewed in its entirety this deficiency has severely limited the welded joint's load-bearing capacity."<sup>22</sup>*

- The expert is of the opinion *"[...] that the accident would have been avoided if the hook in the lock had not been damaged beforehand. The pressure pulse generated during ignition was sufficient to exceed the number of load cycles of the damaged hook's fatigue strength, which would not have been the case with an undamaged hook."*<sup>26</sup>

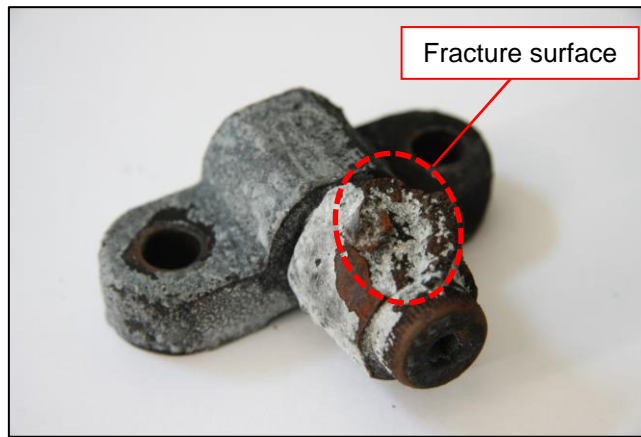
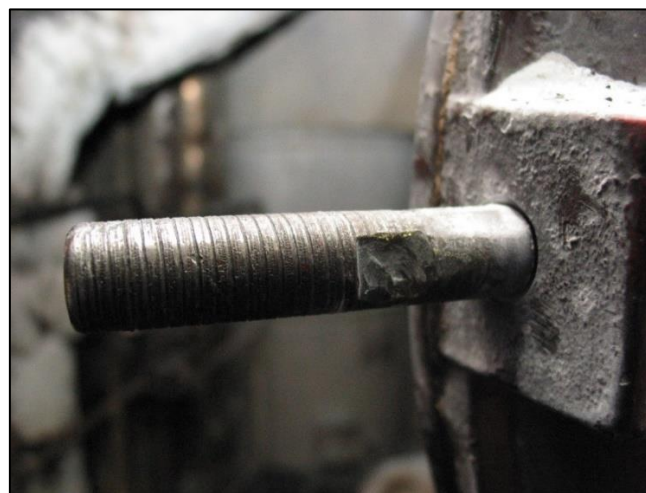
Figure 15: Bolt from the door's locking mechanism

With regard to the door's locking mechanism, it was also found that the original bolt, which is the mating part of the hook on the burner door (Figure 15), had been replaced by a threaded rod on the WEICHSELSTERN. It was not possible to establish the reason or when this happened, either. However, the investigators believe that the replacement did not restrict functionality or safety.

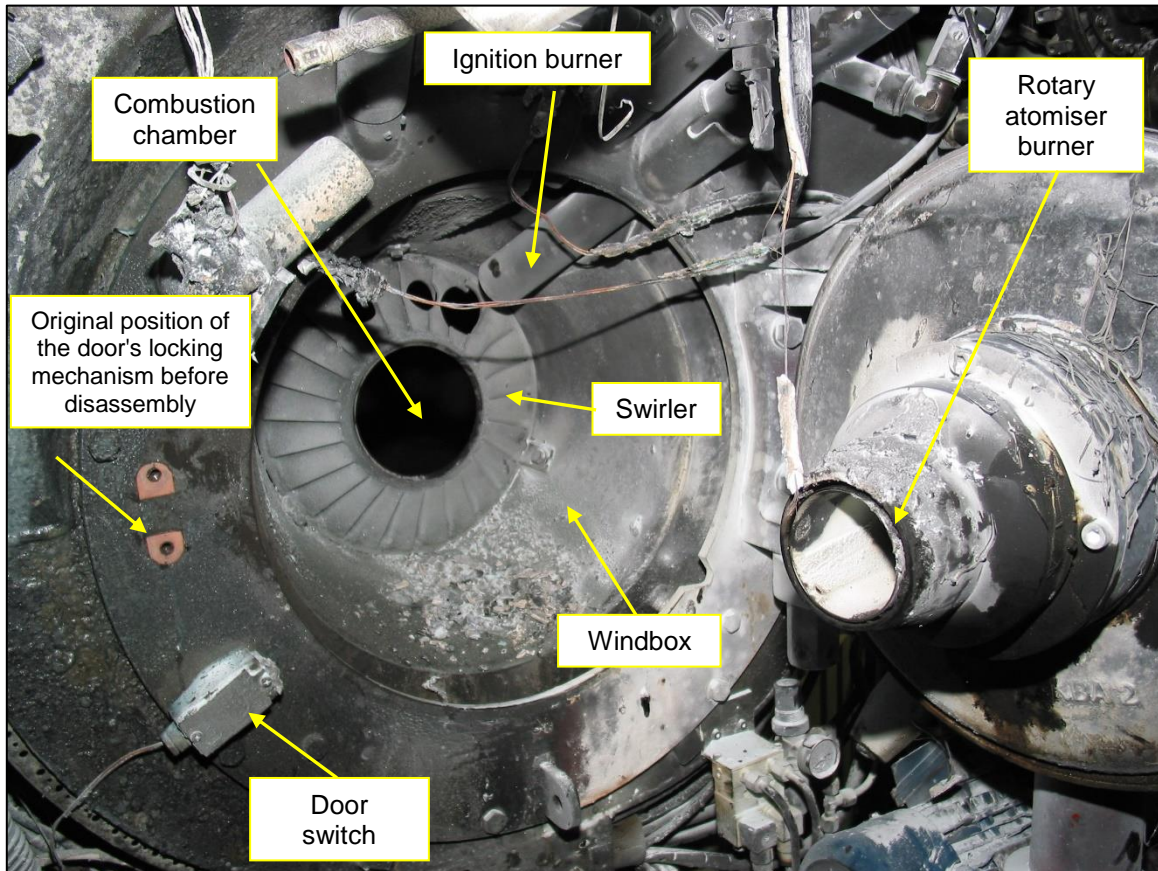
Figure 16: Burner door with rotary atomiser burner and windbox

During the survey of the windbox (Figures 10, 11 and 16) it was found that the ignition burner was not fully inserted into its guide tube (Figure 16). The ignition burner is usually secured in the guide tube with a wing screw. During the investigation it could

not be conclusively determined whether the ignition burner had been pushed about 5 cm out of its actual position, and if so, which event was responsible for this.

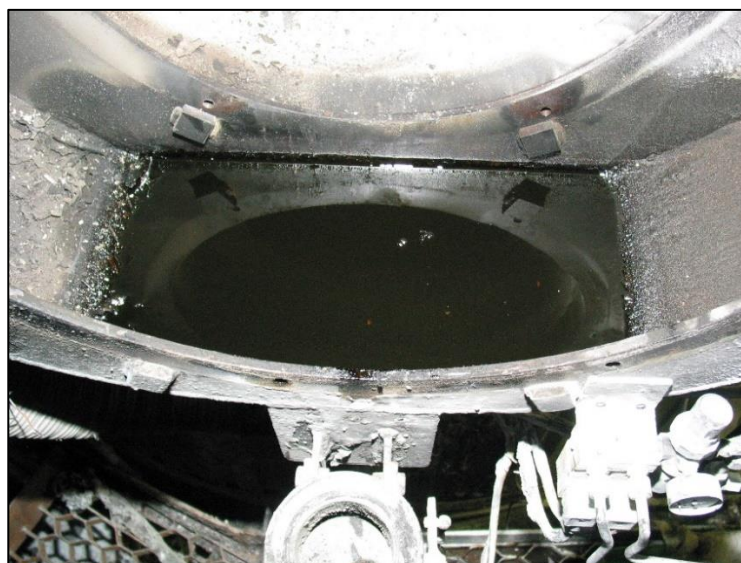
Figure 17: Fuel in the windbox

To gain better access to the combustion chamber, the swirler was disassembled. After removal it was found that there was a substantial amount of MDO in the lower part of the windbox (Figure 17).

*Aalborg believes causes b), c) and d) are rather unlikely, which is a reasonable assumption. Cause a) is only feasible when no ignition flame is produced, which cannot be excluded due to the lack of a flame failure device for the ignition burner. If the rotary atomiser were not rotating, then cause e) would lead to an ingress of fuel which could accumulate both on the bottom of the boiler and in the windbox.*

*The electro-pneumatic fuel valves were therefore tested for leak tightness for 15 minutes at a static pressure of 16 bar after the accident. No leakage was found. Nevertheless, MDO can still enter via the rotary atomiser even with tight fuel valves, as diesel can still enter the boiler in the outlet of the rotary atomiser. This is no longer atomised and can run outwards over the edge of the cup and into the rear of the*

*windbox. A large number of switch-off procedures can thus cause a lot of diesel to accumulate in the windbox. This danger hardly exists in the case of HFO on its own due to the significantly lower fluidity.*

*Leaking rotary atomiser connections are another possible source of the MDO. Oily surfaces were found on the burner's rear wall in the area of the pipe fitting. Consequently, the latter two alternatives are the most likely cause of the MDO in the windbox."<sup>23</sup>*

The owner took wide-ranging measures after the accident. For example, a separate investigation into the cause of the accident was carried out with the involvement of the manufacturer of the boiler installation and all similar boiler installations were inspected with the involvement of service companies. All safety equipment was inspected in this context and renewed or readjusted if necessary. In addition, the descriptions of maintenance works were expanded upon and completed. This also includes checking the drain pipe belonging to the windbox.

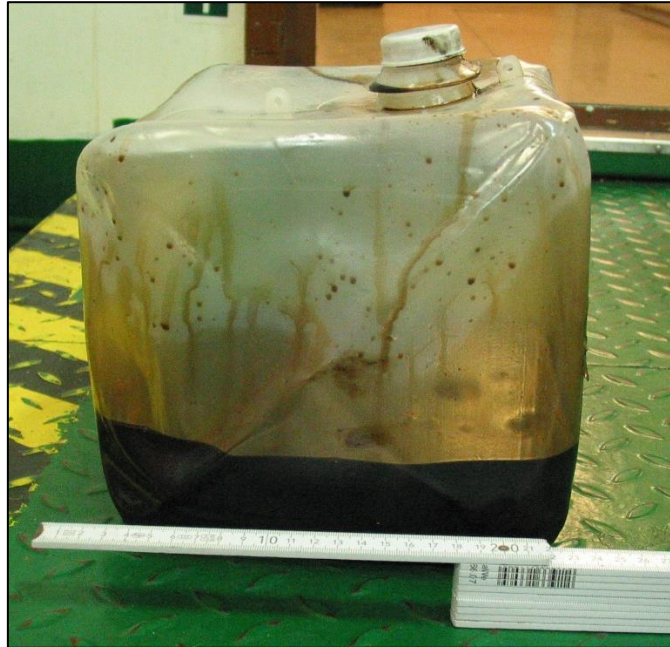
Figure 18: Fuel drained from the windbox

It was not possible to drain the fuel via the drain pipe at the bottom of the recess provided for this purpose (see Figure 9) to begin with because the shut-off valve was extremely stiff and the entire pipe was clogged with HFO residues. The amount of fuel found was determined to be about 2 litres.

The investigation failed to clarify for how long the fuel had accumulated at this point but the clogging found in the drain pipe indicates that this condition has persisted for quite some time. The two maintenance reports submitted for the boiler installation for the months of June and July did not provide any further information.
