FLEET CIRCULAR			
<b>FMS 02/2020</b>	<b>Additional safety measures for cargo holds</b>		<b>ALL</b>
<b>ISSUE DATE:</b>	<b>22.01.2020</b>	<b>VALIDITY:</b>	<b>unlimited</b>

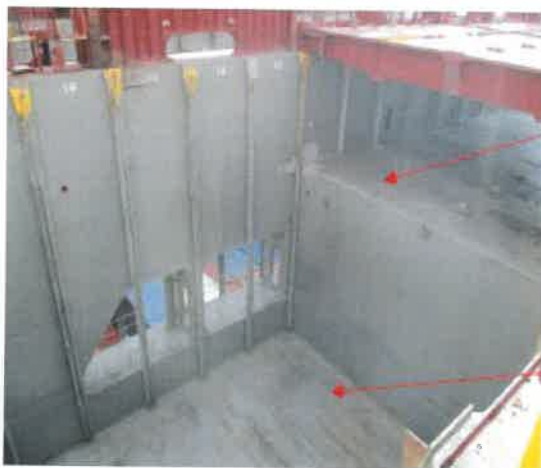
As you are most probably aware, we sadly had to experience a fatal accident on board of our vessel CMS "SAJIR". The accident occurred during an inspection of the cargo hold No. 9 where one crew member fell approximately 8m from an upper part of the hold onto the tank top, suffering fatal injuries.

assumed place of falling  
view from port side aft of Bay 70

Position of person

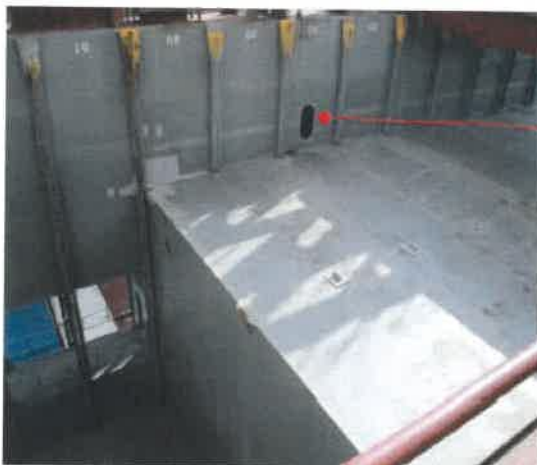
the only opening in bulkhead from where the top part of hold nbr 9 (Bay 70) can be accessed

A location as displayed on the pictures above can also be found on other "2-Island-Vessels", that have two accommodation structures and where the engine room is extending into the cargo hold: e.g. on the vessels of Hamburg class, at bay 70 & 74, and also similar on the Valparaiso Express class.

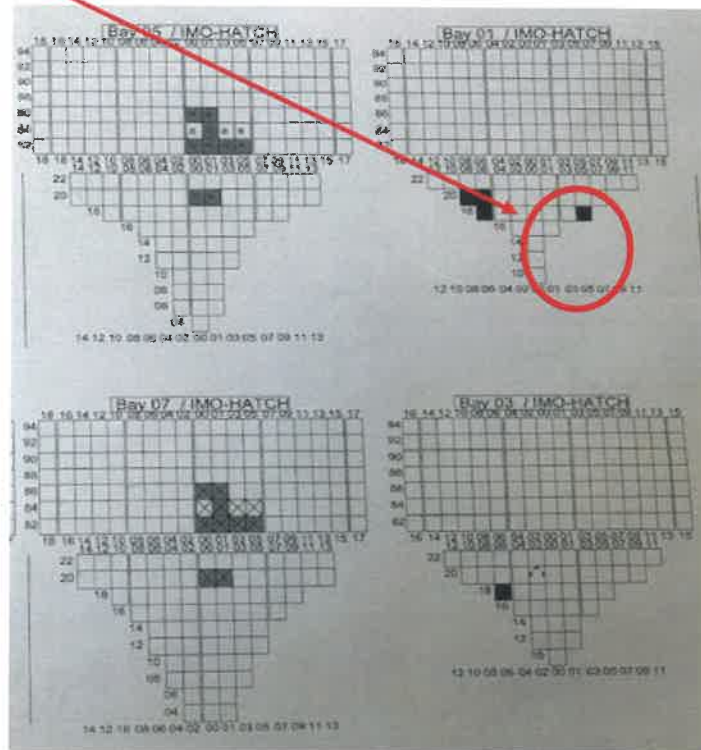
**General Remark:** We are aware, that all vessels have similar single container storing positions in the forward, e.g. here:

These areas are normally only “single stowage positions”, which are neither used for breakbulk, nor can be entered accidentally, due to their open construction. Therefore, we do not deem it necessary to install a “tiger” marking as mentioned above. However, all other measures are also applicable for the forward locations.
