Interim Investigation Report

Serious Marine Casualty 282/20

**Grounding of the RUBINA
after steering gear failure
on the river Weser
on 27 August 2020**

26 August 2021

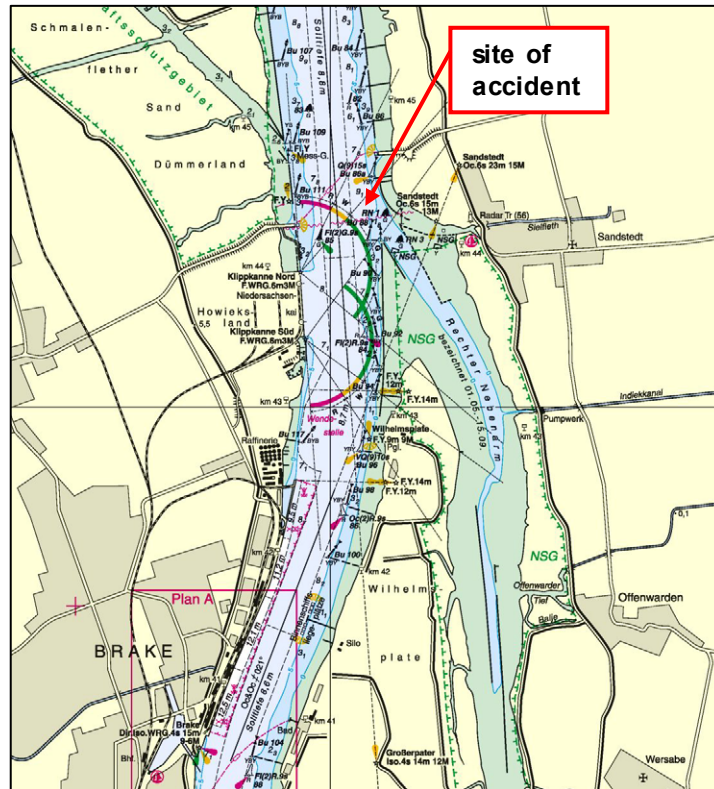
Figure 2: Site of the accident

Type of marine casualty:	Serious marine casualty / Failure of steering gear
Date, time	28/08/2020, 2215
Location:	Weser, at the mouth of the river's "right branch" (km 44)
Latitude/Longitude:	$\varphi = 53^{\circ}21,7' \text{ N}$ $\lambda = 008^{\circ}30,2' \text{ E}$
Ship operation and voyage segment:	Manoeuvring mode / pilotage waters (north-bound)
Consequences (for people, ship, cargo, environment, other):	<ul style="list-style-type: none"> - Grounding at the eastern edge of the Weser fairway - First attempt to tow ship free (two tugs) at about midnight unsuccessful due to falling tide - Second attempt to tow ship free (4 tugs) with next high tide (morning of following day) successful; - Vessel shifted to Brake to await class confirmation

Despite an immediately initiated full-astern manoeuvre, the RUBINA's prow ran aground within moments. Fortunately, this happened in a relatively "innocuous" position on the Weser: at the mouth of the "right branch", and on the edge of the fairway.
