Interim Investigation Report

Serious Marine Casualty 285/20

**Allision of the multi-purpose-ship ELSE with a lock
gate of the Kiel Canal in Kiel-Holtenau on 29 August
2020**

27 August 2021

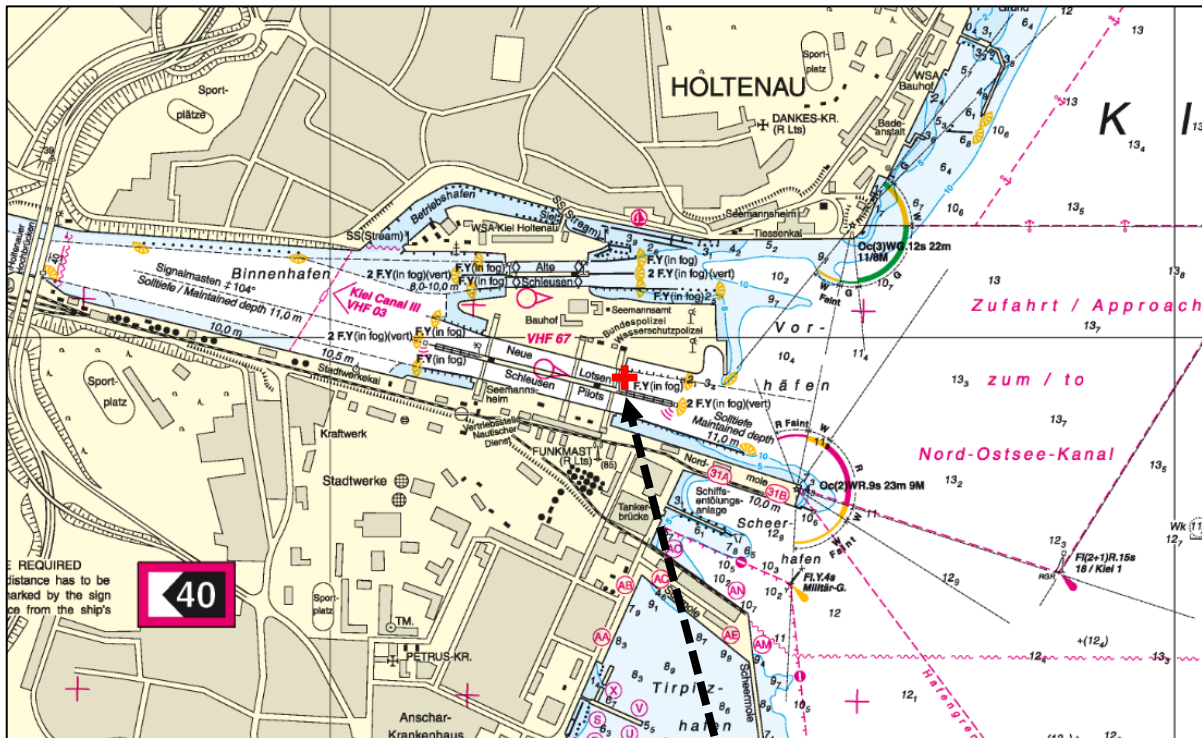
Type of marine casualty:	Serious marine casualty, allision with lock gate
Date, time	29/08/2020 0507 LT
Location:	Kiel-Holtenau; approach to the north chamber of the Kiel Canal (NOK) lock "Neue Schleuse" ² , coming from the Baltic Sea
Latitude/Longitude:	φ 54°21,9'N λ 010°08,7'E
Ship operation and voyage segment:	Pilotage waters / NOK approach
Consequences (for people, ship, cargo, environment, other):	Damages to the bow section of the ELSE; serious damage to the outer gate of the north chamber of the "Neue Schleuse" lock; lock gate not in operation for several days

Figure 2: Scene of the accident

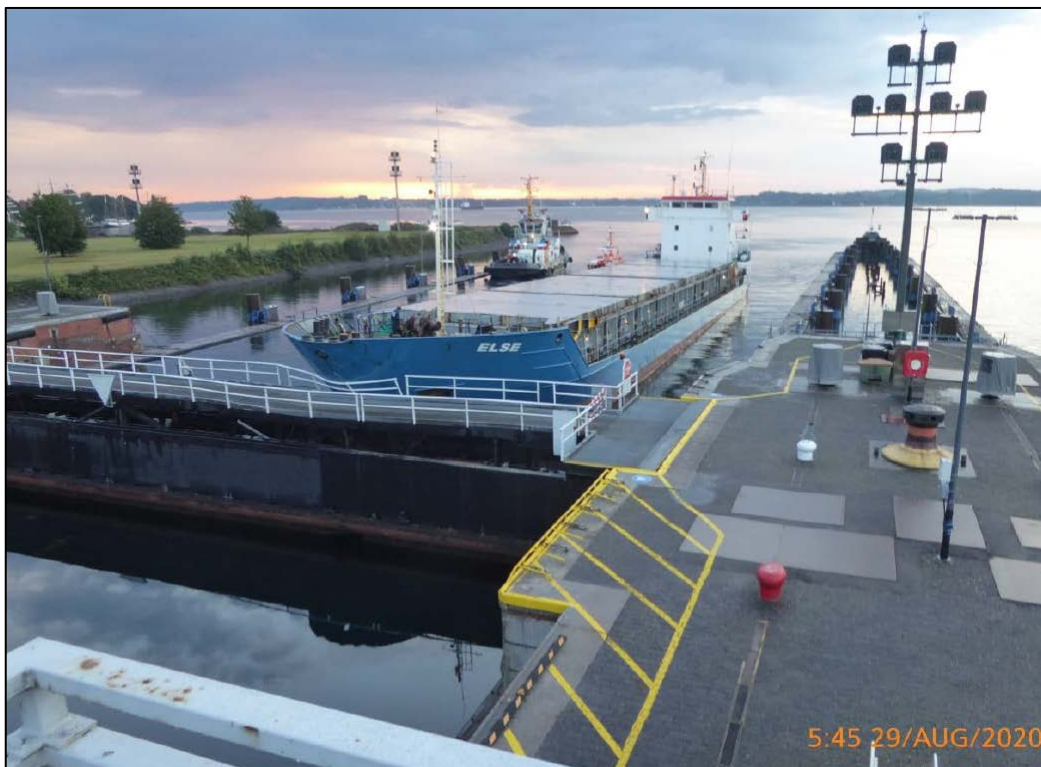
At 0507⁴ on 29 August 2020, the Panama registered multi-purpose ship ELSE, coming from the Kiel Fjord, collided head-on with the gate of the north chamber of the “Neue Schleuse” lock of the Kiel Canal in Kiel Holtenau, which was completely closed at that time, and remained stuck with its bow in the lock gate (see **Figure 3**). No crewmembers or persons on the lock facility were harmed, and no pollutants were released.

Figure 3: MV ELSE with her bow in the lock gate⁵

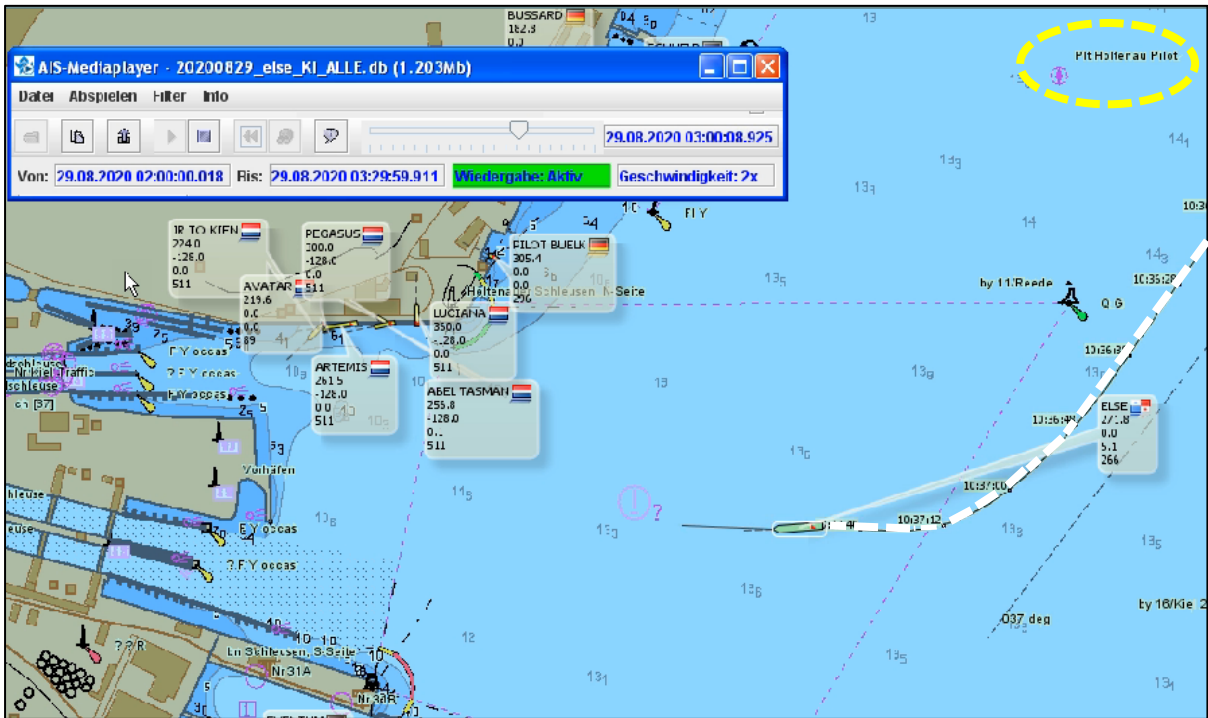
The following screenshots are from the AIS recording of the ELSE's track, provided by the VTS NOK: They show that, after passing buoy no. 9, ELSE duly changed course towards Holtenau Roads (**see Figure 4**). However, the vessel subsequently left Holtenau Roads on its starboard side without changing course and, in particular, passed the pilot transfer point shown on the chart without reducing speed (**see Figure 5**). Shortly thereafter, the vessel made a starboard course change and then headed directly to the approach of the north chamber of the "Neue Schleuse", before colliding with the closed lock gate (**see Figures 6 - 8**).

Figure 6: ELSE changes course towards lock approach (track up until 0500)

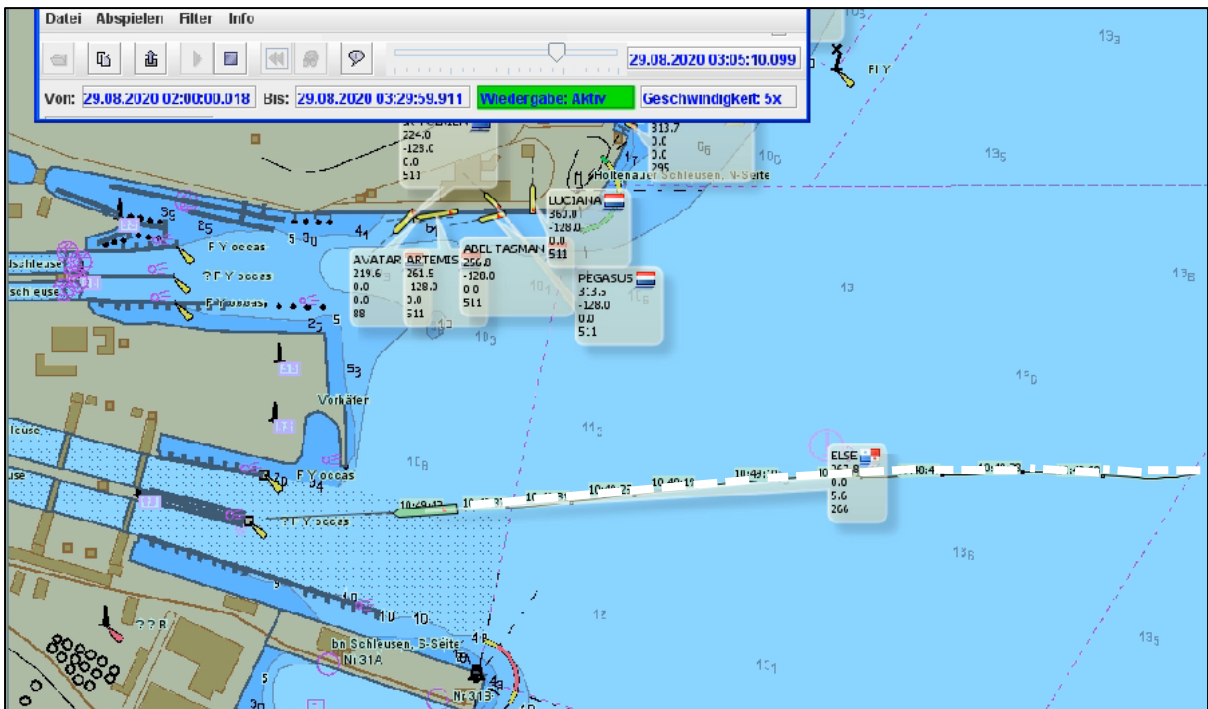
According to VTS records, the vessel's speed over ground was consistently between 5 and 6 knots throughout the course of the voyage described here. The ship's speed only decreased a few seconds before impact with the lock, and inevitably dropped to zero as a result of the collision.

Figure 7: ELSE proceeds with undiminished speed (track up until 0505)

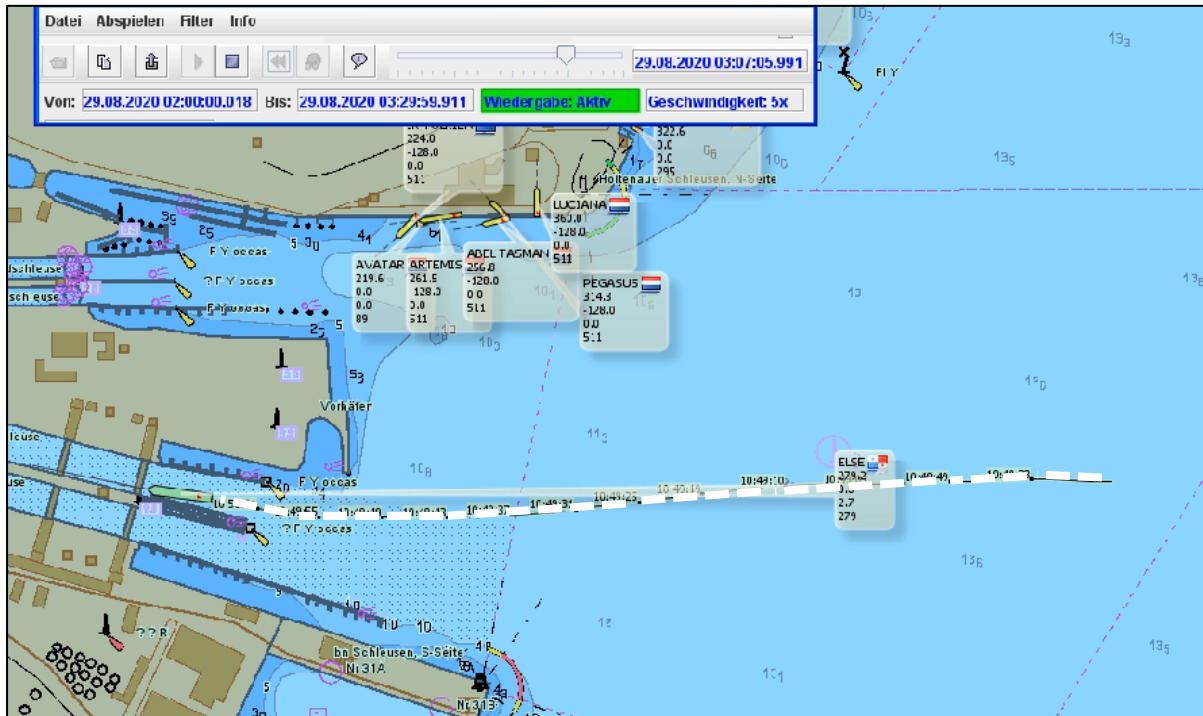
Immediately after the aforementioned VHF contact, the pilot station called the ELSE at **05:06**. The OOW responded immediately and seamlessly said: "My position enter to channel". The pilot station duty officer immediately demanded of the ELSE's OOW to turn around and proceed to the pilot transfer point. He made it clear that the ship did not have permission to enter the lock without a pilot. ELSE did not respond to this request. Instead, the vessel continued towards the lock gate and collided with it at **05:07**.

Figure 8: ELSE immediately before the collision with the lock gate (0507)
