## **Investigation Report 20/20**

### **Very Serious Marine Casualty**

**Fatal person-overboard accident  
involving a crew member  
of the fishing vessel HELEN MARY  
in the North Atlantic  
on 30 January 2020**

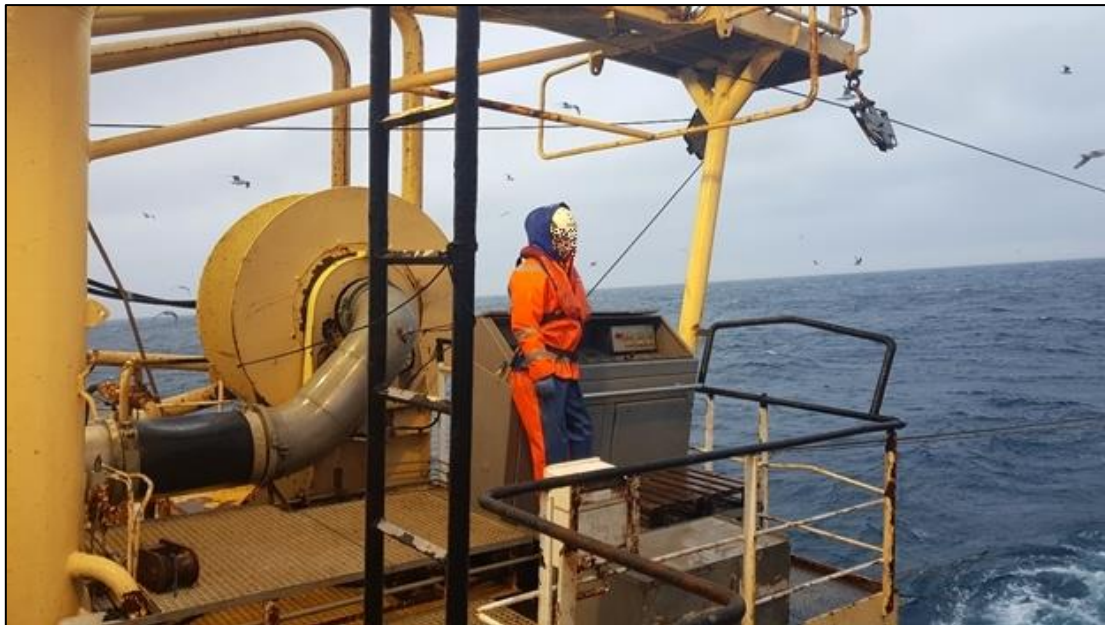
Figure 19: Crane operator's workstation

Position from which the fall from a height into the water was observed.

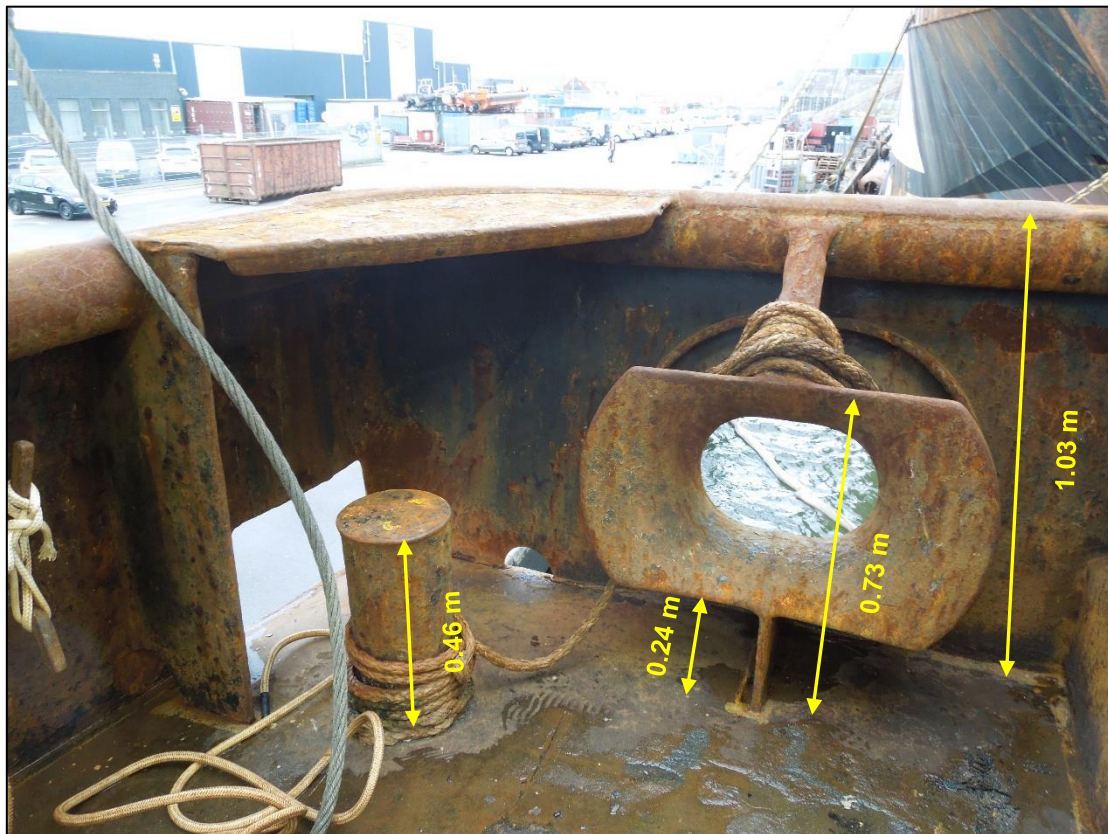
Figure 20: Starboard workstation at the stern

When the ship was inspected, the height of the bulwark was measured at 1.03 m. The upper edge of the hawsehole in this area and the bollard next to it are 0.73 m and 0.46 m high, respectively.

The investigators believe that the scene of the accident cannot be seen from the bridge (the winch console, in particular). A direct view of the work area on each side of the stern is not possible due to the hardware installed and the equipment stored on the sides (see Figure 7). However, the view of the middle of the stern is also limited due to the considerable distance, as well as partially obscuring protective tubes and other objects. As a consequence of this, the winch console on the bridge is equipped with large screens. In addition to fishing-related information, these also display images from cameras installed on board (Figure 21).

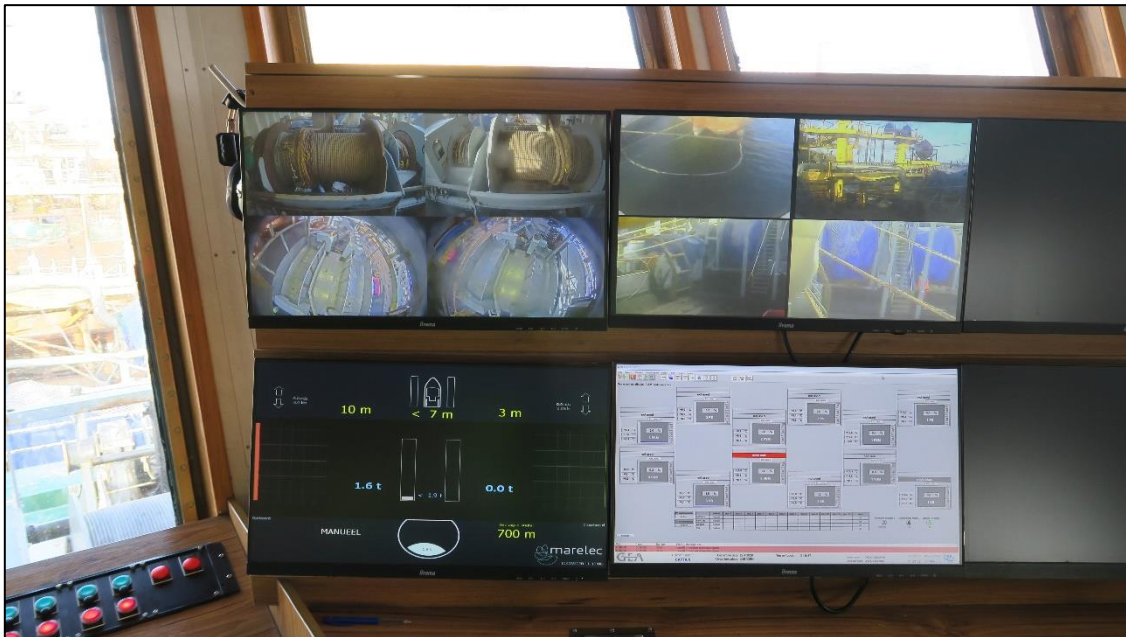
Figure 21: Screens for displaying information and camera images

The scene of the accident was not visible by camera when the accident happened because the camera that was installed there had not yet been replaced following damage.

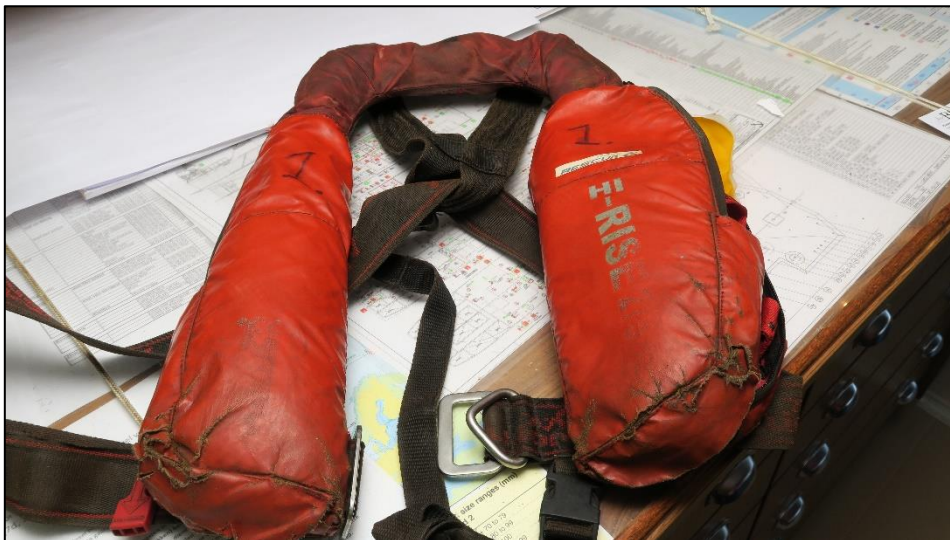
Figure 22: Inflatable work vest issued to the casualty

The ship's command secured the casualty's inflatable work vest after the accident and handed it over to the investigators in a sealed case on the day the ship was inspected. A service company inspected and furnished with a test label the inflatable work vest issued to the casualty before it was used on board. The next service would have been due in August 2020.

In the BSU's view, the extent to which the casualty's failure to don an inflatable work vest influenced the outcome of the accident remains conjectural to some degree. Having said that, it is reasonable to assume that the AIS-SART integrated into the inflatable work vest would have made it possible to rescue the casualty from the water far more quickly.
