Bundesstelle für Seeunfalluntersuchung
Federal Bureau of Maritime Casualty Investigation
Federal Higher Authority subordinated to the Federal Ministry
of Transport and Digital Infrastructure

Investigation Report 211/19

Very Serious Marine Casualty

Collision between traditional vessel N° 5 ELBE and container vessel ASTROSPRINTER on the River Elbe on 8 June 2019

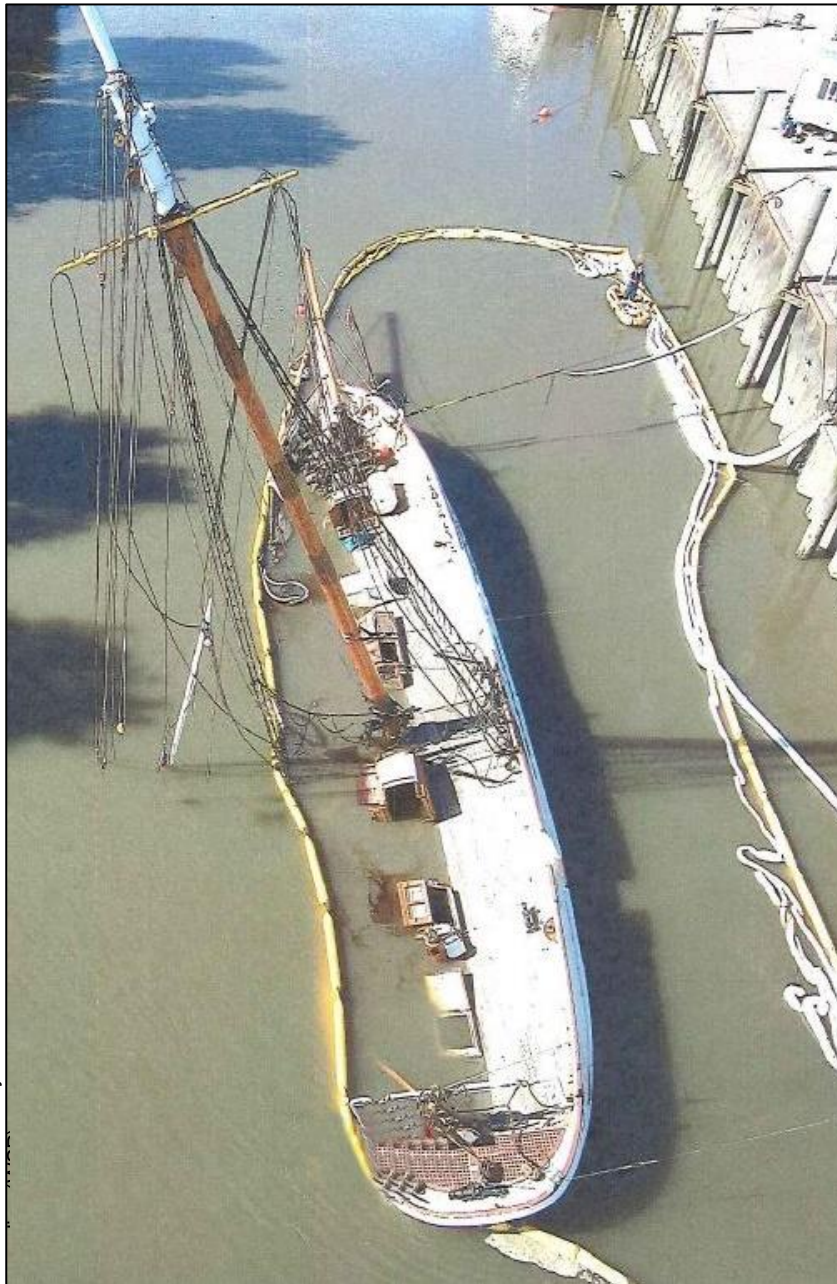
Figure 6: The № 5 ELBE foundered in the River Schwinge

After everyone had been taken off board, it transpired that it was no longer possible to hold the schooner, despite the pumps being started immediately. Since the leakage following the collision was so great, the schooner foundered in the River Schwinge as the tide was coming in.

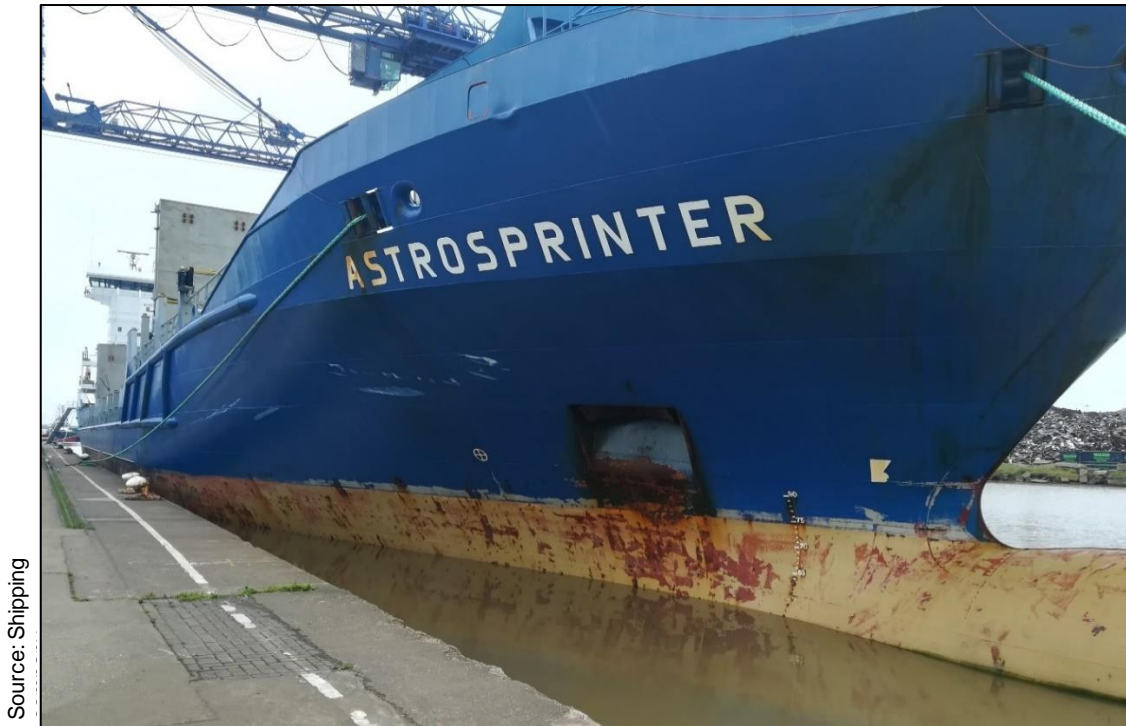
Figure 7: Overall view of the damage to the ASTROSPRINTER

The collision with the N^o 5 ELBE merely resulted in paint abrasions on the starboard side of the ASTROSPRINTER's fore section. These were repaired over the days that followed during a scheduled call at a shipyard.

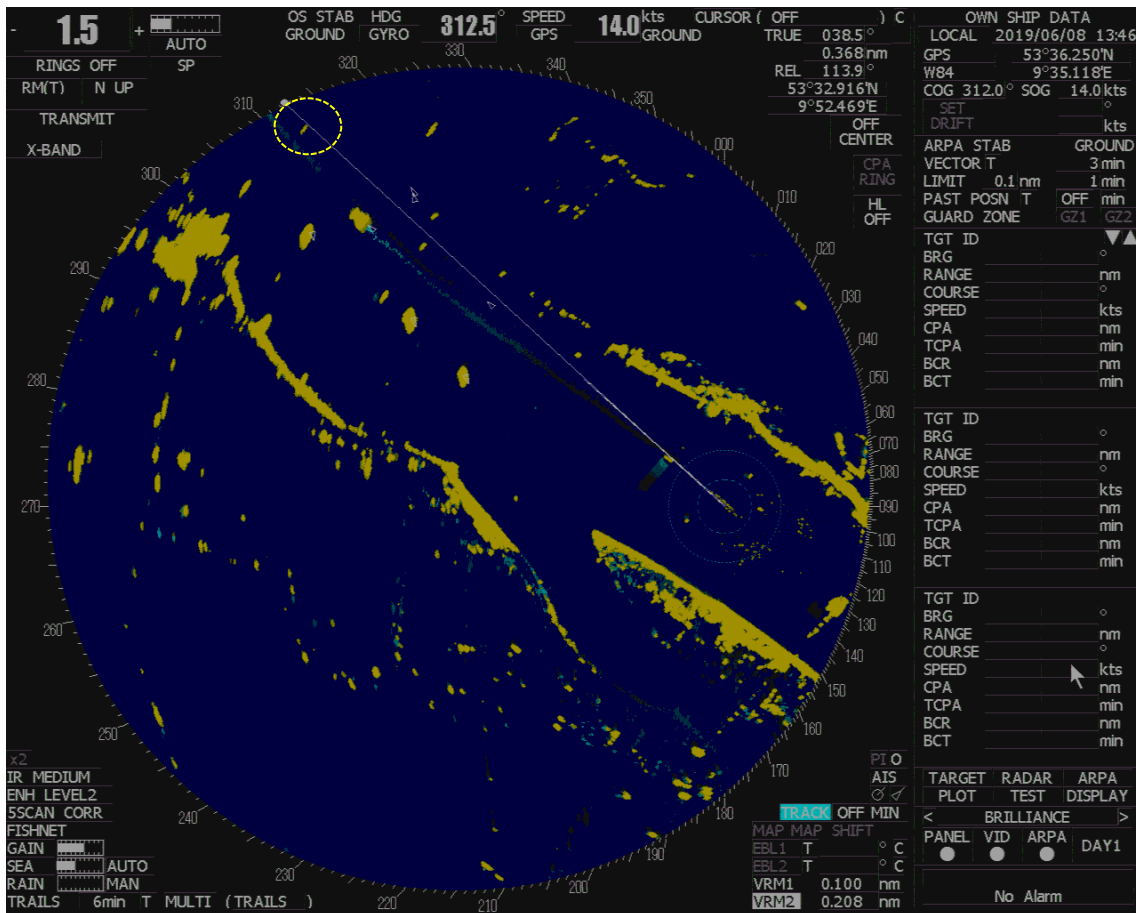
Figure 12: 134631 – sails damaged

The screenshots shown here start at 1346, at the time when the N^o 5 ELBE's sails tore. Figure 12 shows buoy 106 in the yellow circle.

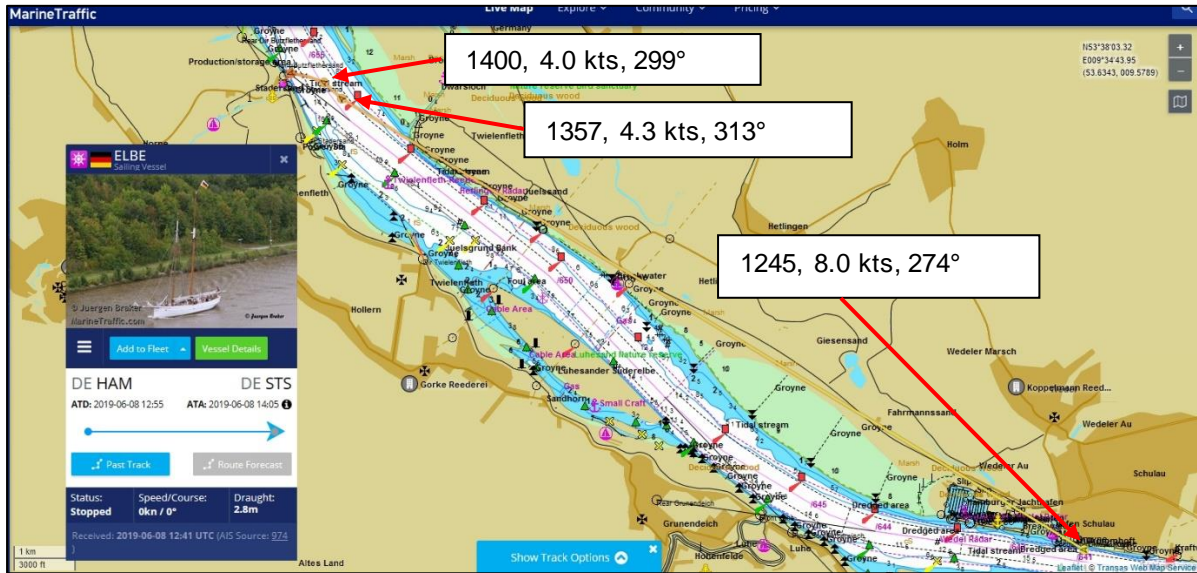
Figure 29: MarineTraffic AIS image showing the course of the N^o 5 ELBE

A Class A AIS was on board the N^o 5 ELBE.¹⁹ When the BSU tried to track the course of the schooner by means of MarineTraffic on 11 June 2019, it was found that the transmissions stopped when she passed the Hamburg port boundary near Schulau and only started again after the collision.

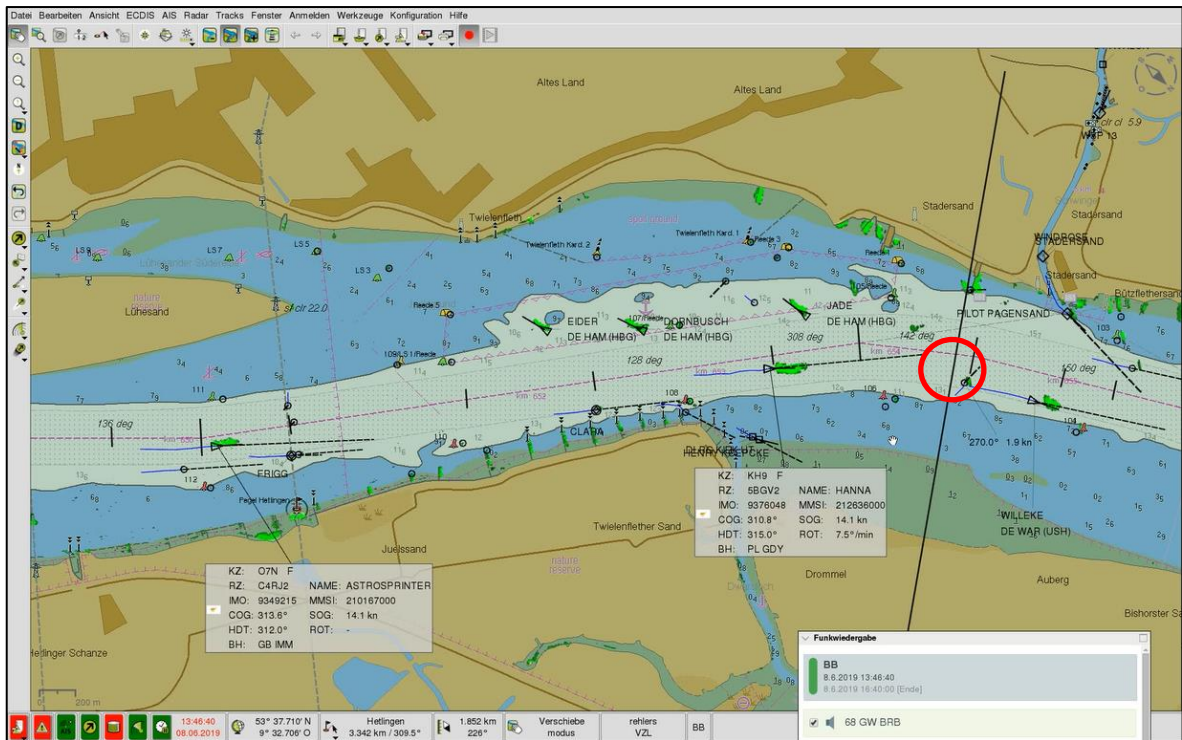
Figure 43: Inner jib of the № 5 ELBE tears

The schooner's course vector points toward the southern bank of the River Elbe for a few seconds at about 134640, then turns to the east and becomes much smaller, meaning the ship is slowing down. Figure 43 and Figure 44 also show the period in which the damage to the sails occurred.

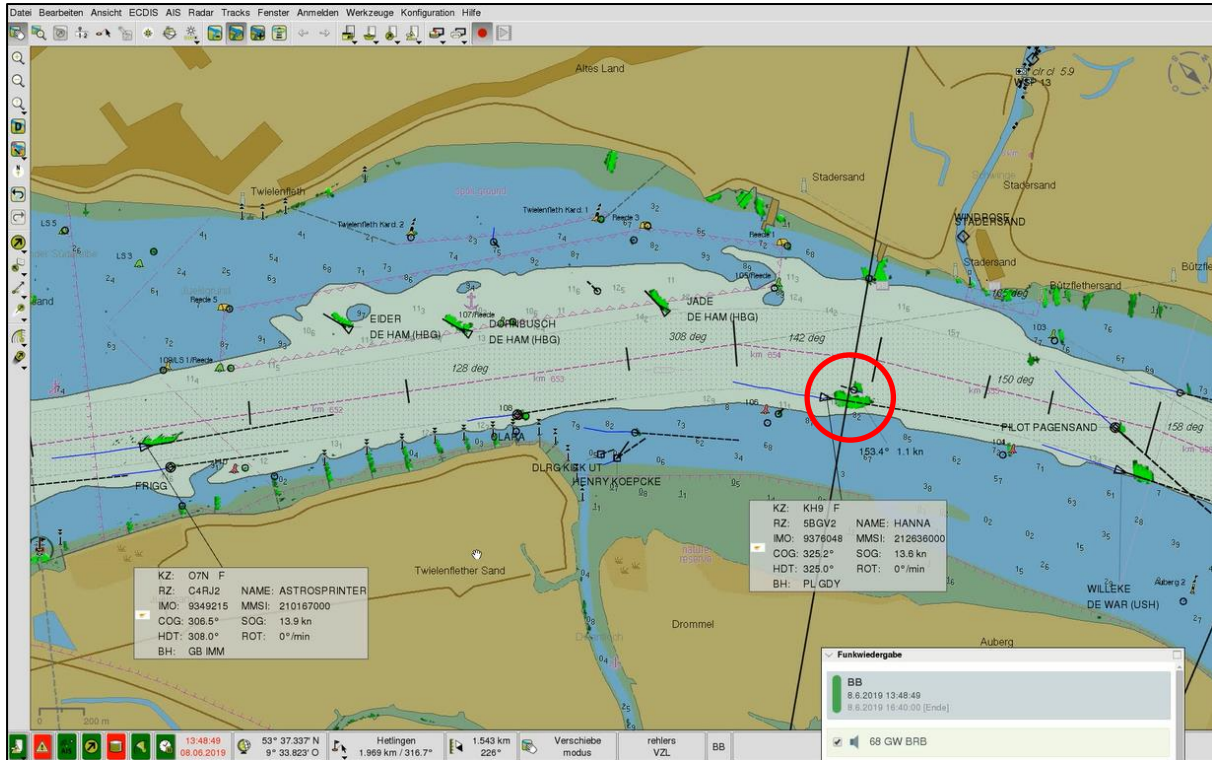
Figure 45: Near collision between the HANNA and N° 5 ELBE at 134849

There is no response, however. Instead, the two vessels continue to converge and the pilot of the HANNA can only prevent a collision by executing an evasion manoeuvre to starboard, even though this entails his vessel moving close to the fairway boundary (Figure 45). The two vessels thus pass on their port side.

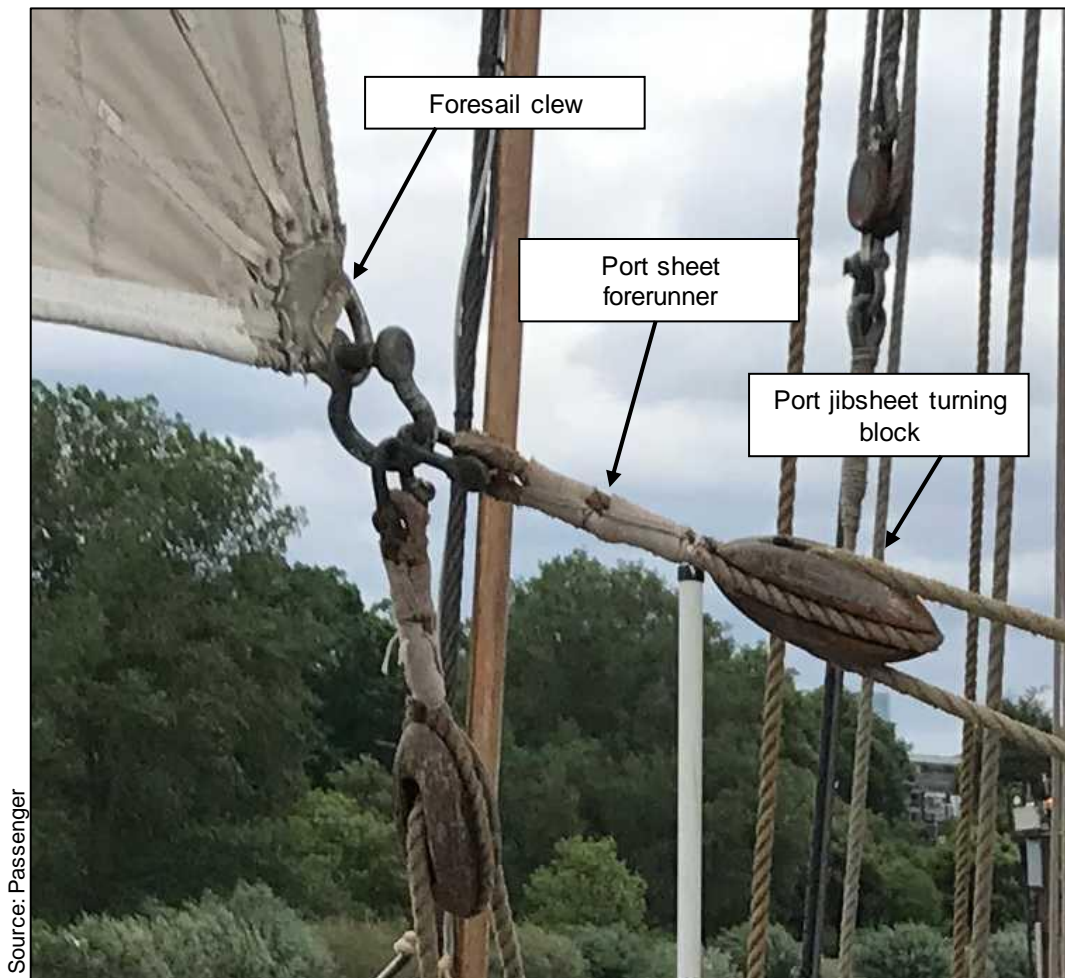
Figure 57: Damage situation at the foresail

To support the turn, the foresail was backed during the turn. Shortly before the turn was completed and the foresail was to be tightened on the port side after the starboard sheet was loosened, the starboard sheet's forerunner parted, causing the pulley and sheet to fall on deck. A crew member reported that the rope running over the pulley was frayed. The foresail was then tightened on the port side.

Damage to the inner jib clew's reinforcement was detected after completion of the turn. The skipper went to the bow to inspect the damage. He decided that the inner jib should be struck. He then went aft, where he started the engines to improve manoeuvrability while the sail was being struck.

Before it was possible to strike the inner jib, the foresail suffered more damage, probably a tear. The sail then began to beat violently. To prevent the beating sail from harming anyone, the inner jib was left and they started to strike the foresail, which turned out to be more difficult than expected. Consequently, several people were then involved in striking the sail.

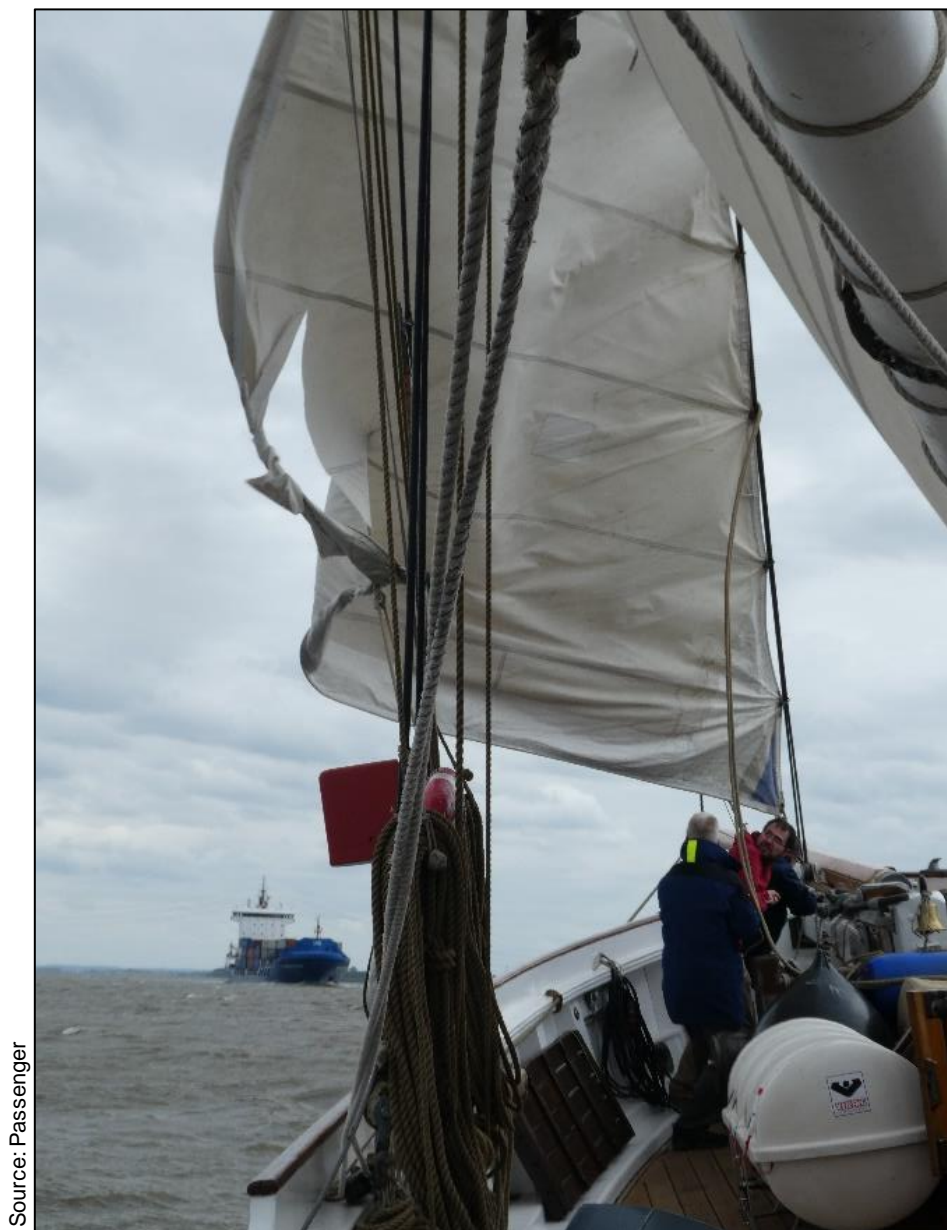
Figure 58: Tear on the foresail

Due to the damage caused, the owner (SHM) was asked how old the sails on board are and what maintenance measures had been carried out. The BSU thus discovered that most of the existing sails are still from America. The ship had only been sailed rarely until she was taken over by SHM. In 2007, SHM had a new inner jib made professionally.

Furthermore, the foresail and jib were sent for assessment and repair in the autumn of 2018. Sailmakers maintained and repaired all other sails regularly. The following table can be found in the ship safety manual prepared by the current operator:

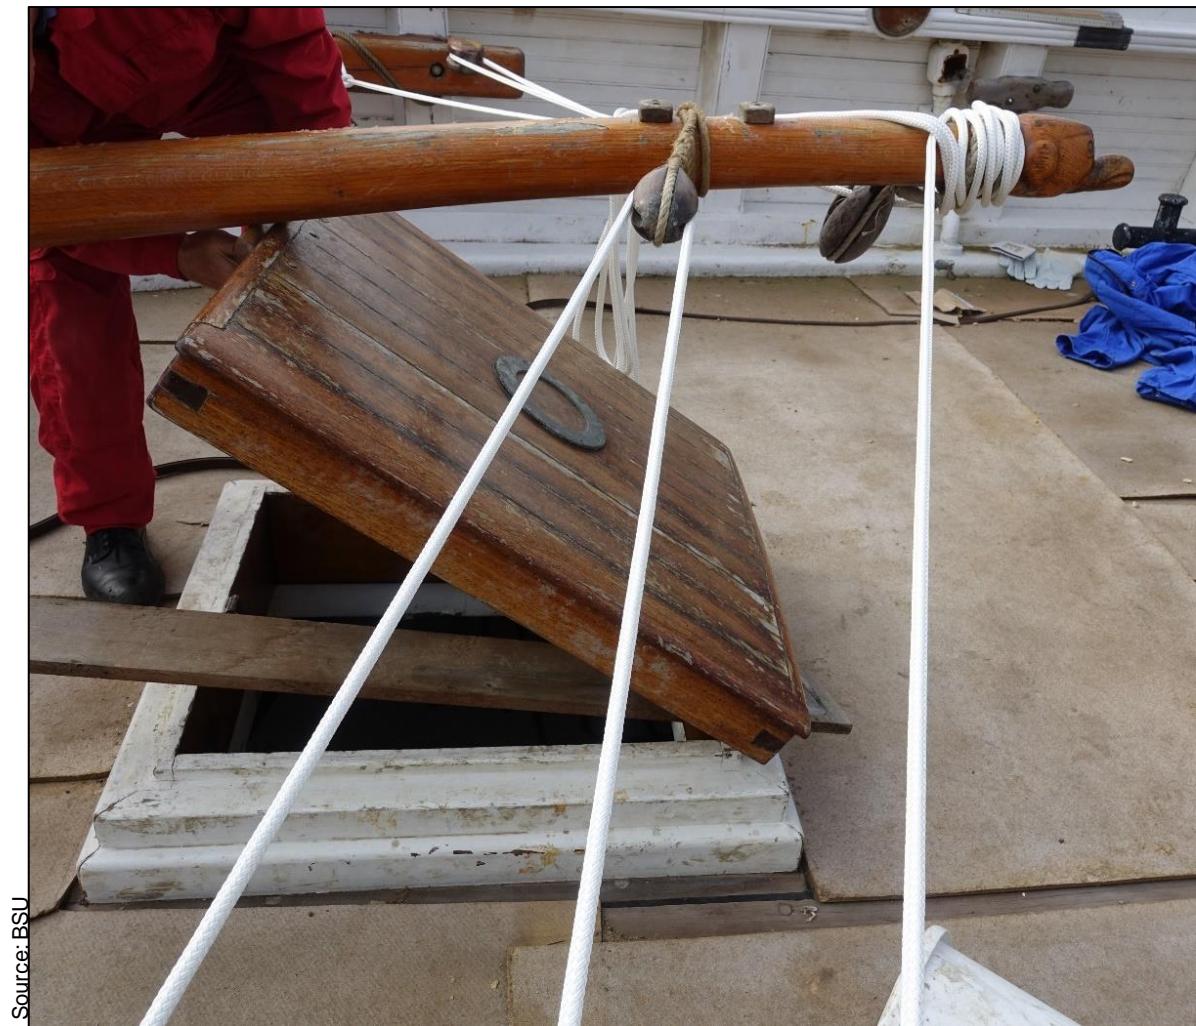
Figure 64: Aft hatch blocked by the tiller

"The propulsion system is designed so that the engines are operated only from the deck control position. People are not situated in the extremely narrow, barely accessible after-peak during the voyage, meaning that an emergency exit is not needed there."

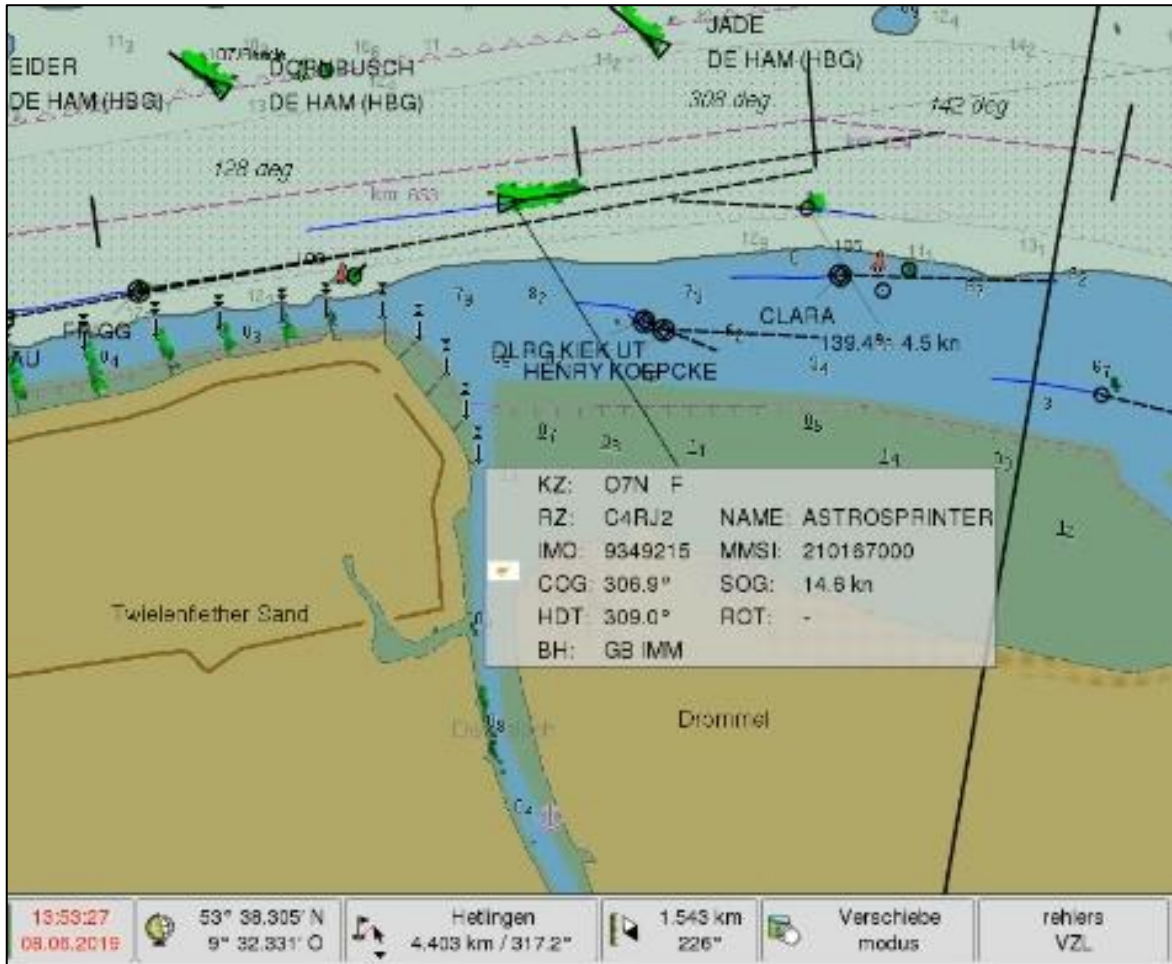
Figure 70: VTS Brunsbüttel radar image at 135327

As the two vessels were converging, the ASTROSPRINTER started to make a course alteration of 4° (from 307° HDG to 311° HDG) toward the N° 5 ELBE at about 135327 (Figure 70).

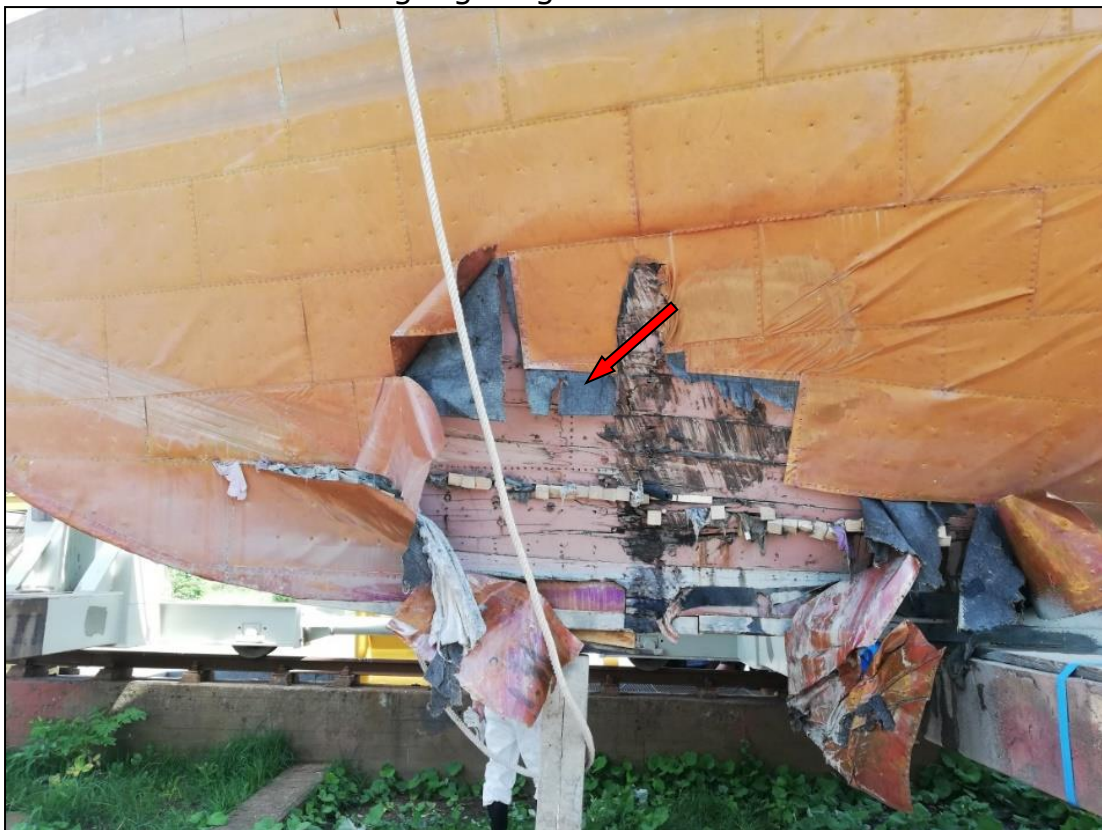
Fig. 7

- Leck im Bereich der Plankenstöße an B.B.-Seite. Mitte des Lecks ca. 3,90 m achterlich vom Vorsteven. Die Kupferbeplattung ist zerstört. Die Auftreffstelle des Wulstbuges der „CMS ASTROSPRINTER“ ist gut zu erkennen. Die Holzstruktur der äußeren Beplankung ist weitestgehend intakt. Der Plankenstoß zwischen 1. und 2. Planke ist geweitet und ist als Leck zu erkennen. Die eingebrachten Holzkeile sind im Rahmen der Bergung eingetrieben worden.

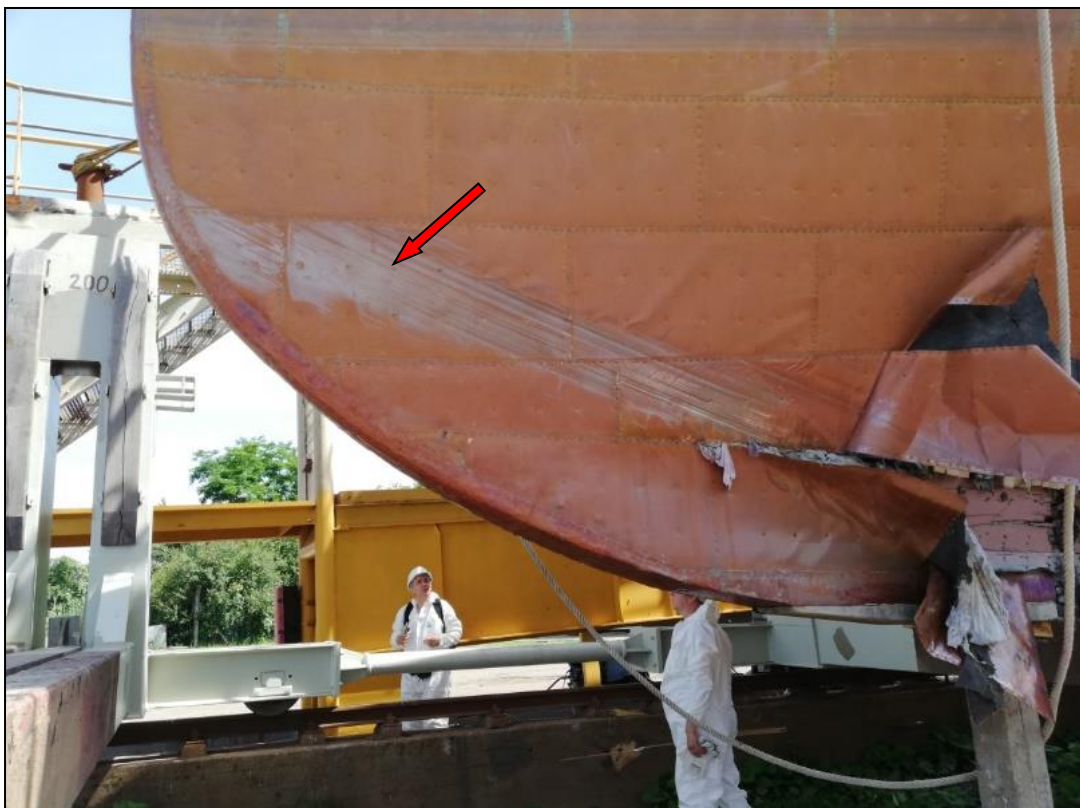
Fig. 9

Nach dem weiteren Entfernen der Kupferbeplattung wird ein größerer Schaden der Außenbeplankung sichtbar. Die erste Panke oberhalb des Kiels ist im hinteren Bereich eingerissen. Auch oberhalb der Schleifspuren durch den Wulstbug sind Planken gelöst und sicherlich nicht mehr wasserdicht gewesen.

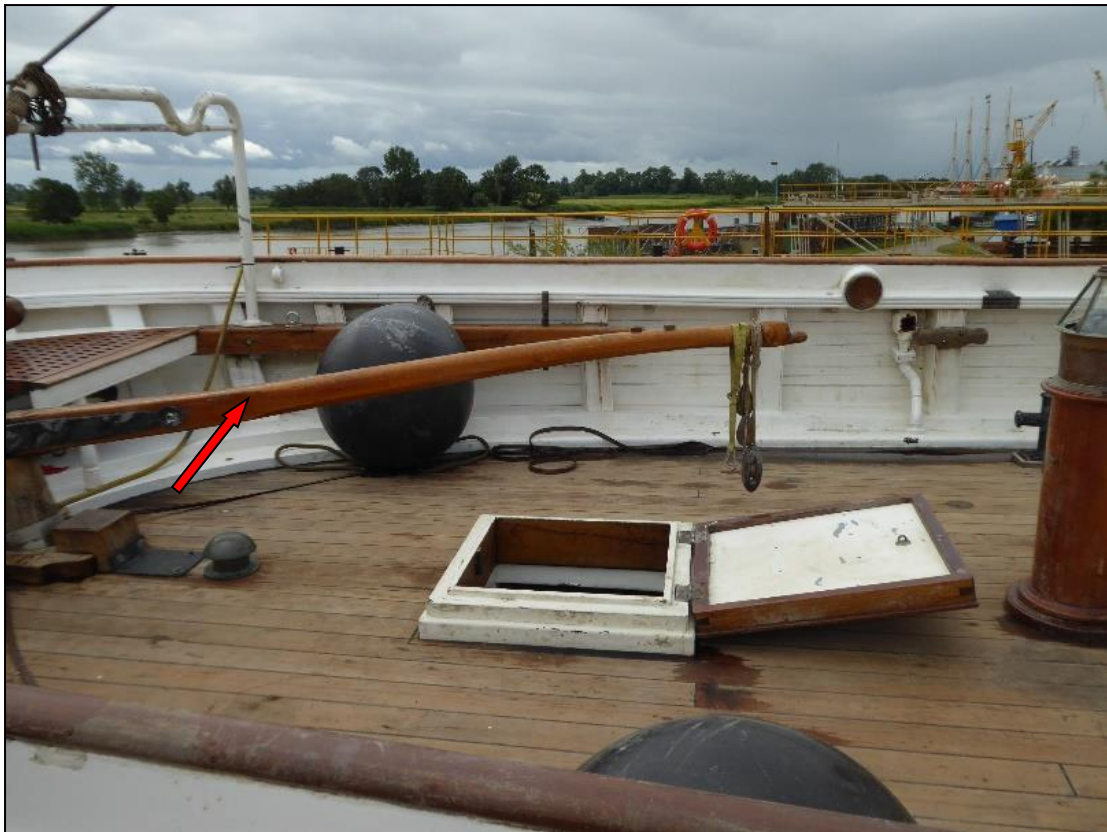
Fig. 15

Risse im Bereich des Holz-Dollbordes auf beiden Seiten im Vorschiffs- und Mittschiffsbereich
