Bundesstelle für Seeunfalluntersuchung
Federal Bureau of Maritime Casualty Investigation
Federal Higher Authority subordinated to the Federal Ministry
for Digital and Transport

Investigation Report 23/20

Less Serious Marine Casualty

**Cargo-related accident
(loss of two mobile cranes)
on the
JUMBO VISION
at berth in the port of Rostock
on 31 January 2020**

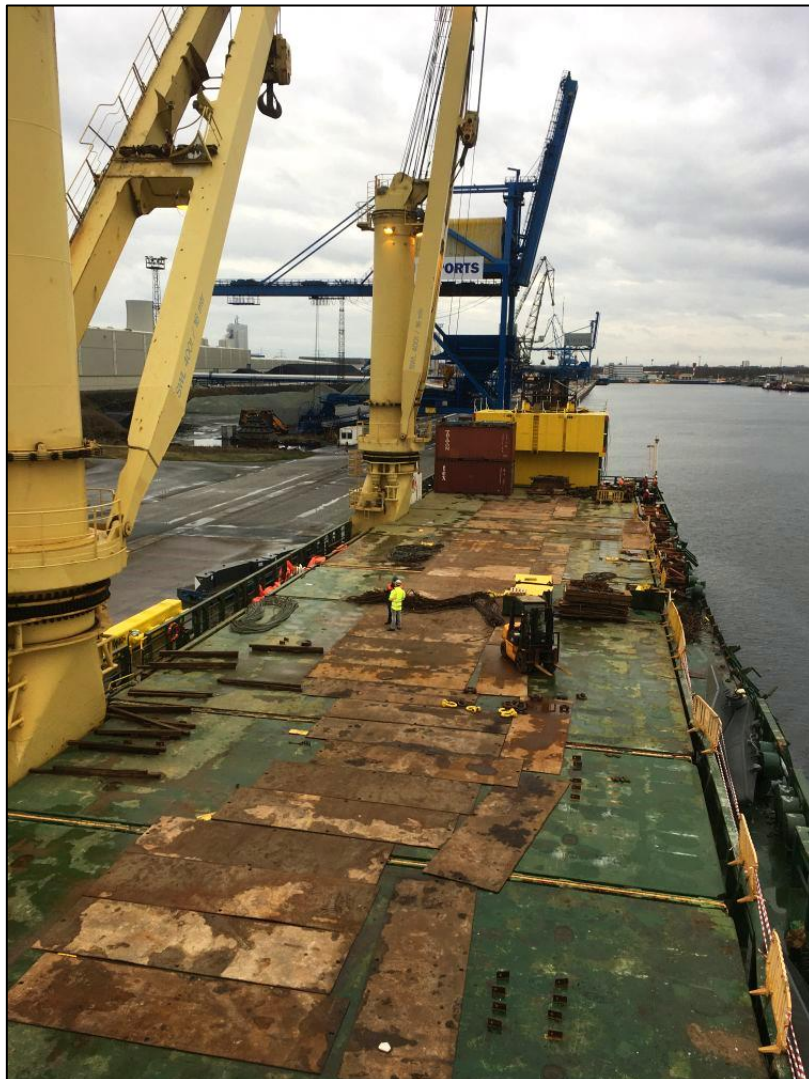
Steel plates on which most of each crane's running gear would later stand (see Figure 5) were put down for load distribution. The plates had been taken on board in the previous port of Antwerp.

Figure 5: Steel plates laid out on deck
(view towards the stern; photograph taken after the accident)

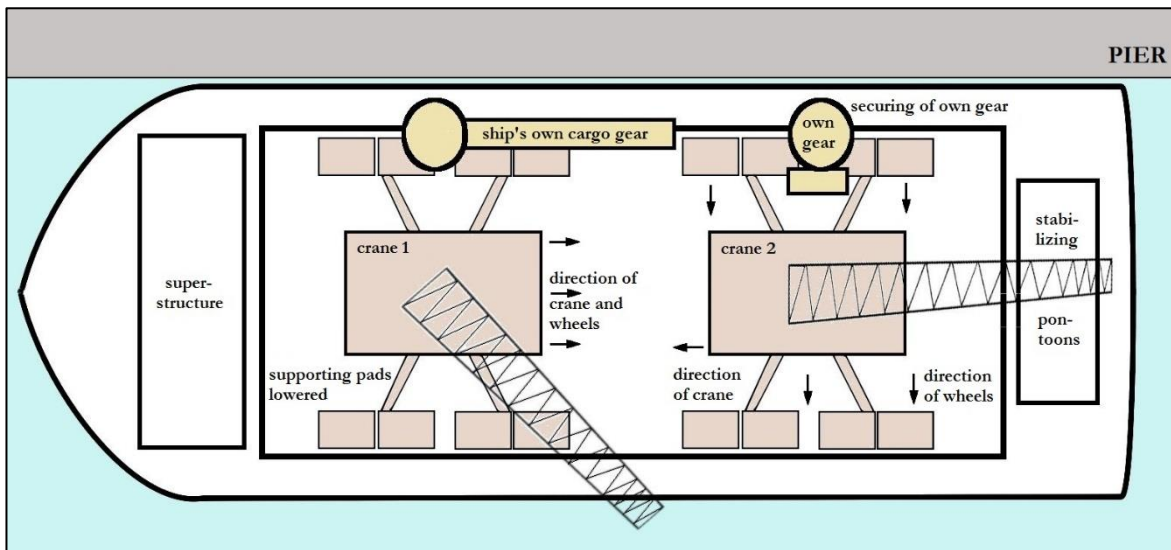
Crane 2 had just been moved a short distance aft and was now standing amidships with its support cylinders raised (see Figure 8 and Figure 9).

Figure 9: Schematic: Position of the cranes on deck just before the accident (length-to-width ratio distorted)

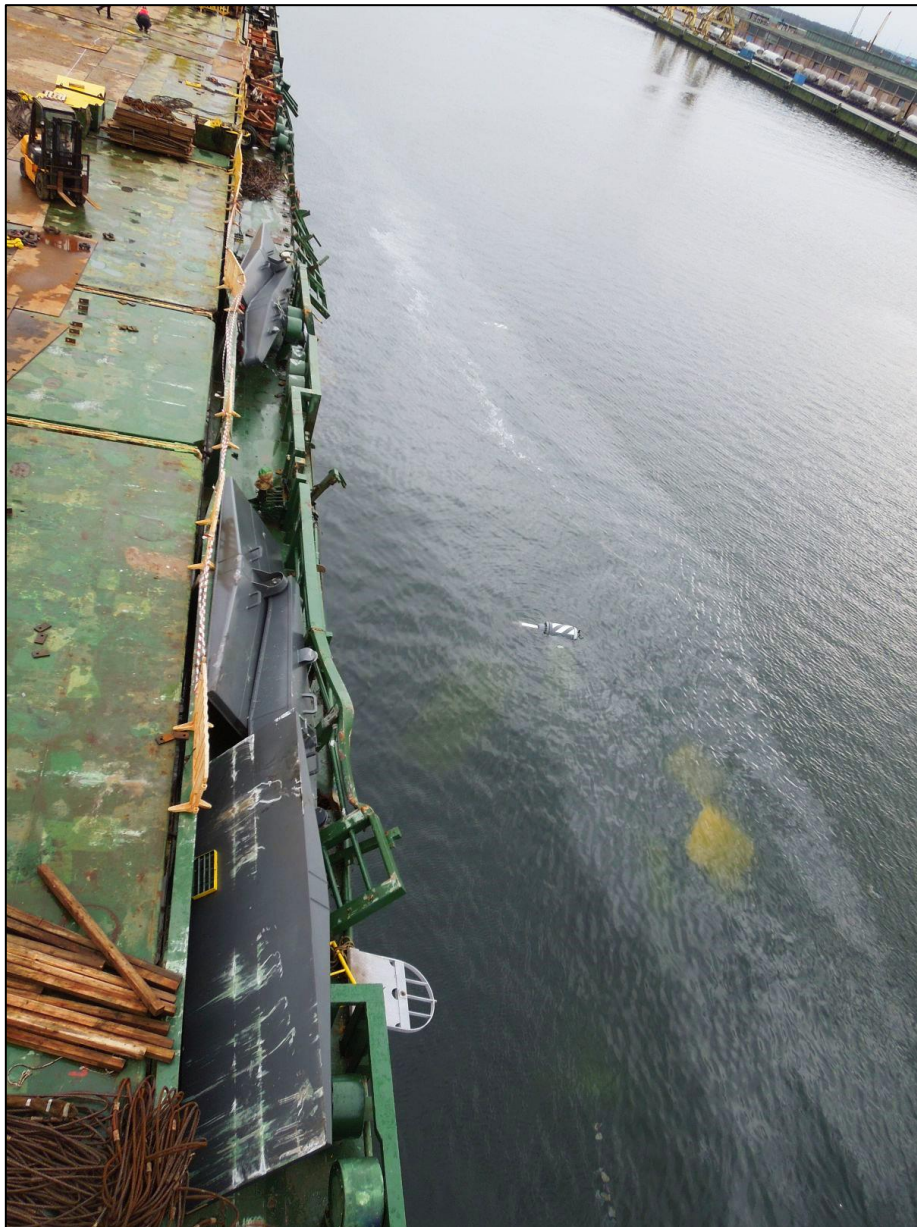
On 3 February, divers from the contracted diving services and salvage company found that the ship had sustained no structural damage to the underwater hull, only a few small dents, scratches and paint abrasions.

Figure 11: Damage to deck passageway, oil slick
(crane 1 visible under water)

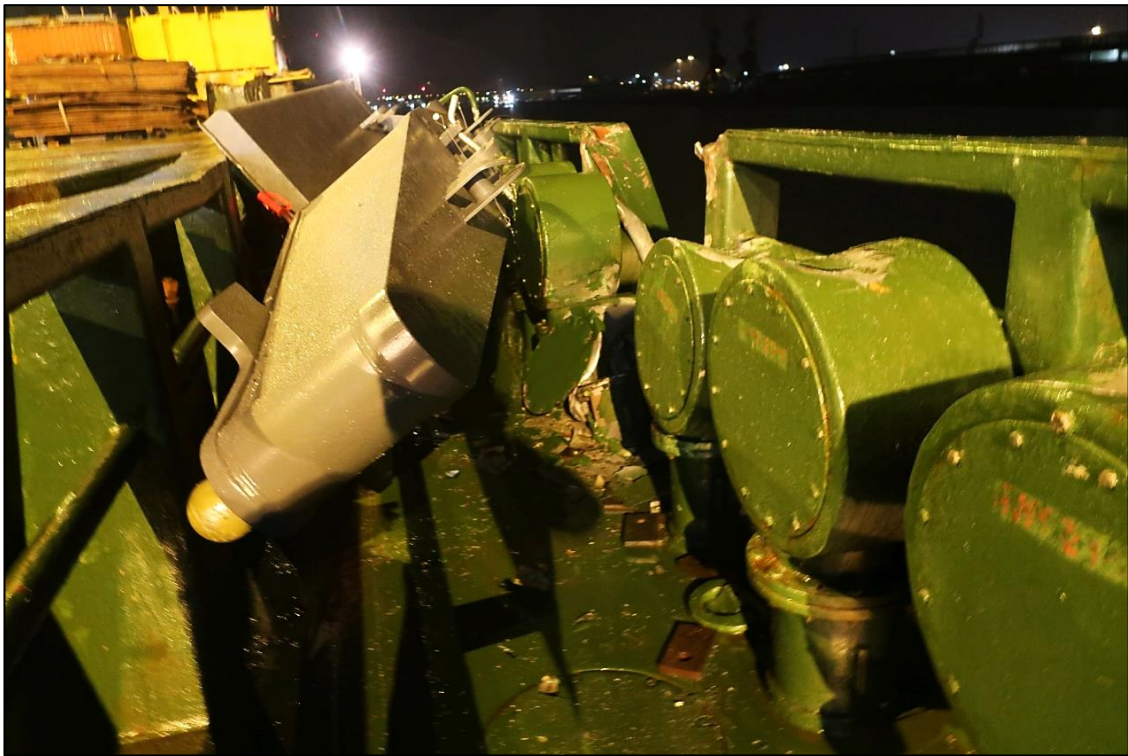
The heavy list that ensued caused the unsecured crane 1 on the front part of the hatch covers to slide and also fall into the water shortly afterwards. Its supporting pads broke off in the port side passageway because no wooden blocks had been put down there.

Figure 12: Damage to port-side deck passageway caused by crane 1 (e.g. broken off supporting pad)

Various repairs were carried out on the JUMBO VISION's damaged port side (see Figure 12 and Figure 13). For this, the ship was rotated and made fast with the damaged side alongside the pier. Class was confirmed by a Lloyd's Register surveyor, and the vessel was allowed to proceed only after the severely buckled and partly missing railing, the broken and buckled sounding pipes, overflows and vent heads, the damage to the main deck (dents and penetrations) and the lifting gear from the gangway, which had gone overboard, had been repaired.

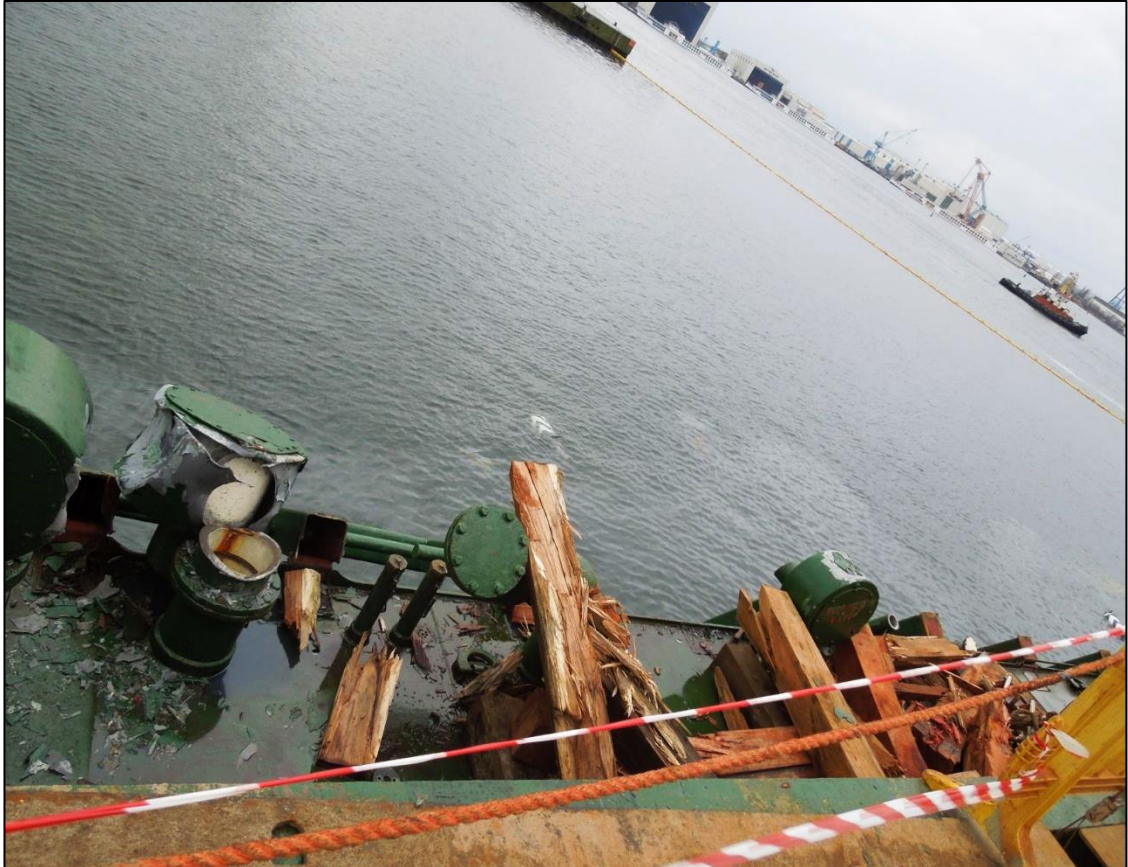
Figure 13: Damage to port-side deck passageway caused by crane 2 (sounding pipes, vent heads, overflows, wooden blocks, missing railing)

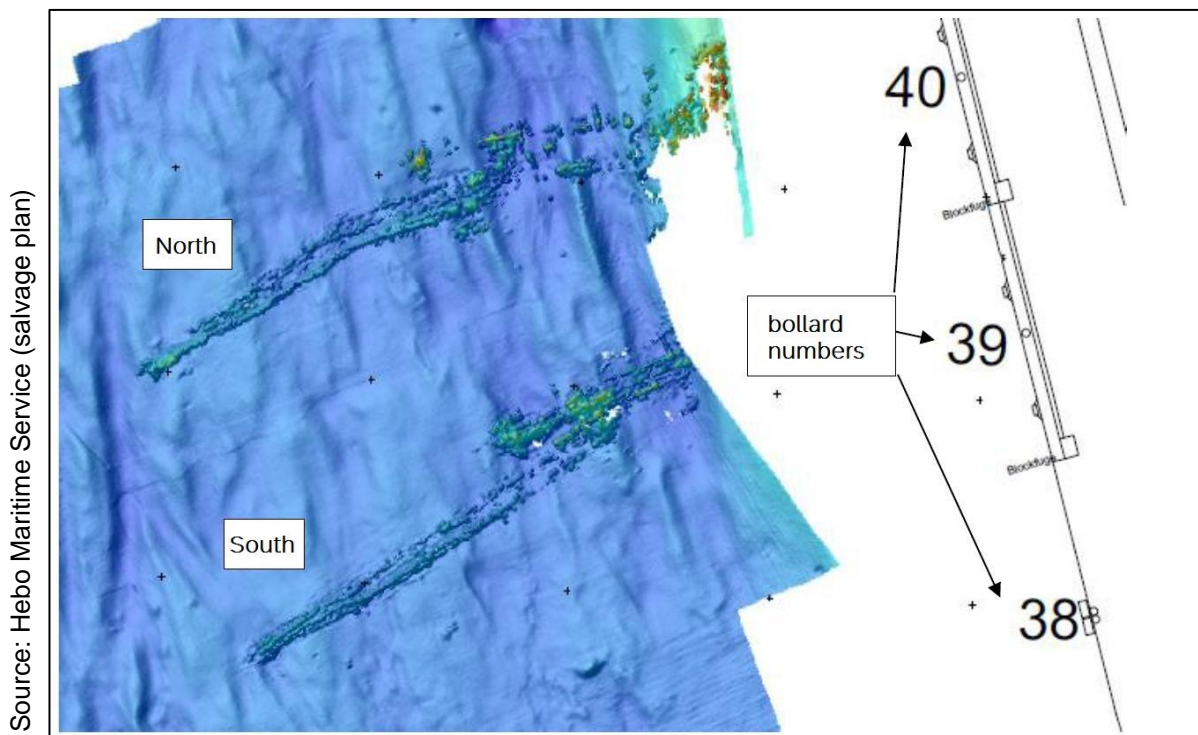
Figure 14: Three-dimensional image of the surveyed harbour basin bottom with damaged cranes

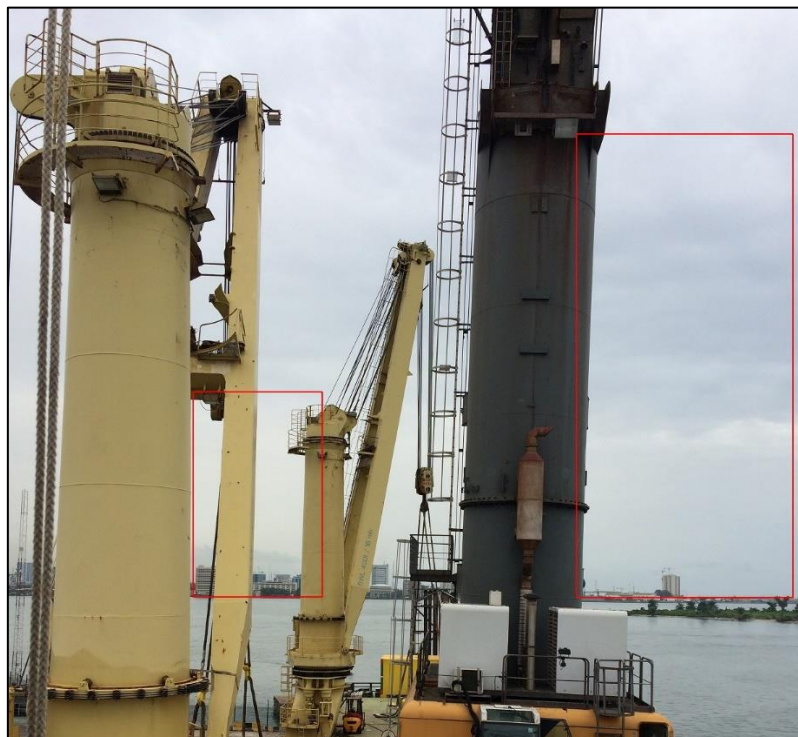
Figure 23: Loading of LHM 550 cranes on the following voyage (view of horizon)
 The insertion of rectangles shows that although the ship was not heeling
 (own cargo-handling gear, left, is at a right angle to the horizon), the loaded crane was still inclined
 (right; no right angle)

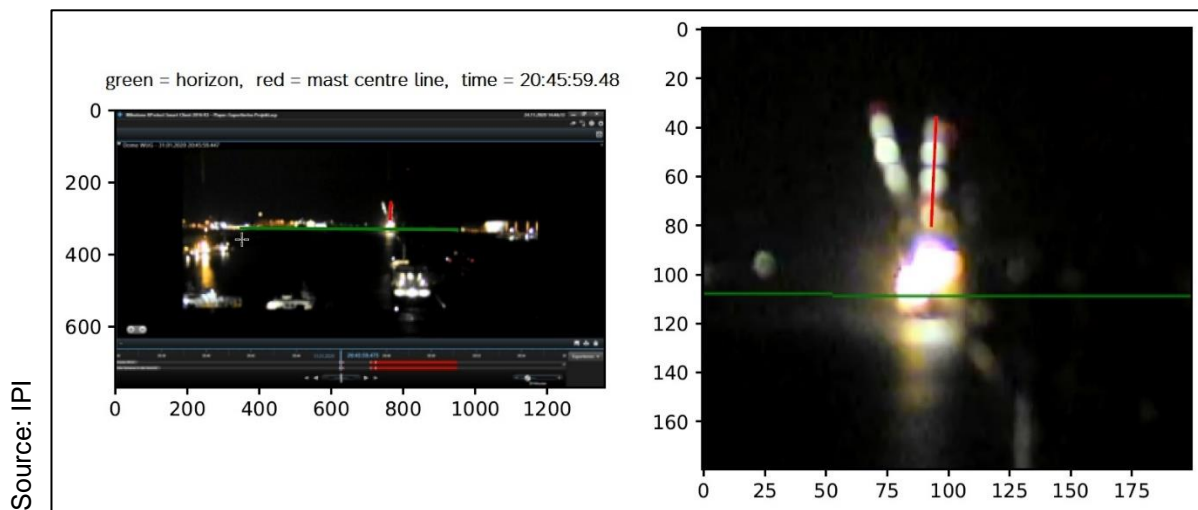
A maximum jib angle of 92.2° was determined when the slewing process took place (20:45:59), i.e. a clear heel to the landward side (see Figure 31). Crane 2's position sensor recorded a landward inclination of 2.1° at the same time²³.

Figure 31: Photogrammetry:
 Heeling to landward side due to slewing of the ship's own cargo-handling gear
 (approximately two and a half minutes before t_0 ; reading 92.2°)

The slewing of the ship's own cargo-handling gear was therefore clearly visible. However, it had been completed and the ship had already righted itself fully, *before* crane 2 was set in motion, which was also clearly visible.

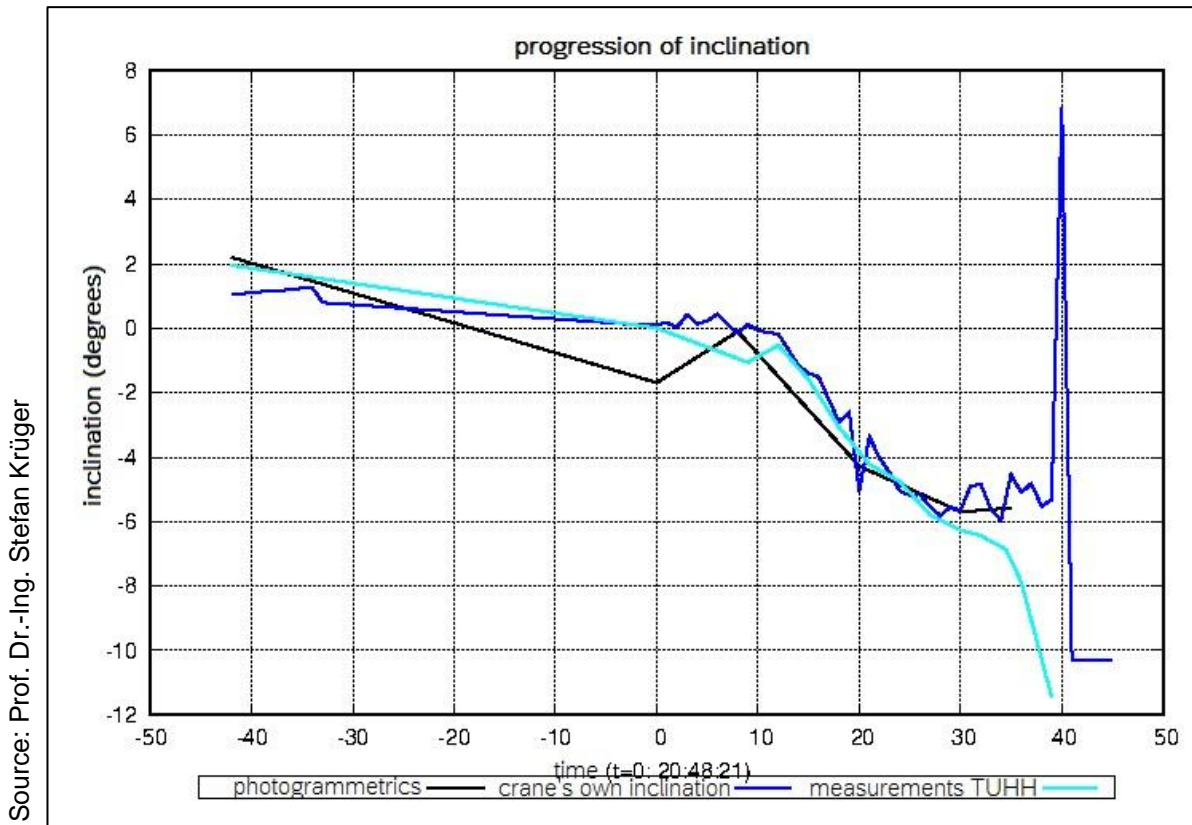
Figure 34 compares the angles determined by the IPI and the TUHH, as well as those of crane 2's inclination sensor over a period of almost two minutes. Over the course of the last movement of the crane up to the accident, an *increasing* heel is clearly visible – in contrast to the originally assumed heel that *already* existed at t_0 (which was refuted). The observed heeling motion does not seem to be linear, as one might expect for a crane travelling sideways at a constant speed, but rather resembles an oscillation.

Figure 34: Roll angle over time according to all three measurement methods

The first attempt to stop crane 2 was made 15 s after it was set in motion. The control lever was (unsuccessfully) moved to the neutral position for this purpose. Figure 34 shows that the JUMBO VISION was already heeling by about 1-2°, i.e. the limit for the maximum permissible transverse surface inclination for operating the crane may already have been exceeded.

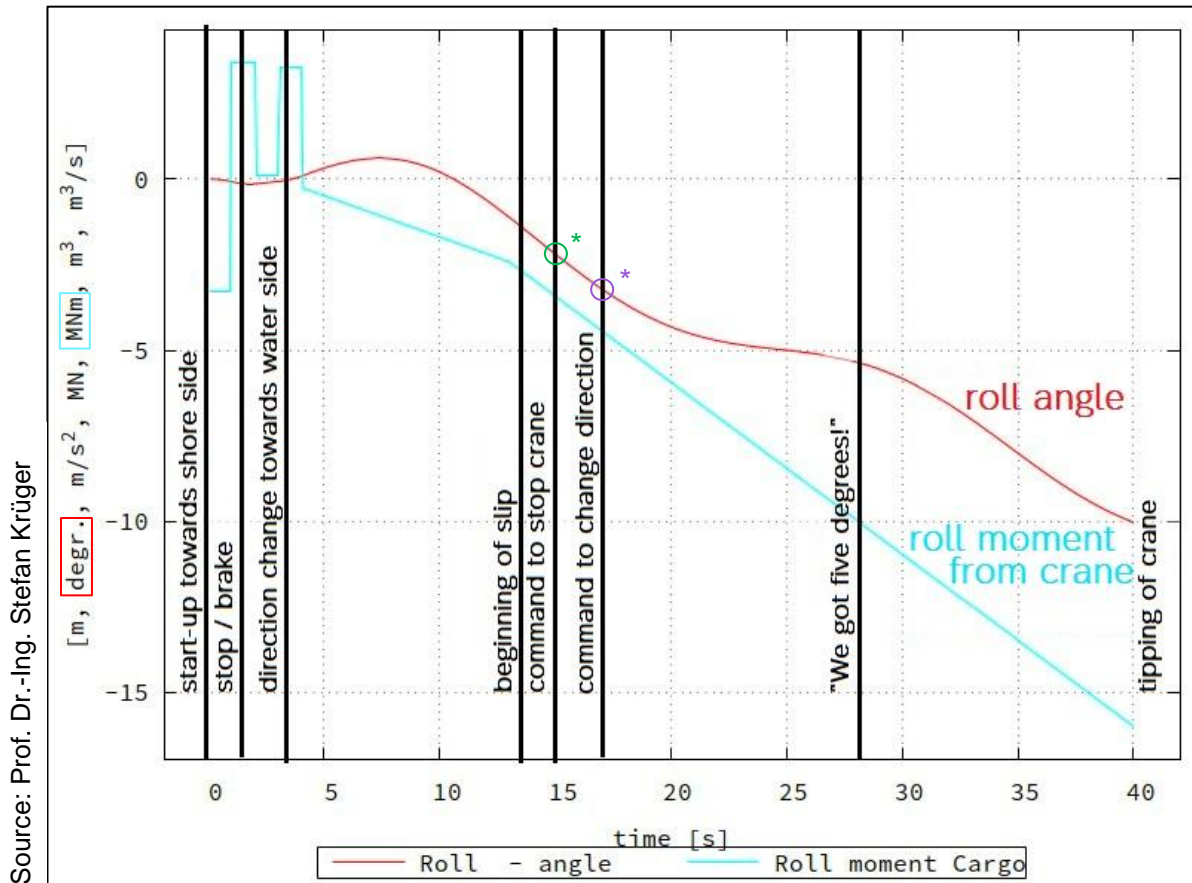
Figure 37: Simulation: Moments acting on the ship and resulting roll angles

The interpretation of Figure 37 shows that at the time the master called out, the simulation also shows a heel of about 5°. It is also clear what effect the rapid direction change (i.e. the crane’s interaction with the ship) had immediately after starting up: One moment towards the seaward side and two moments towards the landward side (light blue curve) acted on the ship as if it were a swing, and triggered an amplifying roll oscillation (red curve). The first almost imperceptible roll to the seaward side was followed by a slightly stronger movement to the landward side. The JUMBO VISION then sharply rolled back to the seaward side, accelerated by crane 2 which was now moving in the same direction. The unsuccessful attempts to stop the crane all happened within the period of this vigorous rollback motion – the first attempt being at about the turning point (*) of the oscillation curve, i.e. when the rolling speed was at its highest.
