**Bundesstelle für Seeunfalluntersuchung**  
**Federal Bureau of Maritime Casualty Investigation**  
Federal Higher Authority subordinated to the Federal Ministry  
of Transport and Digital Infrastructure

**Investigation Report 338/19**

**Very Serious Marine Casualty**

**Fire in the engine room on board the  
multi-purpose carrier KELLY  
with one deceased and two injured  
crew members on the River Elbe  
on 6 September 2019**

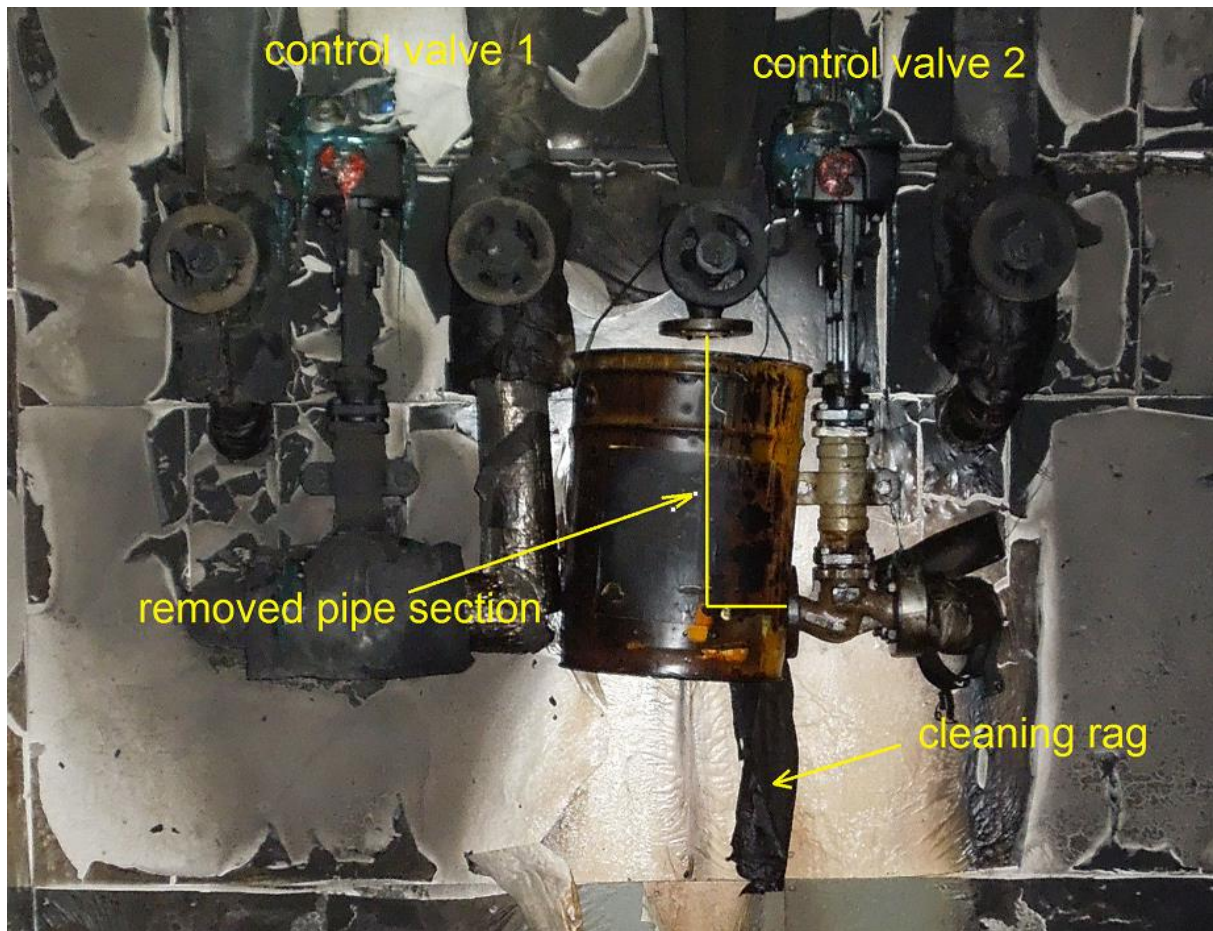
Figure 3: Removed pipe section/working area in the thermal oil system

*Deposits found in the dismantled pipe section (or in this case assumed fuel residues leftover from an earlier fuel ingress in the thermal oil system) were removed mechanically and the pipe section was then cleared with compressed air. The second engineer stated that this work had been completed and they then discussed reassembling the pipe section so that it was available for the forthcoming canal passage. Immediately after, he noticed a hissing or rather whistling noise followed by an explosion<sup>4</sup> in the front of the separator room.*

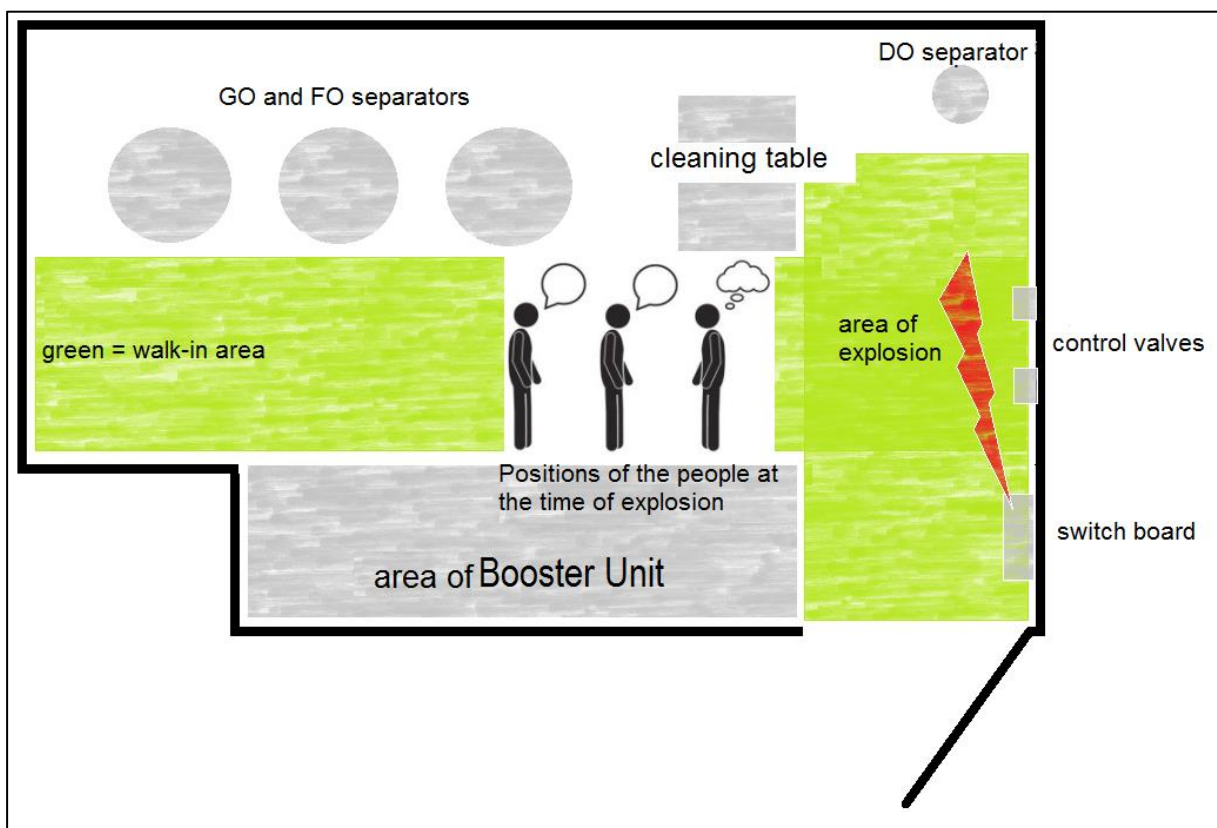
*The second engineer stated that the separator room suddenly filled with dense acrid smoke accompanied by fire. Figure 4 shows the position of the three casualties at the time of the explosion. He yelled at his two colleagues, who were apparently in shock, to follow him. He reportedly slipped on the oily floor and fell several times when leaving the separator room. Parts of his overalls that were soaked with oil, mainly on his arms and legs, were on fire.*

Figure 4: Schematic representation of the room immediately before the explosion  
 Deceased motorman, seriously injured motorman, seriously injured second engineer (from left).

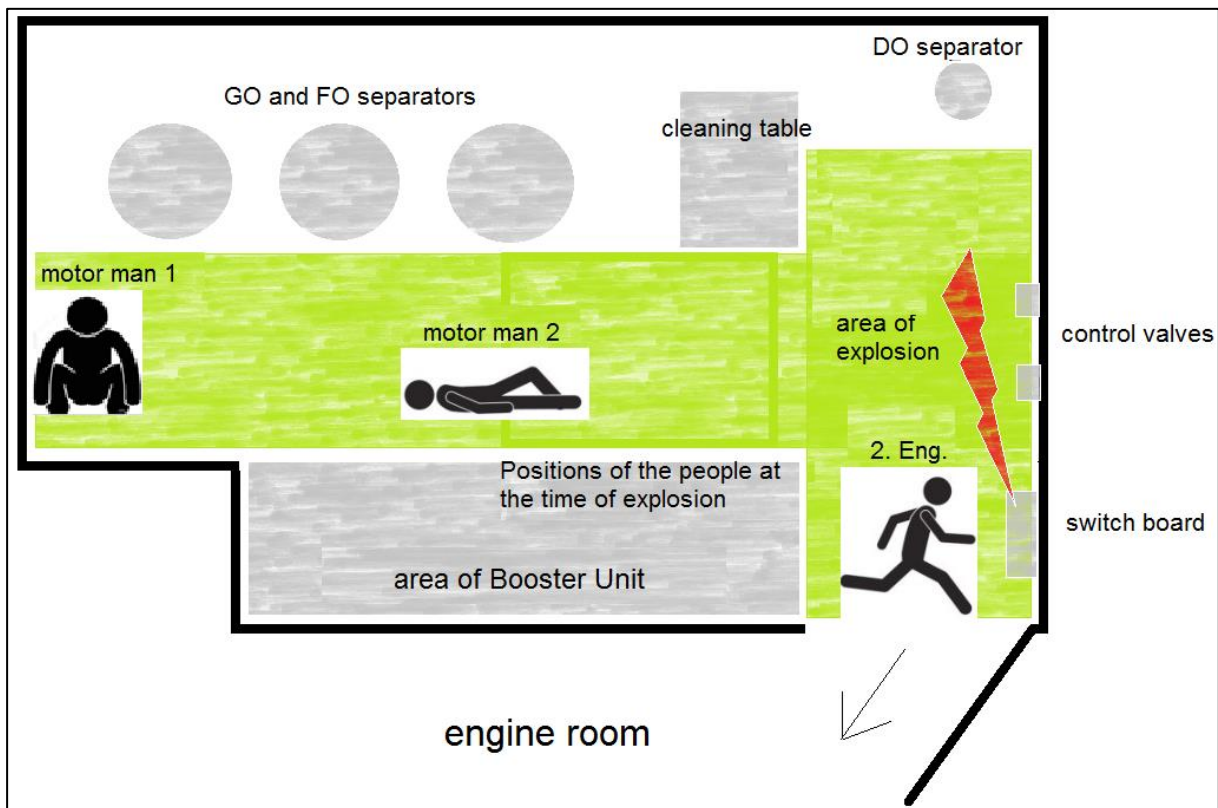
Figure 5: Schematic representation of the separator room shortly after the explosion

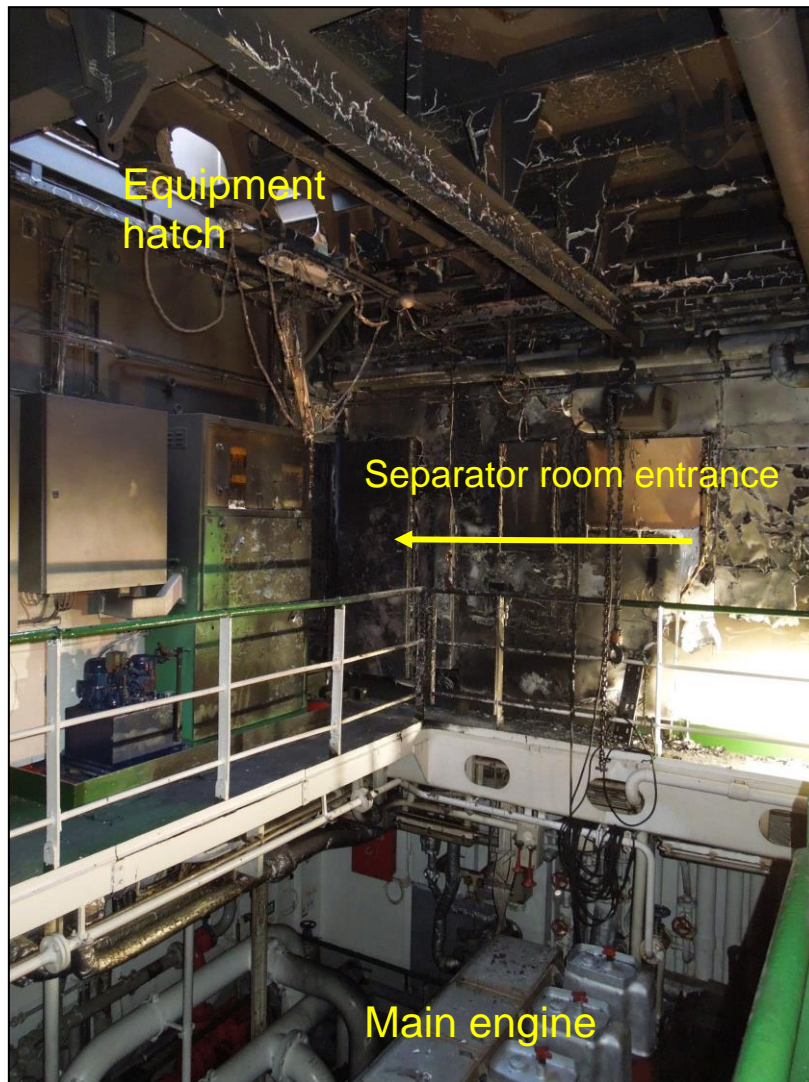
Figure 8: View ahead and of the separator room entrance

The damage in the actual engine room as well as in the adjoining separator room mainly affected the forward bulkhead and adjacent ceiling areas. The aft area and floor of the rooms were not affected. The main engine and the areas beneath the gallery had not been exposed to heat stress. When considering the extent of the damage, it was noted that the fire evidently started in the separator room. This was indicated by the traces of fire running out of the room into the engine room (Figure 8).

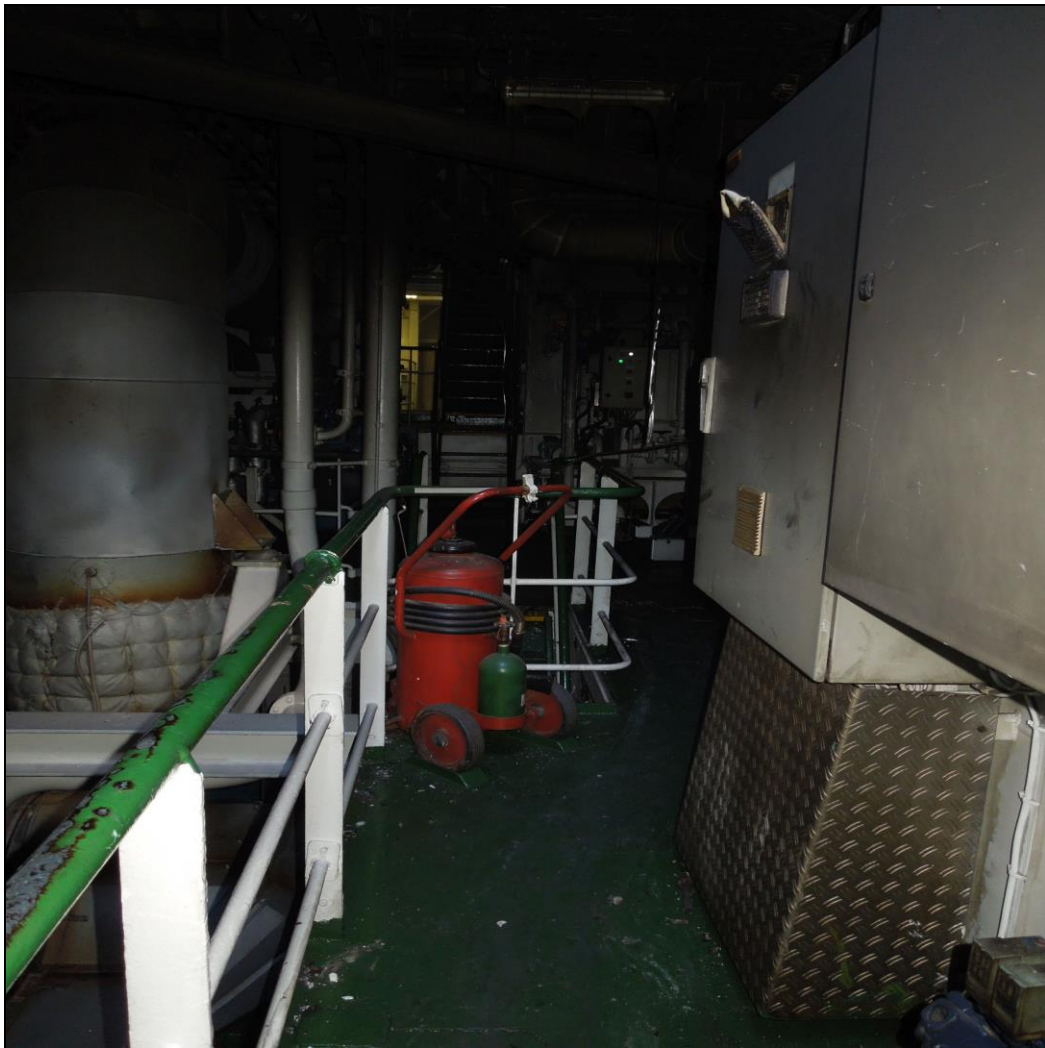
Figure 9: View from the separator room toward the exit of the engine room

Figure 10: View from the separator room toward the exit of the engine room

Figures 9 and 10 show the escape route chosen by the crew. An unused fire extinguisher (powder) can also be seen there. According to the rescuers' accounts, they had considerable problems recovering the last motorman, described as tall and bulky, from the engine room. Either his arm or leg reportedly caught in the left handrail several times, which complicated his evacuation considerably. The use of a stretcher was not considered. Presumably, positioning and securing the casualty in a timely manner would have been difficult due to the lack of space in the separator room. Added to this was the fact that visibility was still severely limited.

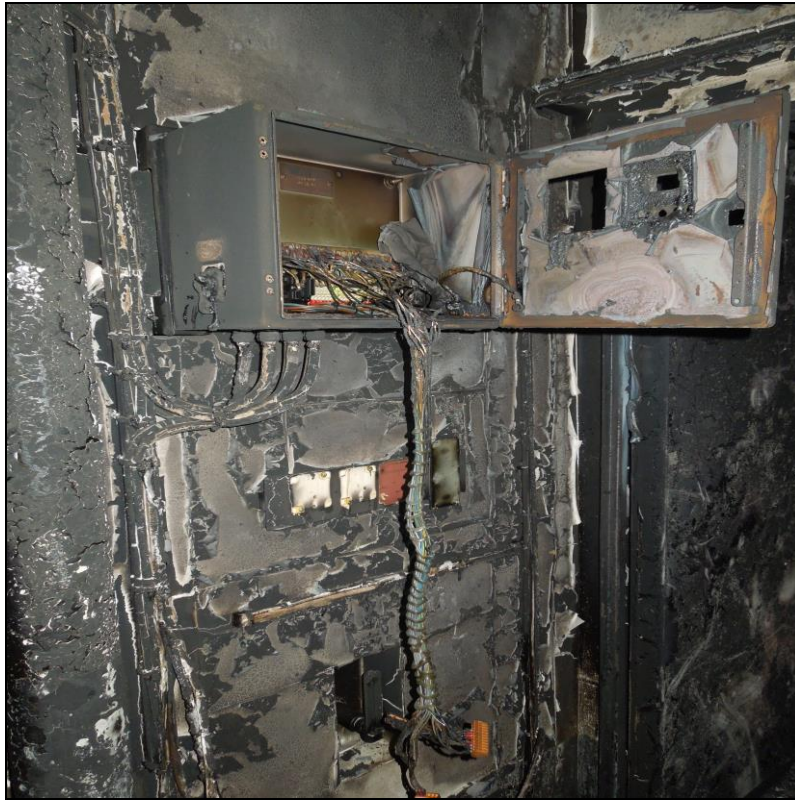
There was an open control cabinet on the right-hand side of the separator room's entrance area. The mounting height was measured at 1.40 m to the lower edge and 1.80 m to the upper edge. Integrated and attached parts of the cabinet were lying on the floor and in front of as well as behind the passage door. It was not possible to reconstruct whether these parts were hurled out of the room by the explosion or had found their way there as a result of the crew's recovery measures. The components only exhibited traces of fire on one side. They were located on the side facing out of the housing, i.e. the control panel.

Figure 12: Control valve's switch box with wiring harness hanging out

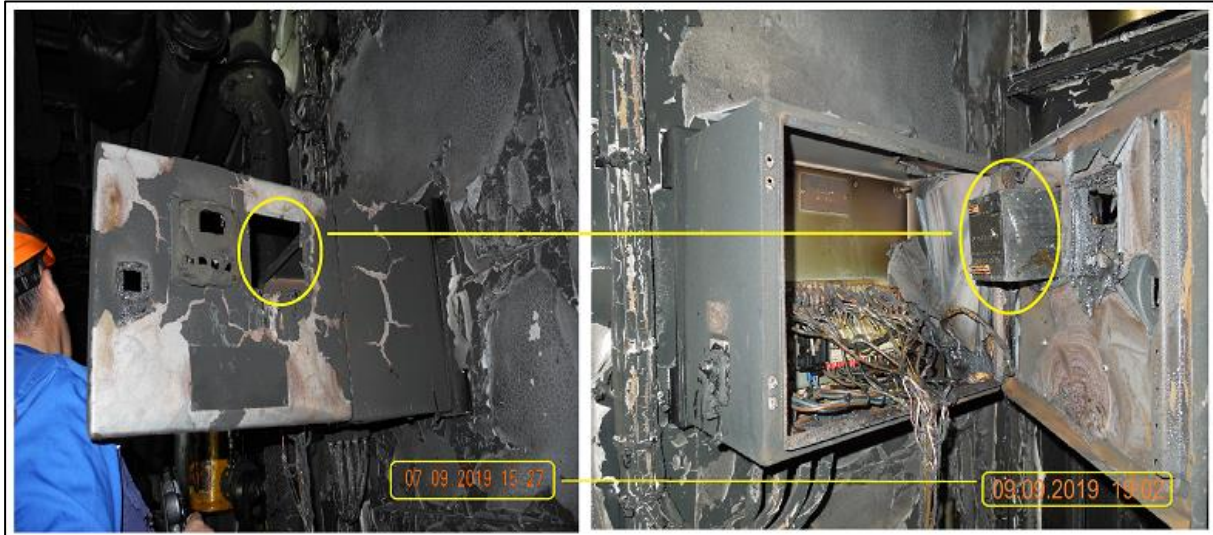
Figure 13: Alterations to the control cabinet

The images in Figure 13 show that a component previously lying on the floor had been reinserted in the door of the control cabinet, even though the police had already cordoned off the room as a crime scene. It is no longer possible to trace whether further alterations were made between the two survey dates. Similarly, the question remains as to who entered this cordoned off room and whether any alterations had an impact on the expert's report.

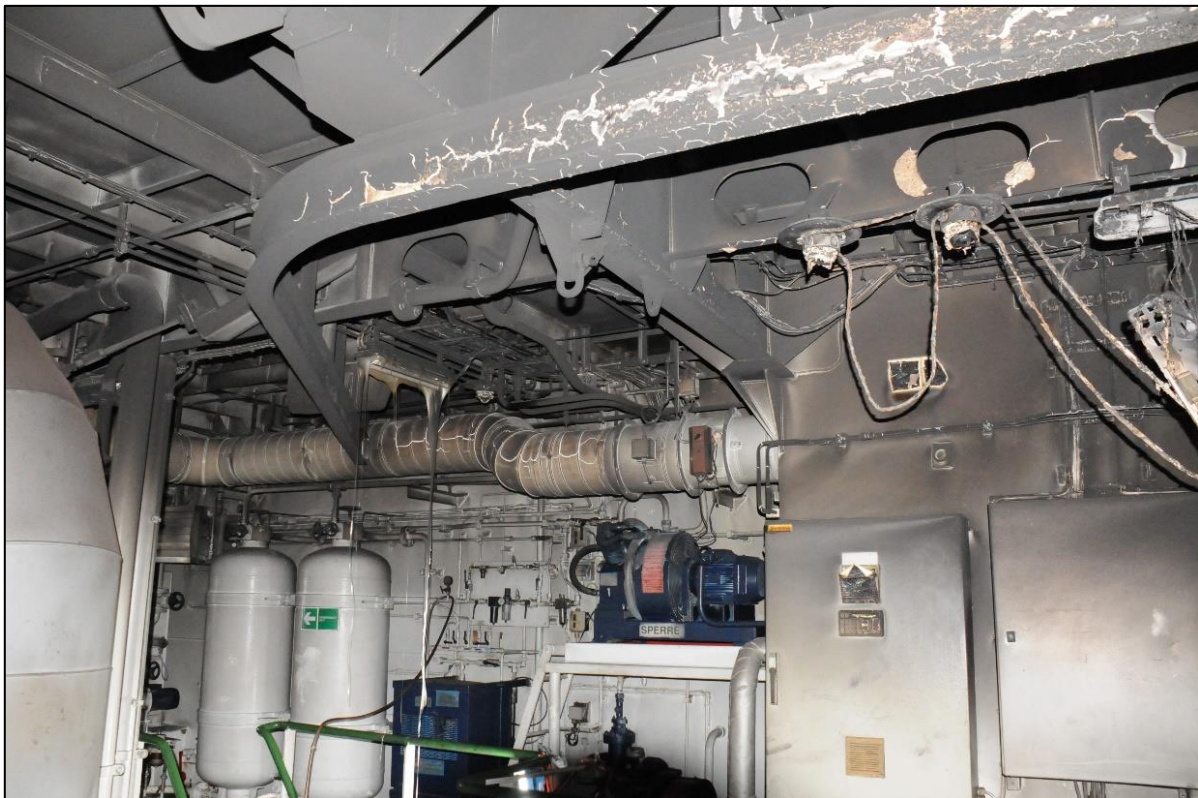
There were also clearly isolated areas beneath the engine room ceiling with extensive fire damage. The mean thermal impact zone was 1.5 m downwards. Apart from superficial contamination, the fixtures directly below exhibited only minor damage. When the focus shifted to the severity of the damage, it was noticeable that the fire had severely affected many areas. Directly adjacent areas were partially only slightly fouled by soot or exposed to heat stress (Figure 14).

Figure 14: Fire zone beneath the ceiling

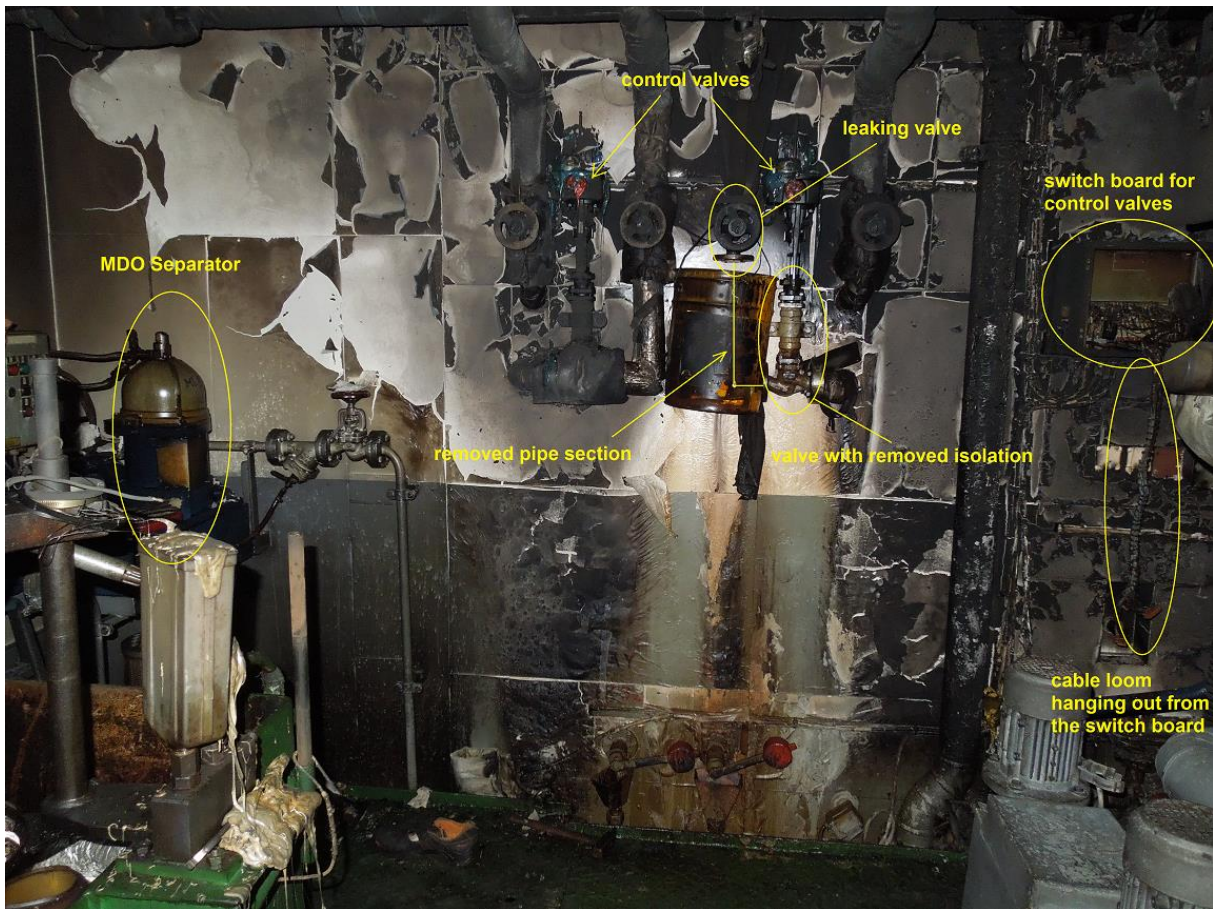
Figure 15: Explosion site

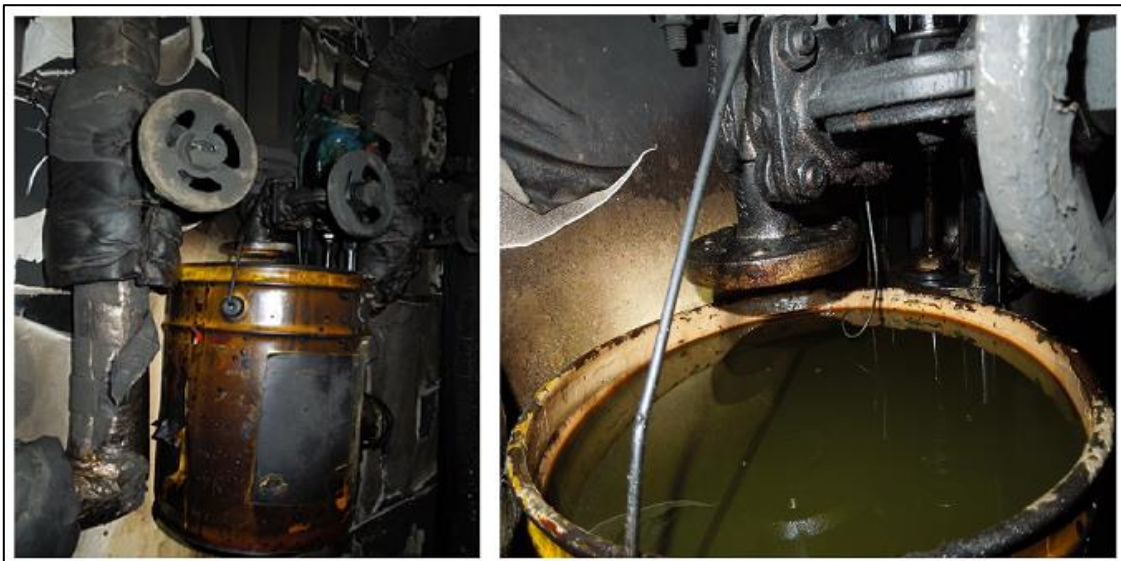
An open pipe system was located in the passage (or at the narrow end of the room toward the bow). An orange bucket that was almost completely filled with thermal oil was suspended from the valve handwheel on the right-hand pipe assembly. The traces of fire decreased further into the room and away from this pipe assembly.

Figure 16: Bucket filled with thermal oil below the valve

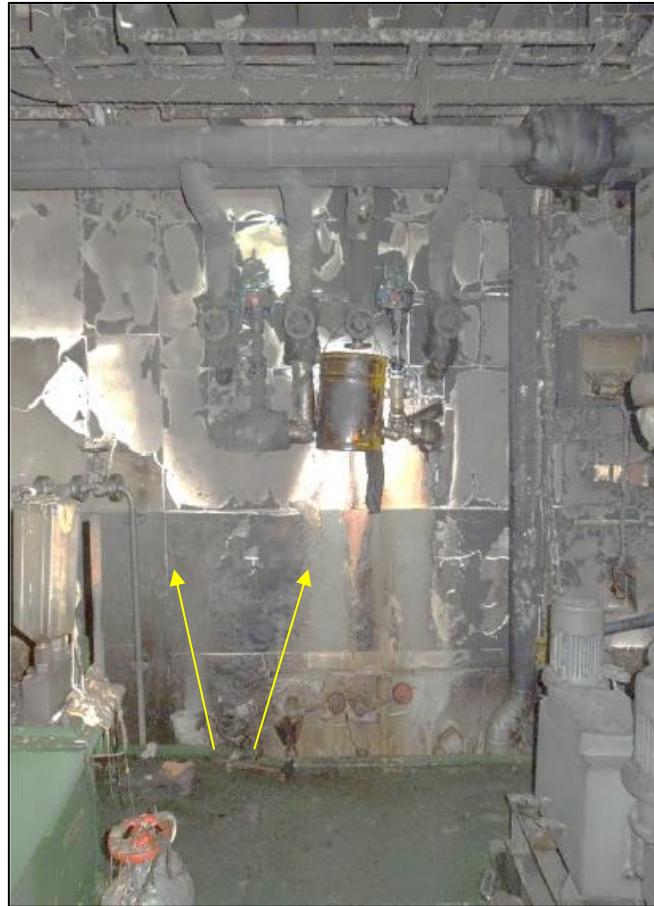
A fire funnel starting from the floor area and running toward the ceiling is visible beneath the pipe system (Figure 19). The fire funnel was to the left of the open pipe on the bucket suspended there. A burn mark coming out of the fire funnel was visible there, too.

Figure 19: Partial overview of the scene of the fire with opened pipe system

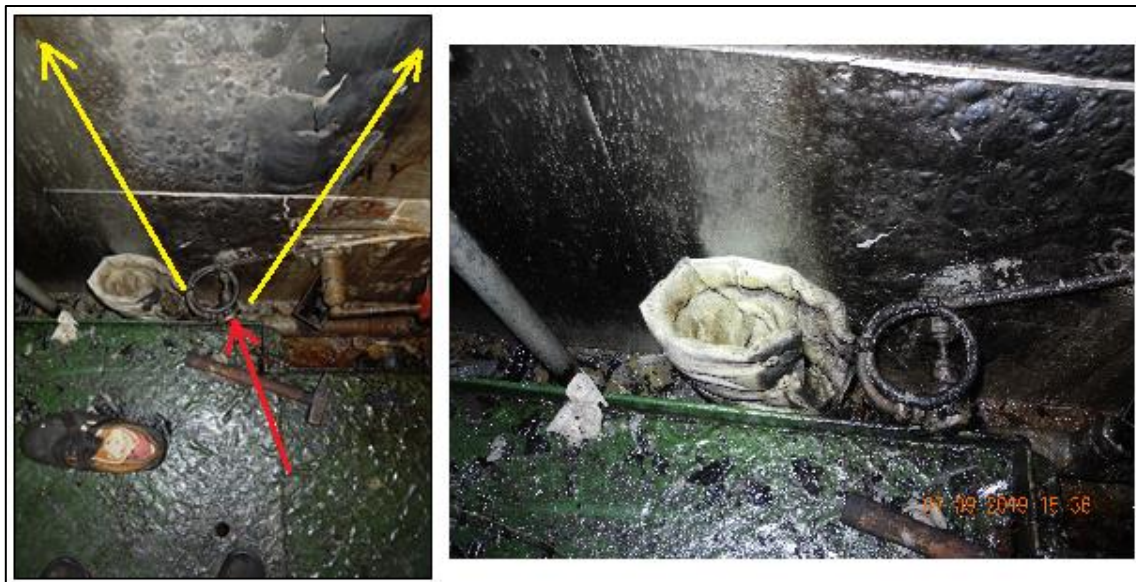
A hammer with a work shoe next to it was on the floor below the bucket. Furthermore, to the left of the fire funnel was the removed insulation for the exposed control valve. This insulation exhibited a burn mark from the direction of the visible fire funnel. An electrical tank sensor unit was fitted in the floor area in the position at which the fire funnel started. A clean burn inside the fire funnel was visible immediately behind it.

Figure 22: Position at which the fire funnel starts

The red arrow points to the sensor unit and the yellow arrows indicate the fire funnel.

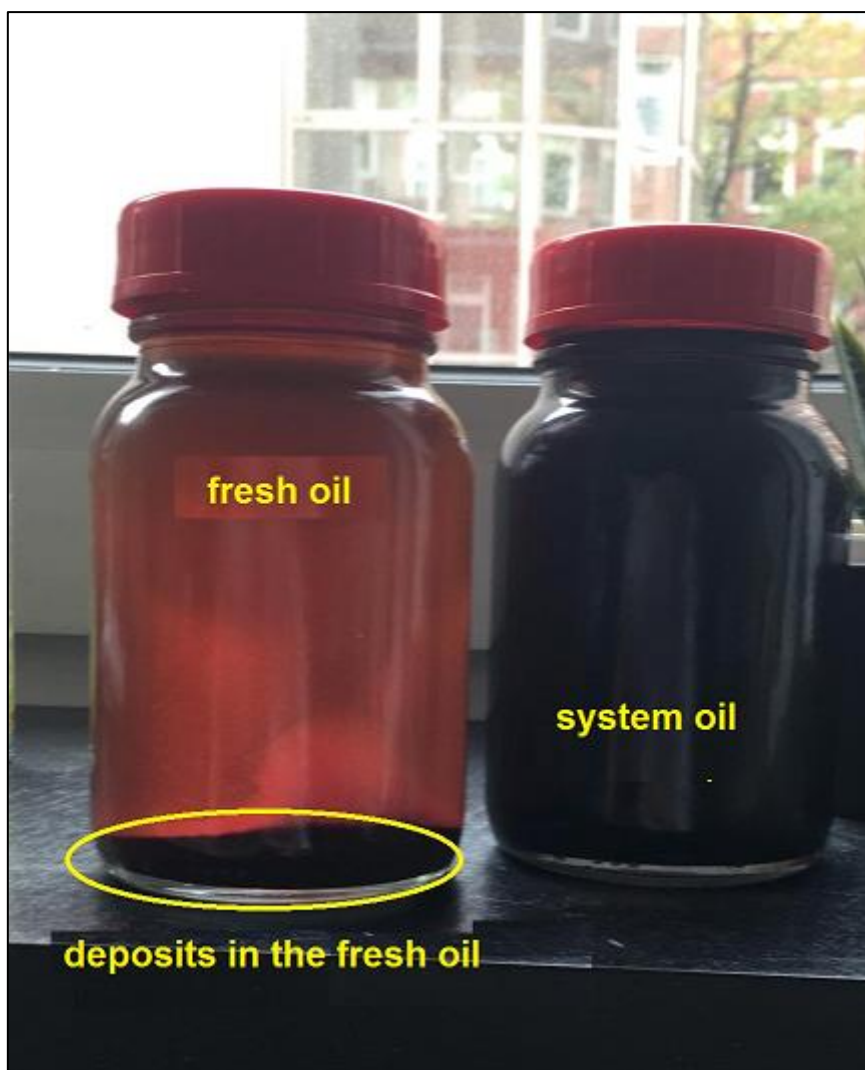
Figure 24: Thermal oil samples from the KELLY

To ensure representative sampling, the sample vials were filled to the brim and sealed without trapping air. This approach was taken to prevent the oil from oxidising. Unused thermal oil should range from light amber to a colour reminiscent of honey. Samples two and three were almost black. Tar-like deposits were visible at the bottom of the fresh oil sample (see bottle on left-hand side of Figure 24) after only 24 hours.

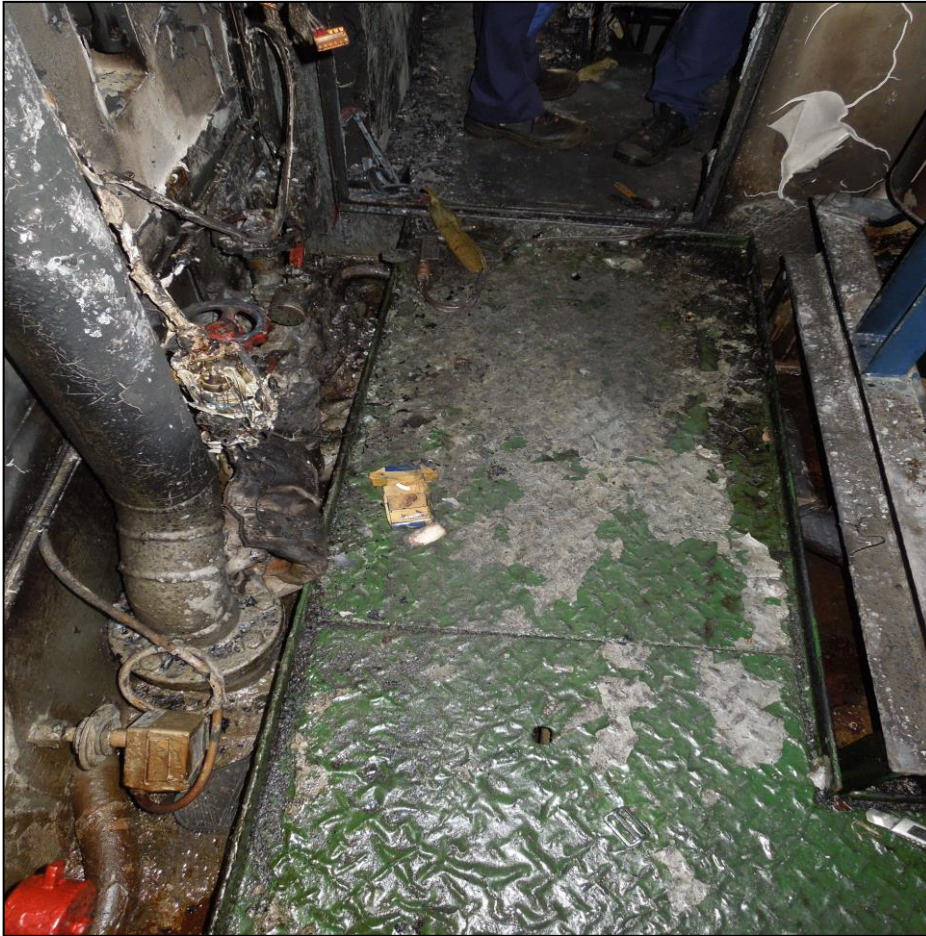
An open packet of cigarettes was found at the scene of the accident (directly in the passage<sup>14</sup>). A lighter could not be secured. Similarly, there was no ashtray or the receptacles usually used on board for such purposes. Investigations revealed that at least two of the three casualties were smokers. It was no longer possible to determine which of the three people was the owner of this packet of cigarettes. According to the second engineer, no one had been smoking in the separator or engine room when the accident happened or at any other time. A general ban on smoking existed in the entire

area. It is conceivable that the cigarettes fell out of a pocket when the second engineer fell or during the recovery of the other two crew members.

Abbildung 25: Cigarette packet at the scene of the accident

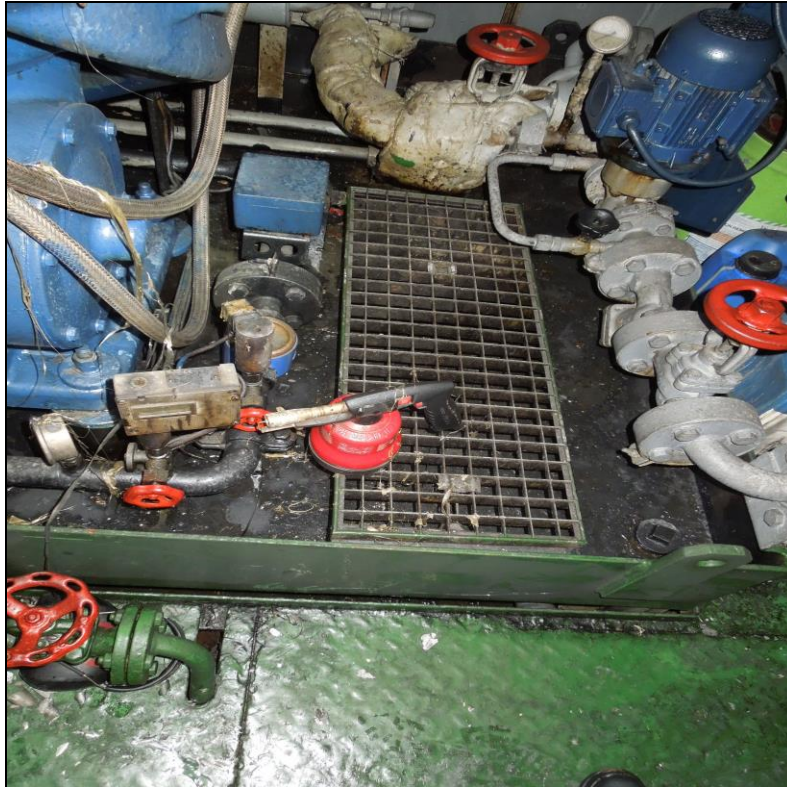
Figure 26: Bunsen burner between the separators

A Bunsen burner with gas cartridge was on the floor between the wash-stand and separator marked HFO<sup>15</sup>. Based on its location, the position of the second engineer, his burn injuries and the fire pattern in the separator room's entrance area, the BSU's investigators believe that the Bunsen burner did not cause the explosion. It was not possible to establish what it was being used for.

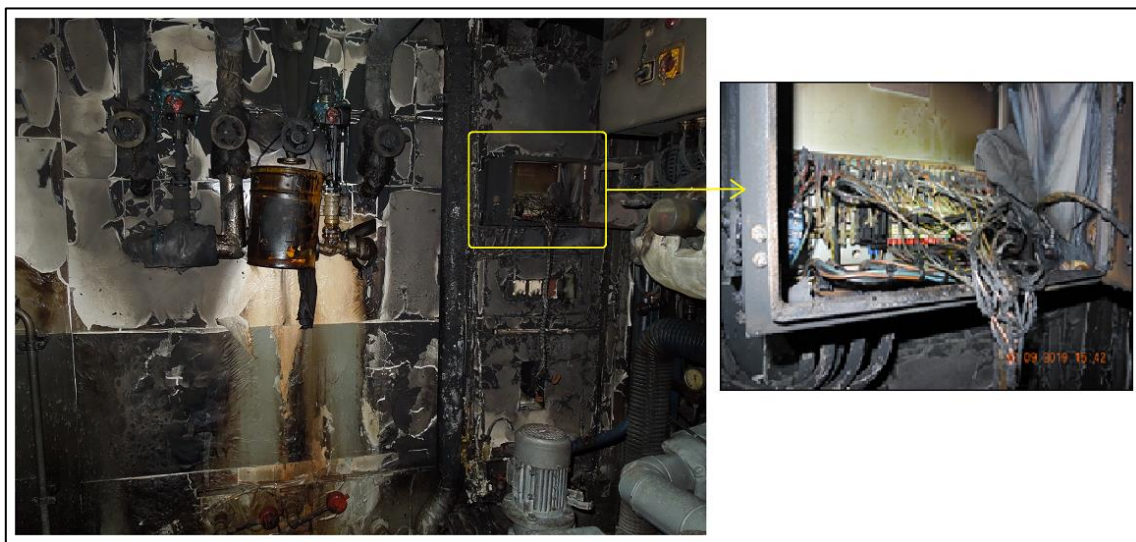
3. Although seriously injured and still burning himself, the second engineer was able to leave the room unassisted. He testified that he had slipped on the oily floor and fell several times in the passage. Here, too, the unlocked cabinet could have been opened unintentionally and the cable harness torn out and damaged.

In the case of the second and third theories, there is a possibility that mechanical damage to the cables could have occurred as a result of the recovery operation, as well as that the control elements and parts of the locking system landed on the floor in front of the separator room's entrance area. Assuming that the cables had suffered mechanical damage in the course of the explosion or due to the second engineer's escape attempt, a short circuit could have occurred even after the explosion or ignition. Similarly, the cables may have melted due to heat stress during the fire. The fire was only extinguished when CO<sub>2</sub> was discharged into the engine room by the second engineer. A blackout did not occur until several minutes later. This means that the switch box or the cables were still conducting immediately after the explosion.

Figure 27: Open control valve control cabinet

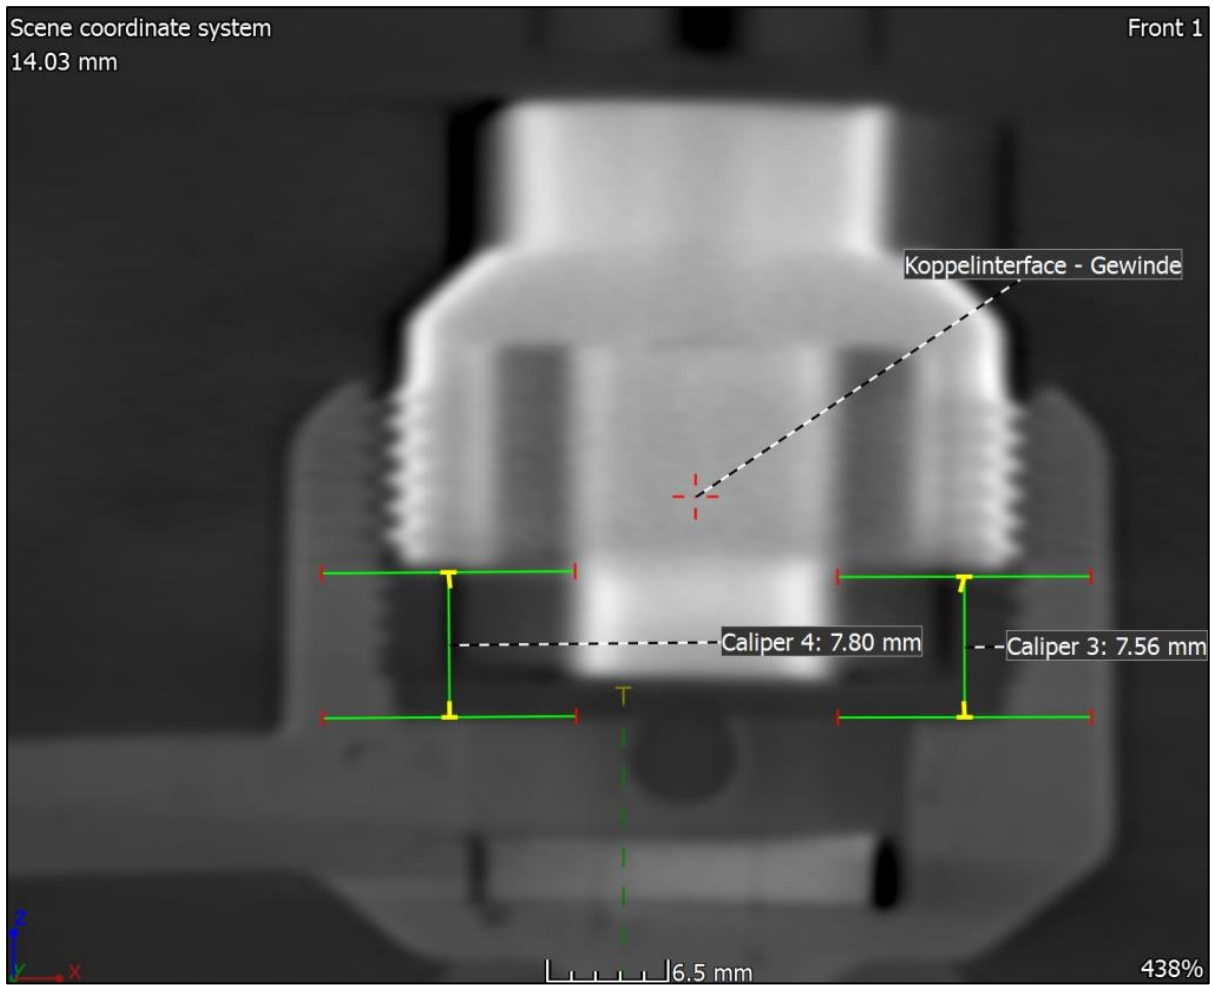
Both valves were subjected to non-destructive testing using computer tomography so as to determine their functional performance. It was evident from the threaded connection between the control unit and the pipe valve (referred to as the coupling interface in Figure 28) that the valve (immediately to the right of the bucket) was not closed. At the same time, the thread guide exhibited a thread misalignment, indicating that the valve was no longer fully functional.

Figure 28: Coupling interface

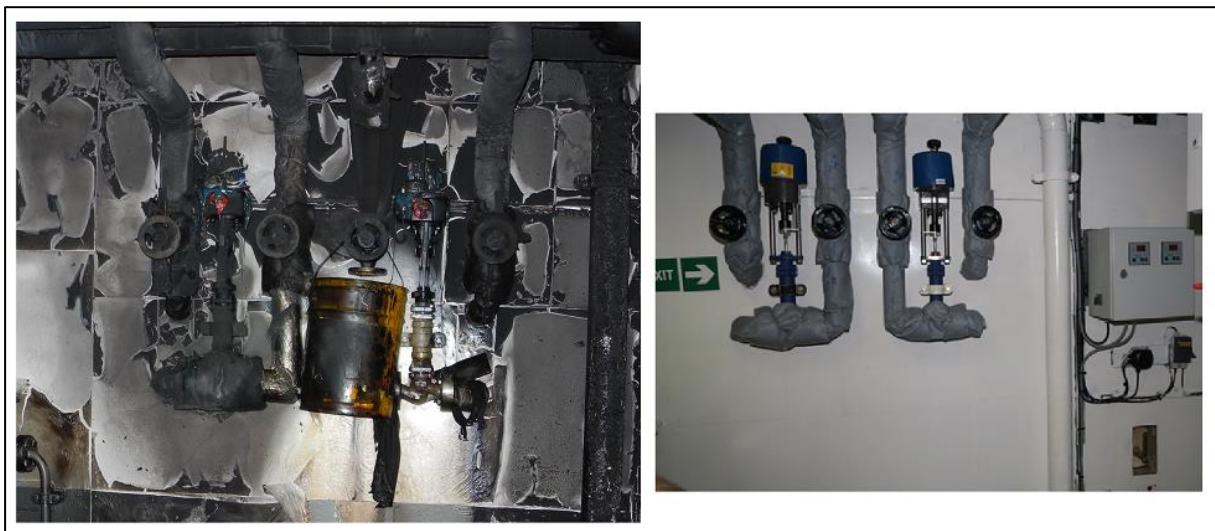
Figure 30: Control valves after the accident on the left and after the repair on the right

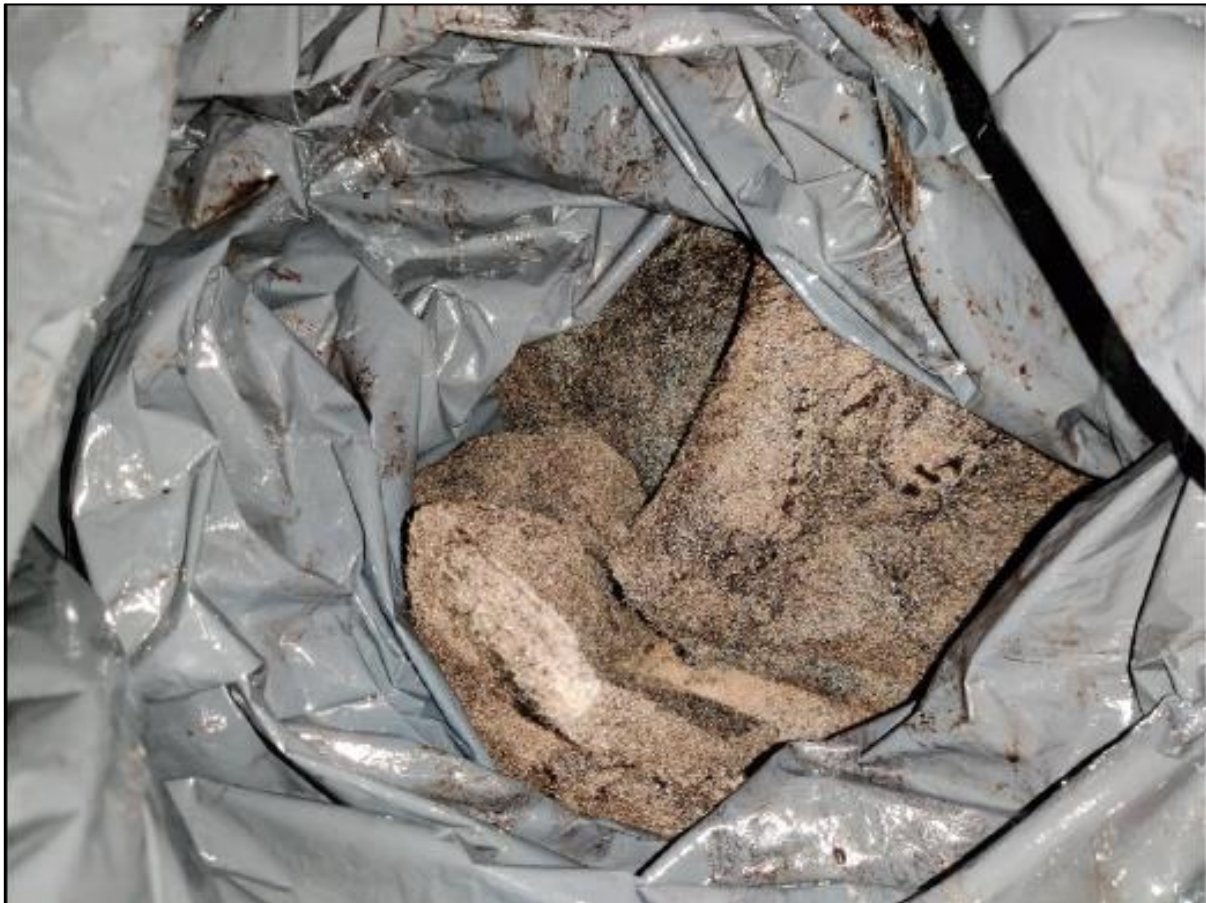
Figure 32: Residues in the filter mats

Since it was apparent that a positive trend in the analyses was not to be expected, the shipping company decided at the end of February 2020 to have the thermal oil system chemically cleaned by GLOBAL BOILER, a company based in Aalborg. This involved connecting a cleaning system to the ship's boiler system and charging it with about 1,300 litres of conventional diesel oil and 300 litres of carbon remover<sup>21</sup>. After allowing this solution to circulate for 15 hours, a further 100 litres of carbon remover were added to optimise the cleaning result. This mixture was then circulated for another 6-8 hours. The result was seen as residues in the filter mats and in the bottom of the cleaning tank. The company recommended that the system be flushed thoroughly to remove any diesel or chemical residues. It was also recommended that the thermal oil be tested (or analysed) regularly after the cleaning procedure. The BSU is not aware of whether and with what result this was carried out.
