Bundesstelle für Seeunfalluntersuchung
Federal Bureau of Maritime Casualty Investigation
Federal Higher Authority subordinated to the Federal Ministry
of Transport and Digital Infrastructure

Investigation Report 405/20

**Allision with a quay wall by
the tanker NORTHSEA RATIONAL
in Hamburg
on 25 November 2020**

25 November 2021

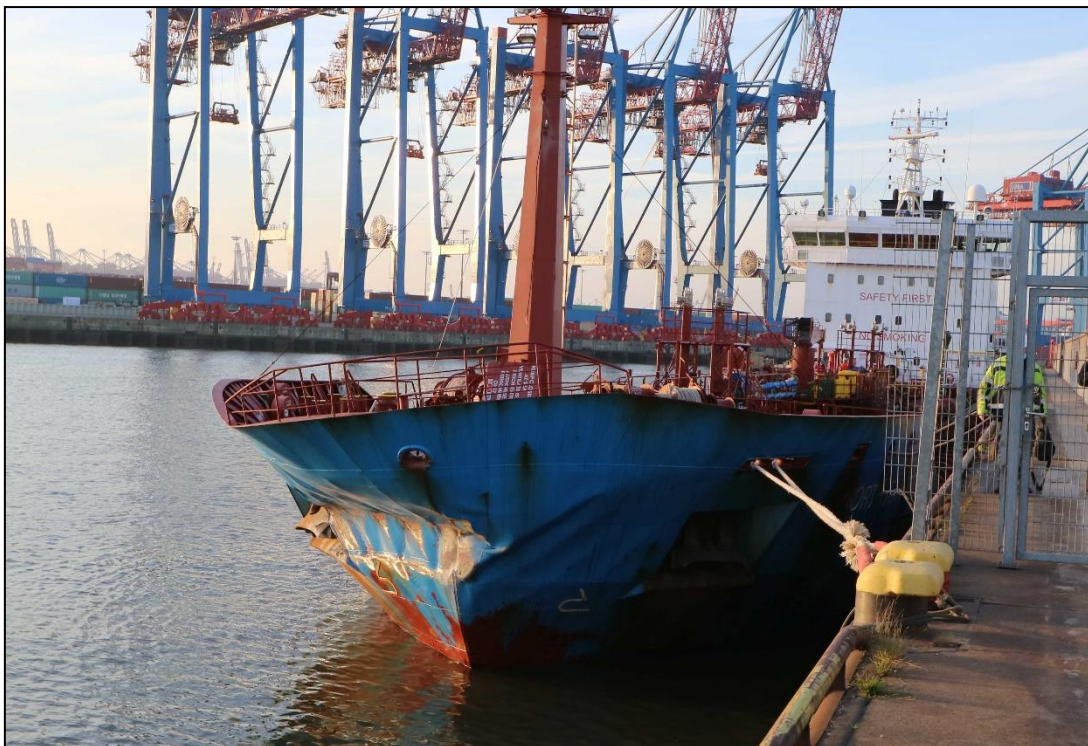
The allision caused heavy damage to the NORTHSEA RATIONAL's forecastle, which made it necessary to call at a shipyard. The quay wall also suffered heavy damage. Nobody was injured and there was no damage to the environment due to the event.

The impact with the quay wall was at an angle of about 60°. Therefore, most of the damage to the ship was on the starboard side of her bow.

Figure 3: NORTHSEA RATIONAL – damage to the bow after the allision

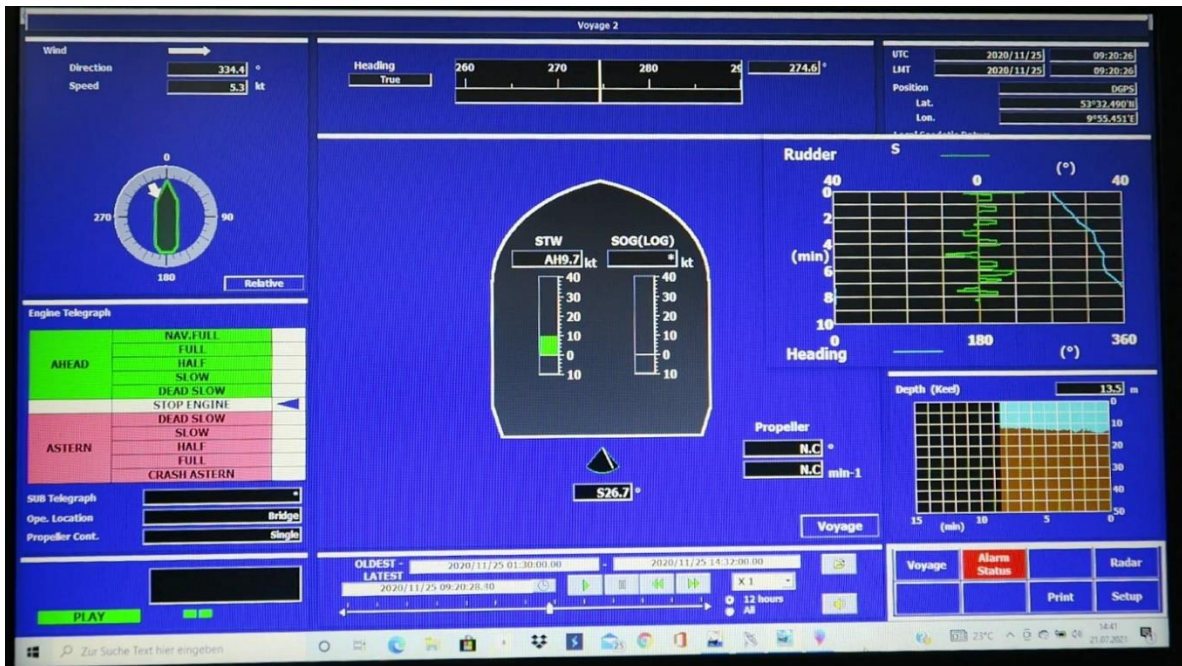
Figure 4: Still frame from the VDR playback at 102028

Figure 4 gives an impression of how the playback software presents the data. The figure shows the point at which the rudder position to starboard was at its greatest (26.7°). The STW is 9.7 kts.

Time at which the rudder position to starboard was at its greatest after the malfunctioning of the steering gear control system.

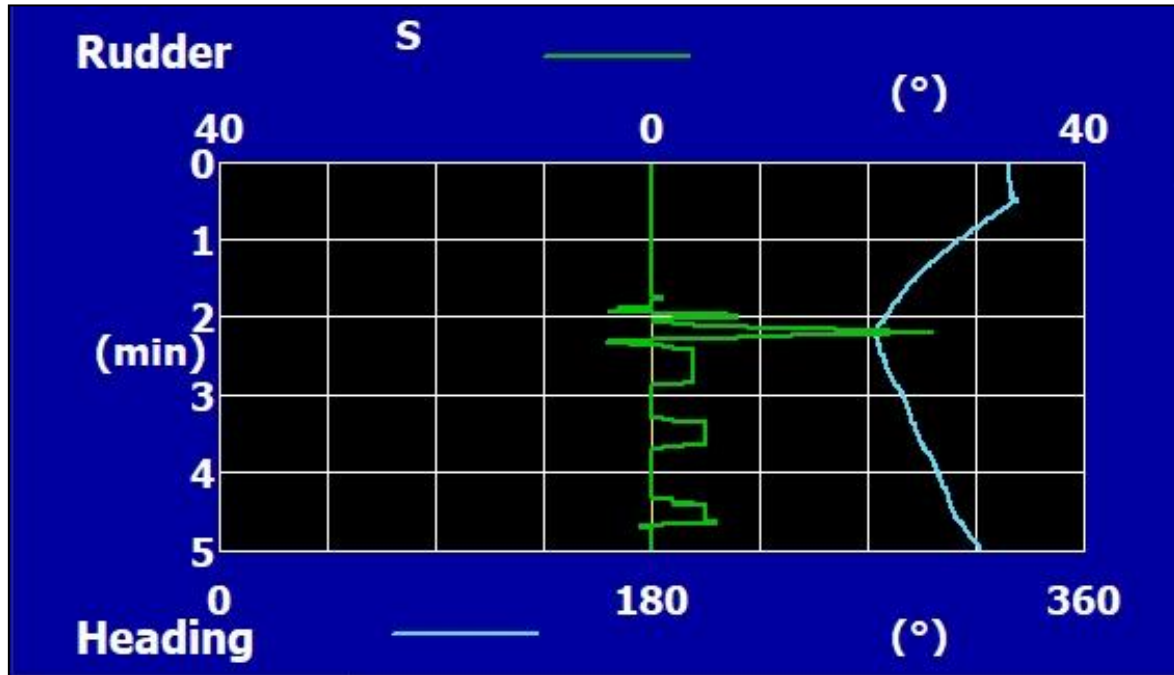
to starboard, another smaller deflection to starboard (about 8°) followed by a deflection to port (about 4°) were recorded. The rudder then remained in a near-midship position.

Figure 5: Rudder positions and courses about three minutes before and two minutes after the malfunction

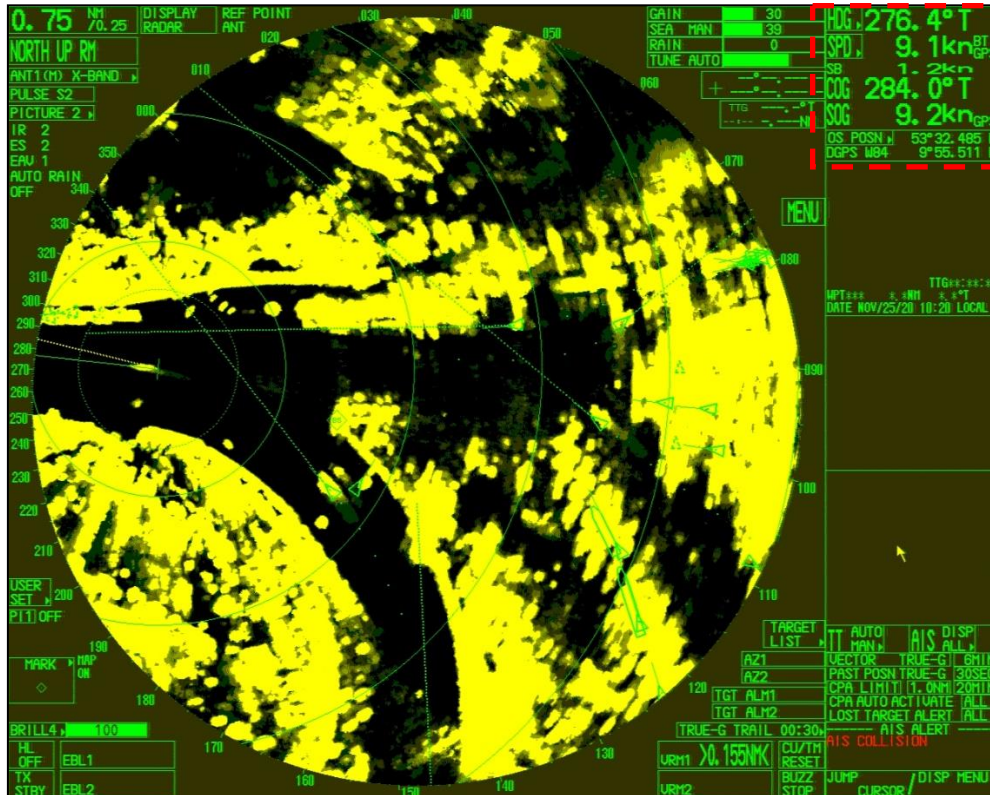
Figure 8: Radar image at 1020, first image
Radar image at about the time of the malfunction.

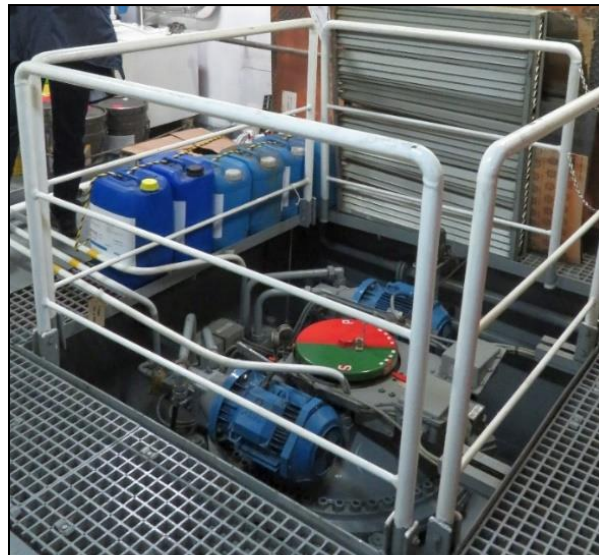
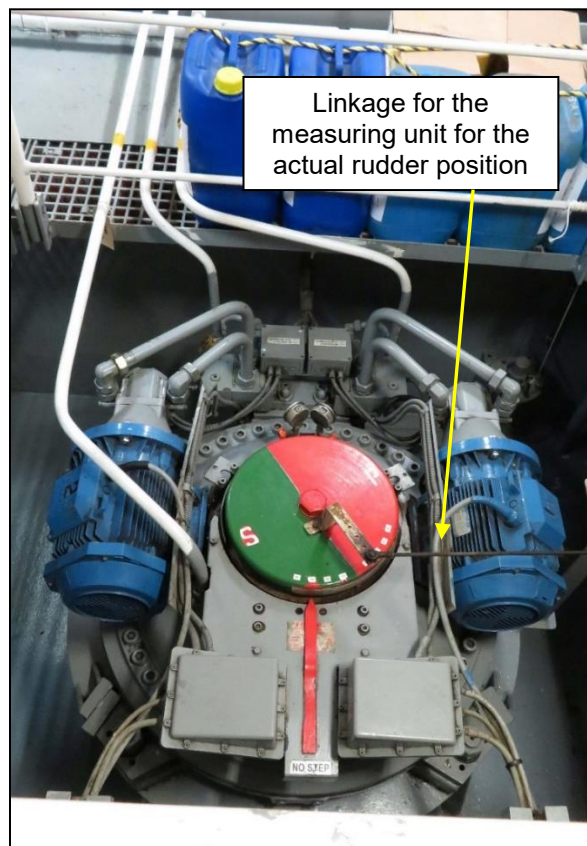
"In the present case, the hydraulic pump units are mounted in a compact manner on the steering gear's housing (see Figures 12 and 13). In accordance with class design regulations, two identical pump units, hydraulically connected in parallel, are provided for reasons of redundancy. The hydraulic system is a closed, controlled circuit, i.e., the
