Bundesstelle für Seeunfalluntersuchung
Federal Bureau of Maritime Casualty Investigation
Federal Higher Authority subordinated to the Federal Ministry
of Transport and Digital Infrastructure

Investigation Report 452/19

Very Serious Marine Casualty

**Accident with subsequent Loss of Life
on board SAJIR
in the Roadstead off Ningbo (China)
on 19 December 2019**

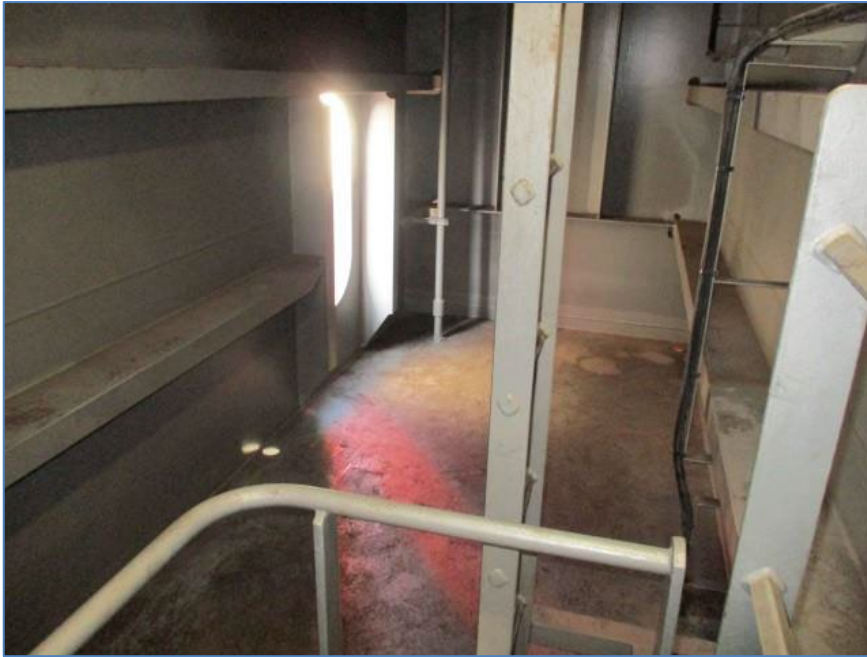
Figure 3: Entrance Area of Cargo Hold No. 9 level with the Manhole¹⁵

The able seafarer saw the bosun climb from one of the transverse corridors through an unsecured manhole into the aft section of cargo hold no. 9, meaning he was no longer visible.

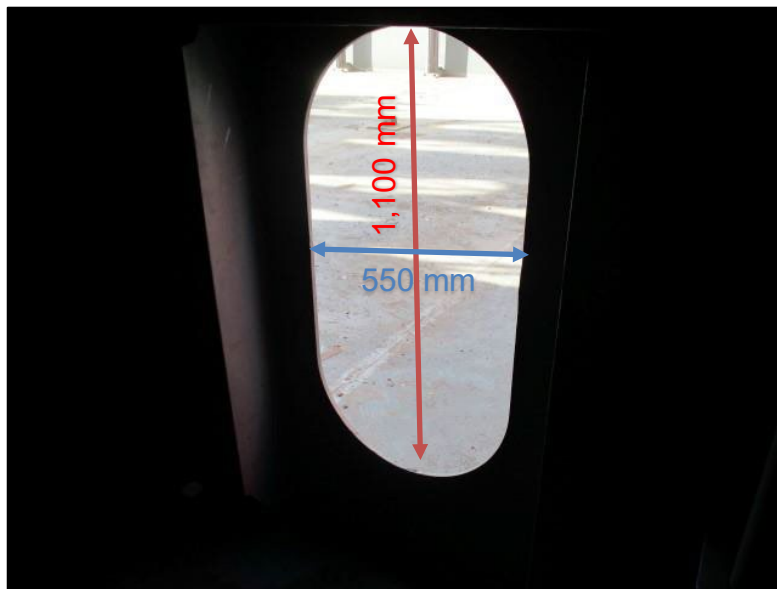
Figure 4: Manhole¹⁶

This part of the cargo hold was dark because of the closed hatches and lack of illumination. Very little light came from the illuminated entrance area of the transverse bulkhead through the manhole into the cargo hold.

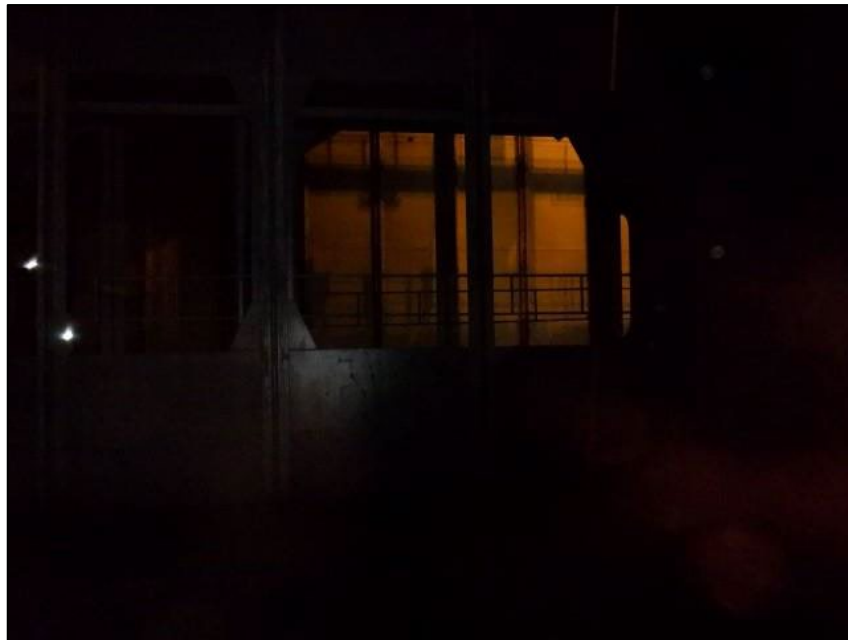
Figure 5: Light available with closed Hatch Covers and reduced Daylight¹⁷

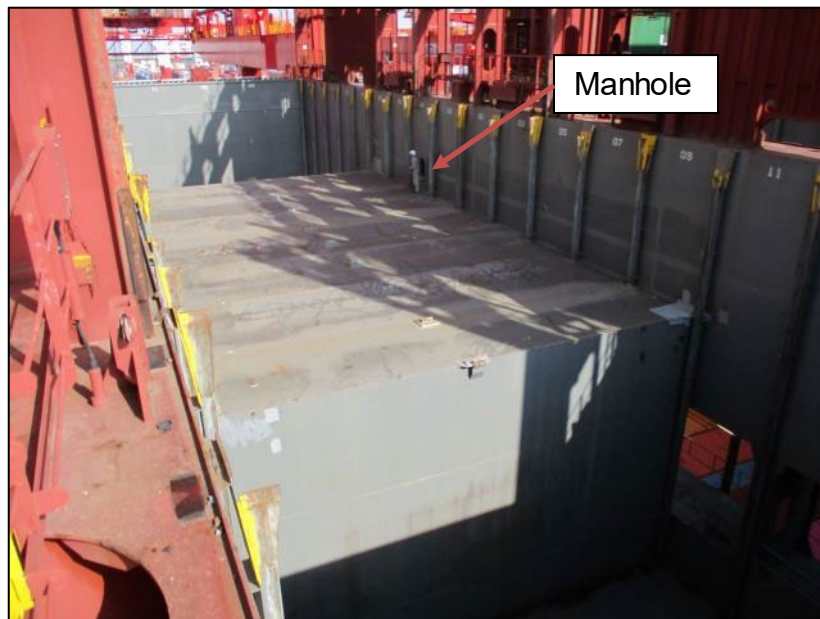
The manhole led the bosun to the upper side of the engine room's box-shaped enclosure, which was nearly 8 m in height and did not offer any protection against falling at its edges.

Figure 6: View of the Enclosure from the Starboard Side with open Hatch Cover¹⁸

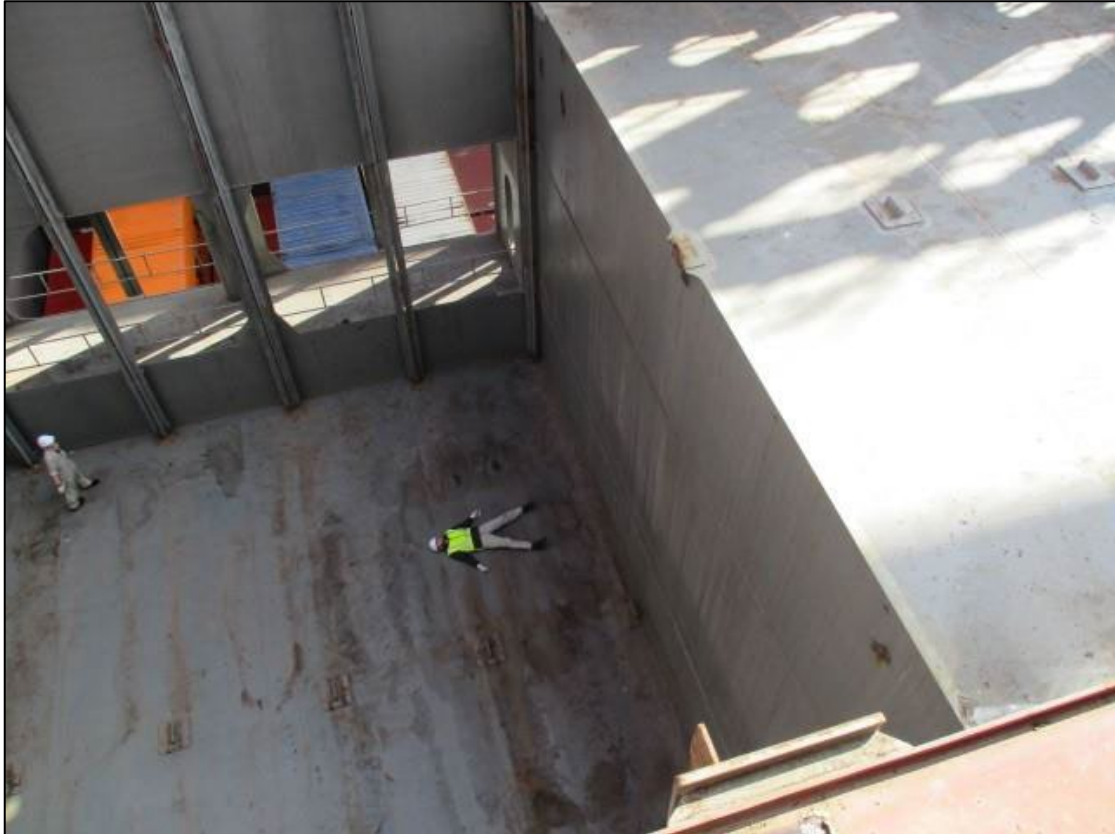
onto the enclosure and carefully went to the edge of it. He saw the bosun on the port side lying on his back on the floor of the cargo hold, which was nearly eight metres lower.

Figure 7: Reconstructed Scene showing Position of the Bosun as he was found¹⁹

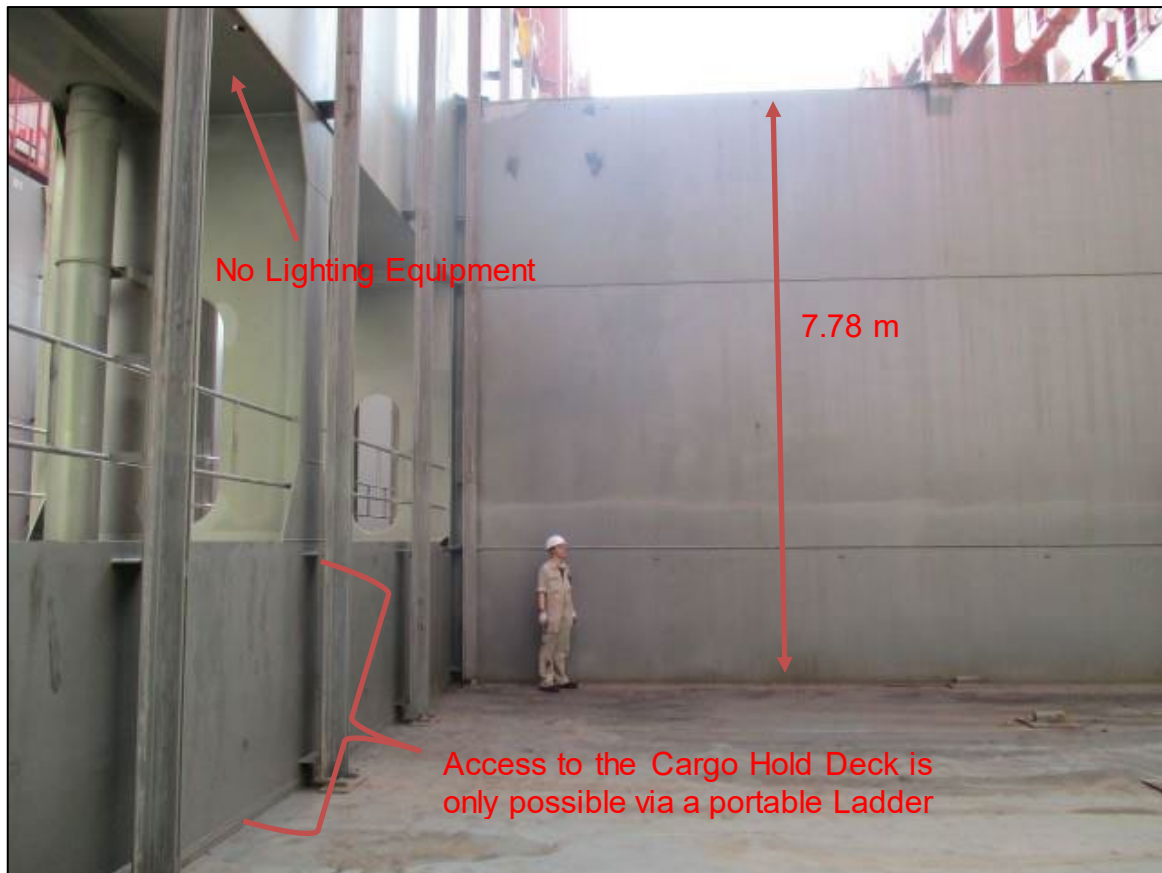
The fall from a height was caused by an unsecured access point to an unilluminated cargo hold, even though – as on comparable ships – a risk of falling from a height does exist there for reasons of ship design.

Figure 8: Height of Fall, Lack of Lighting, Access to the Cargo Hold Deck²⁰

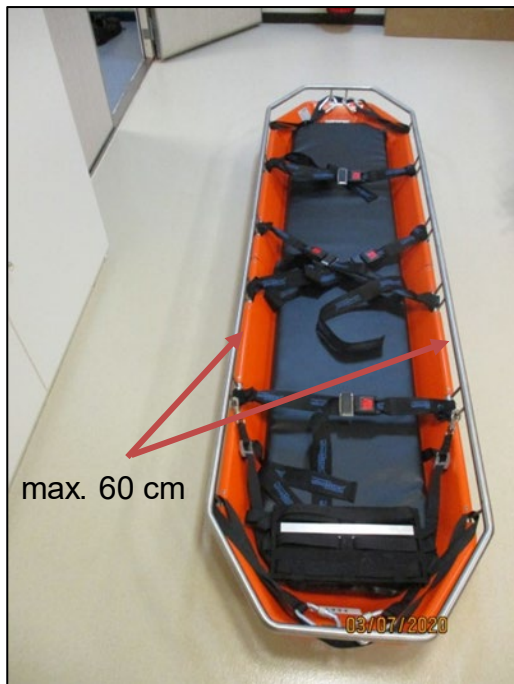
Figure 14: Rescue Stretcher – Width⁴⁹

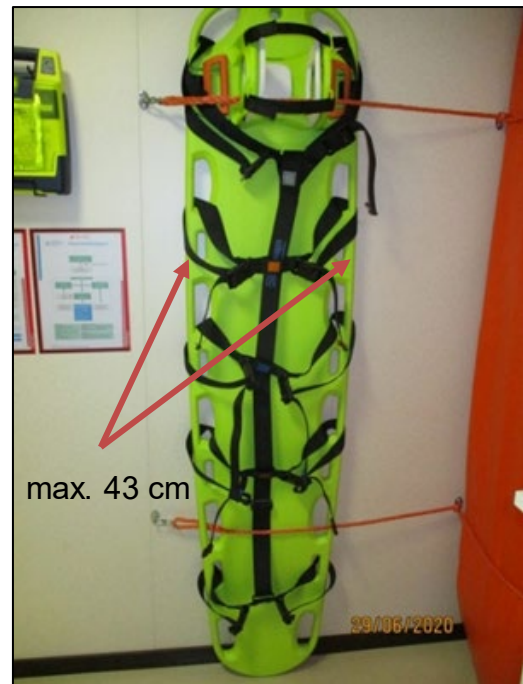
Figure 15: Spineboard – Width⁵⁰

While speaking with the BSU, the chief mate reported that the bosun, who was secured on the spineboard, slipped downward a little due to lack of support during the vertical transport from the cargo hold floor to the enclosure and complained of pain. In the light of the negative experience of crew members, the advantages and disadvantages of the two means of transport are examined in greater detail in this investigation with a view to identifying recommendations for improvement where appropriate.

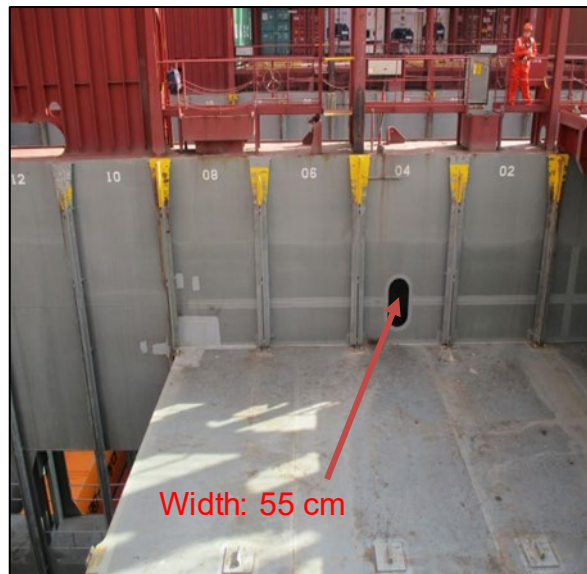
The width of the access to cargo hold no. 9 in the upper platform area was 55 cm.

Figure 19: Access to Cargo Hold No. 9⁵⁴

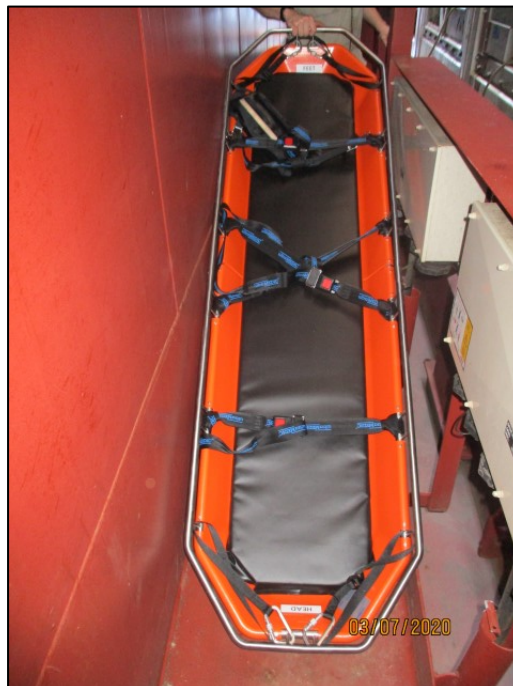
Freedom of movement would have been restricted on deck, too, if a rescue stretcher had been used.

Figure 20: Rescue Stretcher in the Side Passage⁵⁵

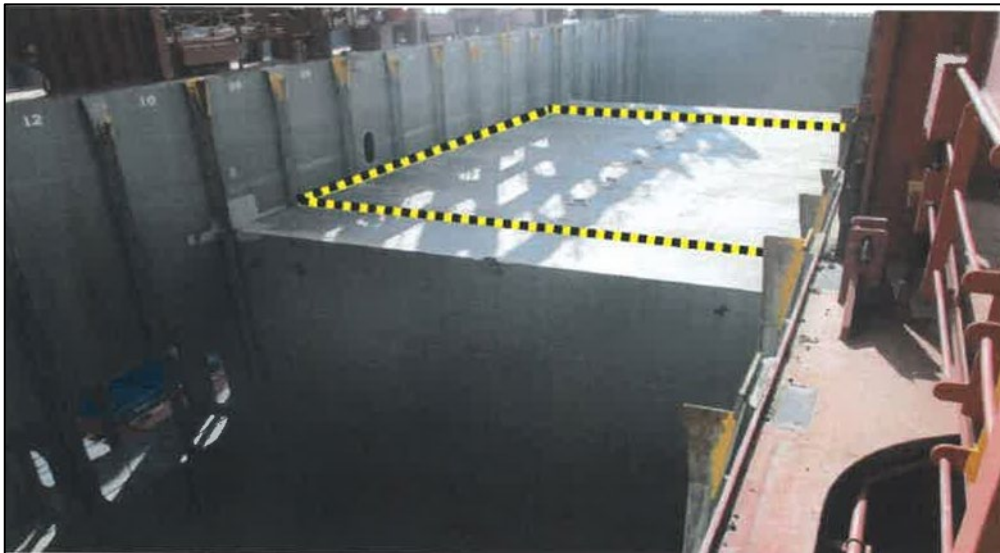
Figure 25: Fleet Circular showing Markings to warn of a Fall Hazard⁷⁷

The ship operator investigated the fatal occupational accident internally and initiated a number of measures to prevent similar accidents with a fleet circular on 22 January 2020 (see Annex 9.6).

Cargo holds with enclosures around part of the engine room and with the deckhouse located far forward separate from the machinery, as on SAJIR, can also be found on other ULCSs belonging to the fleet. They include ten Hamburg Express class ships and five Valparaiso Express class ships. On these ships, any access point that has an area with a fall hazard behind it had to be secured and areas with a fall hazard had to be identified immediately.

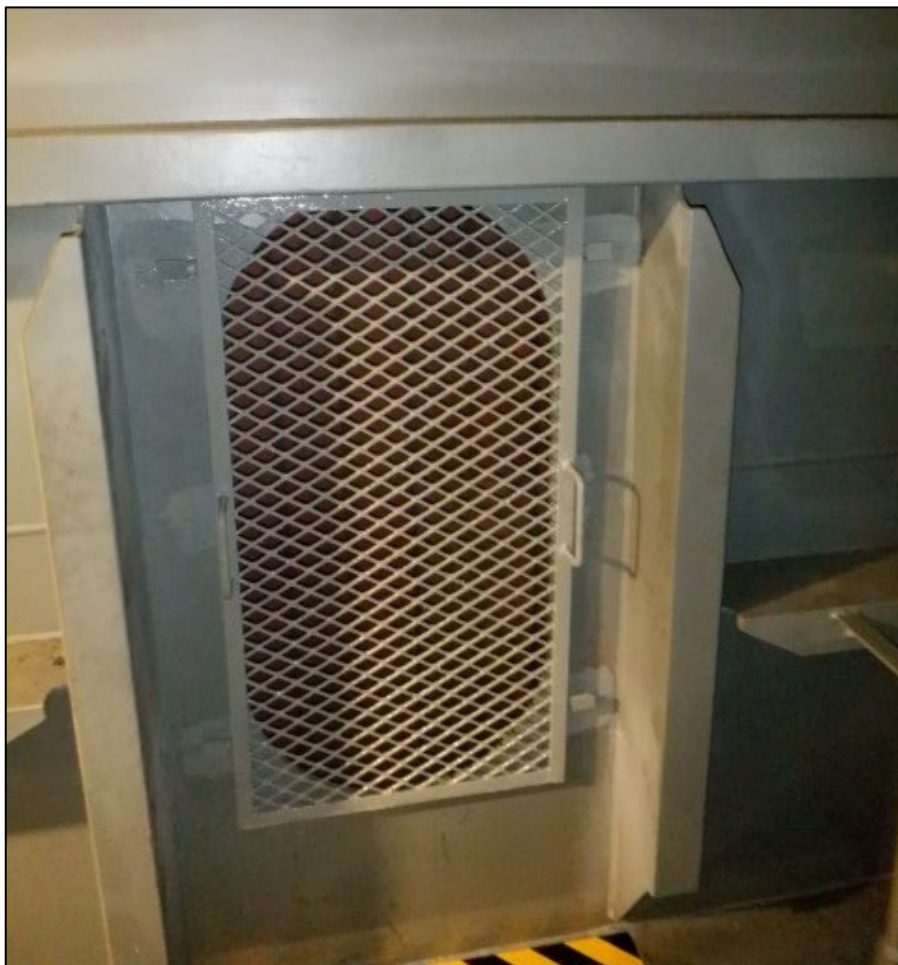
Figure 26: Secured Access to Cargo Hold with a Risk of Falling⁷⁸

The BSU's investigators found that the following measures had been implemented when they carried out the inspection on 27 January 2020:

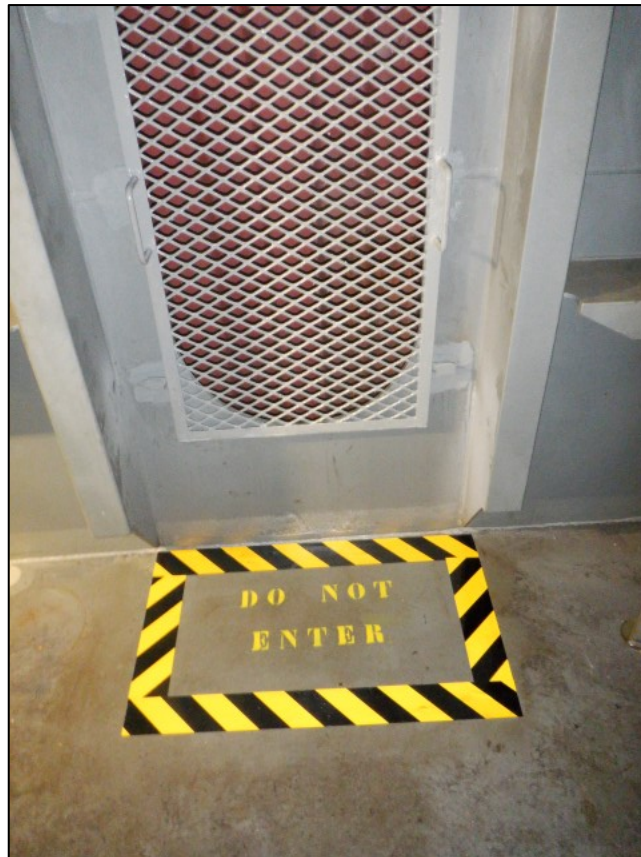
Figure 27: Warning in front of Access⁷⁹

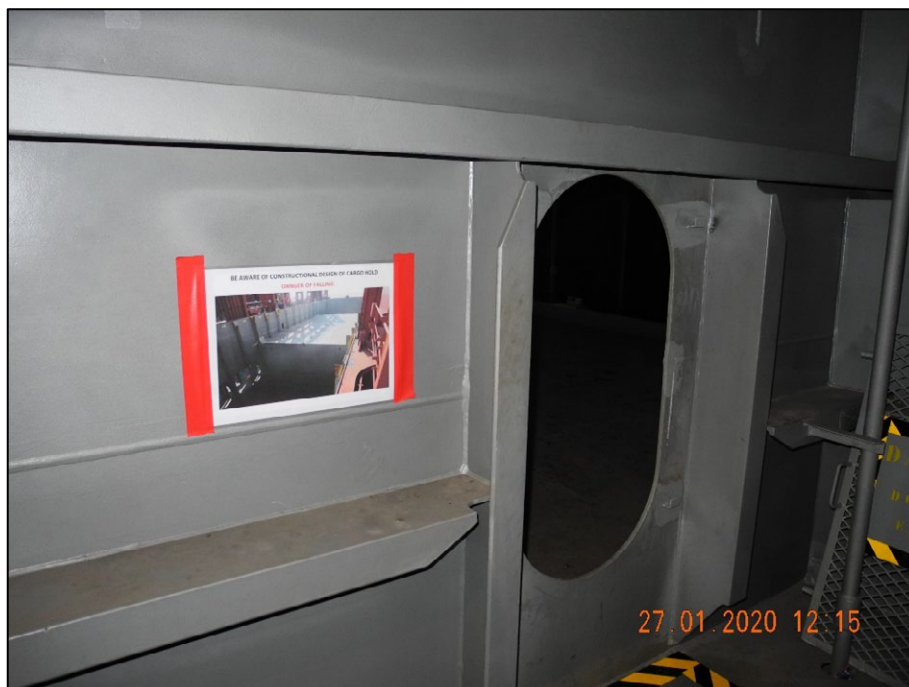
Figure 28: Photograph showing the actual Risk of Falling⁸⁰

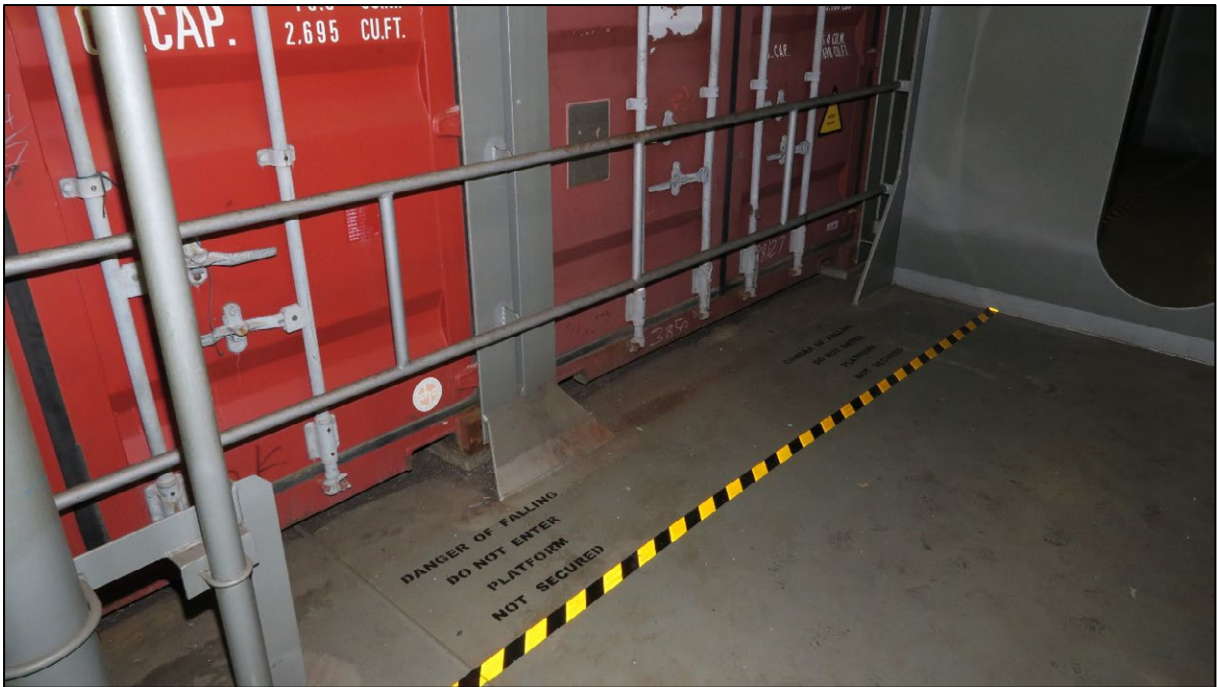
Figure 29: Another Part of SAJIR with Fall Protection⁸¹

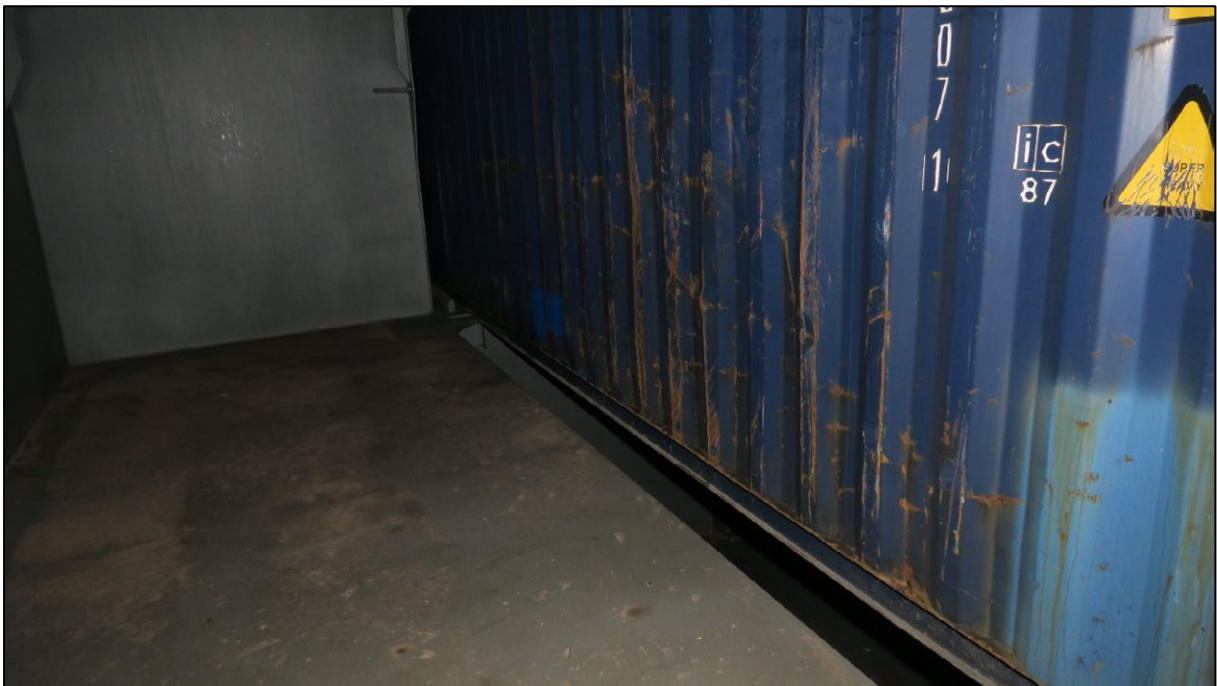
Figure 30: Area that has yet to have Fall Protection applied⁸²
