Investigation Report 74/20

Less Serious Marine Casualty

**Catamaran SEEWIND I suddenly pitches
into a wave in the North Sea
with ensuing physical
injuries and damage
on 3 July 2020**

1 July 2021

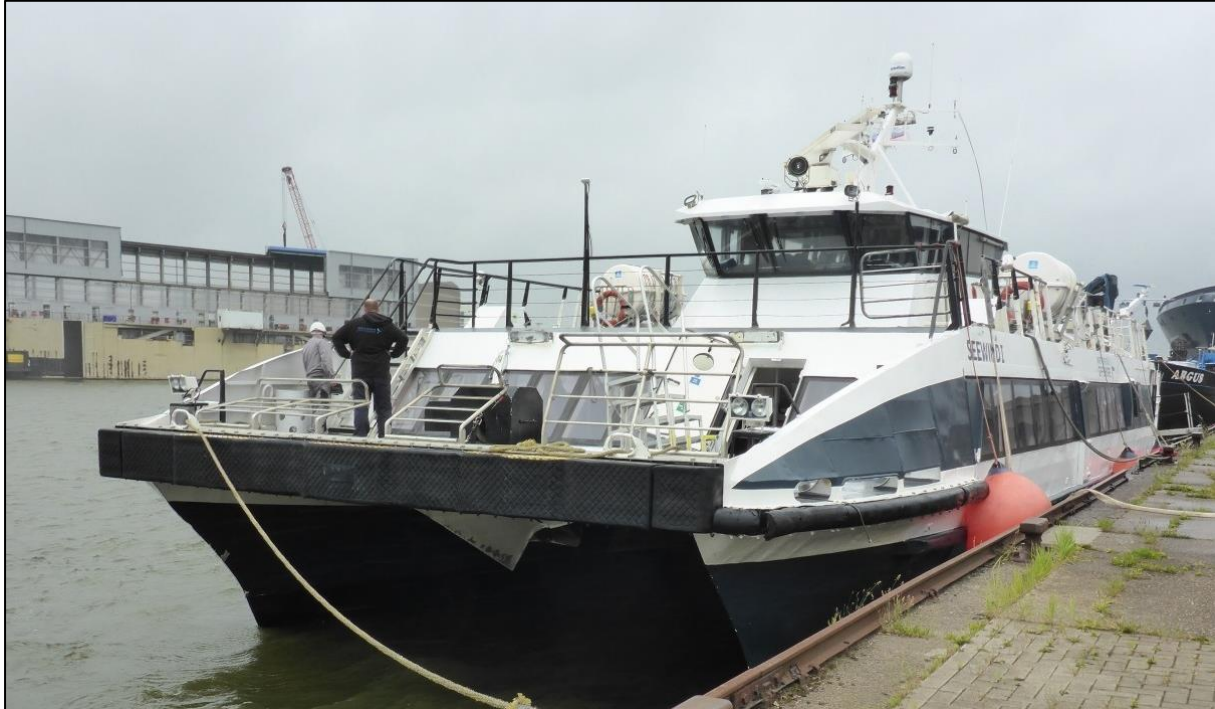
Figure 1: SEEWIND I after the accident²

The SEEWIND I suffered minor damage as a result of plunging into the wave. This was mainly at the bow of the ship, where railings had buckled and some steps on the companionway between the foredeck and bridge deck had parted from their supports. Further damage occurred to another ladder and the deck lighting.

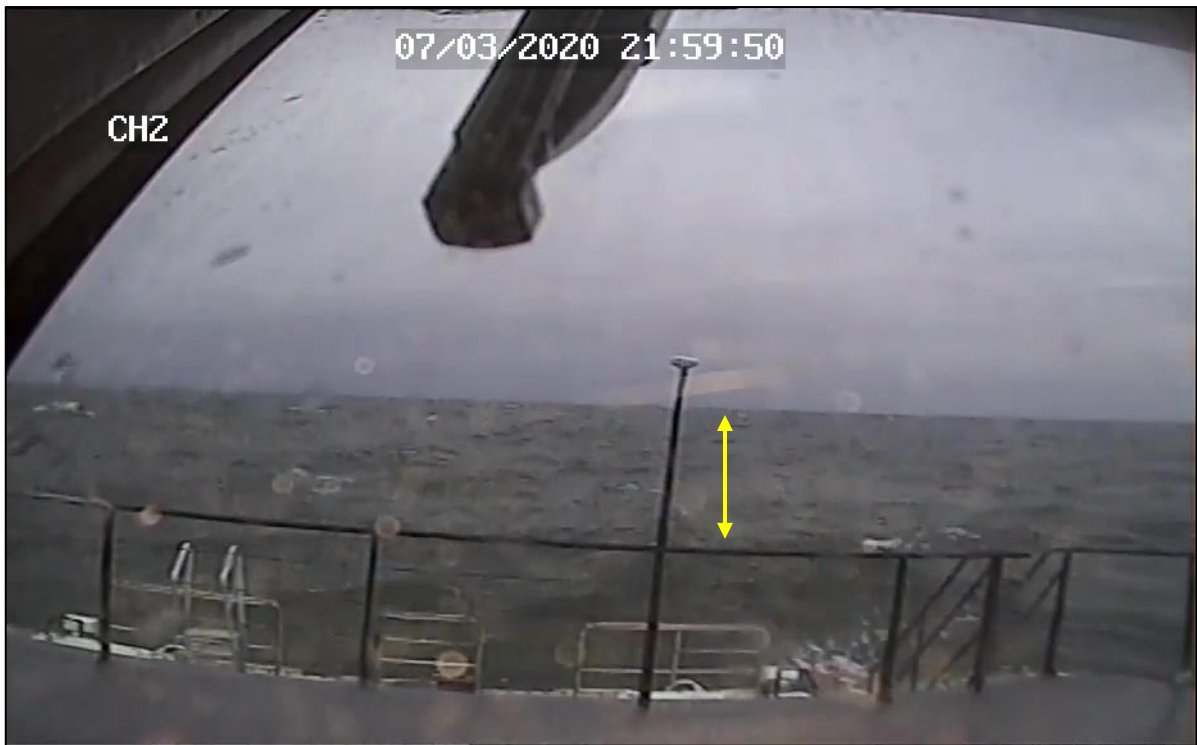
At 215950, the SEEWIND I entered a wave system that had not occurred previously. This appeared to be longer and steeper. As a result, the bow initially dropped further and had not yet risen again when the vessel sailed into the next wave crest (Figures 13, 14 and 15). The SEEWIND I then sailed into this subsequent wave hard at almost 26 kts and stopped abruptly.

Figure 13: Front camera screenshot at 215950
The bow drops further than usual (see also Figure 12).

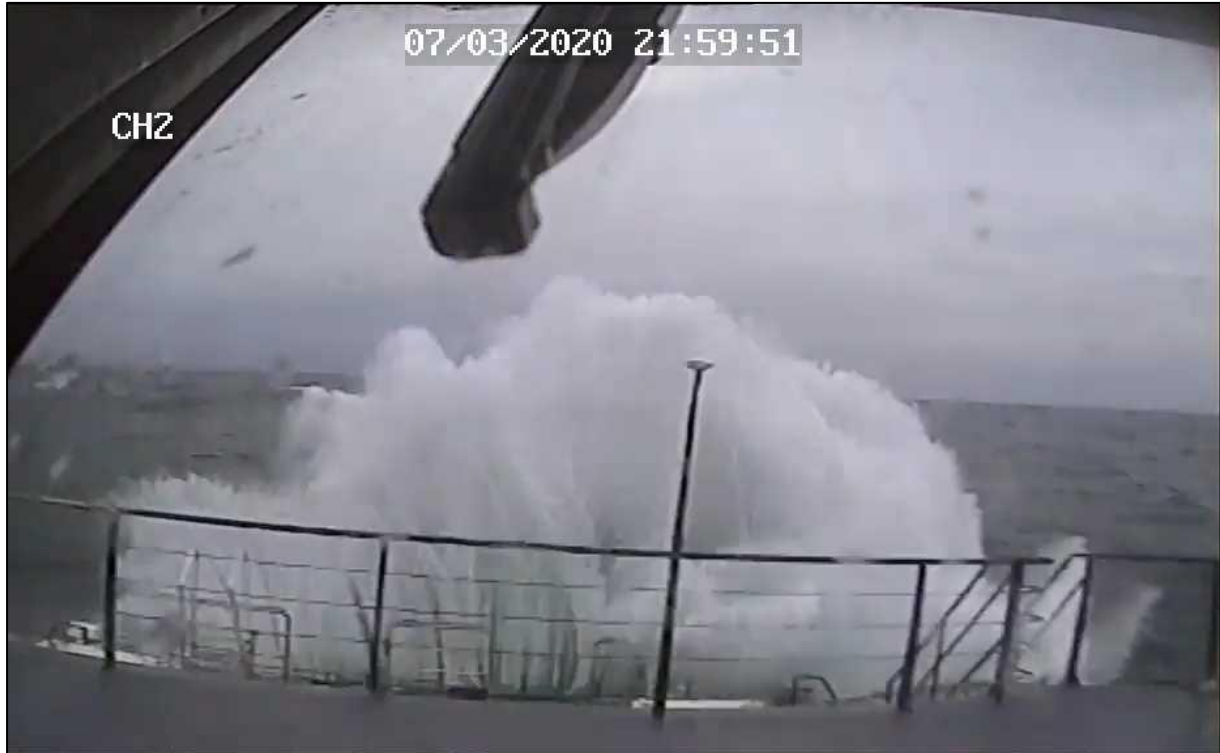
Figure 14: Front camera screenshot at 215802
The SEEWIND I sails into the next wave crest.

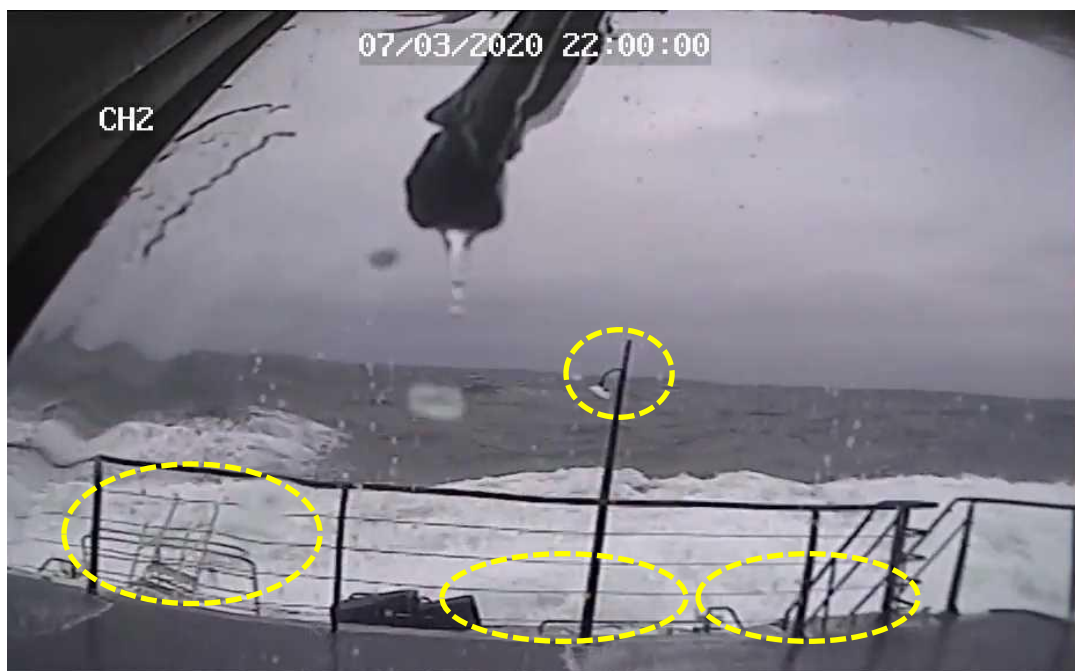
Figure 16: Front camera screenshot at 220000

Visible damage to the bow rail and other components is marked by yellow ovals. See also the previous condition in Figure 13.

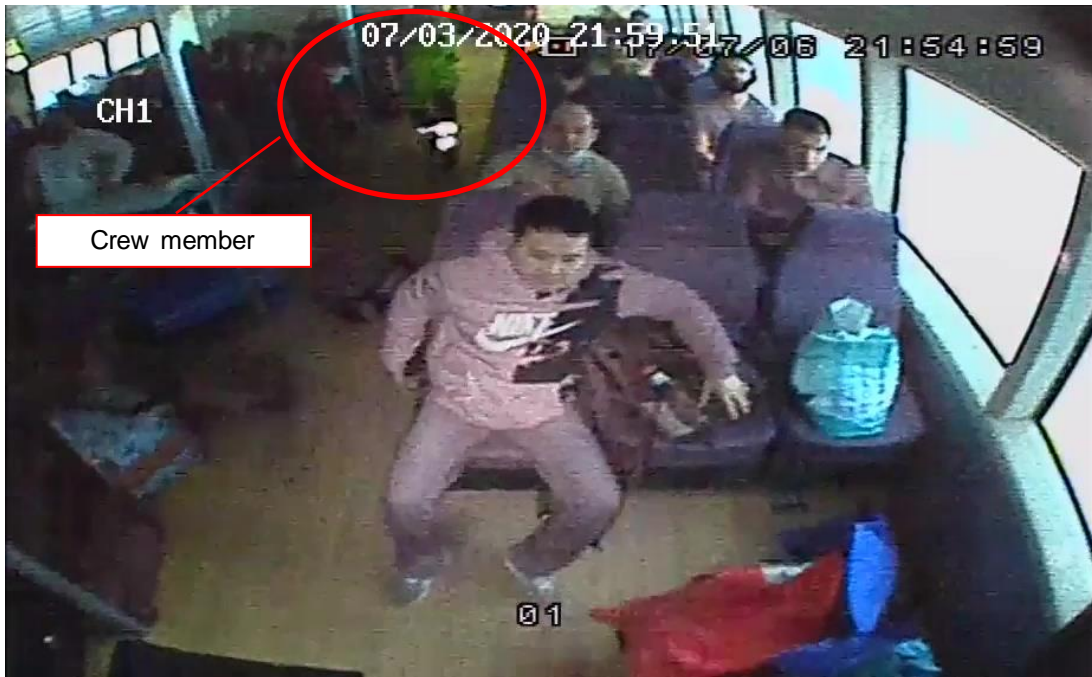
Figure 18: The SEEWIND I's passenger compartment at 215951

According to the time on the recording, the vessel pitched into the wave at 215951. The associated events can be seen in Figure 18. The passenger in the front row lifts off his seat. Passengers with a backrest in front of them have the opportunity use it for support. The crew member in the port aisle cannot counteract the forces he is exposed to and starts to fall forward.

Situation in the passenger compartment when the vessel pitches into the wave. The crew member is in the middle of the aisle on the port side.

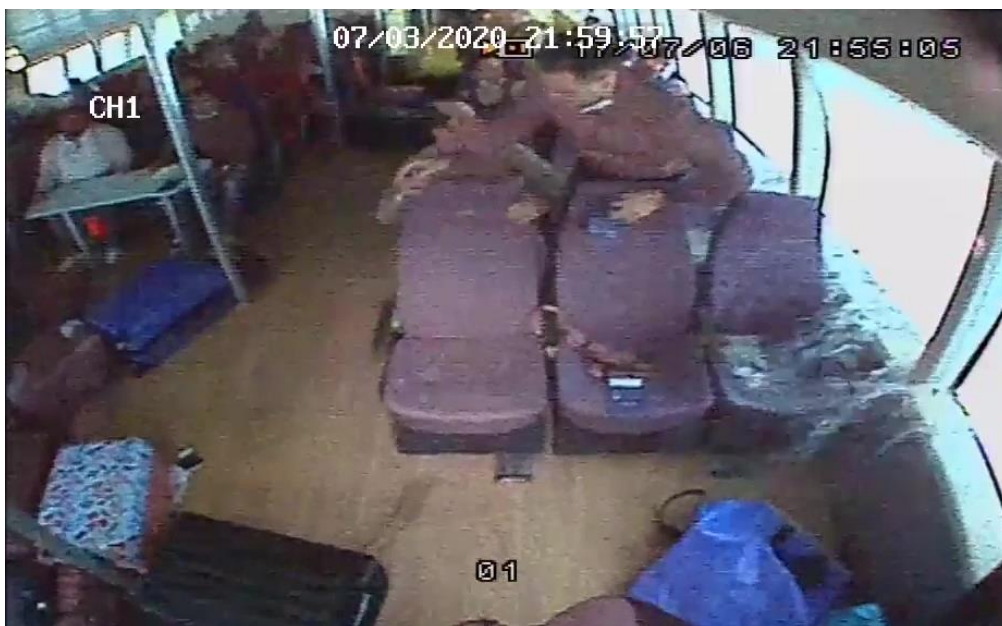
Figure 19: The SEEWIND I's passenger compartment at 215957

Figure 19 shows water entering the passenger compartment through the ventilation apertures. However, the passengers directly affected respond calmly and leave the affected area. The passenger previously seated in the front row has fallen between the items of luggage. Shortly after the time shown, passengers start to attend to the injured crew member.

Water enters the passenger compartment through the forward side windows.

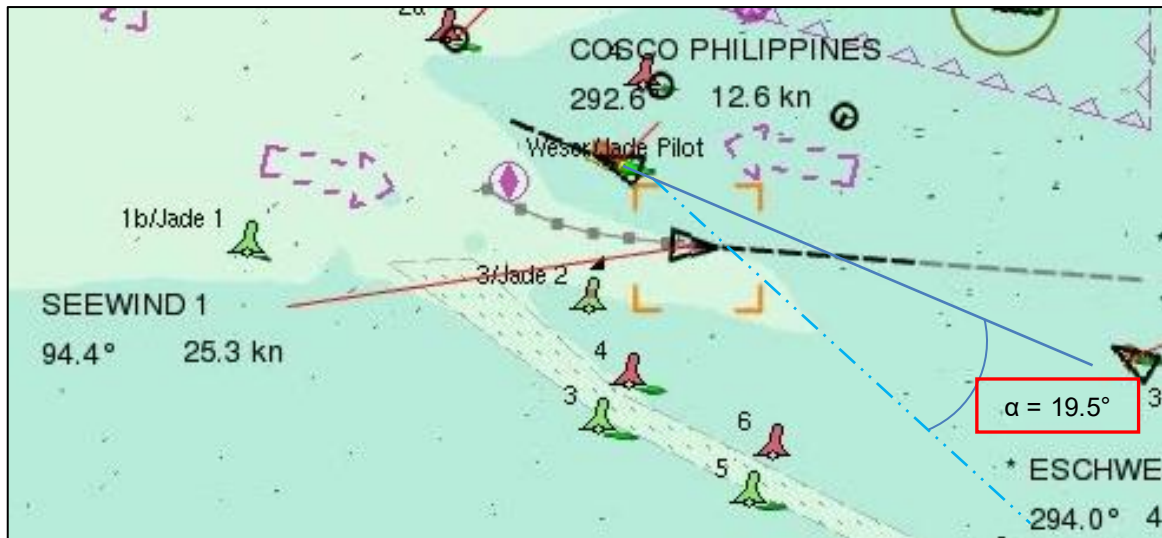
Figure 31: Screenshot at 215800

Based on the recording of the front camera, the BSU investigators believed it was possible that the SEEWIND I had sailed into the wave system (bow and stern wave) caused by the COSCO PHILIPPINES. Both vessels had moved close to one another in the course of the encounter in the fairway.

Course of the COSCO PHILIPPINES is 292.6°, angle of the bow and stern wave on the port side about 312°.

In the opinion of the investigators, the accident was caused by non-observance of the wave system of the COSCO PHILIPPINES.

- it would specify the data and facts to be entered in the deck log book as part of the revision of the safety management manual. This revision should take place in the autumn of 2021. A review of the entries should then also become part of the internal audits within the safety management system²⁷;
- in future there will be a description of the hazards that arise when entering the wave system of another ship and they will also be implemented in the safety management manual. In addition, the shipowner intends to clarify these dangers and the findings of the BSU's investigation in a fleet circular for the ship's commands and in so doing raise their awareness. The fleet circular will be issued as soon as the final version of the marine casualty report is published.
