Summary Investigation Report 415/19

Less Serious Marine Casualty

**Failure of a head line on the chemical tanker
THEMSESTERN
in the Kiel-Holtenau lock on the Kiel Canal (NOK) on
30 November 2019
with three linesmen slightly injured**

23 March 2021

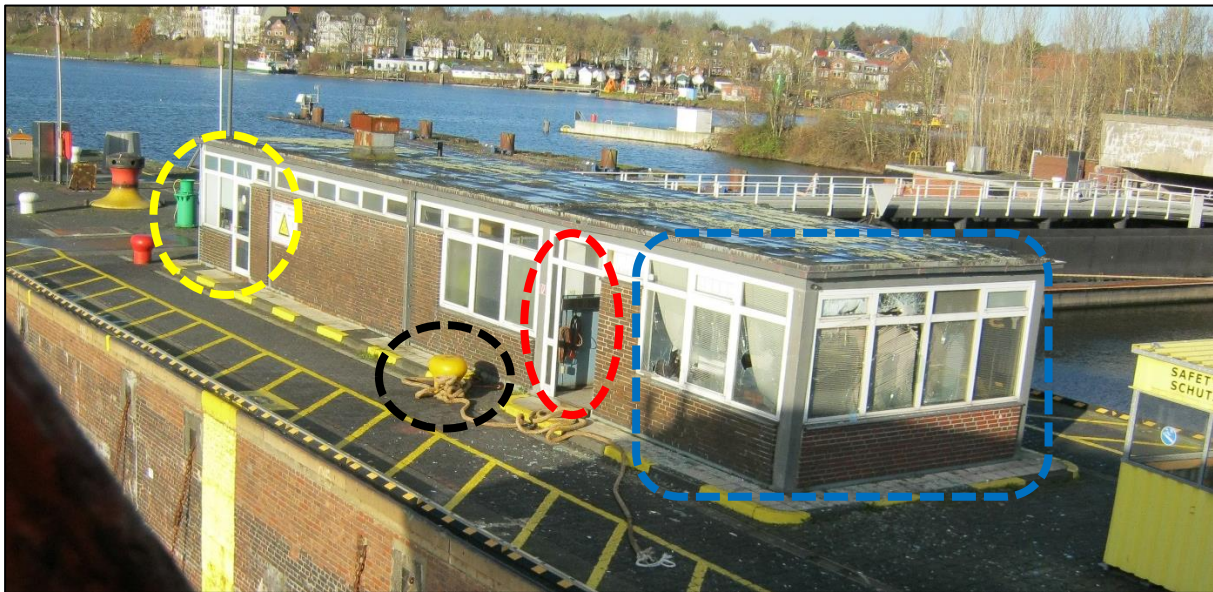
Figure 3: Service building on the lock wall with damaged windows⁵

⁵ The red marking shows the door area of the building where the linesman with an injured leg was standing. The blue marking shows the rest area's partially destroyed windows. The black marking shows the bollard with the end of the head line that was ashore still placed over it. The yellow marking shows the front part of the building, i.e. pointing toward the NOK (workplace of the lock foreman).
Figures 3 to 6 source: Waterway Police (WSP) Kiel.

The WSV has notified the BSU that both the small service building damaged by the line failure on the THEMSESTERN and the ground floor and first floor of the lock control station on the middle wall of the new lock in Kiel-Holtenau have now been fitted with safety glazing. In addition, the glazing of the shelters installed on the lock walls in Kiel-Holtenau and Brunsbüttel was inspected and found to be safe.

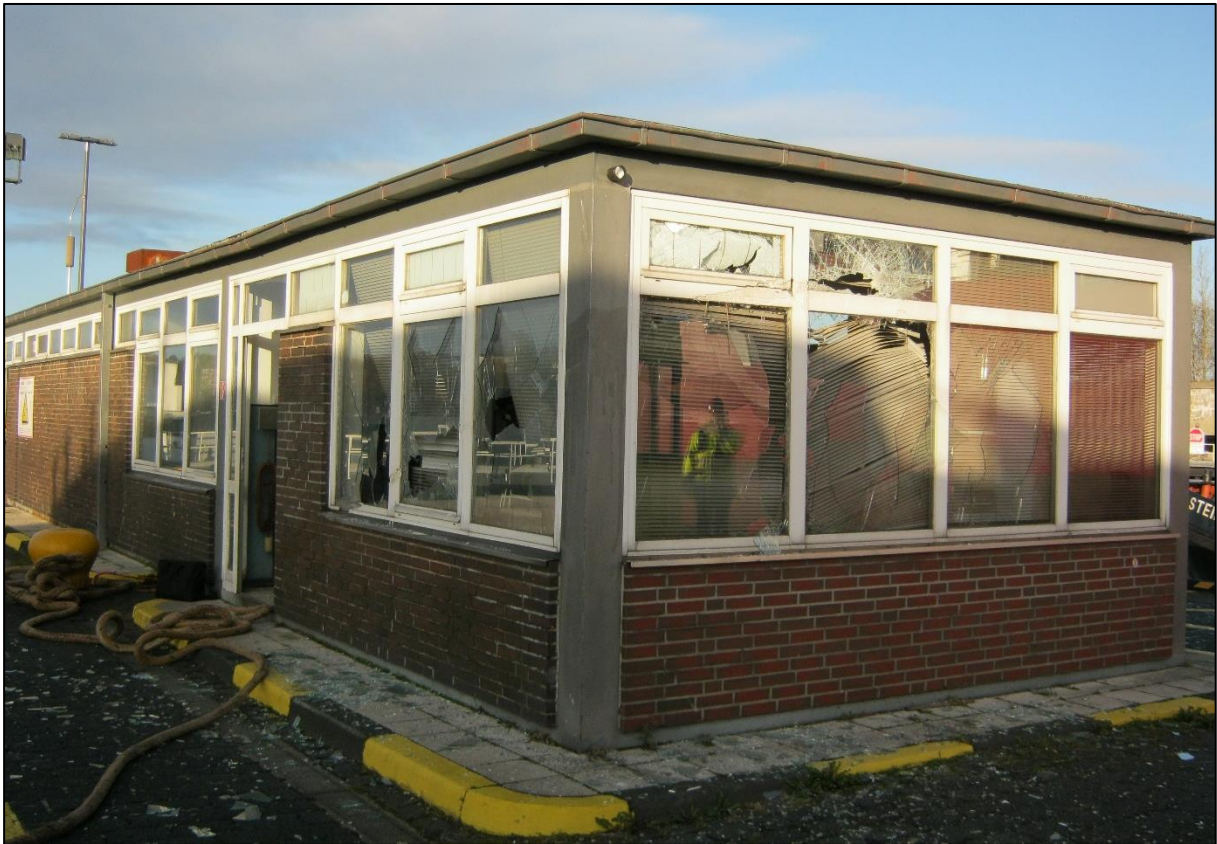
Figure 4: Service building (close-up of the affected part of the building)

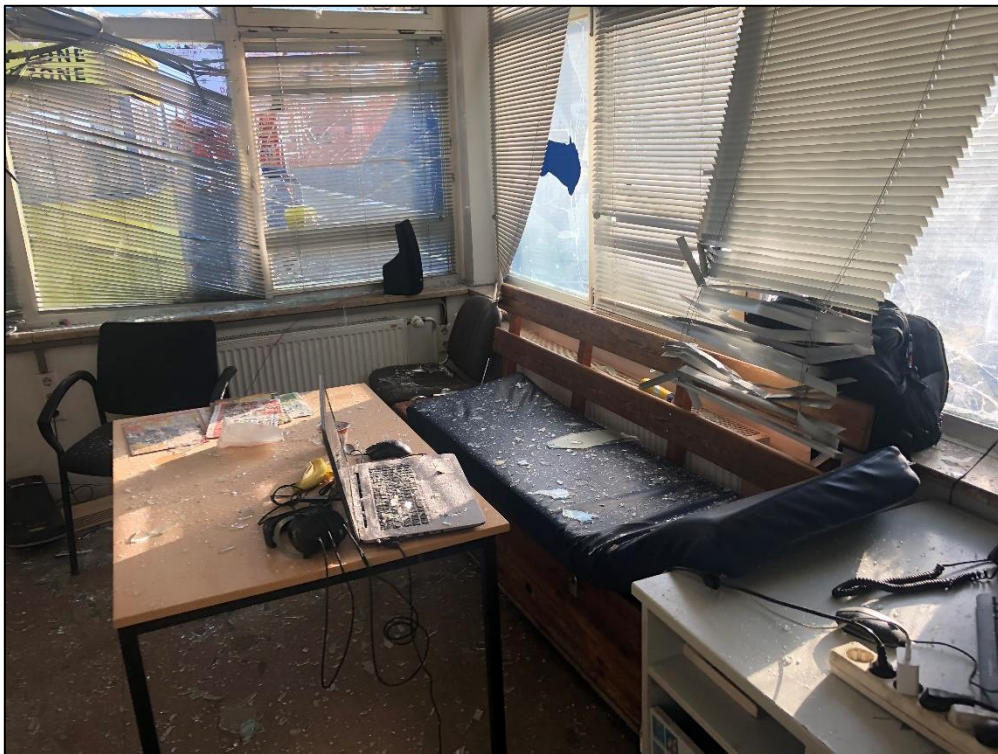
Figure 5: Service building (interior view showing part of the rest area)

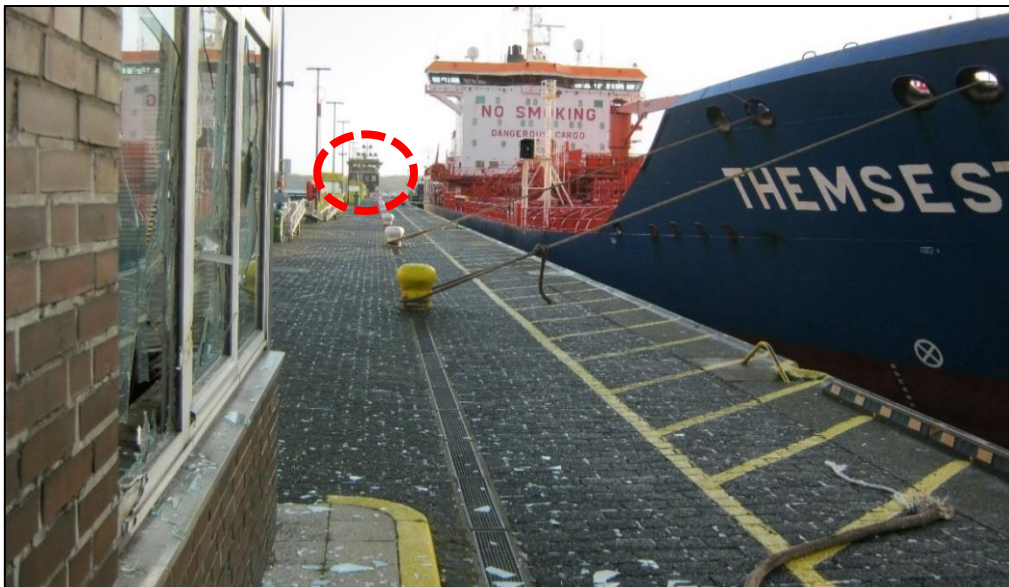
The THEMSESTERN drifted a few metres aft as a result of the sudden failure of the head line. The ship's command and crew members at the manoeuvring stations managed to manoeuvre the ship back to the lock wall very quickly and made her fast again so as to enable the police to investigate. (A loop was temporarily tied at the end of the failed head line that was on the ship and this was used as the new head line.)⁶

Figure 6: The THEMSESTERN after she had been made fast again in the lock⁷

⁷ The red marking shows the main lock building at the other end of the middle wall of the lock, which points toward the Baltic Sea. The end of the failed head line that was ashore is visible in the foreground of the picture.

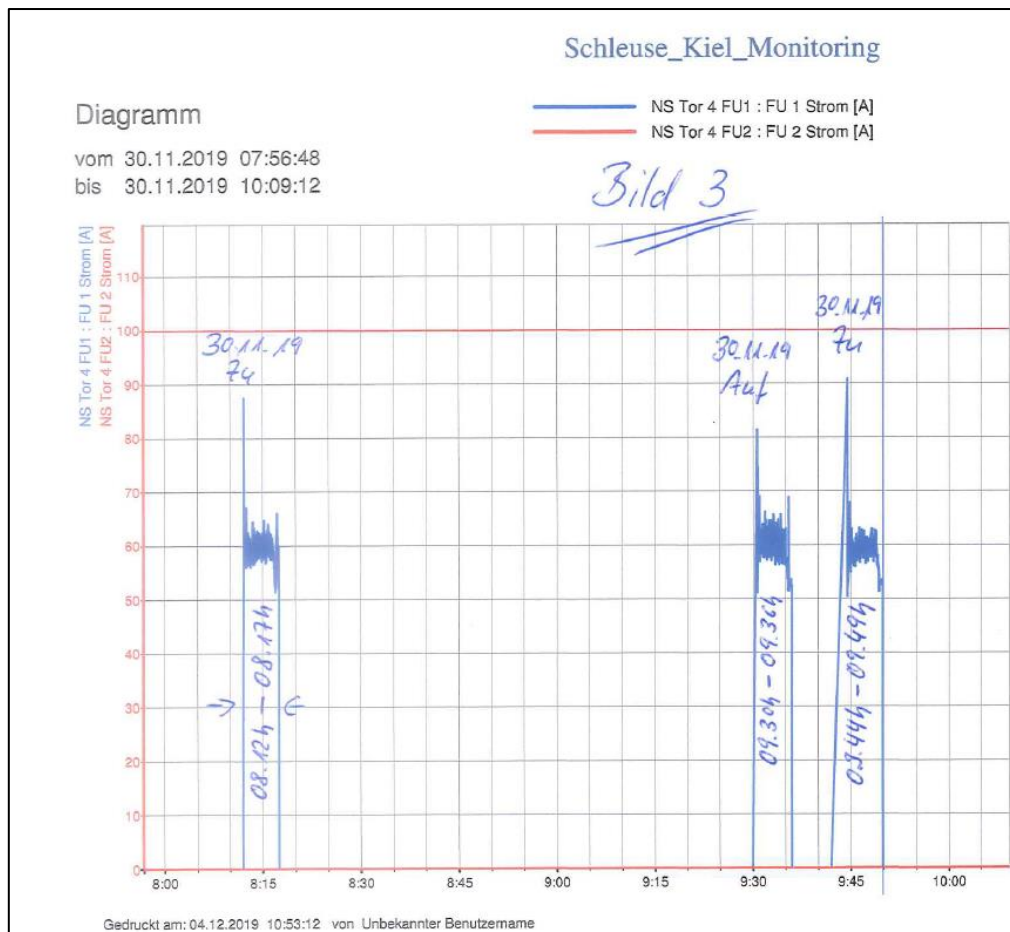
The technical log entries for the lock gate operating times (see relevant extract in **Figure 7**) indicate that the gate through which the THEMSESTERN was to sail for the NOK started and finished opening at **0930** and **0936**, respectively.

Figure 7: Extract from log of lock gate operating times¹²

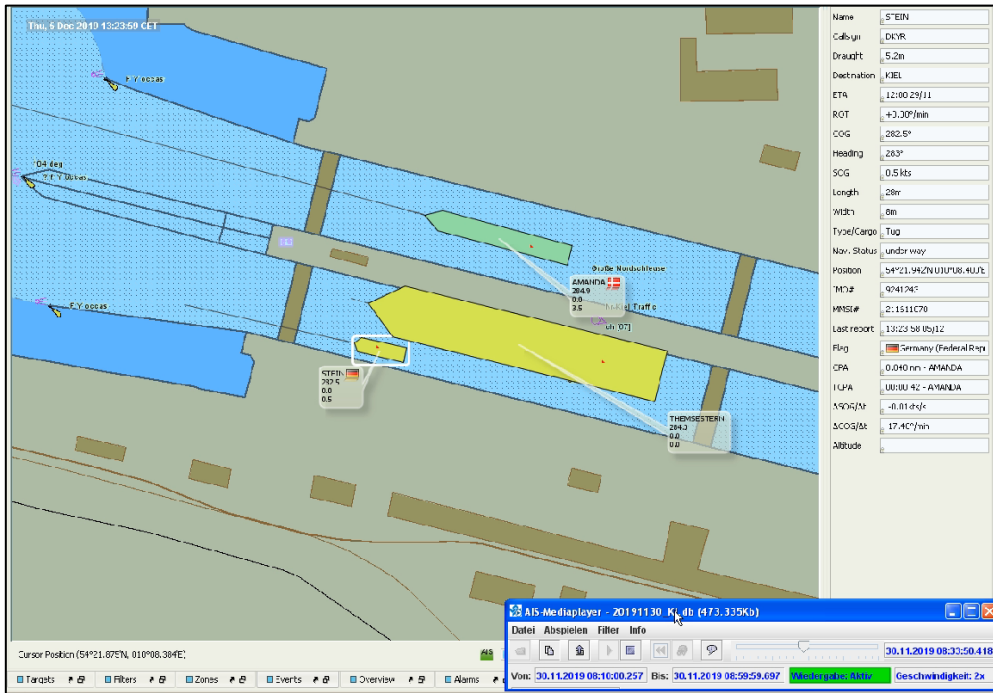
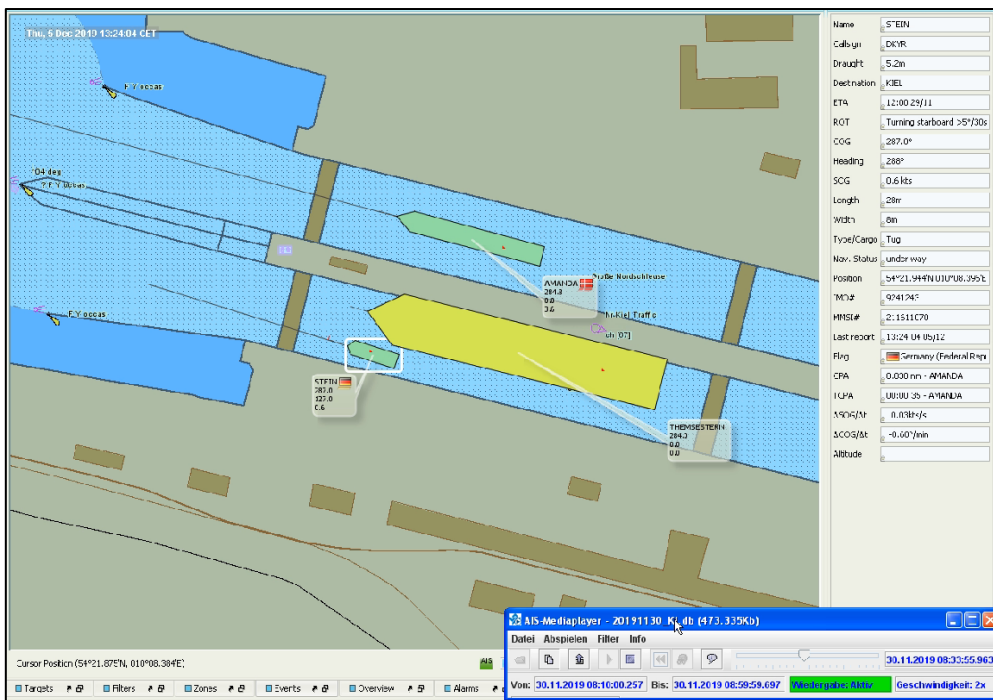
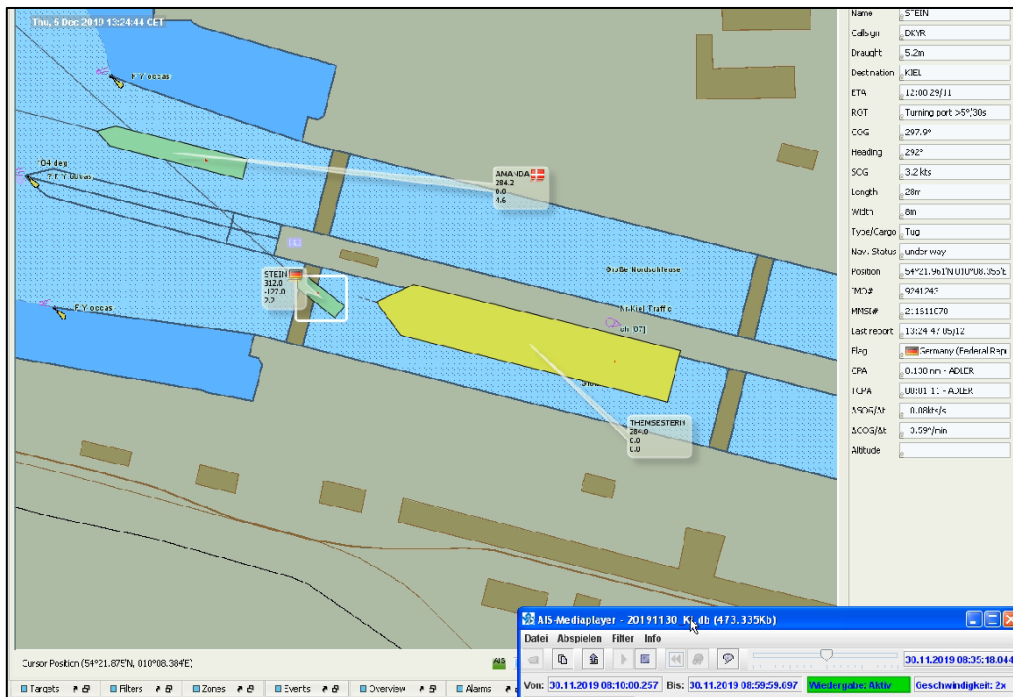
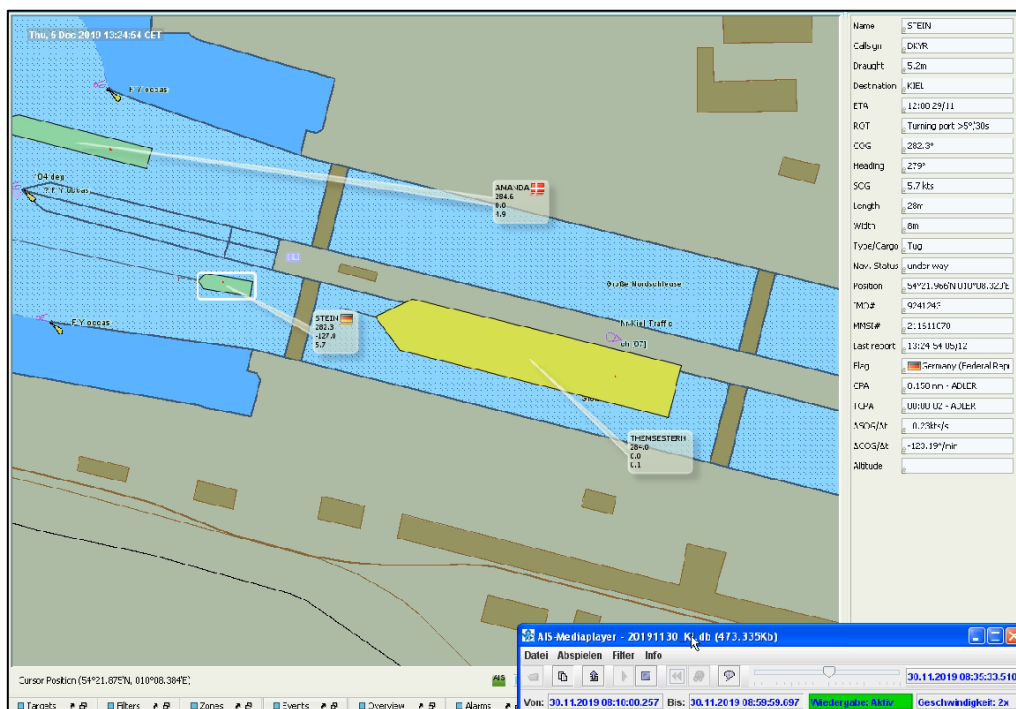
The corresponding AIS recordings made at that time (see **Figure 8 ff.** below) show that the STEIN (IMO number: 9241243; German flag; engine rating: 2,650 kW; see **Figure 12** below) started to pick up speed at about **0934** and passed through the lock gate shortly after **0935**, i.e. before it had been fully opened.

Figure 8: AIS data from 093350 (THEMSESTERN and STEIN in southern lock chamber)

Figure 9: AIS data from 093355 (STEIN gets underway¹³)

Figure 10: AIS data from 093518 (STEIN passes through lock gate)

Figure 11: AIS data from 093533 (STEIN has left the lock chamber)

The analysis of the relevant sources (see above) has unequivocally demonstrated that the STEIN passed through the lock gate before it was fully open. Furthermore, this vessel left the lock first even though she had entered it after the THEMSESTERN.

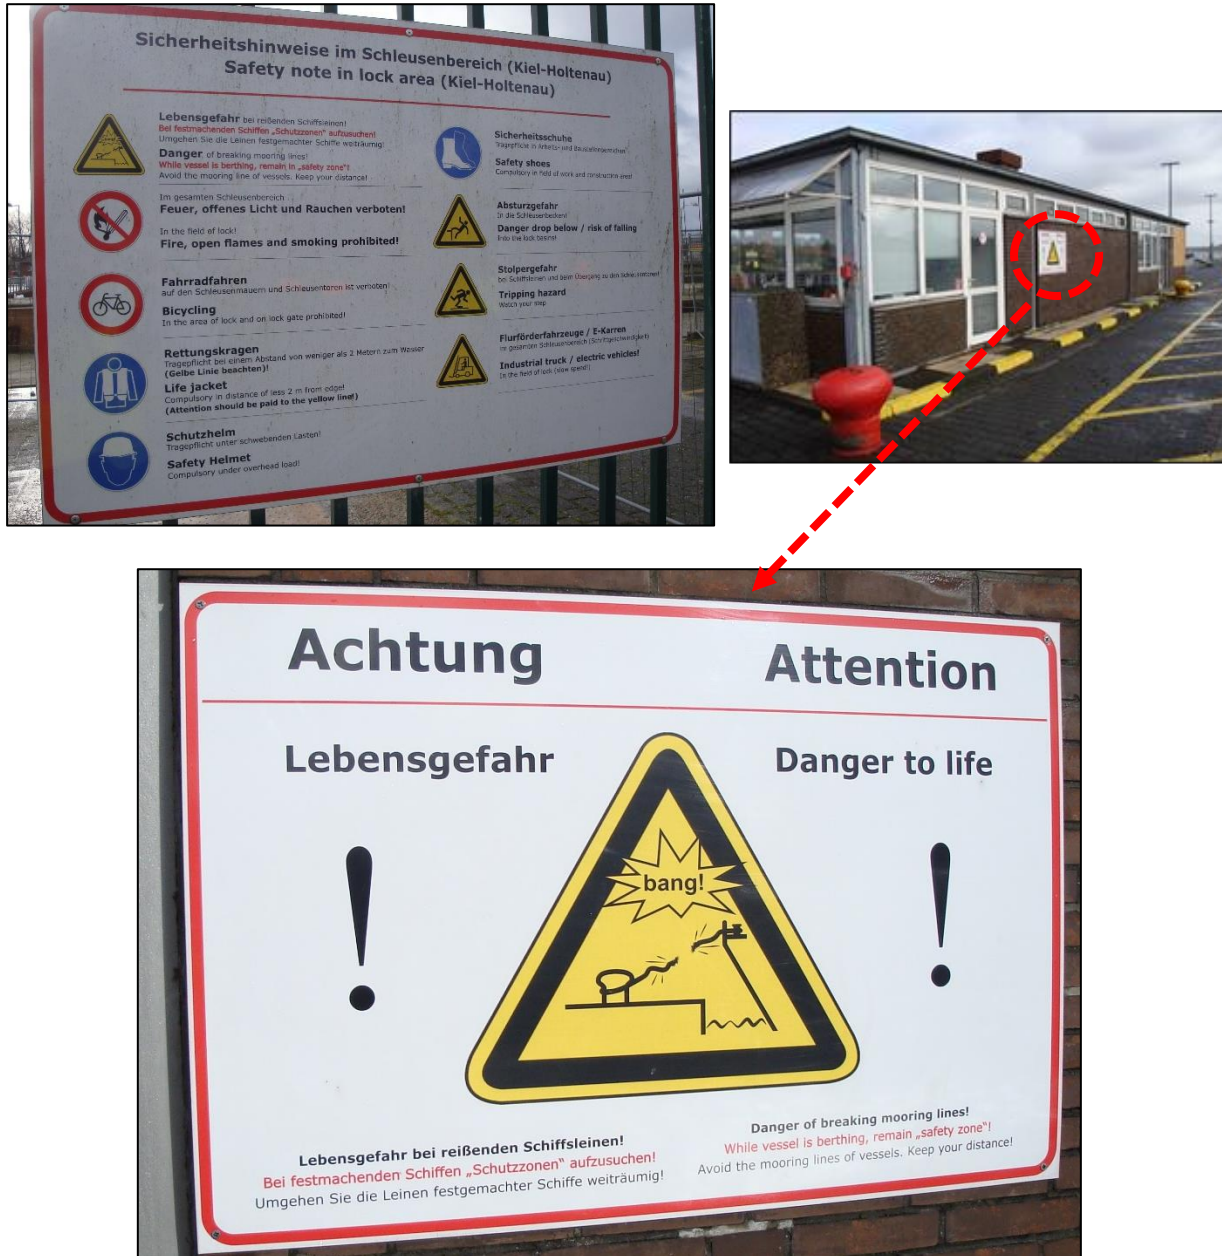
In addition to the aforementioned regulations and regular occupational safety briefings, the prominent warning signs and large notice panels displaying safety instructions, which the WSV has installed at the NOK's Brunsbüttel and Kiel-Holtenau locks, make an important contribution to occupational safety (see **Figure 13**).

Figure 13: Warning sign and safety instructions at the NOK's Kiel-Holtenau lock facility

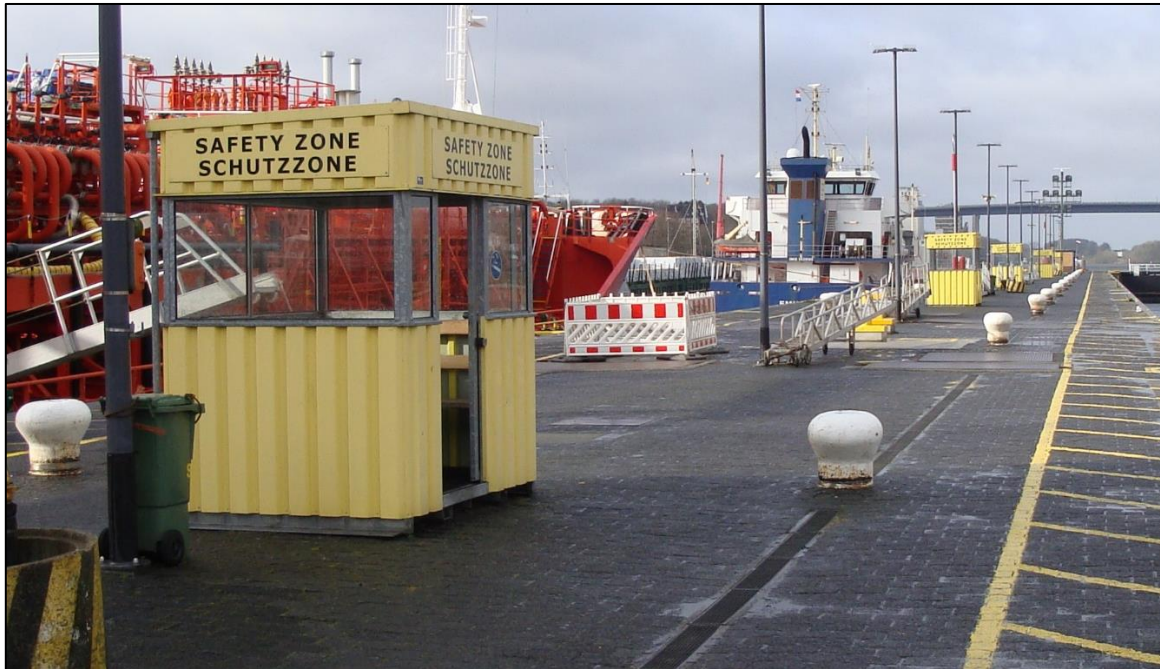
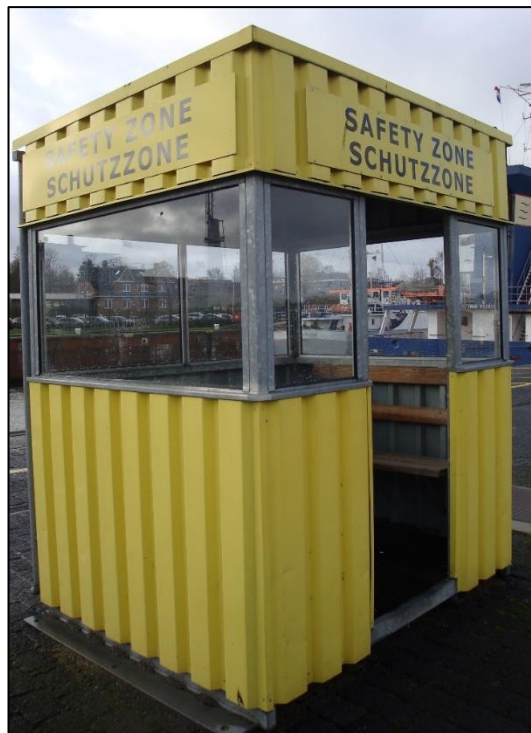
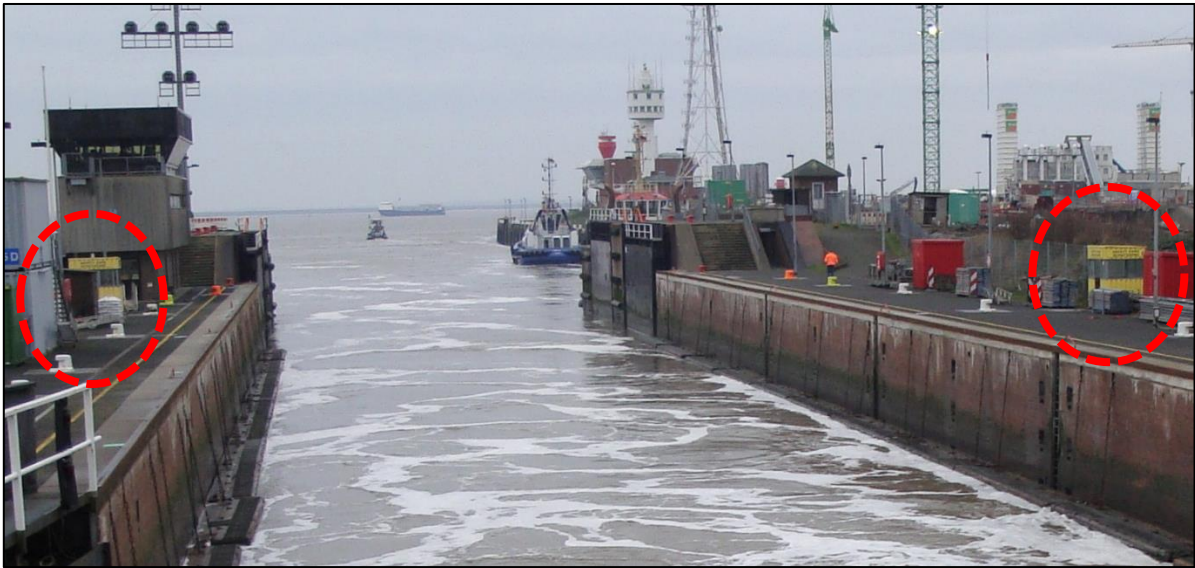
Moreover, following line accidents that occurred a number of years ago various shelters were installed especially for this purpose on the NOK's Kiel-Holtenau and Brunsbüttel lock walls. These are intended as a safe place to stay for linesmen waiting for their assignments, as well as readily accessible places of refuge when typical noises or vibrations indicate that a line may be overloaded (see **Figure 14 ff.**).

Figure 14: Shelter on the middle wall of the lock in Kiel-Holtenau

Figure 15: Shelter (close-up)

Figure 16: Shelters on the lock walls in Brunsbüttel

During a survey of the shelters, it seemed doubtful to the BSU's investigation team that they were actually equipped with shatterproof glass given their external appearance. However, the WSV staff responsible for safe lock operation in Brunsbüttel and Kiel-Holtenau confirmed this was the case when asked.

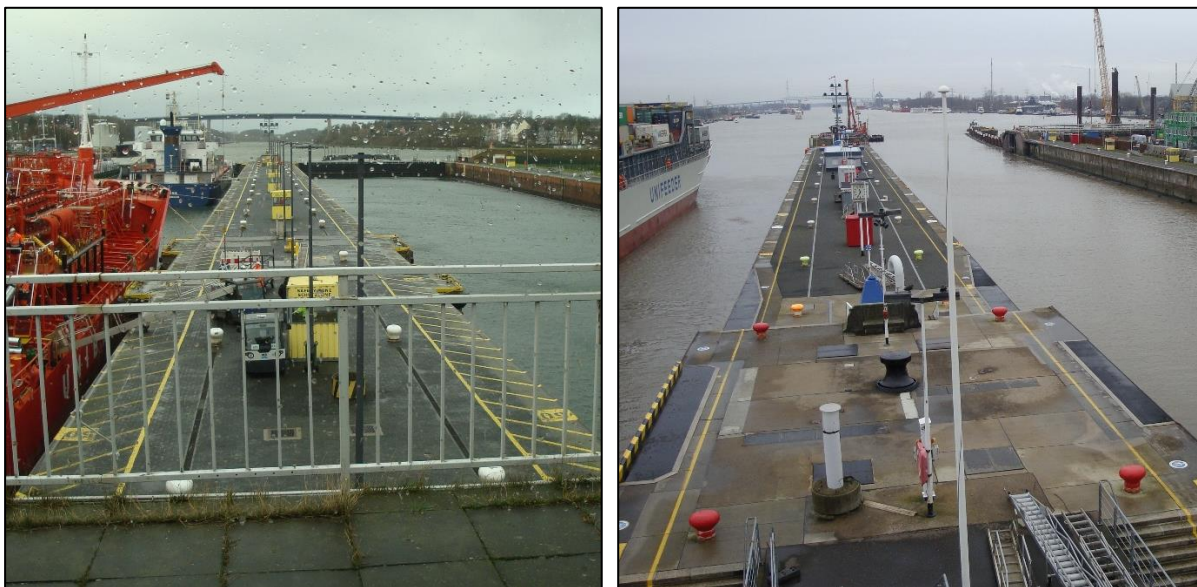
As an additional occupational safety measure for the lock facilities, yellow marking has been applied across the entire length of the area immediately adjacent to the edge of the lock walls in Kiel-Holtenau and Brunsbüttel. To minimise the risk of falling, this area must not be entered (see **Figure 17**).

Figure 17: Edge marking on the lock walls in Kiel-Holtenau (left) and Brunsbüttel (right)

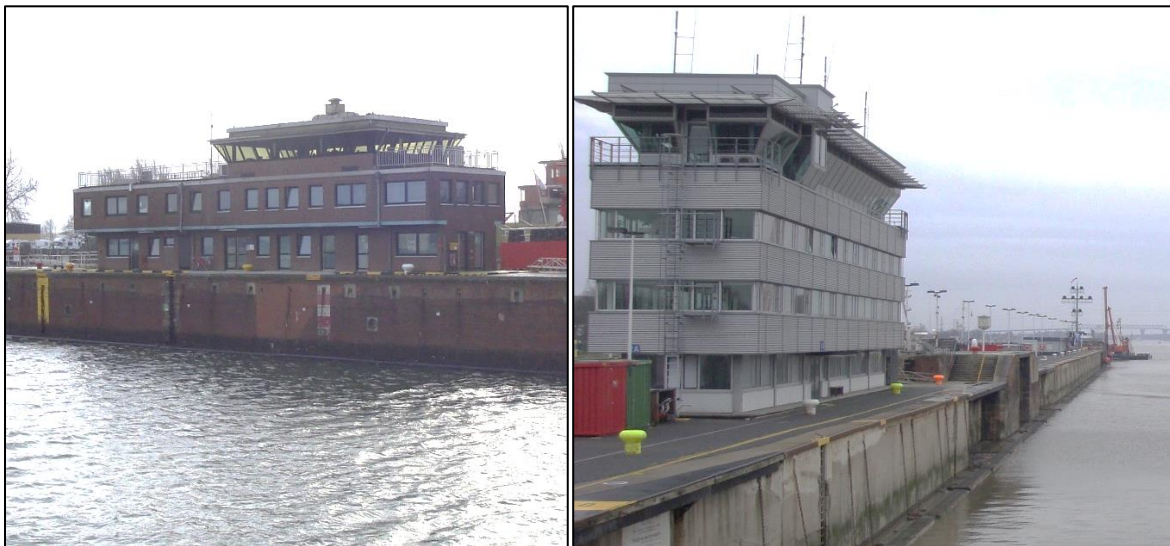
However, the failure of the THEMSESTERN's head line has revealed a hitherto insufficiently identified deficit in the package of measures described above, i.e. that prior to the accident in question the WSV had evidently not considered that a failing ship's line could ultimately smash into the windowpanes or glazed door of a building located in the immediate vicinity of the lock walls. Accordingly, the relevant glazing in the (small) service building damaged during the THEMSESTERN accident, but also that of the large lock control station on the middle wall of the lock in Kiel-Holtenau, was not shatterproof or protected by wire mesh, for example. On the other hand, following a corresponding request for information the BSU was advised that safety glass has reportedly been installed in the buildings (which are exposed to similar risks) at the Brunsbüttel lock facility for many years (see **Figure 18**).

Figure 18: Lock control stations in Kiel-Holtenau (left) and Brunsbüttel (right)
