**Bundesstelle für Seeunfalluntersuchung**  
Federal Bureau of Maritime Casualty Investigation

## **Interim Investigation Report**

### **Very Serious Marine Casualty 103/21**

**Accident with Subsequent Loss of Life  
on Board the Containership SEOUL EXPRESS  
at Sea between Manzanillo and Long Beach  
on 27 March 2021**

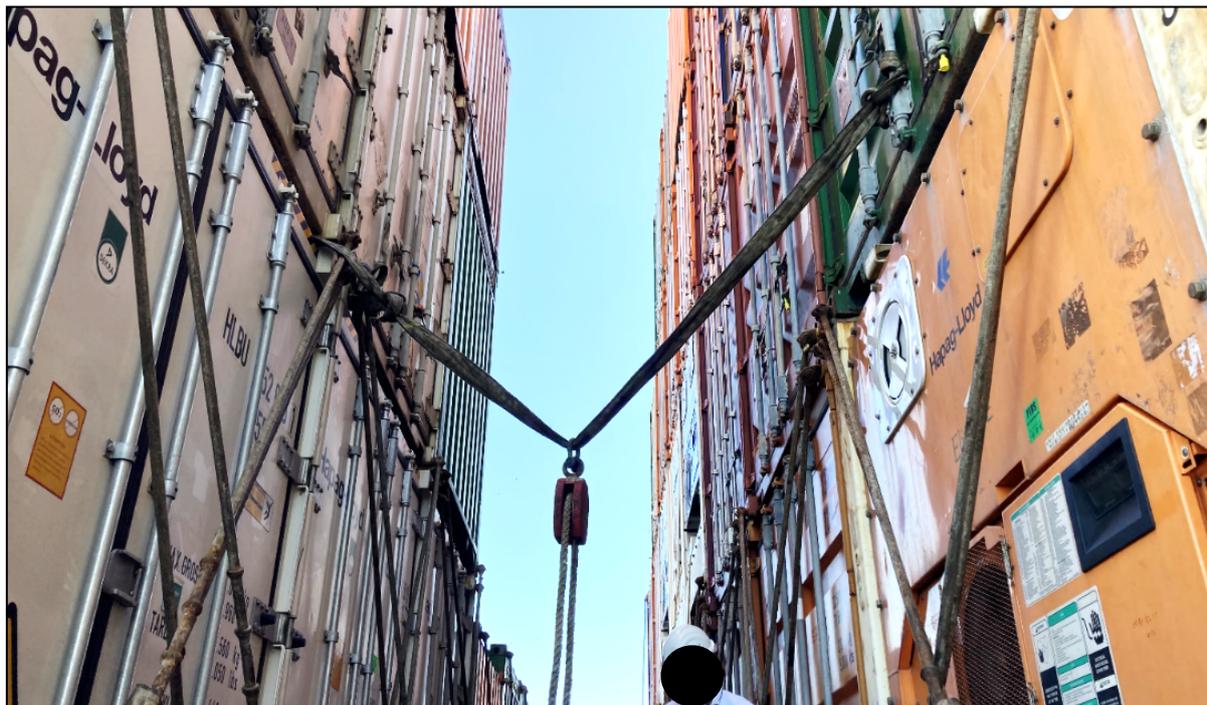
Figure 4: Sling Construction for Evacuation via the Access Hatch (simulated on 19/10/2021)<sup>15</sup>

At about 0817, the Chief Officer and an AB (AB1) descended into the cargo hold No. 3 both wearing a SCBA and reached the casualty two minutes later on the No. 4 stringer deck. He suffered a bleeding wound at the back of his head and showed no reaction. The Chief Officer tried in vain to find a pulse on both the neck and wrist. He informed the Chief Engineer at the access hatch that the injured person should be pulled up by means of a rescue sling. The Chief Officer ascended the ladder again in order to prepare the rescue rope, which had to be attached to the loaded containers or their lashing materials due to the lack of suitable fastening points (see Figure 4). Meanwhile, another AB joined them, equipped himself with a SCBA, descended to the No. 4 stringer deck together with the Chief Officer and AB1, and helped to first lift the unconscious watchman into the sling and then to lead him upwards by the rope. The Chief Engineer and Bosun operated the rope at the access hatch.

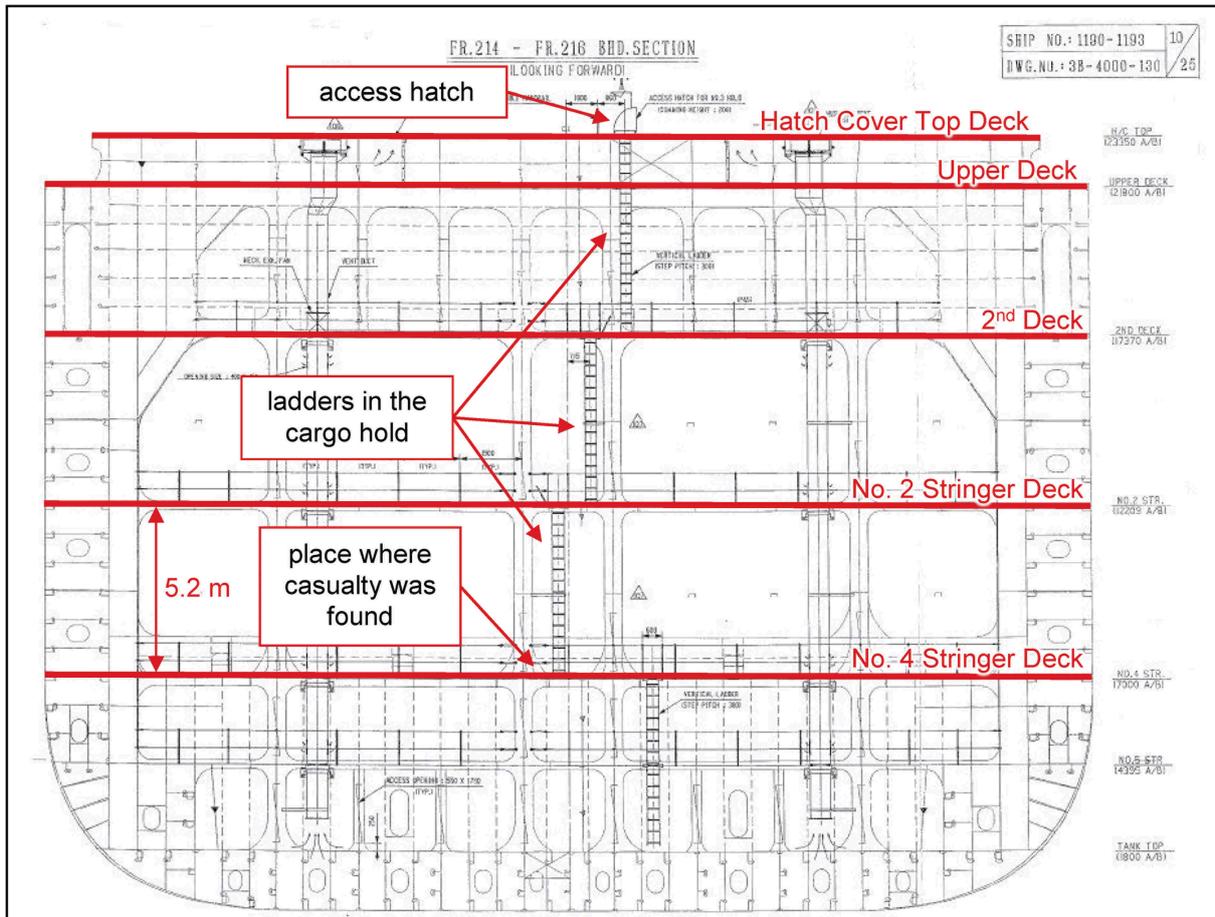
Figure 5: "Ladder Support Plan" Cargo Hold No. 316

From Figure 5, the designation of the individual decks of the SEOUL EXPRESS as well as the descent into the cargo hold via the staggered ladders can be understood:

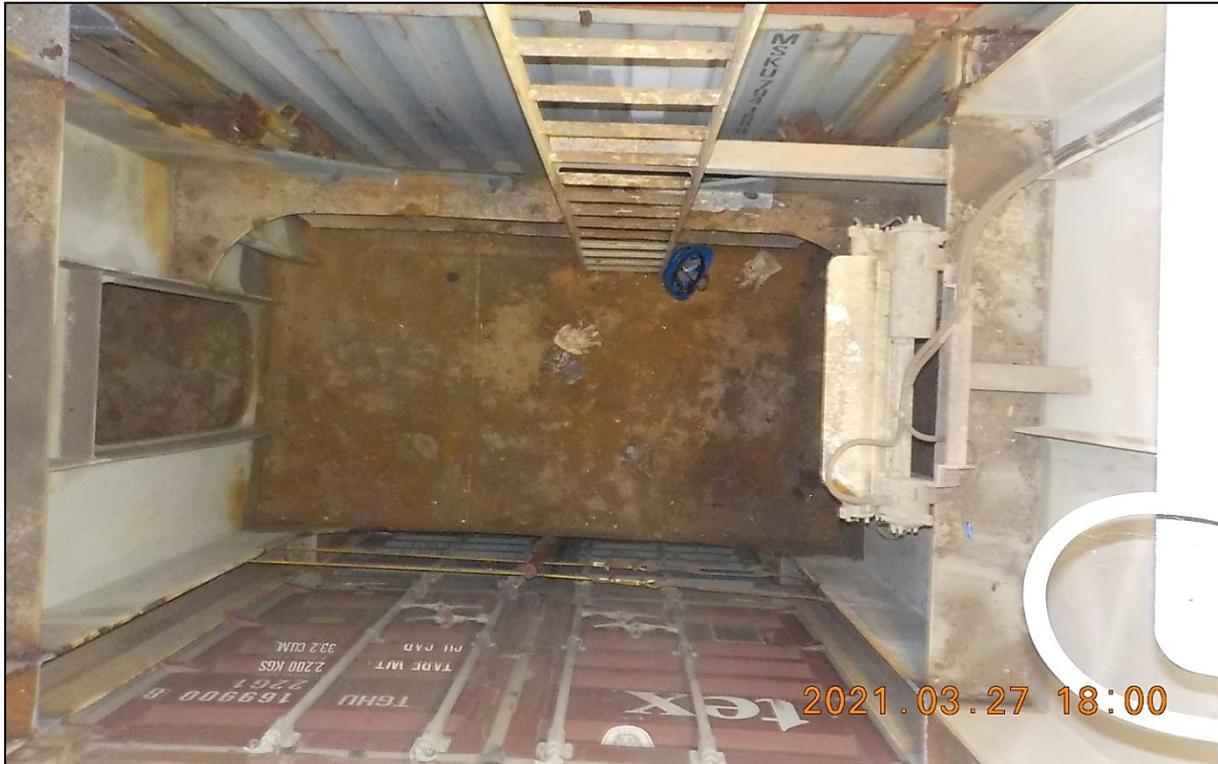
Figure 6: View from Above onto the 4th Stringer Deck in Cargo Hold No. 3, Scene of the Accident<sup>17</sup>

Figure 6 shows the view from the No. 2 stringer deck to the No. 4 stringer deck below, where the injured watchman was found at the base of the vertical ladder, his helmet and gloves also visible in the picture.
