## **Interim Investigation Report**

### **Very Serious Marine Casualty 300/21**

**Fire in the engine room with subsequent foundering  
of the fishing vessel FREYJA in Schleswig-  
Holstein's Wadden Sea during the night of  
17 to 18 September 2021**

2 September 2022

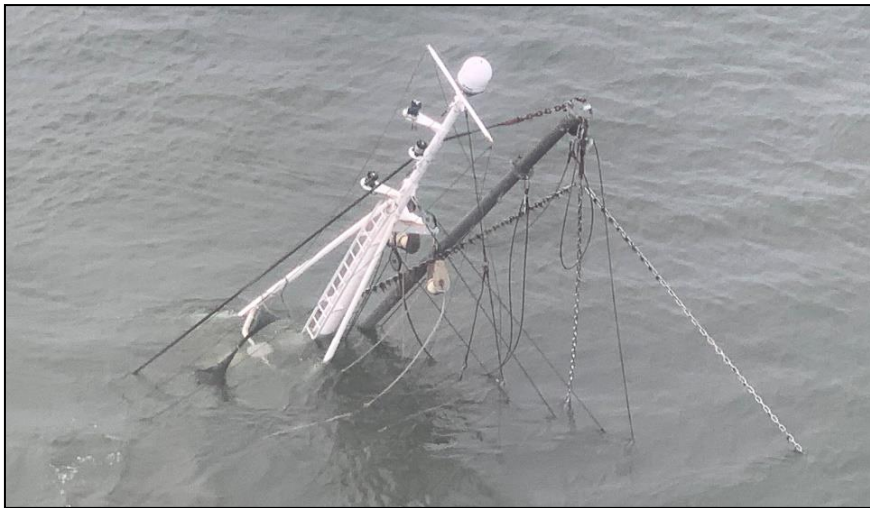
At the same time as these activities were unfolding, MRCC BREMEN transmitted a mayday relay and instructed two rescue cruisers to proceed to the scene of the accident. A WSP boat also made for the burning fishing vessel. After the two crew members were rescued, it quickly became clear to the emergency services that further action, in particular a rapid and effective firefighting operation, was out of the question due to the water levels in the tidal flats but above all because of a suspected risk of explosion on the fishing vessel. The wooden vessel inevitably burnt out completely and foundered at about 0245. Only the top of the mast protruded from the surface of the water (see **Figure 3**).

Figure 3: Mast head of the foundered fishing vessel FREYJA protruding from the water<sup>4</sup>

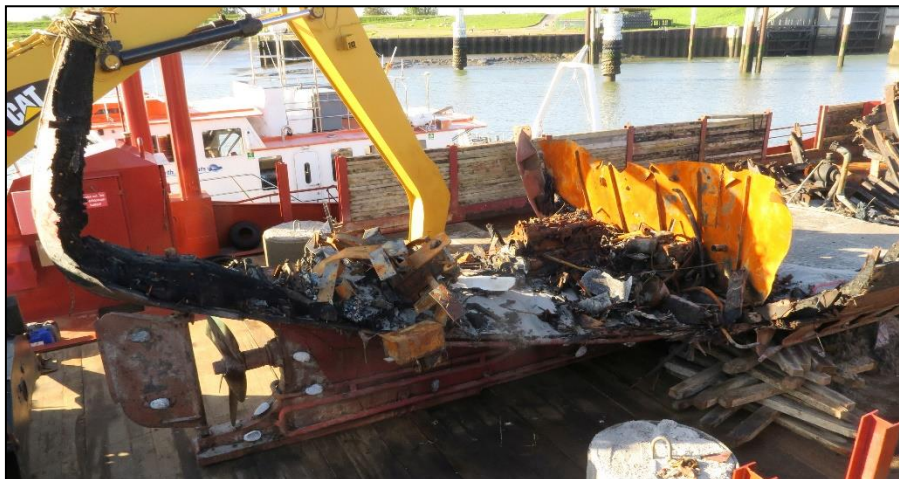
The investigation team inspected the wreck of the FREYJA on 11 October 2021, which was stored on board the service vessel CATJAN and severely damaged by fire.

Figure 4: Burnt-out wreck of the Fishing vessel FREYJA  
(in this case the aft part of the vessel with propeller and the remains of the engine room)
