**Bundesstelle für Seeunfalluntersuchung**  
Federal Bureau of Maritime Casualty Investigation

## **Interim Investigation Report**

**Very Serious Marine Casualty 301/21**

**Foundering of the fishing vessel RAMONA in the  
Elbe estuary on 21 September 2021**

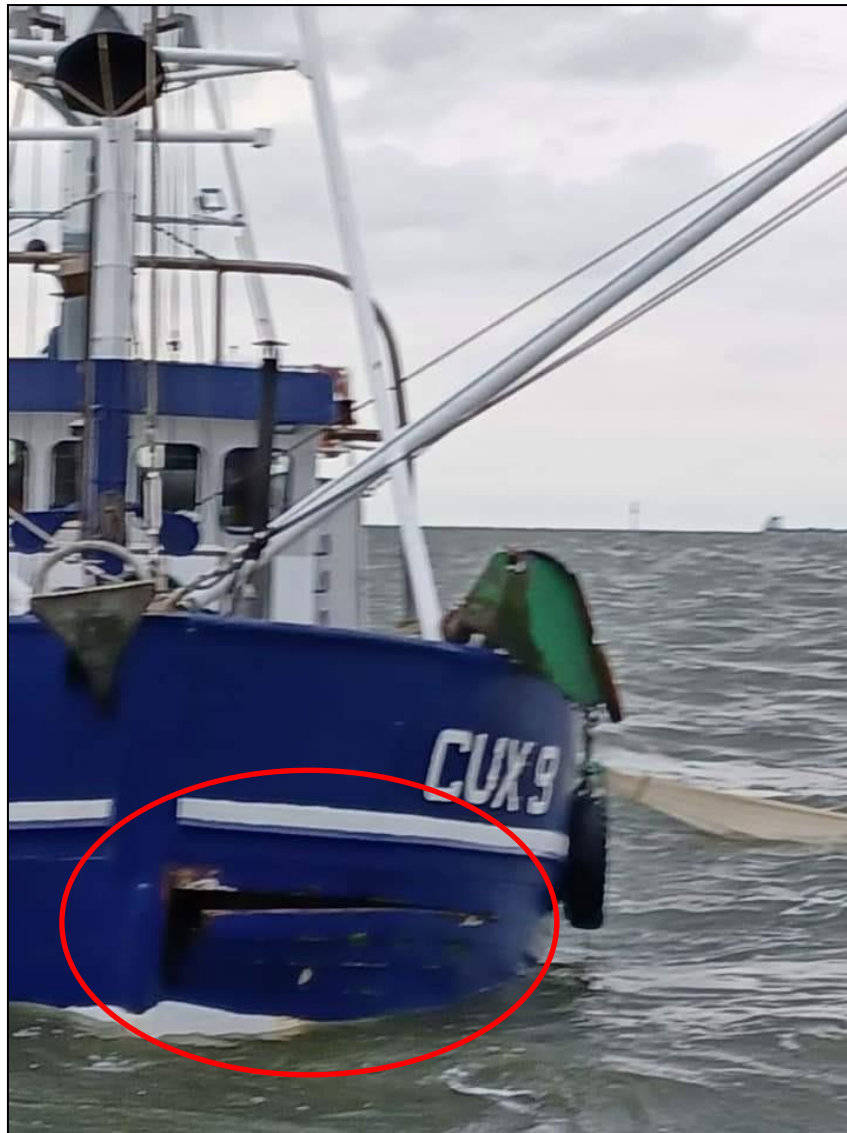
At around 09:00, the master noticed that planks had come loose in the bow area and that the ship was taking on water. This water ingress was so severe that the master made a distress call at 09:21 and had all persons put on their survival suits and then let them climb into the life raft that had been brought along and had been activated in the meantime.

Figure 3: The loose planks at the bow of the RAMONA<sup>5</sup>

Figure 3 shows the protruding planks at the RAMONA's bow. Unfortunately, the figure is only available in poor quality. However, the BSU is grateful for the presence of mind of the crew of the rescue cruiser ANNELIESE KRAMER who took photos in this distress situation. This way, investigations into the cause of the accident at least get some clues.
