**Bundesstelle für Seeunfalluntersuchung**  
Federal Bureau of Maritime Casualty Investigation

## **Interim Investigation Report**

### **Serious Marine Casualty 95/21**

**Allision with pier/dry dock by  
the Vehicles Carrier ENDURANCE  
after a line parted in Bremerhaven on 13 March 2021**

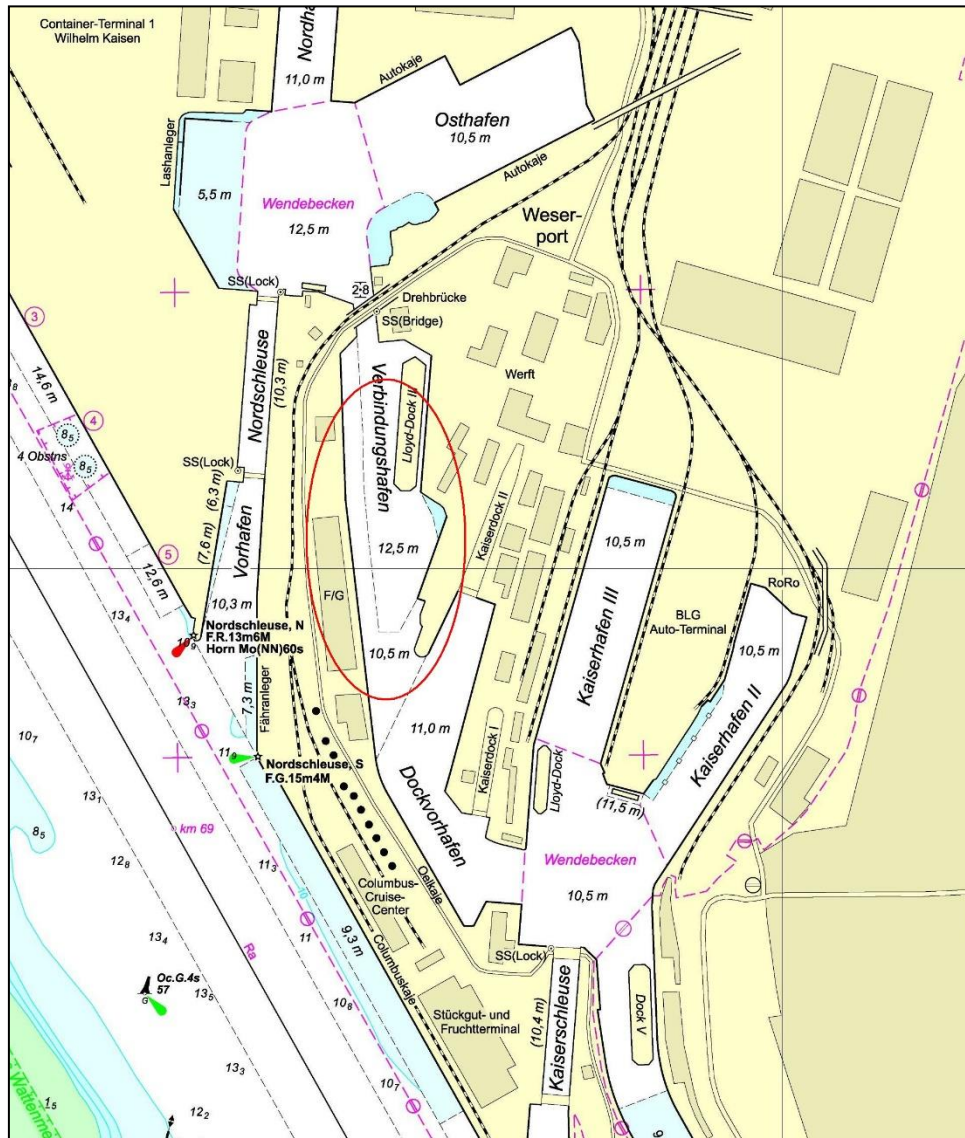
Figure 2: Scene of the accident<sup>3</sup>

- tear of about 0.8 m in length on the ship's side (port side) nearly 3 m above the waterline;
- hole in the bulbous bow;
- dent and paint abrasions of about 1.5 m in length at the stern on the starboard side.

- a bollard cover was torn off;
- three of the bollard's four bolts were torn off;
- a 55x25 cm piece of concrete had chipped off;
- a roll fender was pressed in;
- scrub marks in the tarmac were visible in the area of the Vehicles Carrier 's lowered ramp;
- a lifebuoy bracket was buckled and destroyed.

- two floating pontoons were pushed into the previously damaged concrete quay;
- a fender tore off and sank;
- at the southern end of the floating dock, the forward end of the right-hand edge of the deck

was pushed inwards and the deck was bent downwards in this area.
