Bundesstelle für Seeunfalluntersuchung
Federal Bureau of Maritime Casualty Investigation

Investigation Report 103/21

Very Serious Marine Casualty

**Personnel Accident with Subsequent Loss of Life
on board the Container Ship SEOUL EXPRESS
at Sea between Manzanillo and Long Beach
on 27 March 2021**

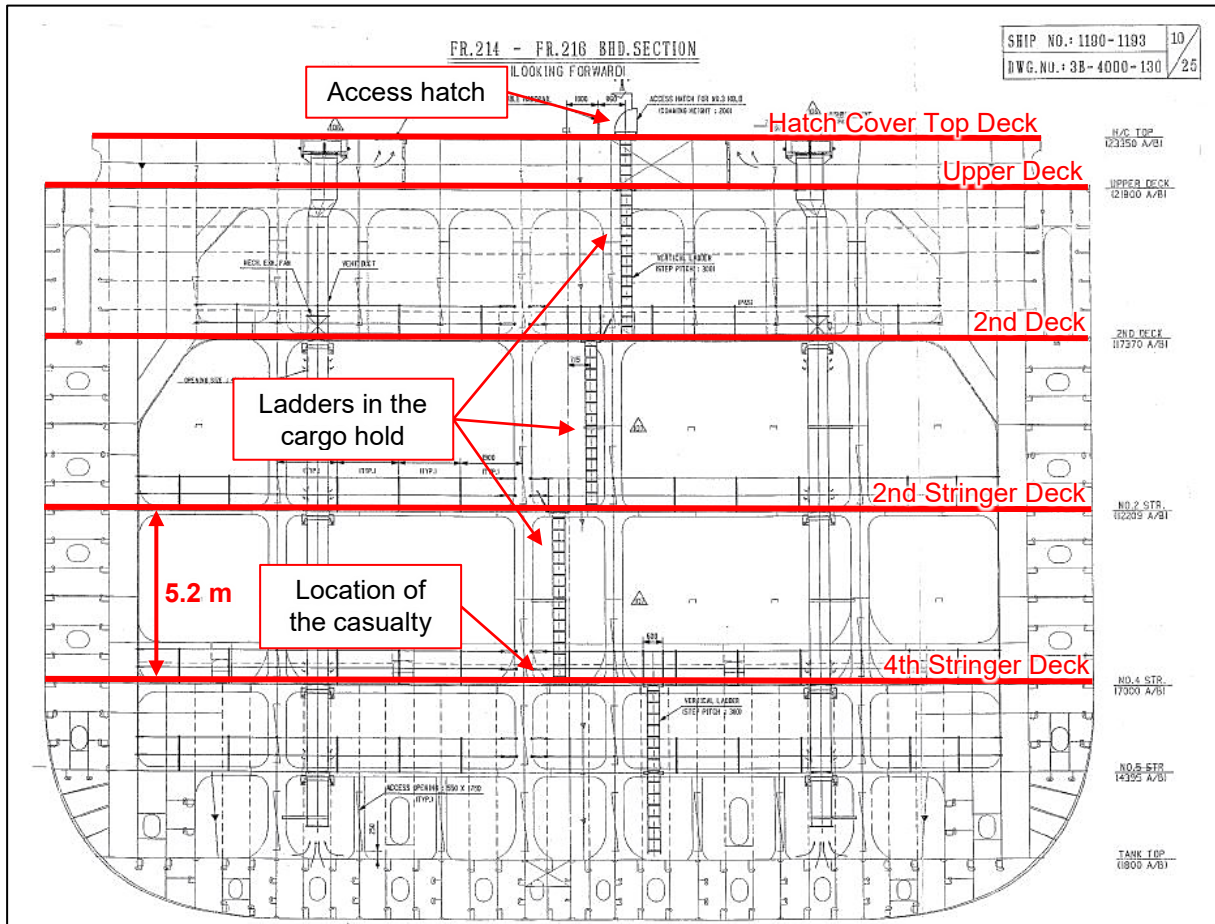
Figure 4: Cargo Hold No. 3 Ladder Support Plan¹⁴

For the stiffening of the hull and for access to the containers, the cargo holds between the 40' bays are subdivided by supporting transverse bulkheads, to which the cell frames/guides for the containers are also attached. These transverse subdivisions in the cargo hold contain companionways from which the containers in the cargo hold can be reached on multiple tiers by several vertical ladders (see Figure 4). The forward access hatch for CH3, where the watchman's fatal accident occurred, is located between Bays 27 and 29 (see Figure 10). As can be seen in Figure 4, three staggered ladders lead down to the 4th stringer deck, where the watchman was found at the foot of the ladder by his colleagues. The height of the 4th stringer deck and thus length of the ladder is 5.2 m (see Figure 4).

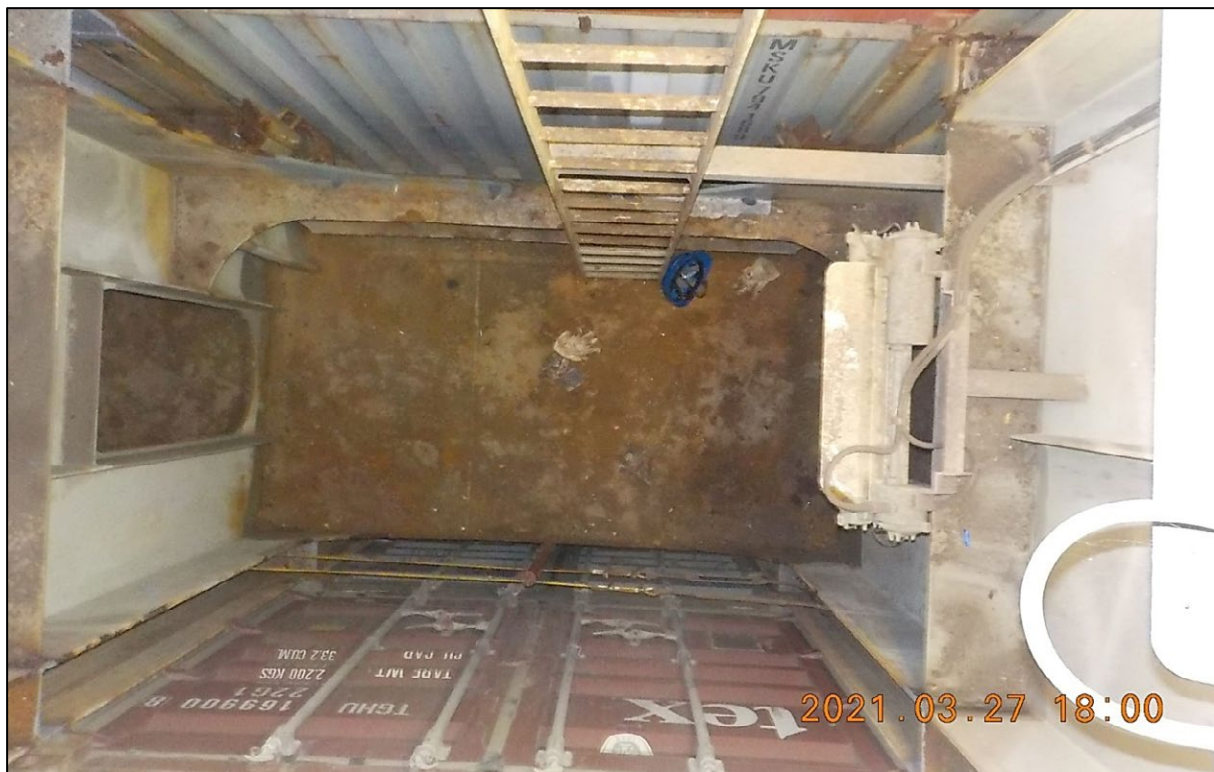
Figure 5: View of the 4th Stringer Deck in Cargo Hold No. 3 from Above; Scene of the Accident¹⁵

deck to the 4th stringer deck beneath it where the deceased watchman was found at the foot of the vertical ladder (his helmet and gloves are also visible in the picture).

The experts only noted that the dust on top of one of the lights permanently installed on the wall was slightly smeared about one metre to the right behind the ladder. This

can be seen in Figure 5 to the right of the picture on closer examination. According to the chief mate, the search party reportedly found a AAA battery on the light, which the chief mate had reportedly taken from the light, possibly smudging the dust on the surface in the process. There were reportedly no traces of blood found on the light. The report also notes that the crew had cleaned the area around the scene of the accident prior to the expert's survey in preparation for unloading in the port of Long Beach.

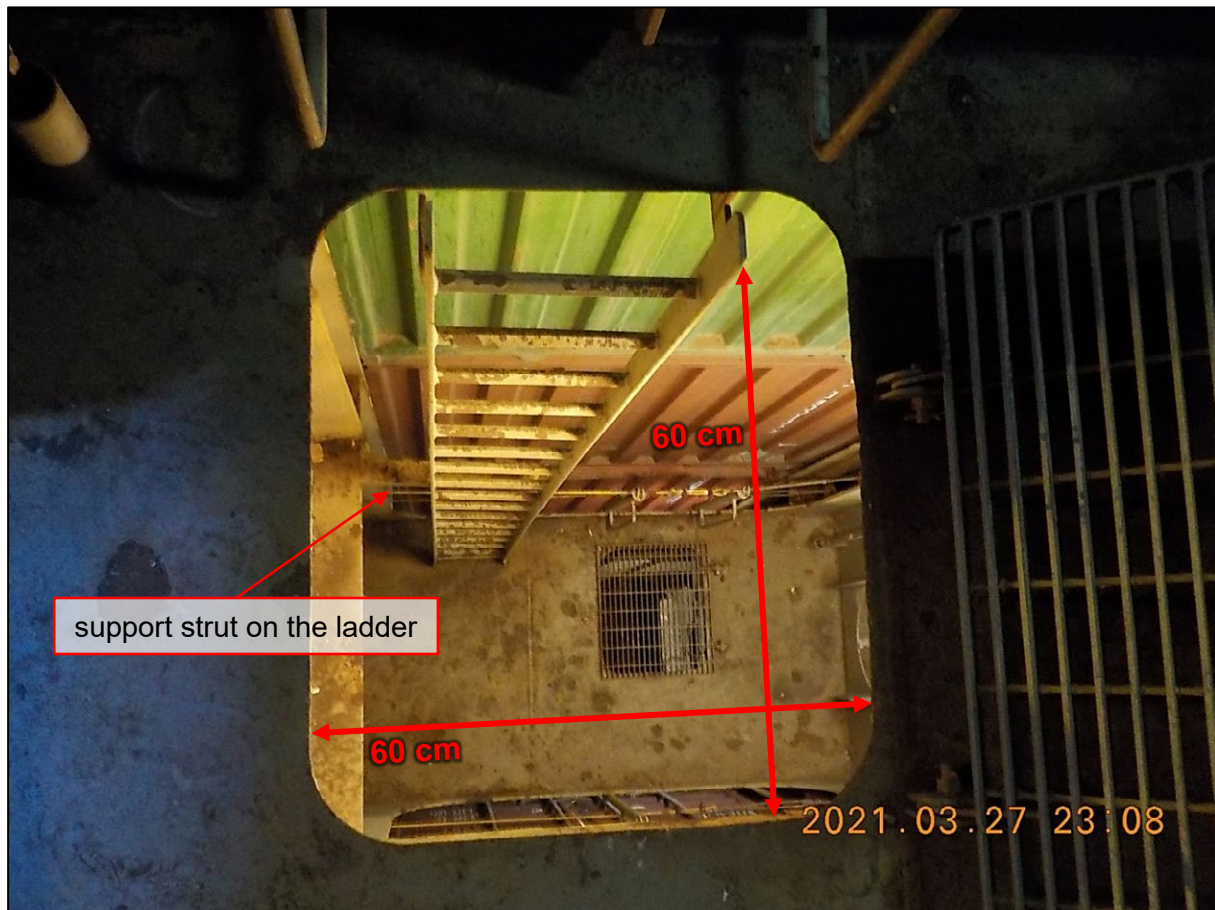
Figure 11: View from the 2nd Deck to the 2nd Stringer Deck⁵²

Figure 11 shows that the companionway in CH3 is well illuminated by fixed lighting, which according to the chief mate is always switched on:

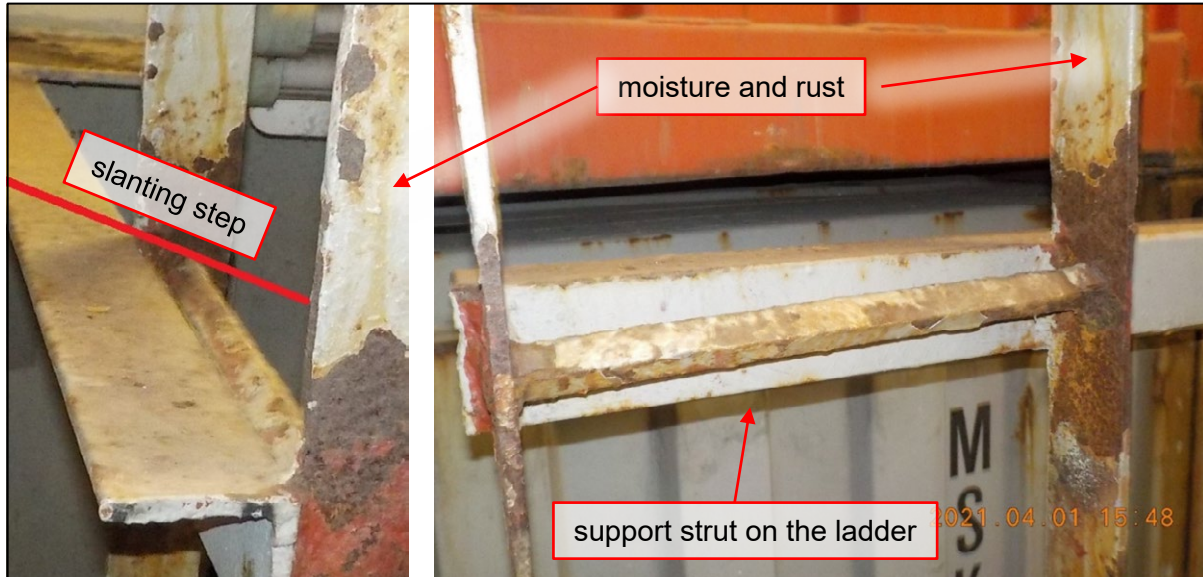
Figure 12: Cargo Hold Ladder with Support Strut, Side and Front View⁵³

ladder rungs are not as easy to grip in the position of the support. Secondly, it is not possible to position the foot straight onto the respective rung when climbing the ladder. Figure 12 illustrates the design more clearly:

Due to the installed support strut, this hold ladder does not comply with the mandatory requirements of Section 21(5) DGUV Regulation 84 (formerly Section 87 of the Accident Prevention Regulations for Shipping Enterprises (UVV See)) because the horizontal distance of the rung centre from fixed parts must not be less than 0.15 m. There must be a clear space for the feet of at least 20 cm high and 15 cm deep spanning the width of the ladder above each rung.

The ship operator reported that further support struts were found near rungs on various ladders on all sister ships of the SEOUL EXPRESS. A fleet-wide circular issued in August 2021 made ship's commands aware of this and of the potential risk of falling when using the ladder. The ship's commands were urged to inspect and identify all support struts and other obstructions on ladders and to inform the ship's operator of their location and design. Specific solutions were then to be found for the slightly differing designs in cooperation with the respective superintendent. (See Annex 9.2 Hapag-Lloyd AG: Fleet Circular 'FMS 18/2021 Ladder Support'.)

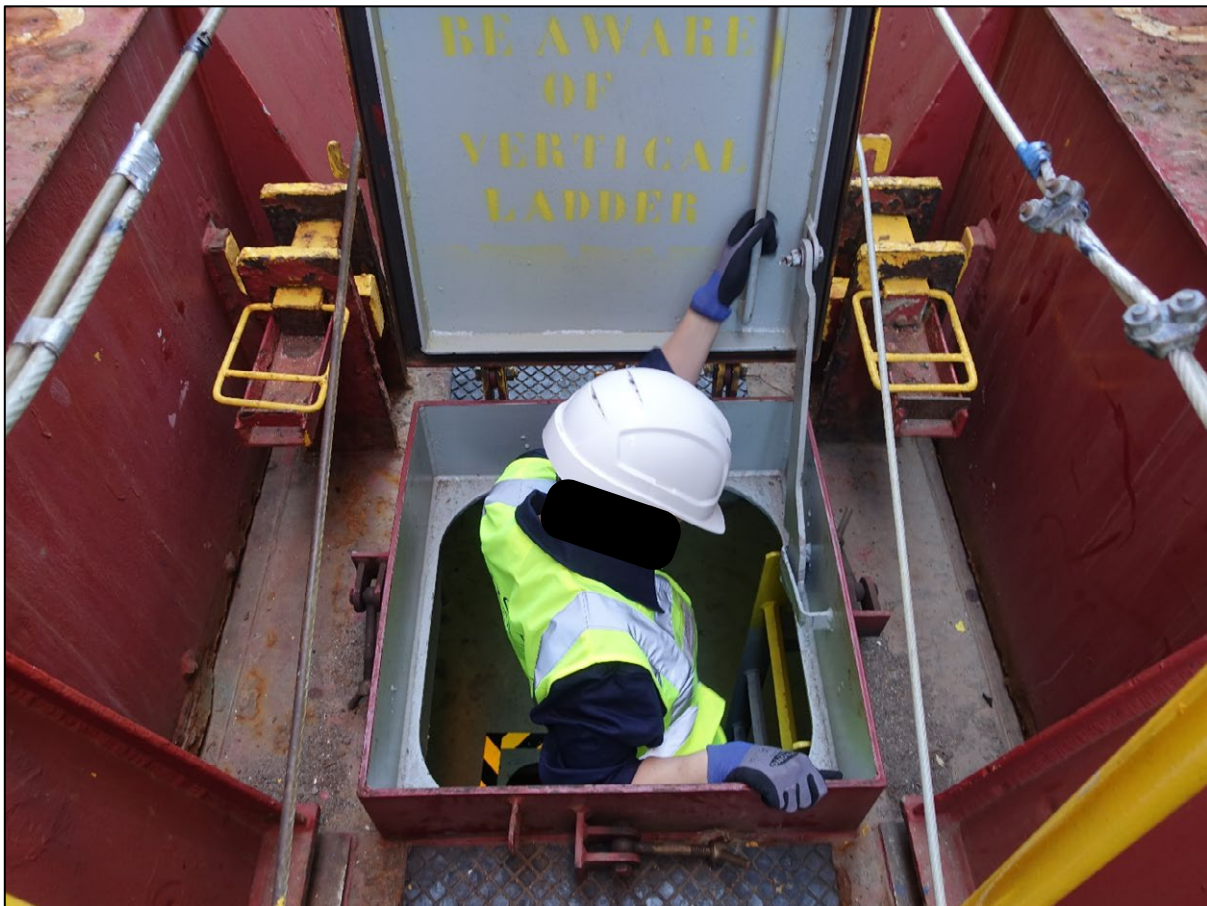
Figure 13: Forward Access Hatch to Cargo Hold No. 3⁵⁵

The cover of CH3's forward access hatch is painted yellow and therefore contrasts visually with the reddish-brown deck. However, since handrail supports and other items of deck equipment are painted yellow in addition to the hatch cover, it is not immediately apparent that the hatch is the entrance to a potentially dangerous area. Apart from the inscription 'NO.3H(F)' in red lettering, there are no other hazard warnings on the outside of the access hatch. A warning ('BE AWARE OF VERTICAL LADDER') in yellow lettering is painted on the inside of the access hatch (see Figure 13).

During the BSU's inspection of the scene of the accident on board the SEOUL EXPRESS on 19 October 2021, it was found that there were no handrails for safe entry and exit immediately adjacent to the access hatch. From the perspective of the BSU, the thin handle in the locked but slightly movable hatch cover (see Figure 13) does not

provide sufficient support and the yellow support next to the access hatch (bottom right of image) is too far away to hold on to. Nevertheless, the access complies with applicable design regulations, as the ladder is a hold ladder for which no handholds are stipulated at the exit points either in national or international regulations. This was confirmed by the BG Verkehr (Prevention Division).

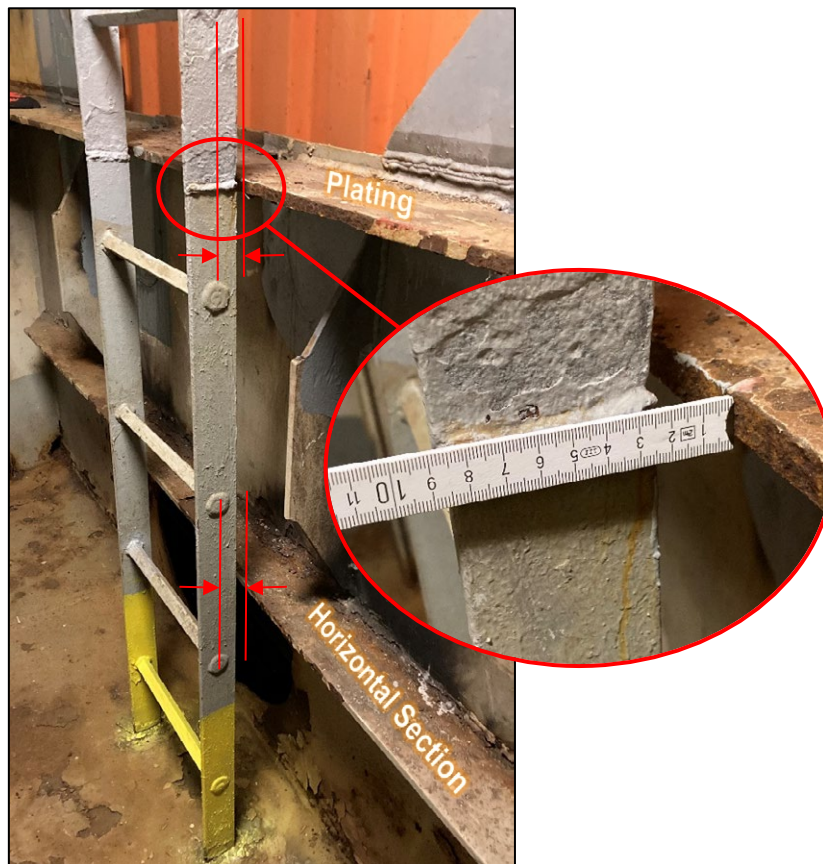
Figure 14: Narrow Space Behind the Cargo Hold Ladder⁵⁶

It was also found that on the lower section of the cargo hold ladder leading to the 4th stringer deck (where the casualty was found), the horizontal space between the centre of the ladder and the fixed components of the upper plating of the transverse beam and the horizontal section of the bulkhead was extremely narrow in two places:

This means that there is a risk of getting caught on the metal edge directly behind the ladder when using it, thus preventing a safe foothold/grip. The mandatory clearance for the feet above each rung of at least 20 cm high and 15 cm deep does not exist here.

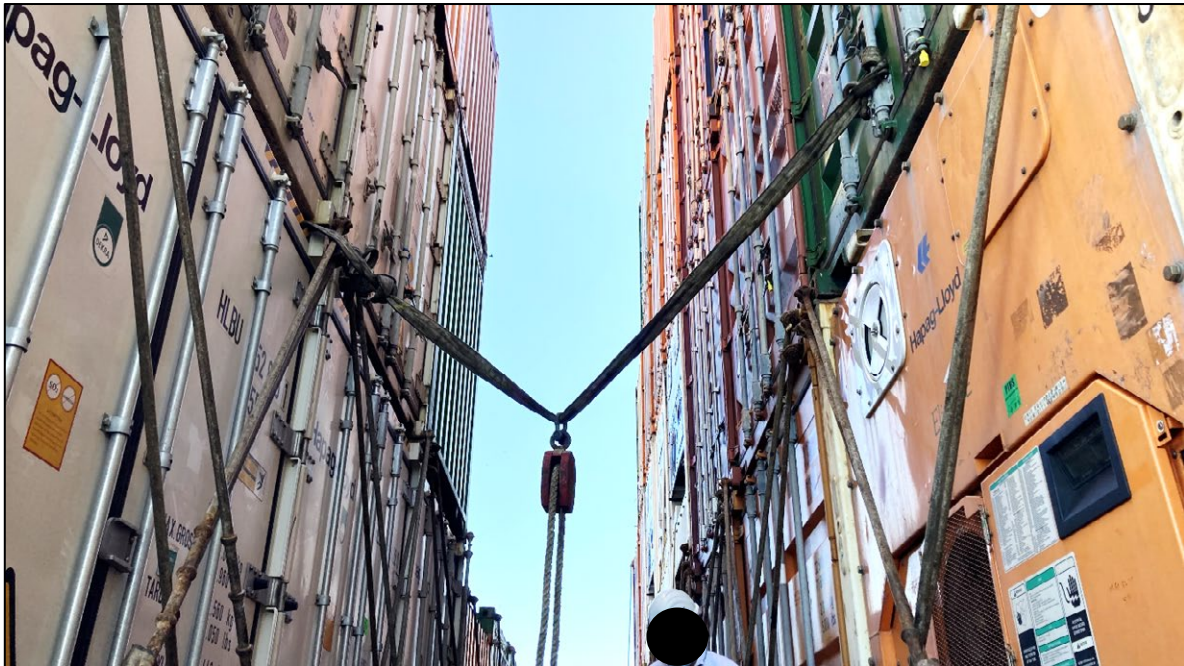
Figure 15: Rope and Snatch Block System for Evacuation via the Access Hatch (reproduced on 19 October 2021)⁸⁰

be attached to loaded containers or their lashing⁷⁹ equipment due to the lack of suitable anchor points (see Figure 15). In the meantime, another AB arrived, put on an SBCA, climbed down to the 4th stringer deck together with the chief mate and the AB1, and helped to lift the unconscious watchman into the sling and then guide him upwards on the line. The chief engineer and the Bosun controlled the lifeline at the access hatch.

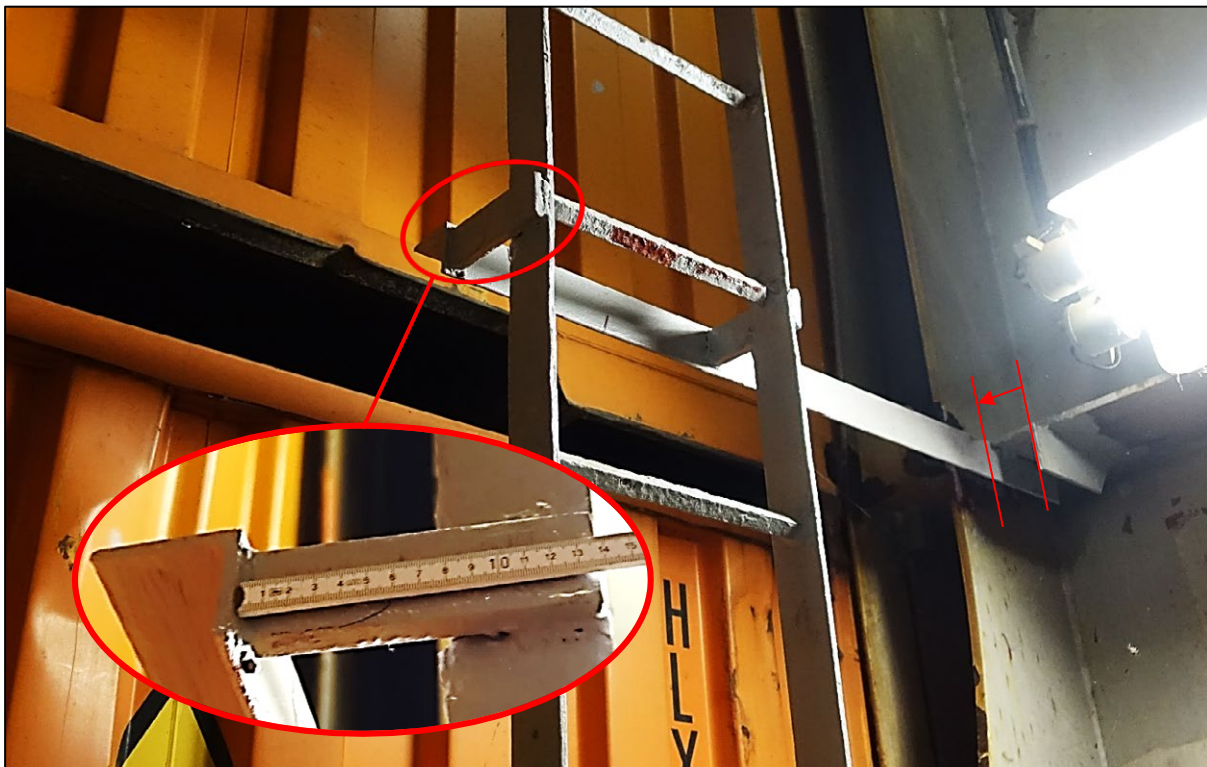
Figure 18: Moved Ladder Support Strut in CH3¹¹¹

The height of the support strut was not changed, as can be seen to the right of the above image. This modification has resulted in a gap of about 10-11 cm between the centre of the rung and support strut. Accordingly, the design is still not in accordance with the standard, as a clearance of 15 cm behind the rung is not given.

On board the SEOUL EXPRESS, the support strut on the ladder in CH3 between the 2nd and 4th stringer decks was moved backwards:
