Bundesstelle für Seeunfalluntersuchung
Federal Bureau of Maritime Casualty Investigation

Investigation Report 117/20

**Collision between the coastal motor vessel
SCHELDEBANK and Kiel Canal (NOK) ferry
HOCHDONN on 8 May 2020**

9 May 2022

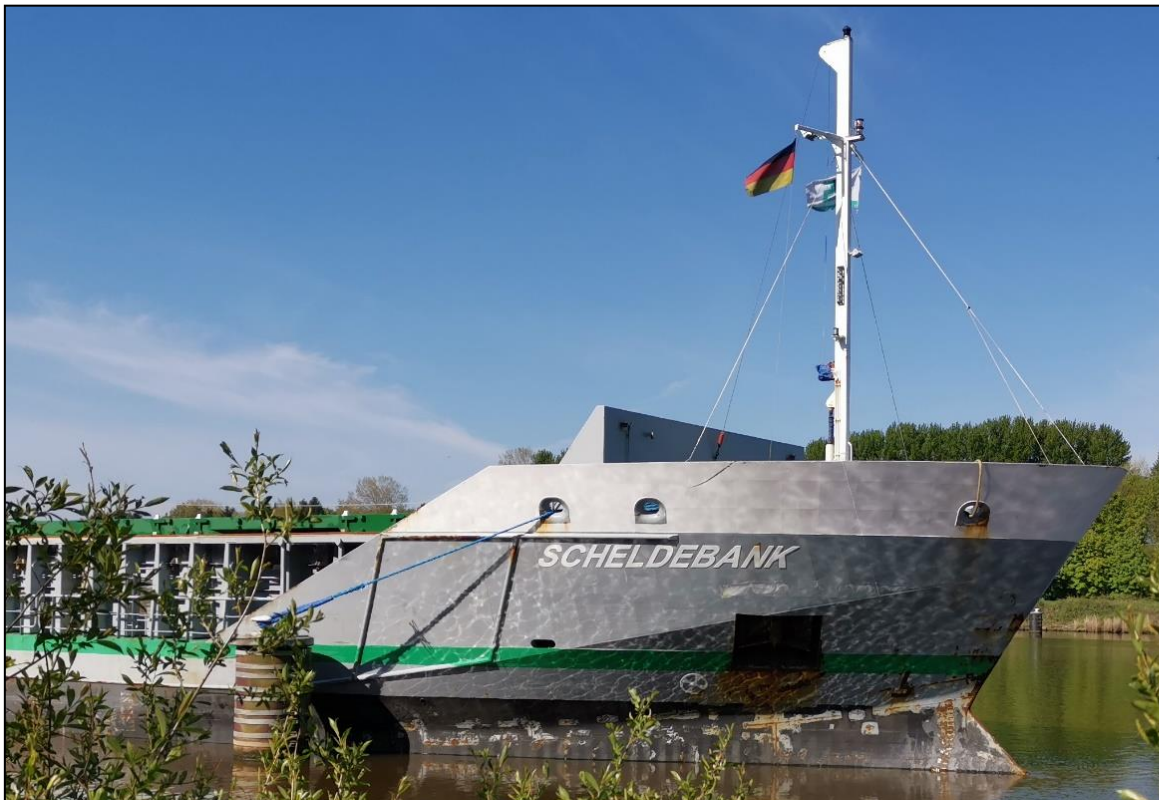
Measures imposed by the SCHELDEBANK's master to determine the damage immediately after the collision revealed that there were no casualties on board. There was also no leakage of pollutants or water ingress. There were merely minor paint abrasions in the shell plating at the bow of the SCHELDEBANK that were caused by the collision, as well as scratches and the ship's bulbous bow was deformed.

The collision with the canal ferry resulted in paint abrasions on the starboard side of the SCHELDEBANK's fore section (see **Figure 4**) and a deformation of the bulbous bow (see **Figure 5**).

Figure 4: Paint abrasions on the starboard bow of the SCHELDEBANK¹⁴

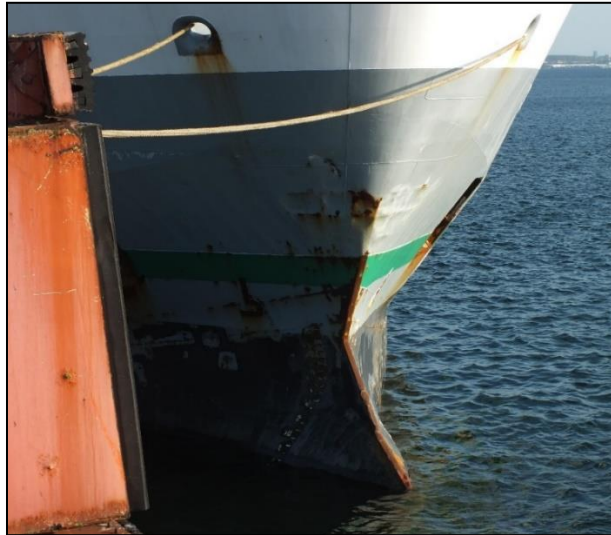
Figure 5: Deformation of the SCHELDEBANK's bulbous bow¹⁵

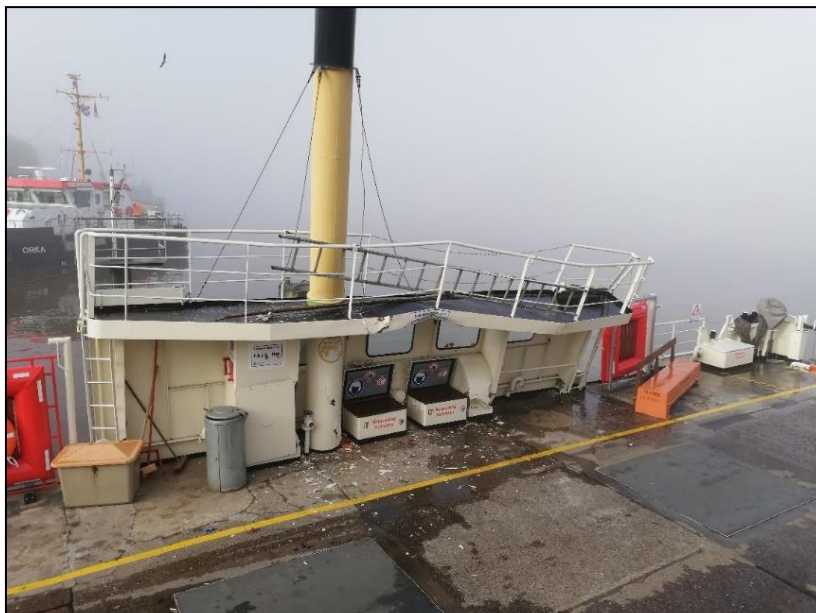
The HOCHDONN was damaged on the vehicle side, which is opposite the control position located on the other side. The superstructure there was pushed in and the funnel buckled over (see **Figures 6 f.**). A compartment of the ferry's hull was also penetrated below the waterline on the side in question. However, this did not significantly affect the ferry's buoyancy (see **Figure 8**).

Figure 6: Damage to the ferry's starboard side¹⁶

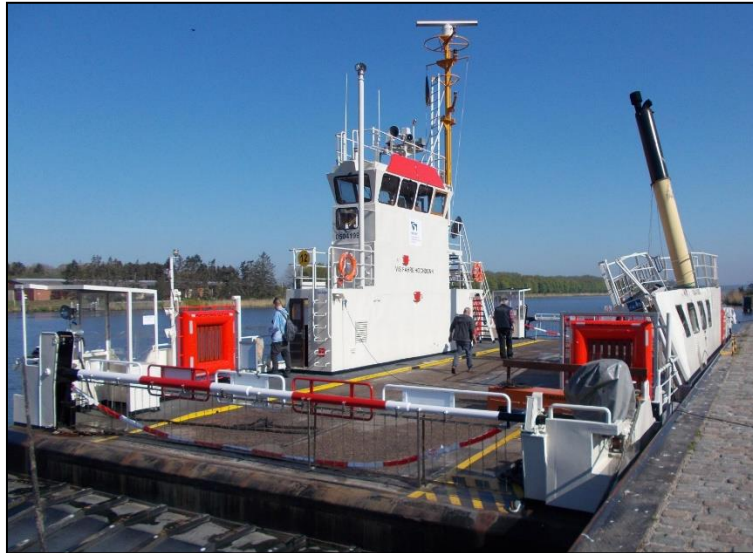
Figure 7: Starboard side of the canal ferry pushed in¹⁷

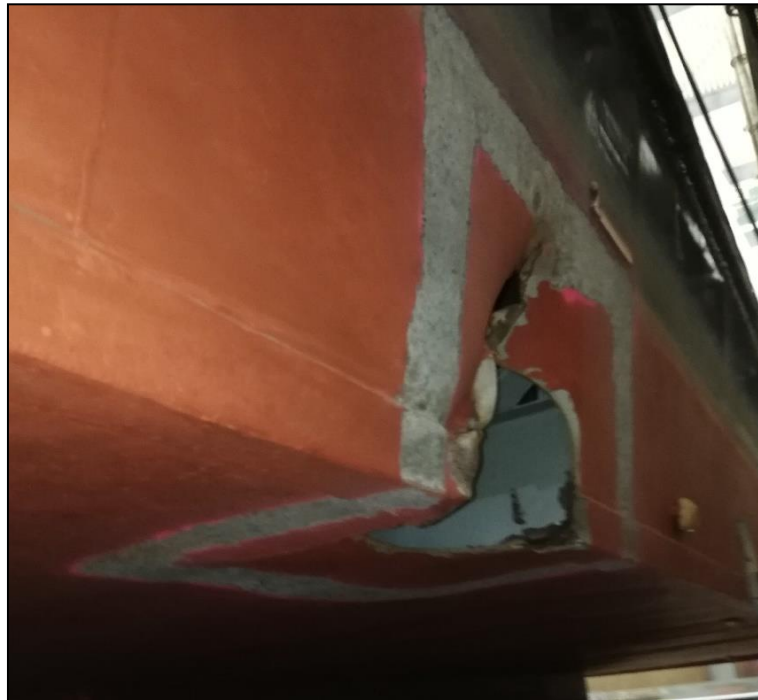
Figure 8: Hole in the HOCHDONN's hull¹⁸

Nobody on board the HOCHDONN was injured, either. One of the transported vehicles suffered minor bodywork damage due to contact with the ferry's deformed superstructure. Since the aforementioned hole in the hull did not affect a fuel or lubricating oil tank, the ferry did not cause any significant water pollution, either.

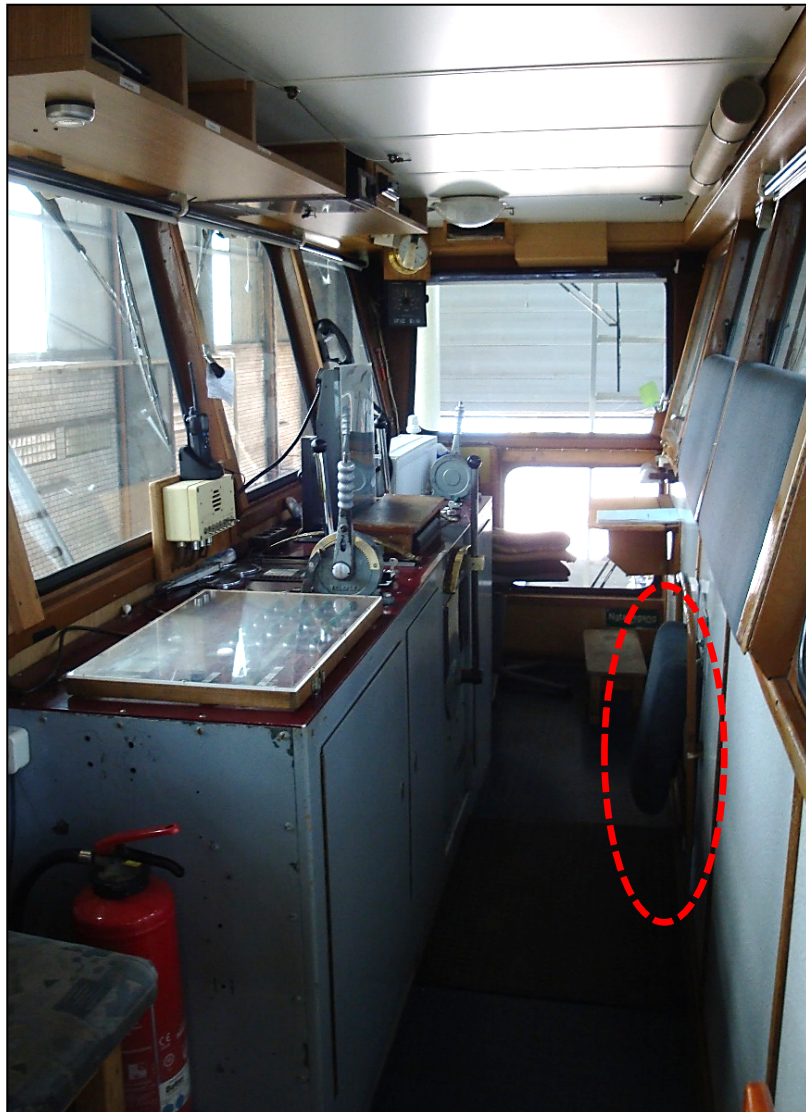
Figure 11: The HOCHDONN's control position (bridge door behind the photographer)²⁶

With regard to the visibility conditions when visually aiming for the ferry terminal, it is worth noting that for the north to south crossing the wooden bridge bulkhead then at the front end of the bridge operator stand must be open, otherwise the ferry pilot's view in the direction of the (southern) ferry terminal being approached is obstructed (see **Figure 10** above). On the other hand, when crossing in the opposite direction (i.e. from south to north), the ferry pilot has to look through a bridge window, which is opposite the bridge bulkhead in the longitudinal direction and divided in half horizontally (see **Figure 11** above). In this respect, the physical visibility conditions for the ferry pilot are even more limited than in the reverse case.

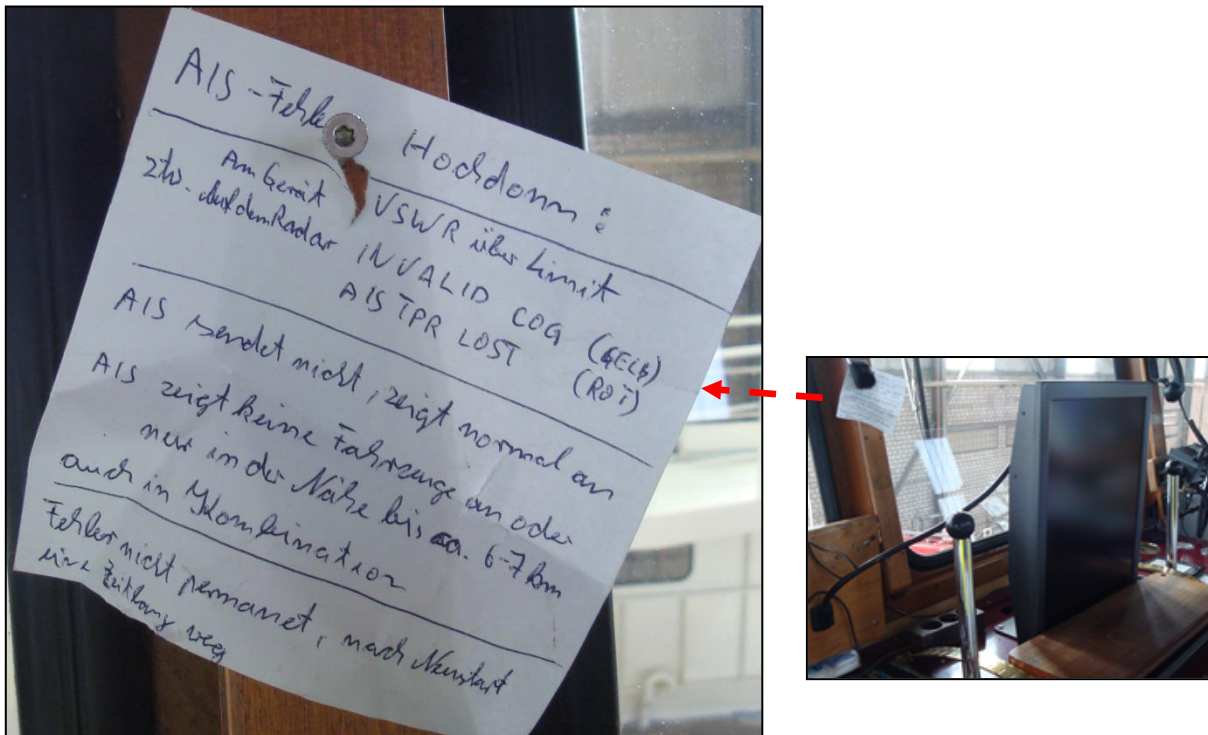
The above statements on the susceptibility to faults coincide with a handwritten note indicating several sporadic transmit and receive faults. The investigators discovered this on the ferry's control position during the survey of the HOCHDONN at the Rendsburg repair facility. The note was attached to a window frame and probably from a ferry pilot, presumably as a warning to colleagues (see **Figure 34**).

Figure 34: Note indicating AIS device fault

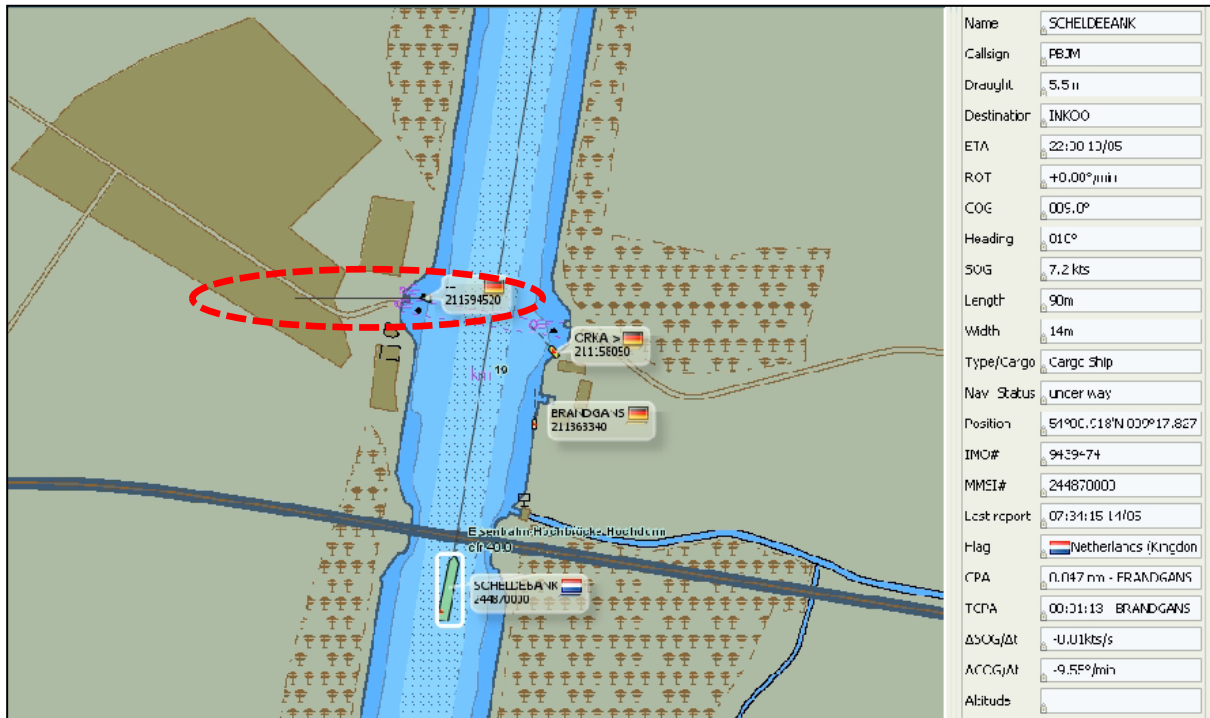
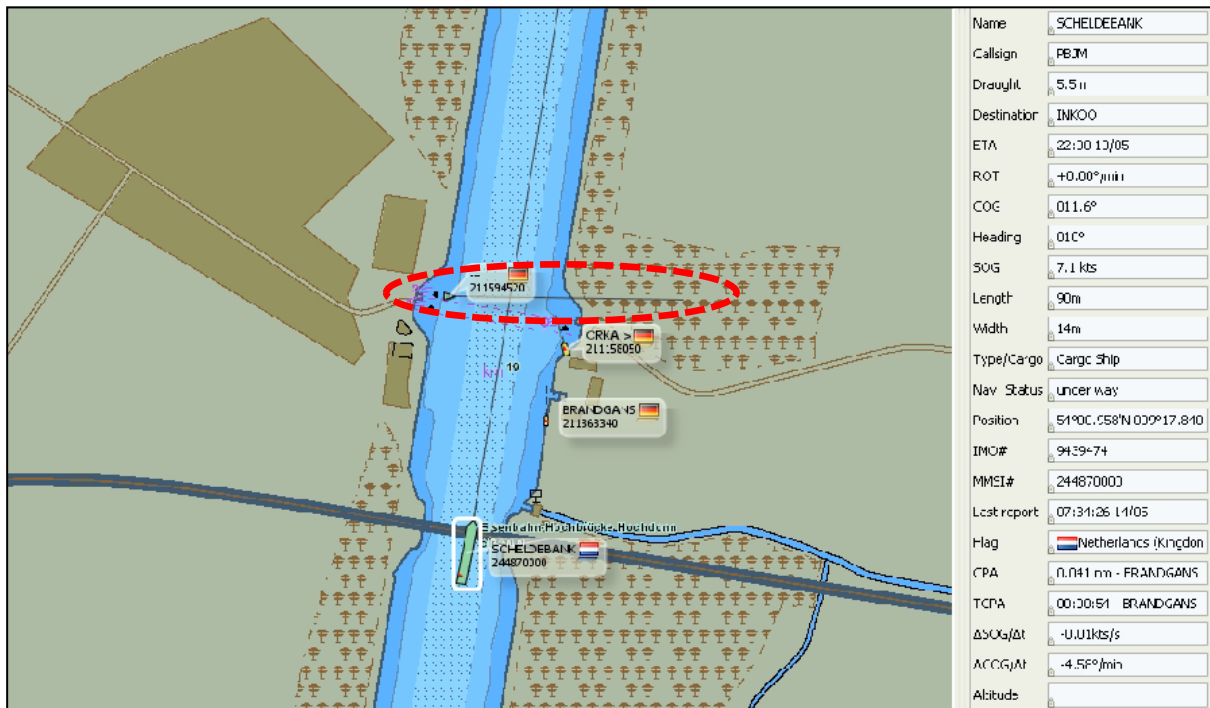
In **Figures 38 f.** below, the SCHELDEBANK has reached the railway bridge about 300 m away from the ferry line. The HOCHDONN's vector changes direction in the course of the two screenshots, i.e. it is directed towards the opposite bank of the canal from about 055428 UTC. However, the HOCHDONN's AIS symbol remains unchanged at the northern edge of the NOK.

Figure 38: WSV AIS recording (situation at 055416 UTC)

Figure 39: WSV AIS recording (situation at 055428 UTC)

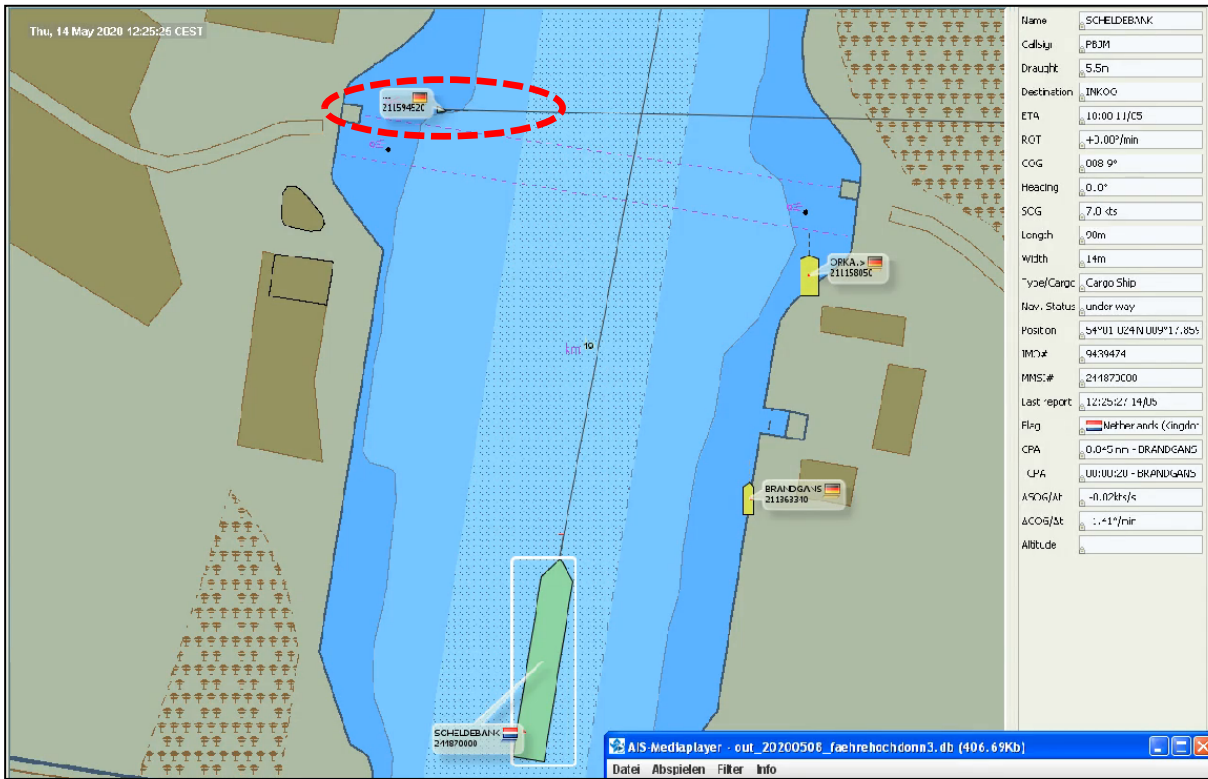
The ferry's apparent motionlessness has not changed after another 30 seconds (see **Figure 40** below). At this point, the SCHELDEBANK is still about 150 m away from the ferry line.

Figure 40: WSV AIS recording (situation at 055502 UTC)

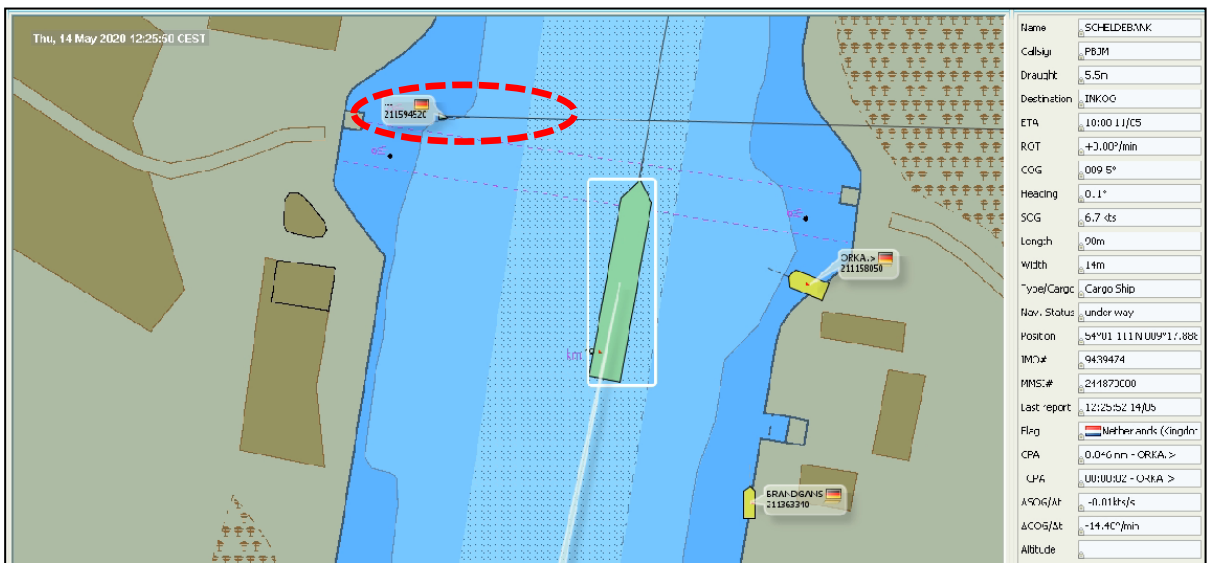
Figure 41 below shows the situation from the AIS view about 10 seconds before the collision. It still looks as if the HOCHDONN is waiting at the northern bank of the canal for the imminent passage of the SCHELDEBANK.

Figure 41: WSV AIS recording (situation at 055546 UTC)

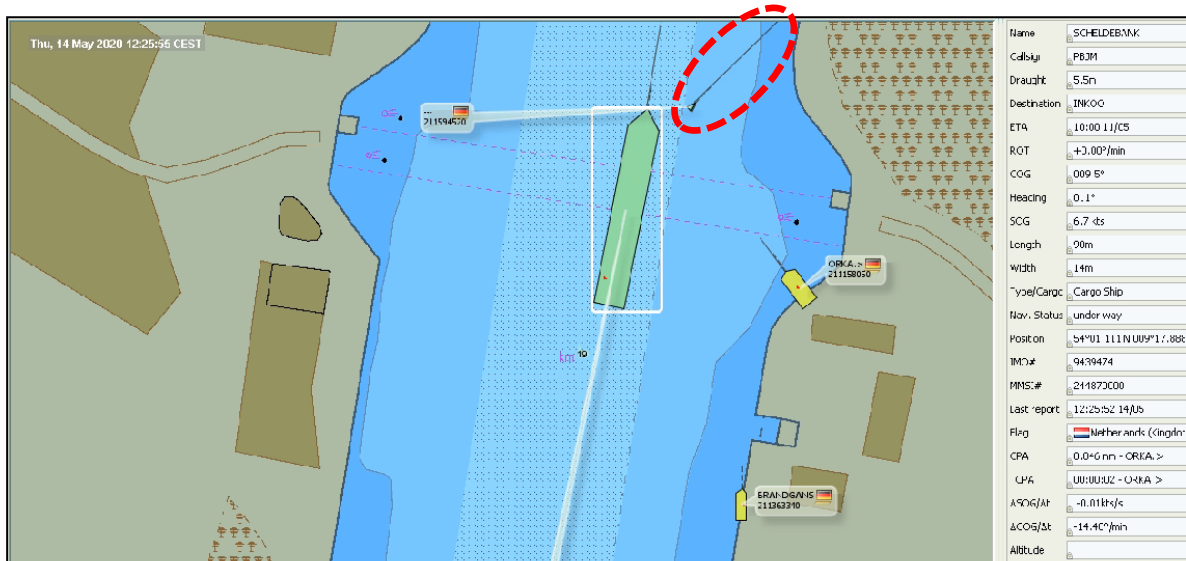
In the following image (see **Figure 42** below), the HOCHDONN's AIS signal has suddenly jumped to the opposite side of the canal. Meanwhile, the SCHELDEBANK (or her AIS signal) is passing the ferry line. Accordingly, the vessels had undoubtedly collided at or immediately before or after this point in time.

Figure 42: WSV AIS recording (situation at 055557 UTC)

All in all, the sequence of events described above demonstrates – even under the premise that the reporting rate⁴⁸ for dynamic AIS information with regard to the HOCHDONN (as well as the SCHELDEBANK) stood at 10 seconds – very clearly that their AIS device did not transmit the ship's own data correctly. The error in this respect should be taken as an indication that the device was generally defective on the day of the accident (i.e. with regard to transmitting the ship's own AIS data as well as with regard to receiving or displaying external AIS data).
