Bundesstelle für Seeunfalluntersuchung
Federal Bureau of Maritime Casualty Investigation

Investigation Report No. 261/20

**Fire in the engine room on board the ferry BERLIN in
the access to the port of Rostock on 13 August 2020**

30 November 2022

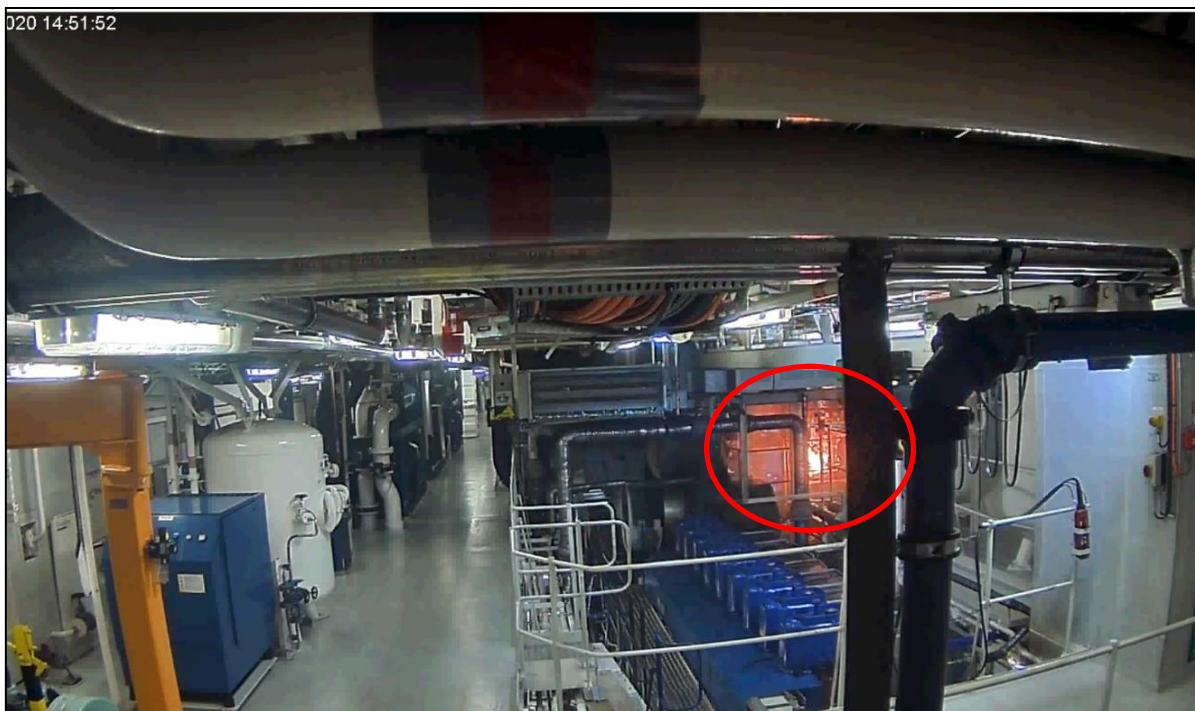
Figure 3: View of the fire from Deck 1⁸

Ship mechanic 2 (SM 2) meanwhile reached the scene via Deck 1. He saw flames and smoke in the area of ME 2 turbocharger.

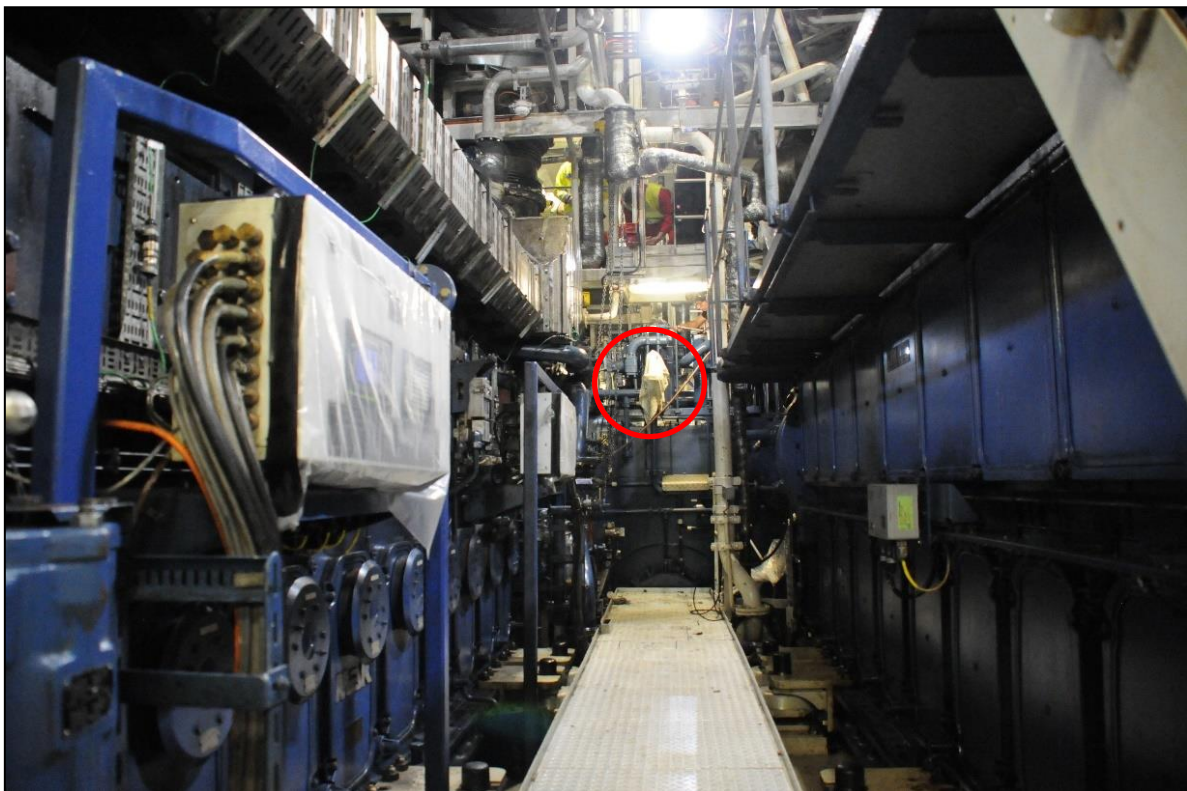
Figure 8: Leakage at the gearbox between ME 2 and ME 1

Adjacent areas, especially the exhaust duct, were extensively covered in oil due to a massive leak of hydraulic oil from the main gearbox. Before restarting the main engines, the oily insulation mats had to be completely replaced and the main engine room thoroughly cleaned. No persons were harmed as a result of the fire. Apparently, the firefighting measures and/or the boundary conditions of the event meant that the fire could be extinguished swiftly. It was possible to prevent the fire from spreading to neighbouring areas.

A broken double nipple was found to be the cause of the leakage. It is installed on the pipe of a gear oil transmission pipe and obviously broke due to material fatigue. Figures 9 to 16 illustrate this.

The expelled gear oil hit hot surfaces and caught fire.

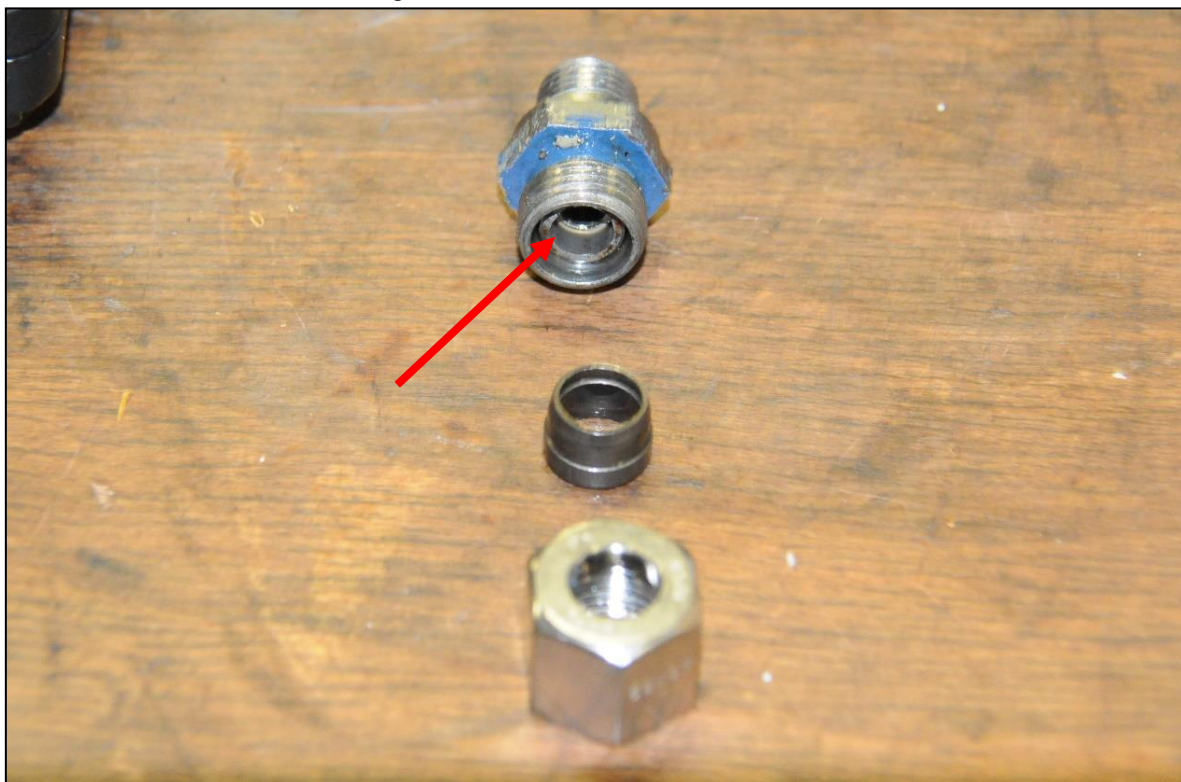
Figure 13: Cutting ring¹⁵ and pipe fragment of double nipple on the inside

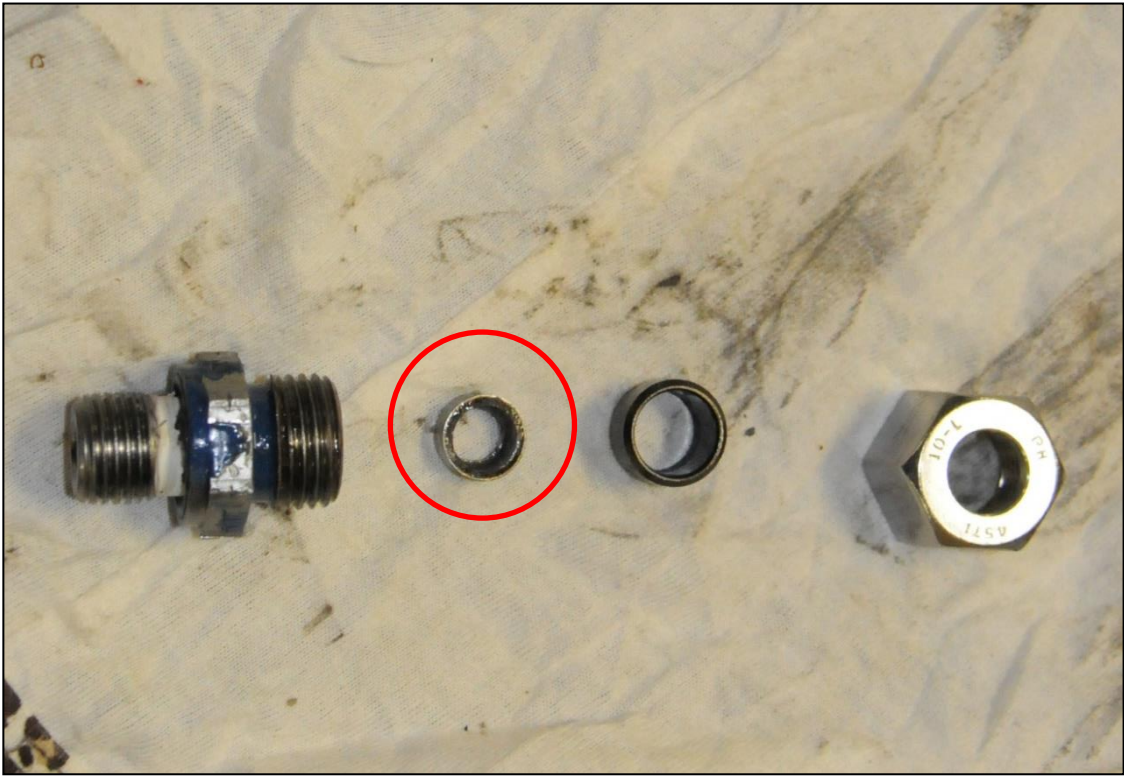
Figure 14: Fitting with broken-off piece of pipe

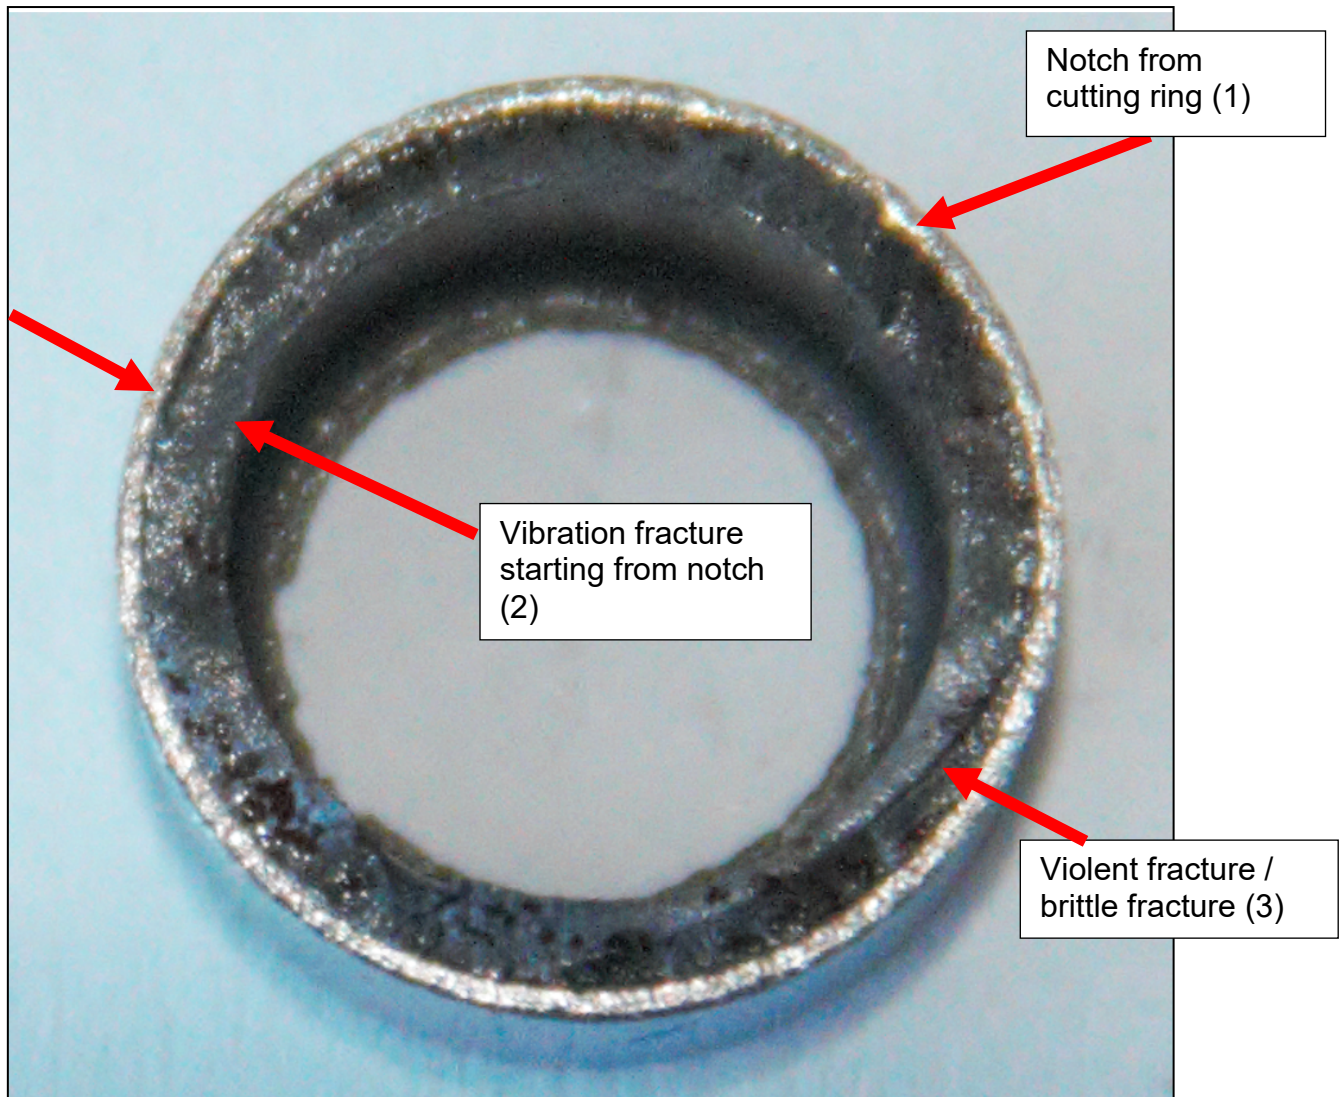
Figure 15: Pipe segment, notch from cutting ring outside and inner fracture surface

Figure 15 shows the fracture surface of the pipe inside the cutting ring connection (2). Component vibration promoted the propagation of the vibration fracture out from the notch edge (1). At some point, due to pressure and vibration load, the material was so weak that the remaining material broke abruptly (3).

Due to material fatigue, the double nipple of a pressure gauge on the pipe of a gear oil pipe broke. This resulted in gear oil spraying far into the engine room and onto hot surfaces, where it ignited. At the same time, this caused the oil pressure in the system to drop.

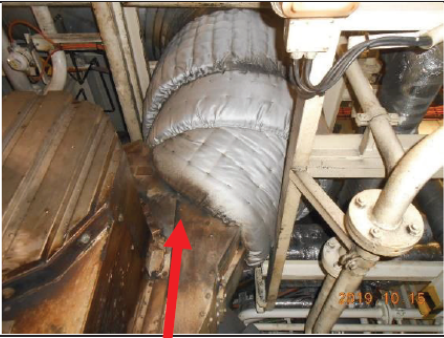
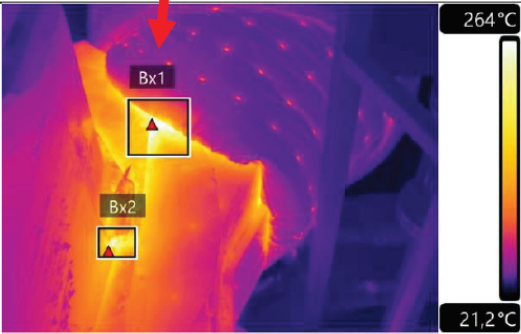
Customer:	M/F Berlin	Inspection date:	15. oktober 2019								
Position:	ME No. 2										
Area:	Insulation around the flange between T/C and exhaust pipe

Remarks: <i>Temperatures above 220 degrees Celsius.</i>

The points of maximum temperature Bx1 with 295.3°C and Bx2 with 297.5°C found in Figure 17 are clearly reflected in the post-fire damage pattern in Figure 18.

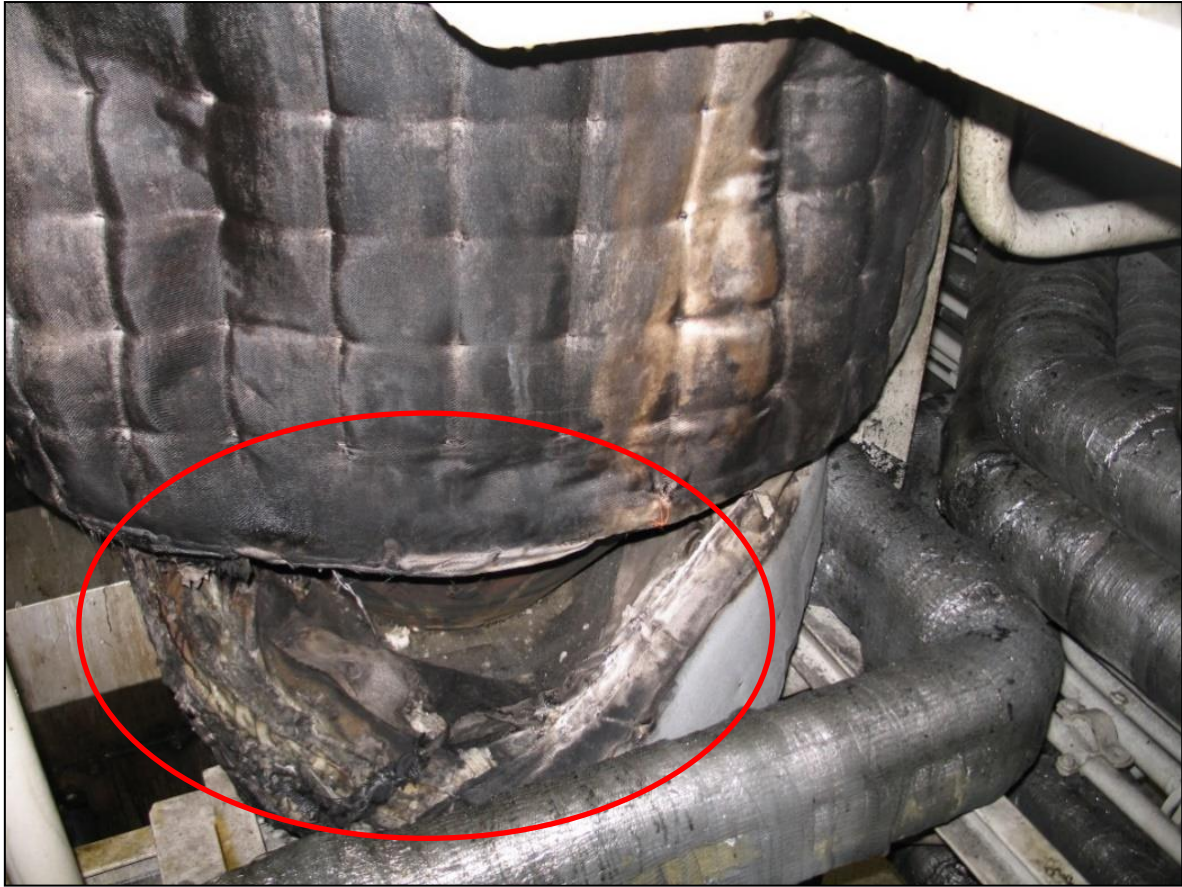
Figure 18: Burn marks on insulation mats of exhaust pipe

It is therefore not surprising that it was precisely these spots that showed particularly severe fire damage. It is highly probable that the escaping oil ignited immediately here.

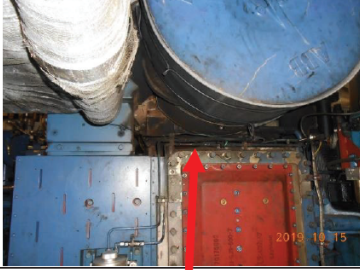
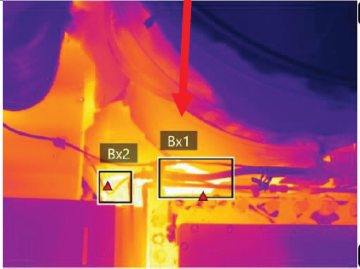
Figure 19: Area below turbocharger (air side)²⁰

Customer:	M/F Berlin	Inspection date:	15. oktober 2019
Position:	ME No. 2		
Area:	Engine

Remarks: <i>Temperatures above 220 degrees Celsius.</i>

FLIR0388 Objektemissivitet 0,95 Punkter - Bx1 Maksimum 255,2 °C Bx2 Maksimum 239,9 °C

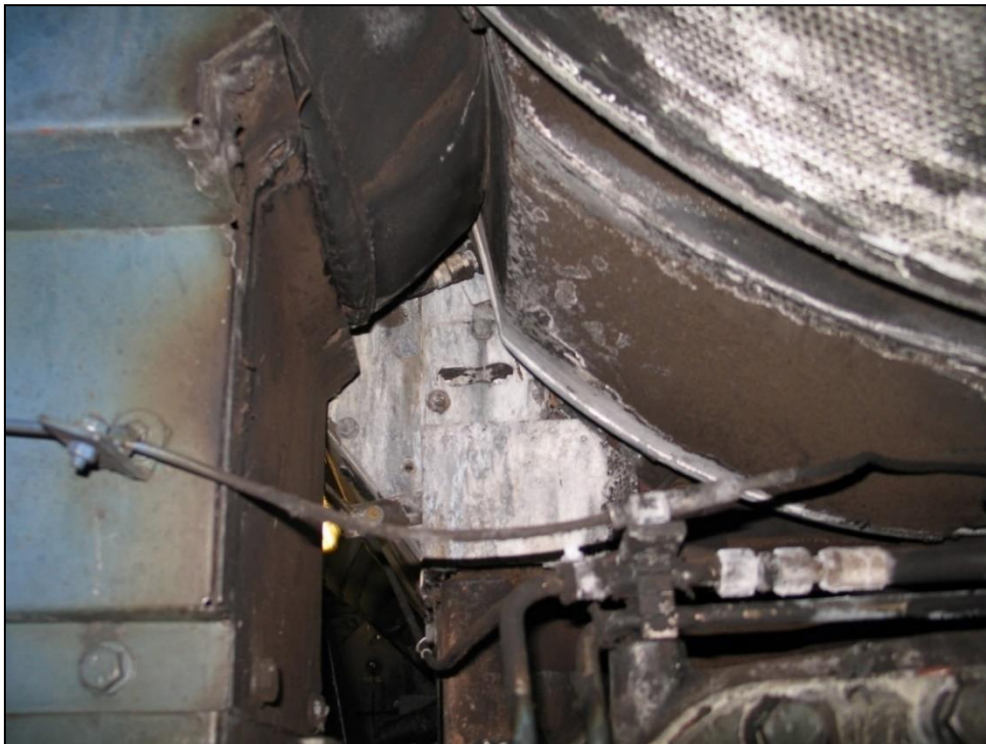
Figure 20: Fire damage to turbocharger insulation (air side)

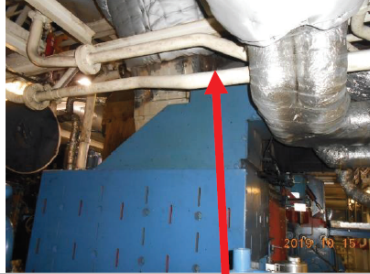
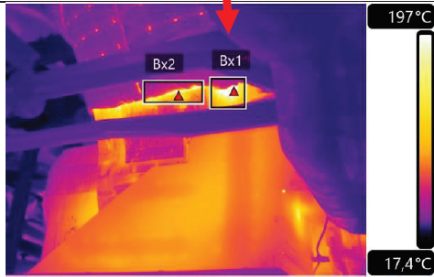
Figure 21: Area of turbocharger exhaust duct ²¹

Customer:	M/F Berlin	Inspection date:	15. oktober 2019								
Position:	ME No. 2										
Area:	Insulation around the flange between T/C and exhaust pipe

Remarks: <i>Temperatures above 220 degrees Celsius.</i>

Objektemissivitet	0,95	Punkter	-	Bx1 Maksimum	247,6 °C	Bx2 Maksimum	204,1 °C
Objektemissivitet	0,95										
Punkter	-										
Bx1 Maksimum	247,6 °C										
Bx2 Maksimum	204,1 °C

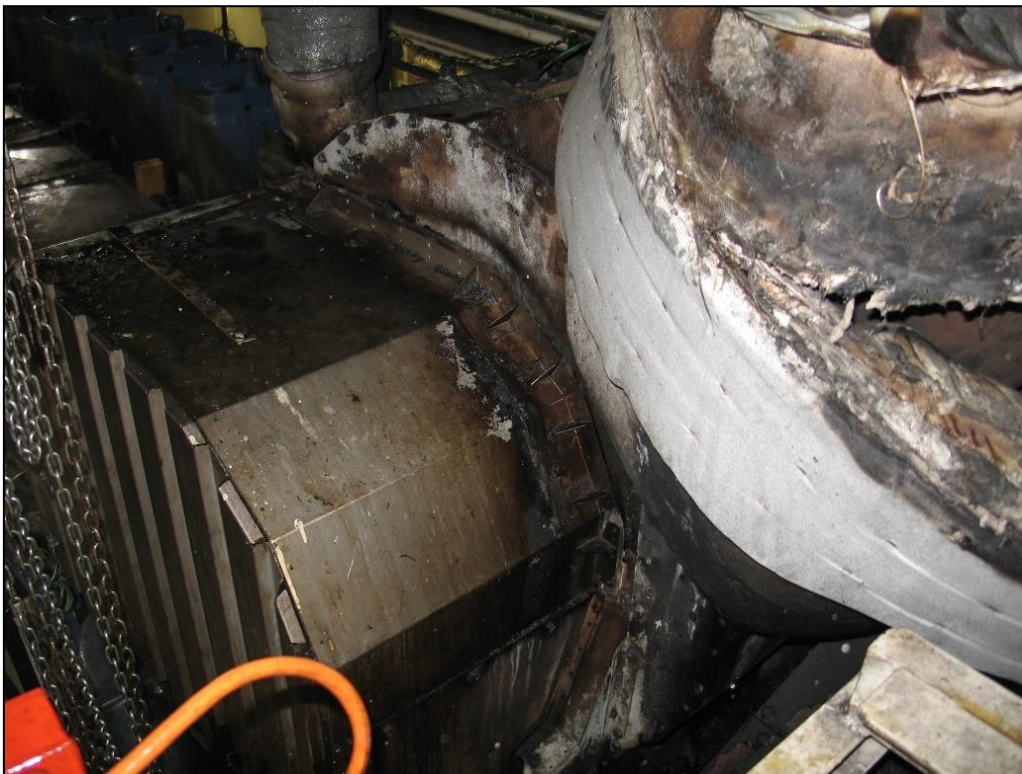
Figure 22: Fire damage to exhaust side insulation in area of turbocharger

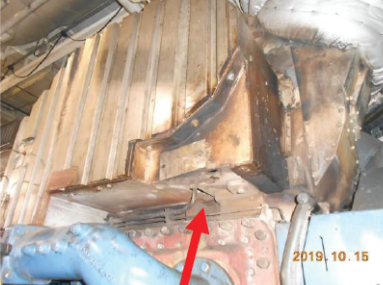
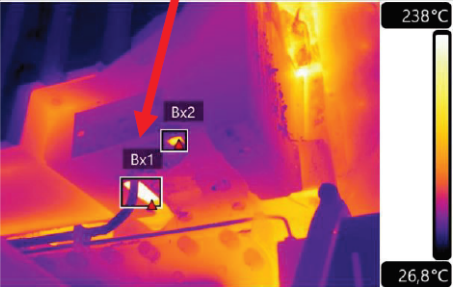
Figure 23: Area below turbocharger (exhaust side)²²

Customer:	M/F Berlin	Inspection date:	15. oktober 2019								
Position:	ME No. 2										
Area:	Engine

Remarks: <i>Temperatures above 220 degrees Celsius.</i>

Objektemissivitet	0,95	Punkter	-	Bx1 Maksimum	352,7 °C	Bx2 Maksimum	196,1 °C
Objektemissivitet	0,95										
Punkter	-										
Bx1 Maksimum	352,7 °C										
Bx2 Maksimum	196,1 °C

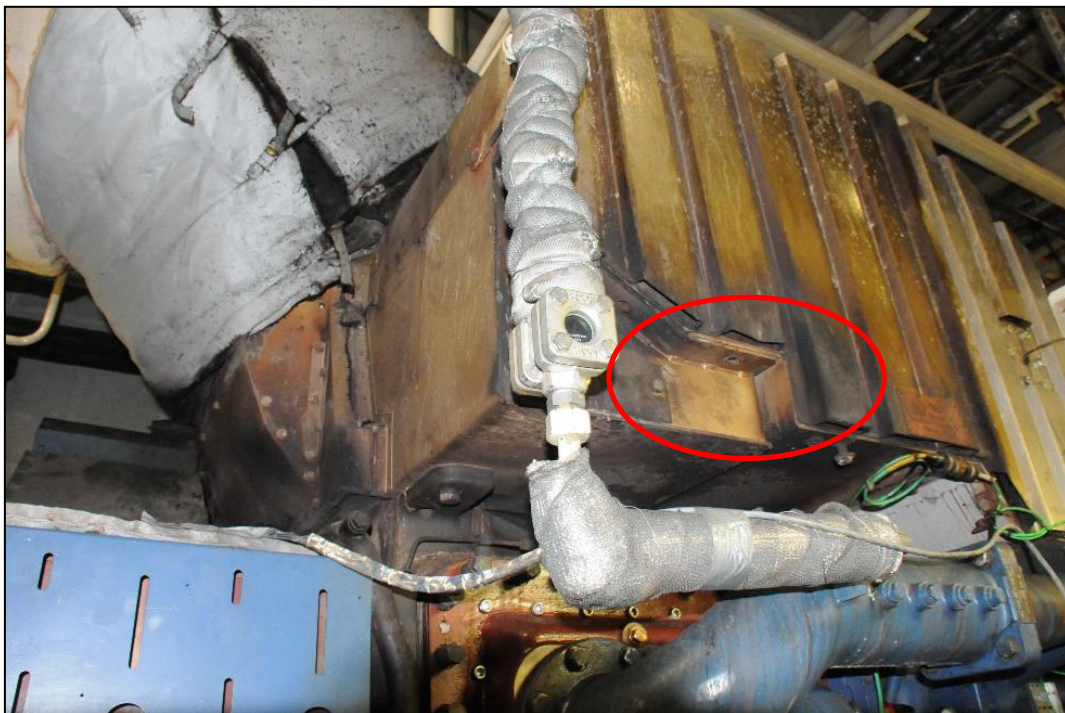
Figure 24: Burn marks on outside of turbocharger (exhaust side)

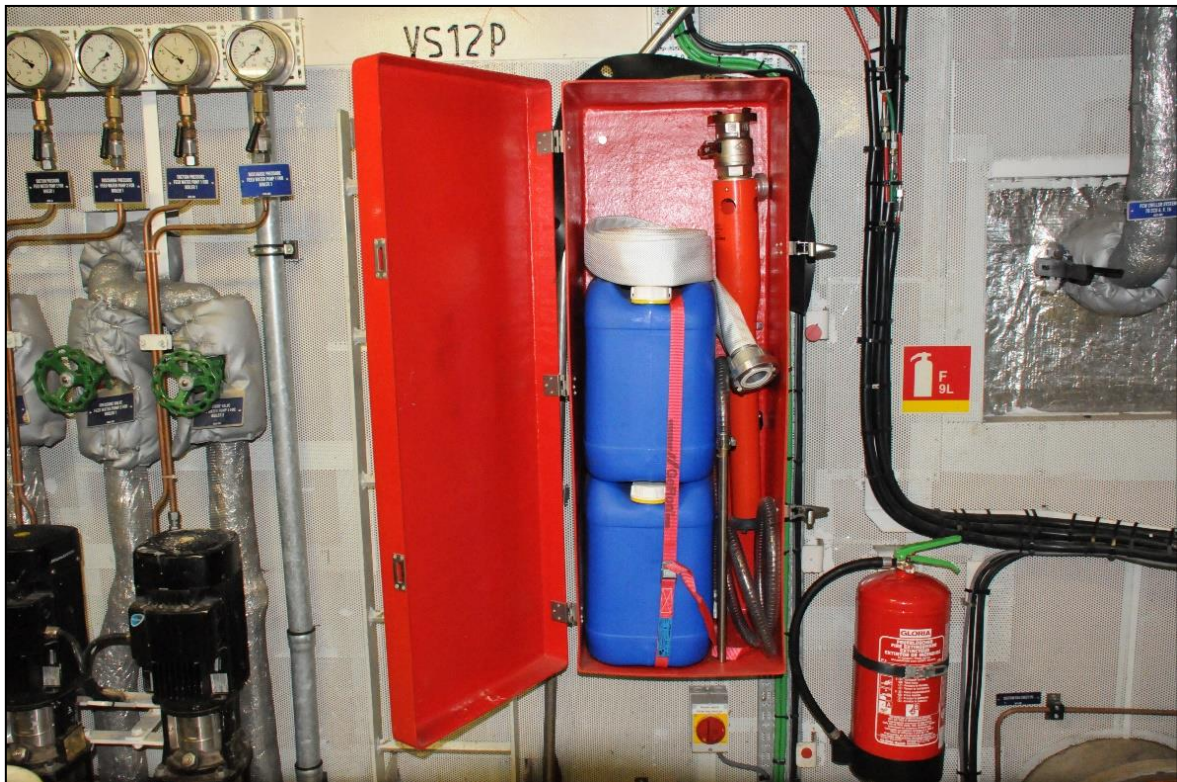
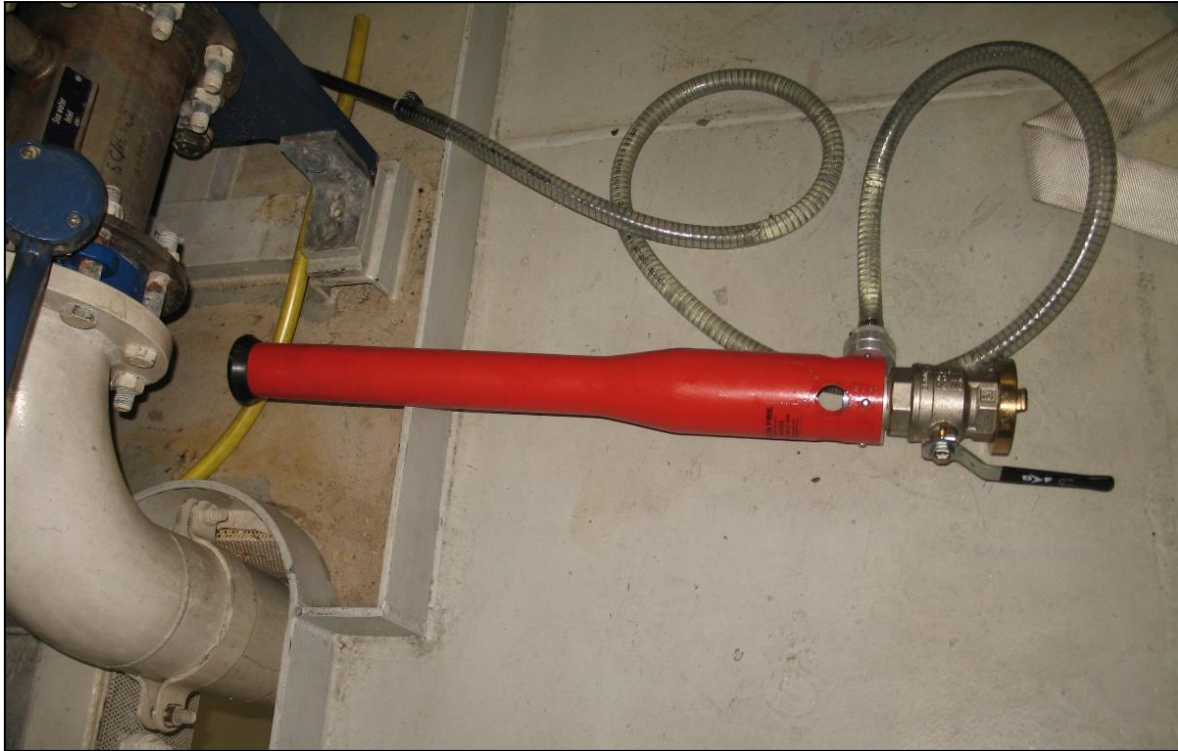
- Effectively not usable under real-life conditions, since the foam agent container (approx. 20 kg) must be carried along all the time. Also, the suction hose with its length of approx. 1.2 m allows hardly any free movement and thus no effective firefighting effort. (see Figure 26 and Figure 27)

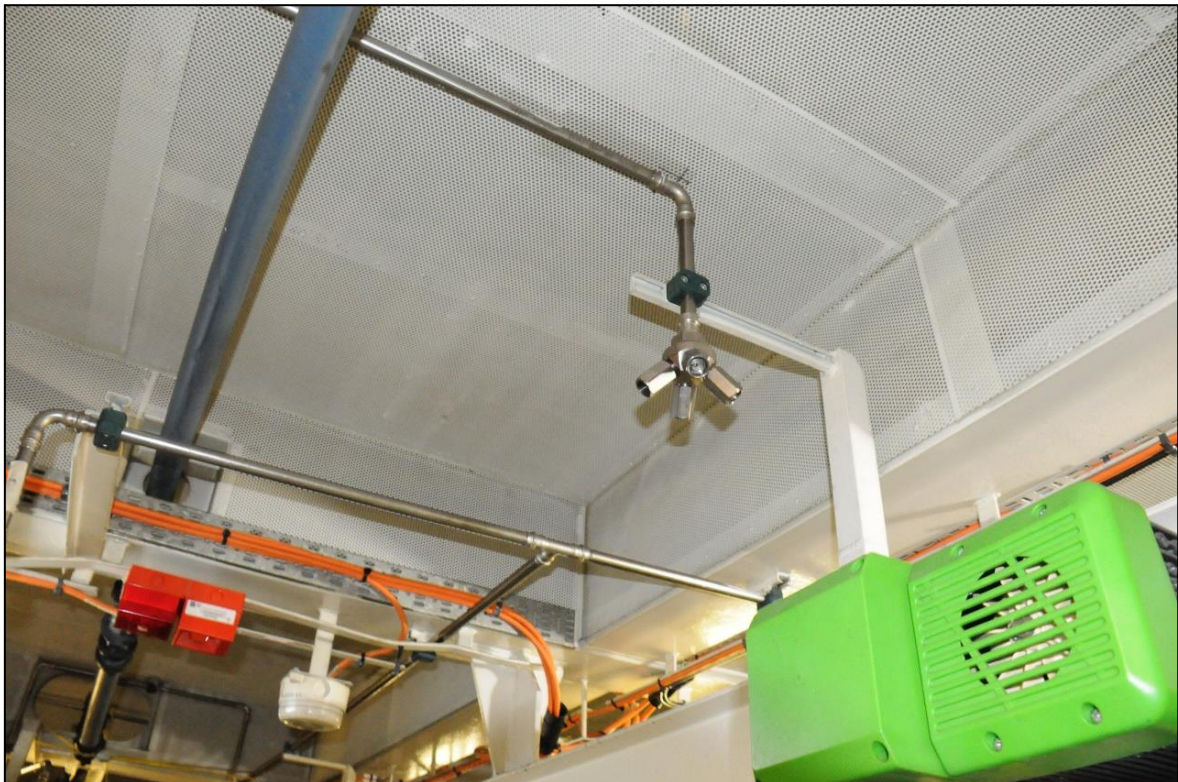
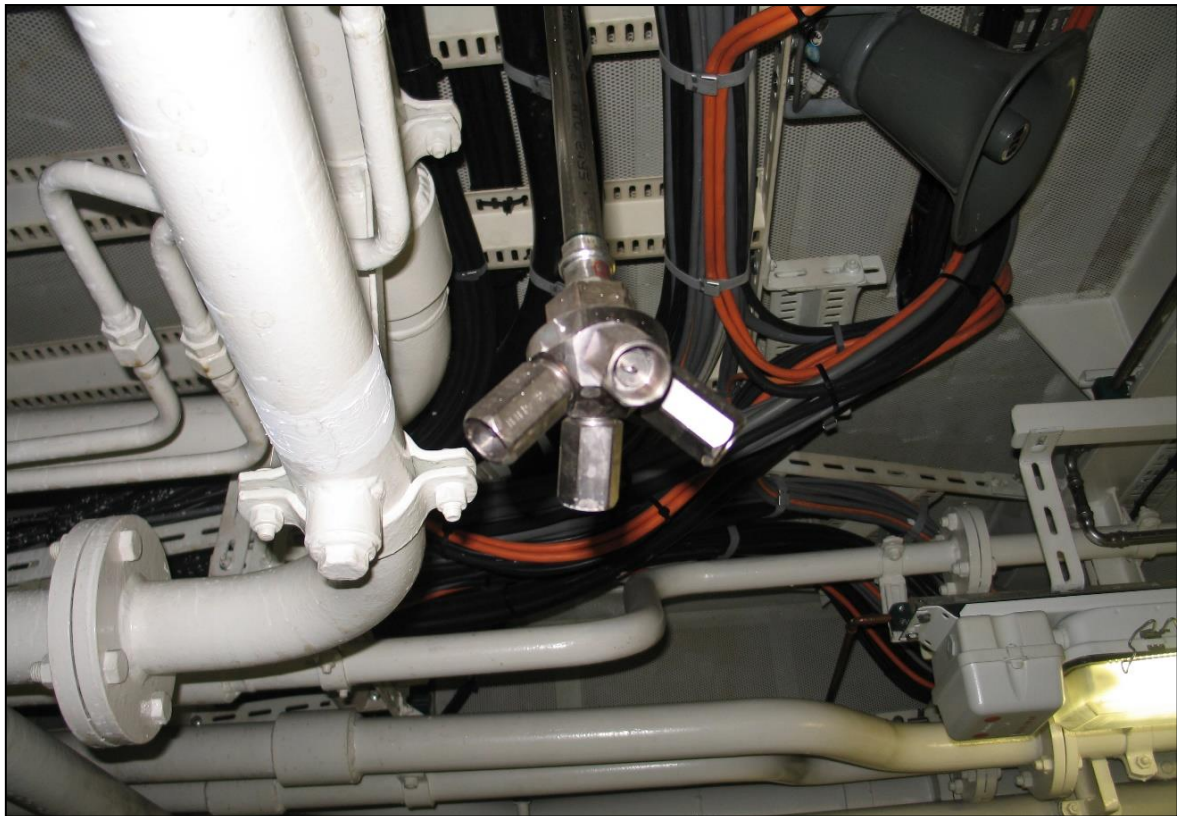
- Low-pressure system of the simplest design, nozzle head with four solid, X-shaped individual nozzles
(X Flow 4x NHP2, 9.5 bar)
- The system for the aft and forward exhaust duct is directly connected to the system (section) of the adjacent main engine room. This means that the room protection system for the exhaust duct cannot be triggered separately. A separate object protection system for the exhaust ducts does not exist (see Figures 30 and 31).
