Bundesstelle für Seeunfalluntersuchung
Federal Bureau of Maritime Casualty Investigation

Investigation Report 276/21

**Foundering of the sailing boat SILJA and death of a
crew member in the Accumer Ee tidal inlet on
26 August 2021**

8 December 2022

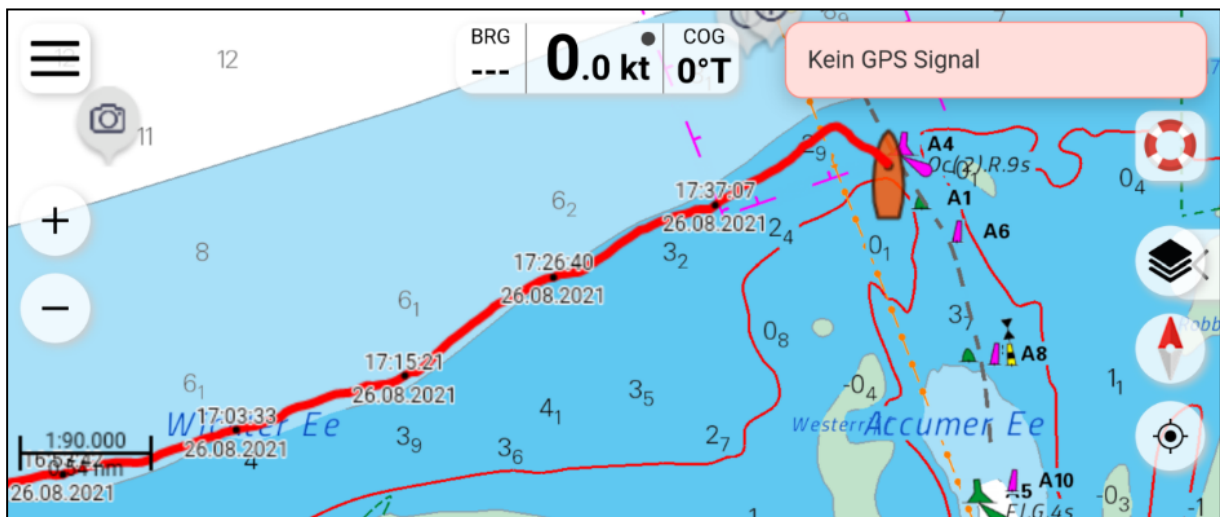
Figure 6: The SILJA's track recording – Accumer Ee²⁴

In the fourth wave, the boat luffed on port and was no longer steerable. It was during this or the next breaking wave that the boat capsized.

According to the track recording on the smartphone, the SILJA capsized at 1749.

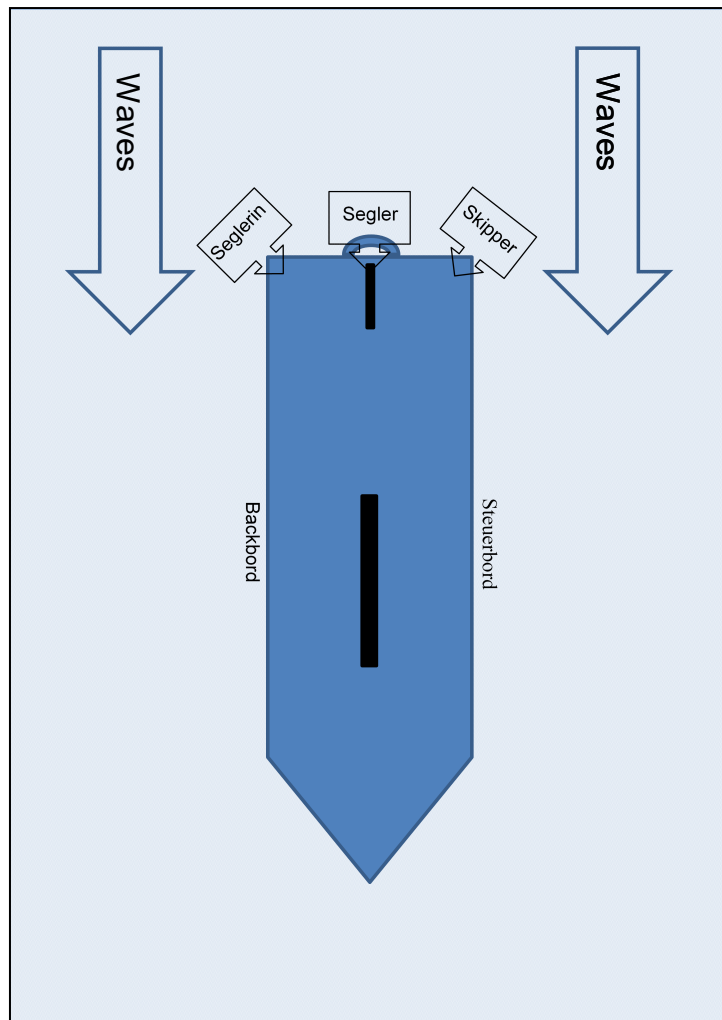
Figure 9: Situation after the boat capsized (drawing)

The skipper noticed his boat was lying deeper and deeper in the water and concluded she was foundering.

The boat's mast had snapped and the SILJA was lying so deep in the water that the skipper was able to swim into the cockpit. Once there, he considered whether the water could be removed from the boat with pumps or buckets. Shortly afterwards, the unlocked locker seats opened and filled up. The SILJA foundered.

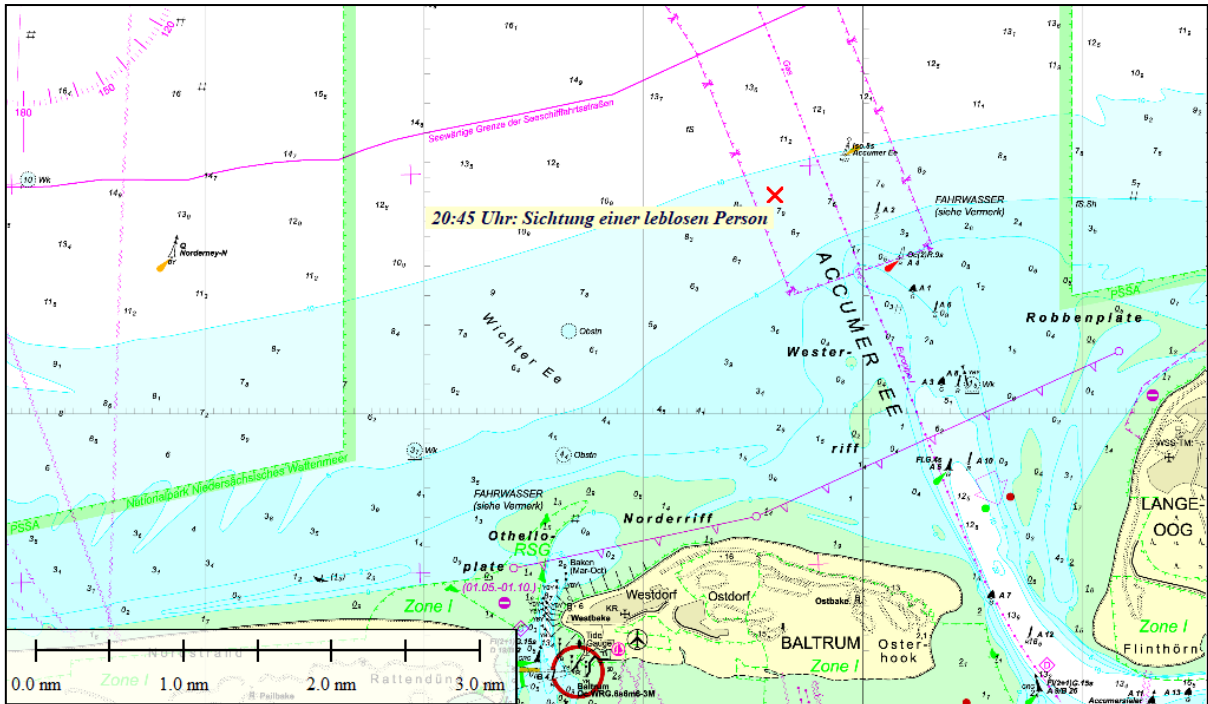
Figure 20: Position of the lifeless body sighted⁴³

At 2045, the SRK EUGEN sighted a lifeless body at the position ϕ 53°46.48'N, λ 007°24.21'E. Due to the state of the sea, the SRK was unable to move to the body floating in the water. The SRB ELLI HOFFMANN-RÖSER was called to assist by recovering the body via her rescue gate.

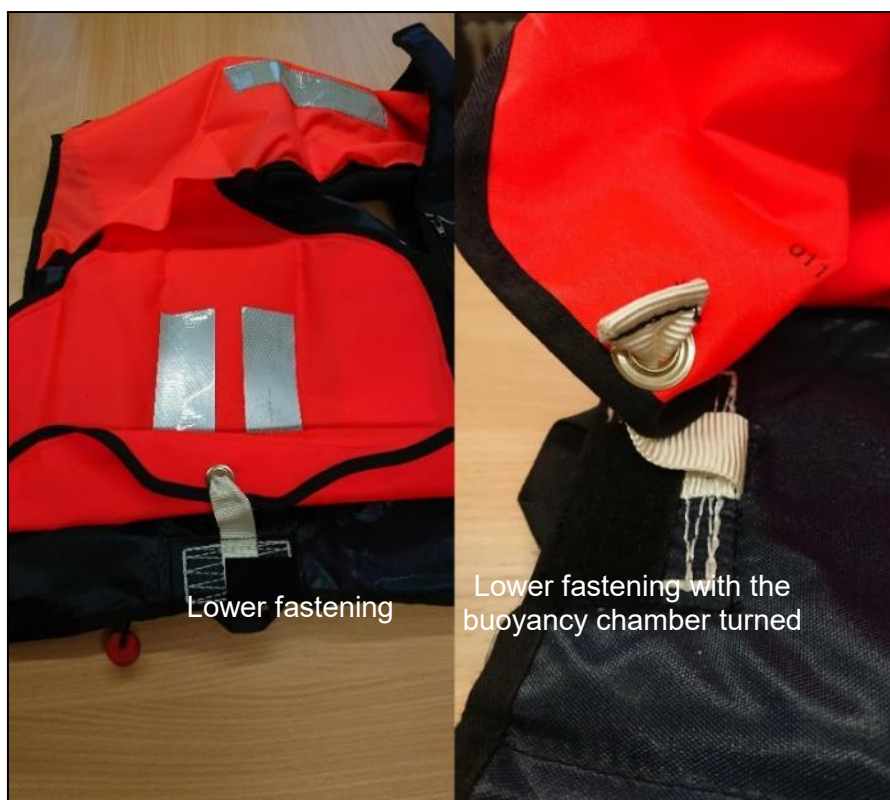
Figure 48: Comparable fastening on a BSU inflatable work vest¹²⁸

However, after an indeterminable period of time, at the latest after the SILJA foundered, the buoyancy chambers on the lifejackets of all three sailors were floating more or less next to their bodies. The buoyancy chamber fastenings had become detached from the protective covers (with integrated harness) at the bottom of the lifejackets and in the case of two of the three lifejackets were only connected to their lifejacket harness at one point.

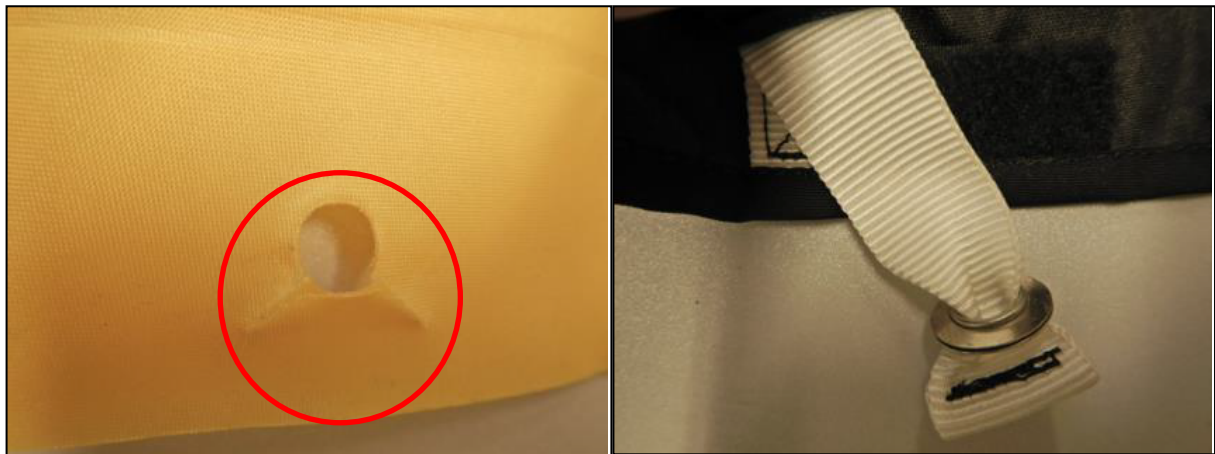
Figure 56: Torn textile surface/torn-out thimble ¹⁴⁵

In the first tensile test, a force acting parallel to the body was simulated on the inflated buoyancy chamber. Such a force can occur when a person floating in the water is rescued by pulling only at the neck of the inflated buoyancy chamber (Annex 5). At a test force of 0.82 kN, the thimble tore from the textile surface of the buoyancy chamber at one of the two connection points and the damage pattern was similar to the casualty's damaged buoyancy chambers.
