Investigation Report 282/20

Serious Marine Casualty

Grounding of the RUBINA after steering gear failure on the River Weser on 27 August 2020

7. April 2022

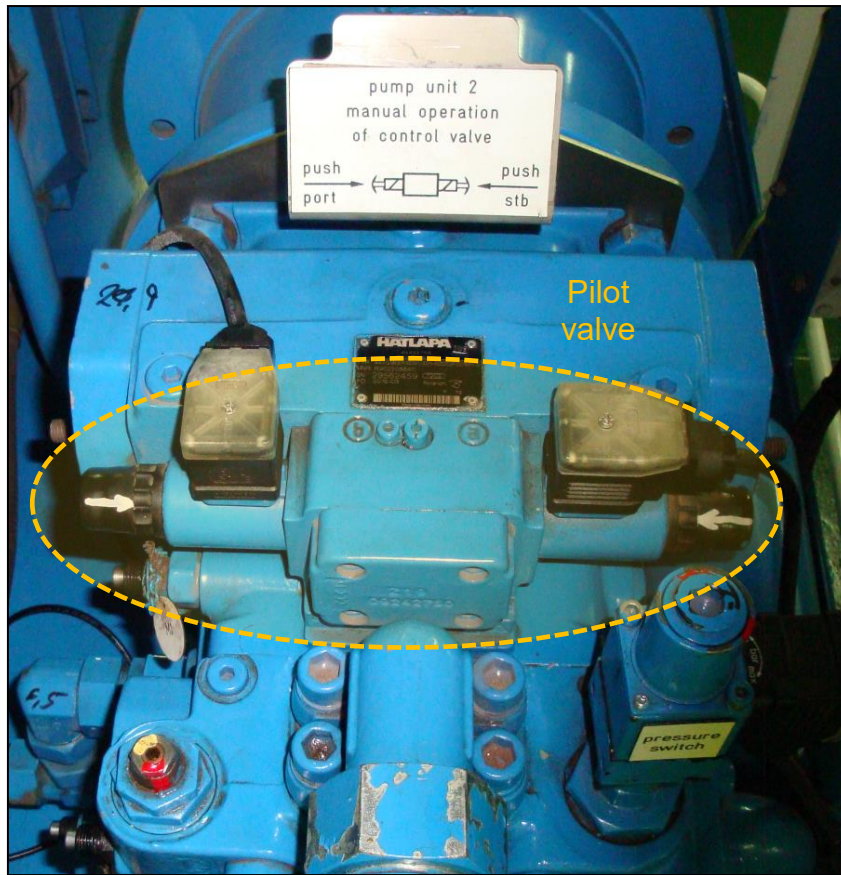
Figure 10: Steering pump 2's pilot valve, incl. brief guide for the emergency control

The cause of the non-responsive rudder was found to be a pilot valve of steering gear pump no. 2, which had stuck in an open position for a while. It was not possible to establish conclusively what had caused the pilot valve to stick.

It was suspected that the valve had stuck due to a tiny contamination, e.g. a very small piece of metal filing. This had probably jammed the sliding surface of the valve's control piston, and later come loose during the manual emergency operation (directly at the valve). It could not be found afterwards. According to the service engineer, it is known that this can happen. He was not able to establish the ultimate cause of the problem.

- Since no faults were found on the automation side, a mechanical problem must have caused the accident.
- The pilot valve of pump no. 2 apparently stuck in an open position for a while due to a small contamination. Briefly, it remained fully open and pumping to the starboard side.

Steering pump no. 2 must have been the source of the problem (the 'Overload' alarm had triggered there). Therefore, the RUBINA's chief engineer decided to replace this pump completely as a precaution, following the recommendation of the service engineer. This was carried out on 18 September 2020 in the next port (Houston). It was purely a precautionary measure deemed necessary in view of the accident (the service engineer had not been able to detect any damage to the pump).

After careful troubleshooting, the rudder pump with the stuck valve was completely replaced, as mentioned above. This exceeded the measures that would have been necessary following the service engineer's troubleshooting, but was consistent with his recommendation. The RUBINA's rudder has not jammed again since then.

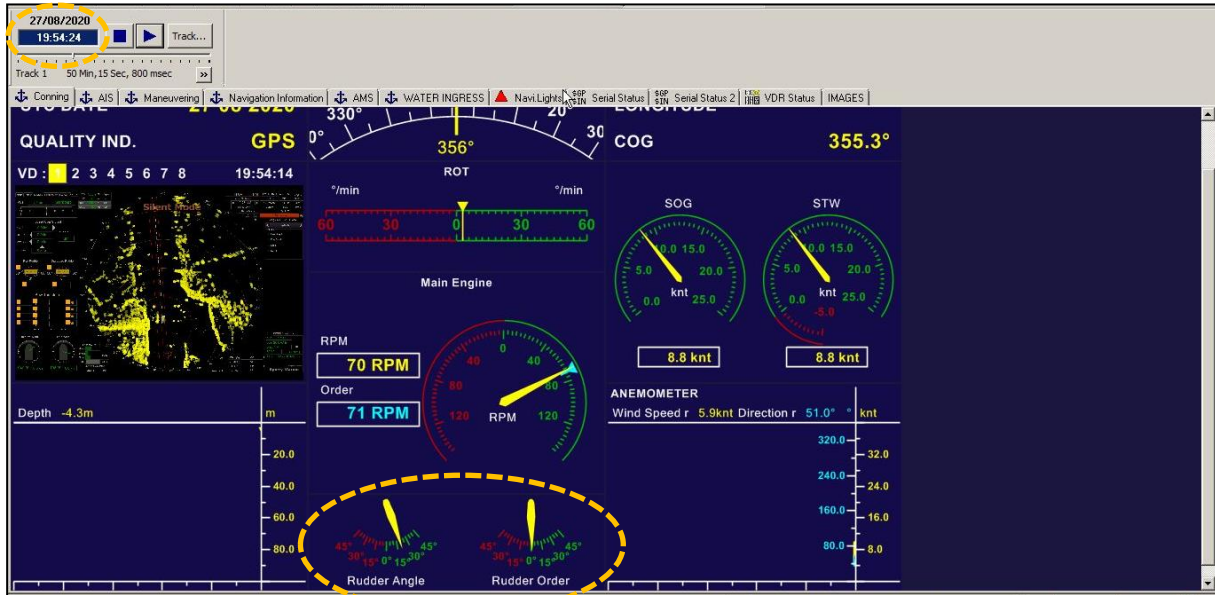
Figure 14: VDR: Non-responsive rudder (first occurrence)²⁸
(215424 local time)

For example, the system deviation between the rudder angle of 15° starboard and the rudder order (midships) on the hand wheel at the time it first occurred is clearly visible (see Figure 14).

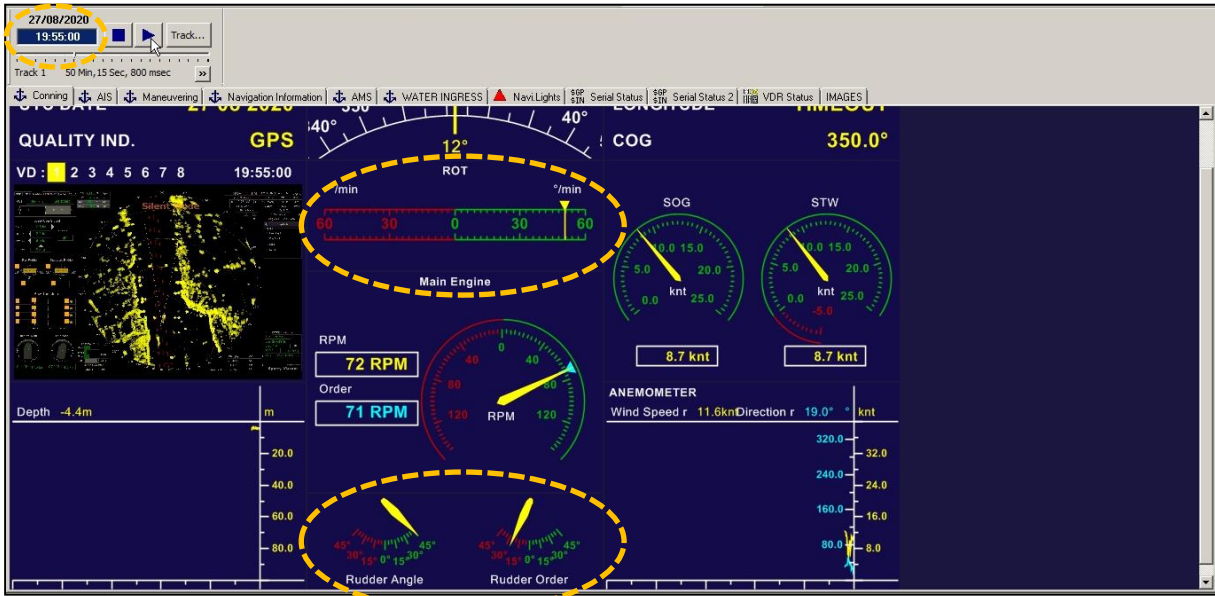
Figure 15: VDR: Hard-over rudder angle and ROT about 30 seconds later (215500 local time)

About 30 seconds after failing to respond for the first time, the rudder had already deflected to the hard-over angle (despite the hand wheel position in the opposite direction – see rudder order). The ROT is already about 50 °/min. (For both see Figure 15.)

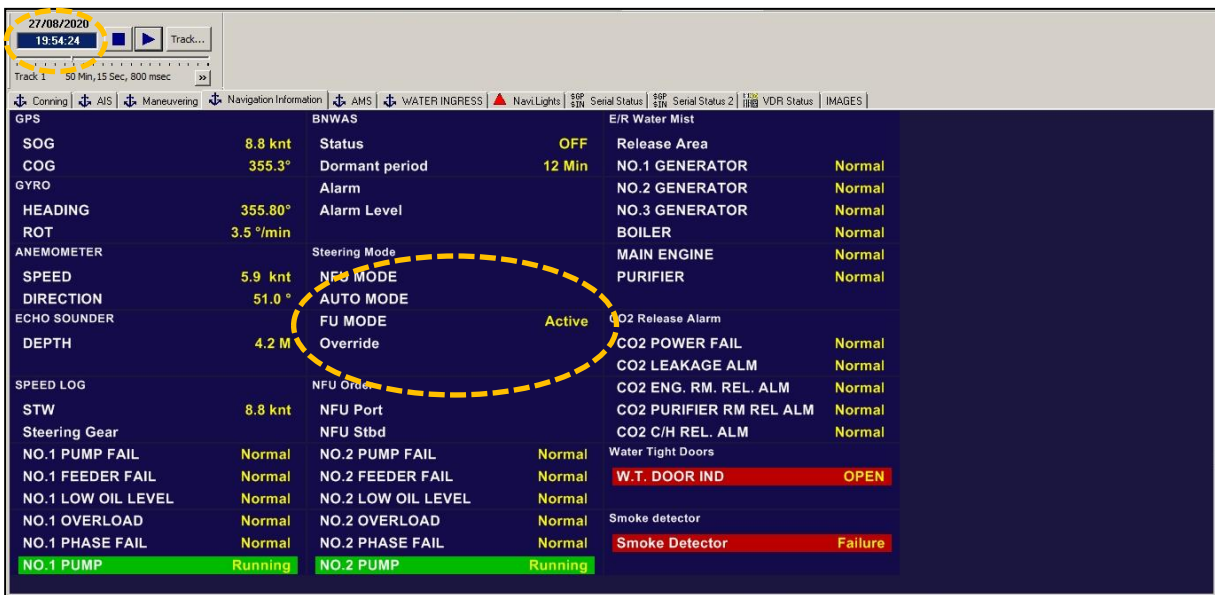
Figure 16: VDR: Non-responsive rudder (first occurrence) (215424 local time)

(The closed-loop control is still trying to compensate for the system deviation and is not indicating any kind of failure.)

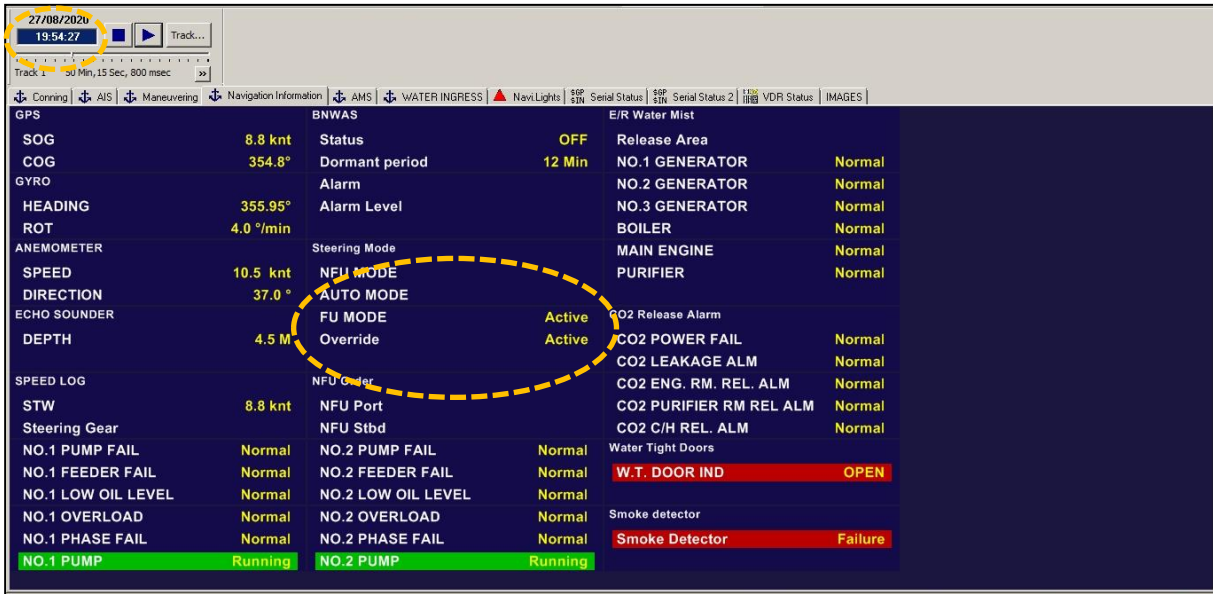
Figure 17: VDR: Override about three seconds later (215427 local time)

(Since the closed-loop control was unable to resolve the problem, the first emergency steering stage, i.e. the override, was activated.)

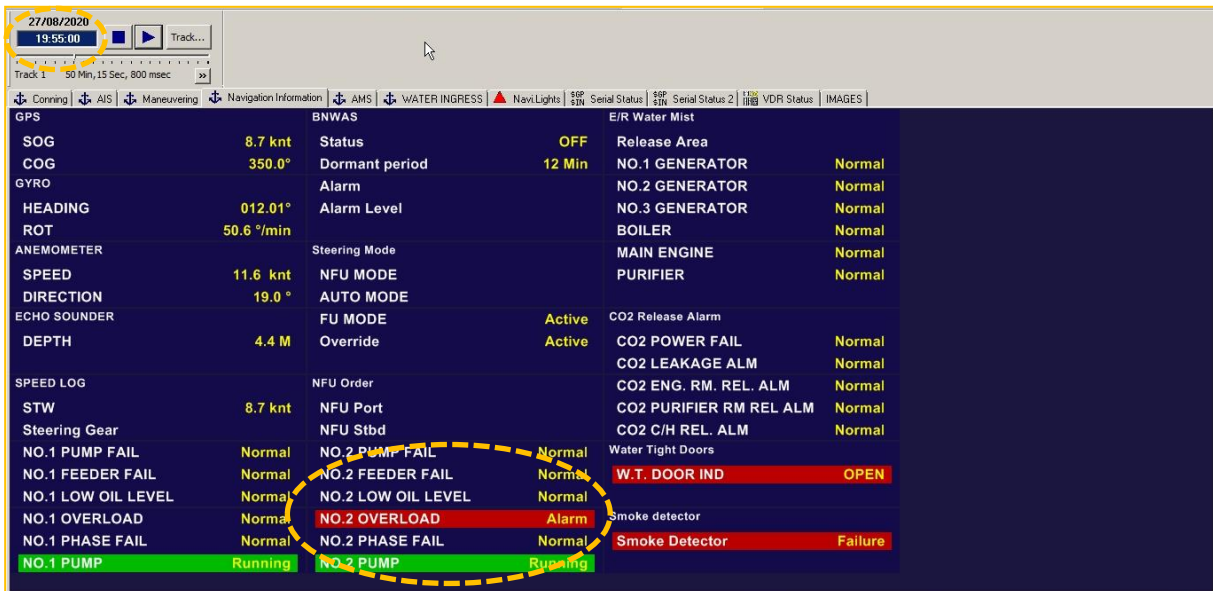
Figure 18: VDR: Steering gear pump alarm (215500 local time)

A good 30 seconds after the first occurrence, the 'Pump No. 2 Overload' alarm first showed (Figure 18)²⁹.

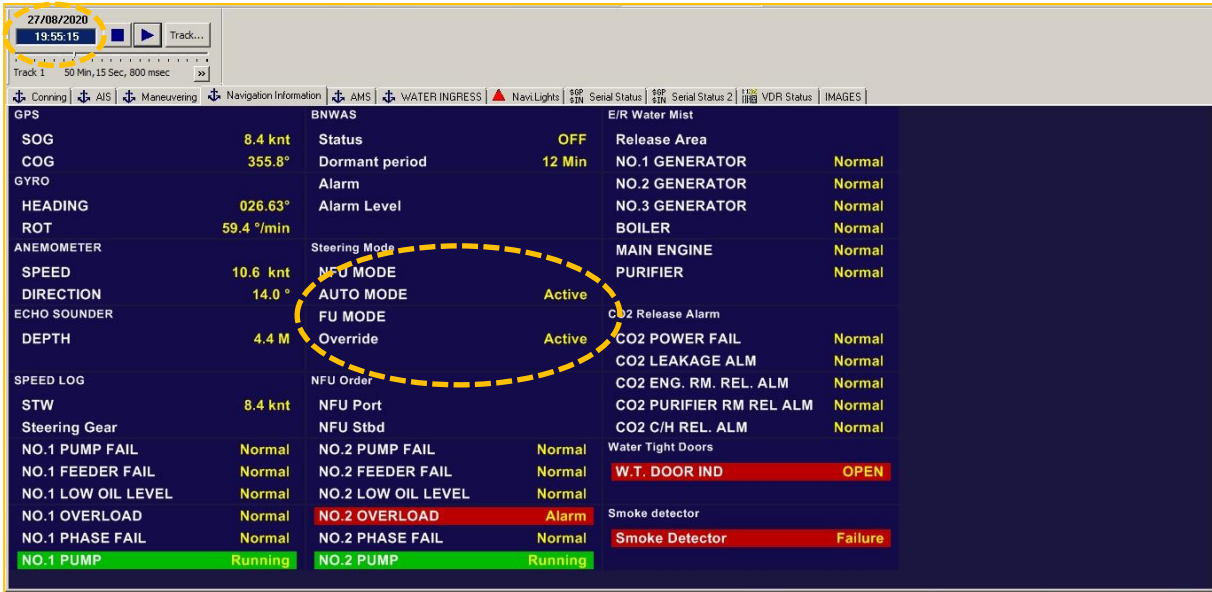
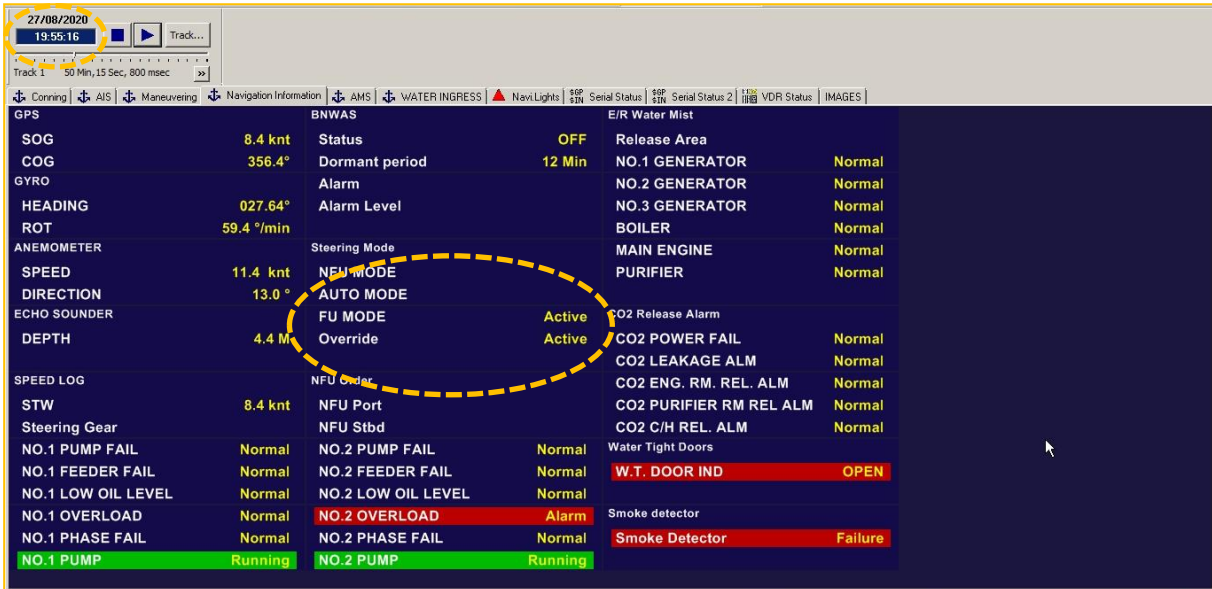
Apparently, several unsuccessful attempts were made to regain control of the hand wheel by switching to 'Auto' steering mode and immediately back again. The VDR data clearly show this (Figure 19 and Figure 20).

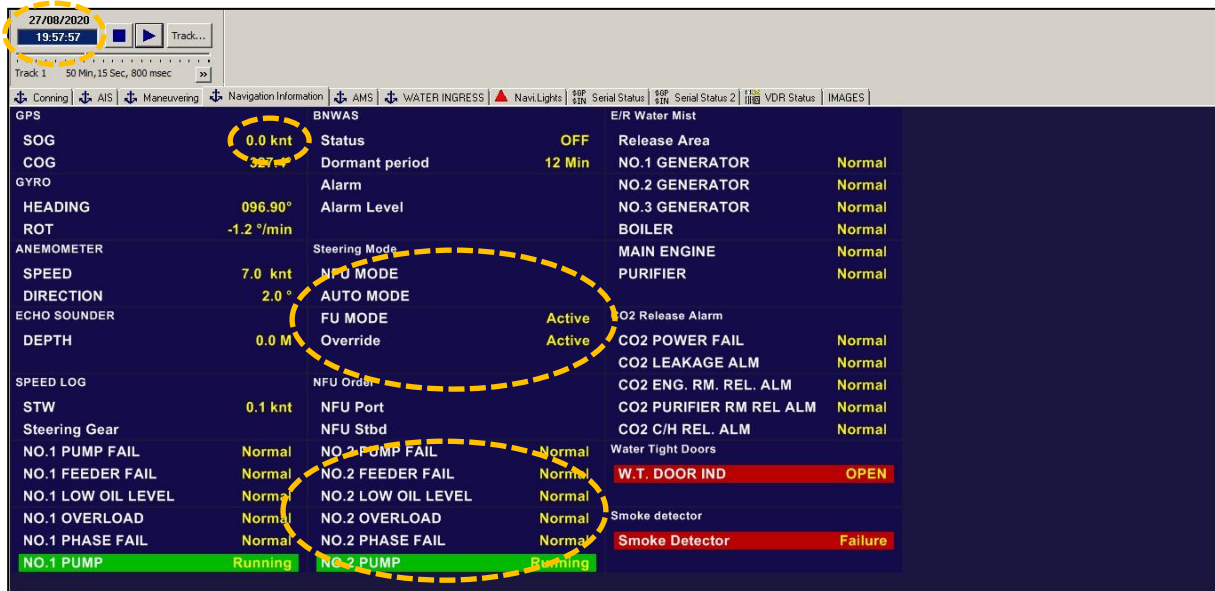
Figure 21: VDR: Time of grounding (speed: 0.0 kts³⁰).
(215757 local time)

(The steering pump is already being operated manually here and no longer pumping against any resistance, i.e. a 'pump overload' no longer exists.)
