Bundesstelle für Seeunfalluntersuchung
Federal Bureau of Maritime Casualty Investigation

Investigation Report 285/20

Serious Marine Casualty

**Allision with a lock gate at Kiel-Holtenau on the
Kiel Canal (NOK) by the multi-purpose vessel ELSE
on 29 August 2020**

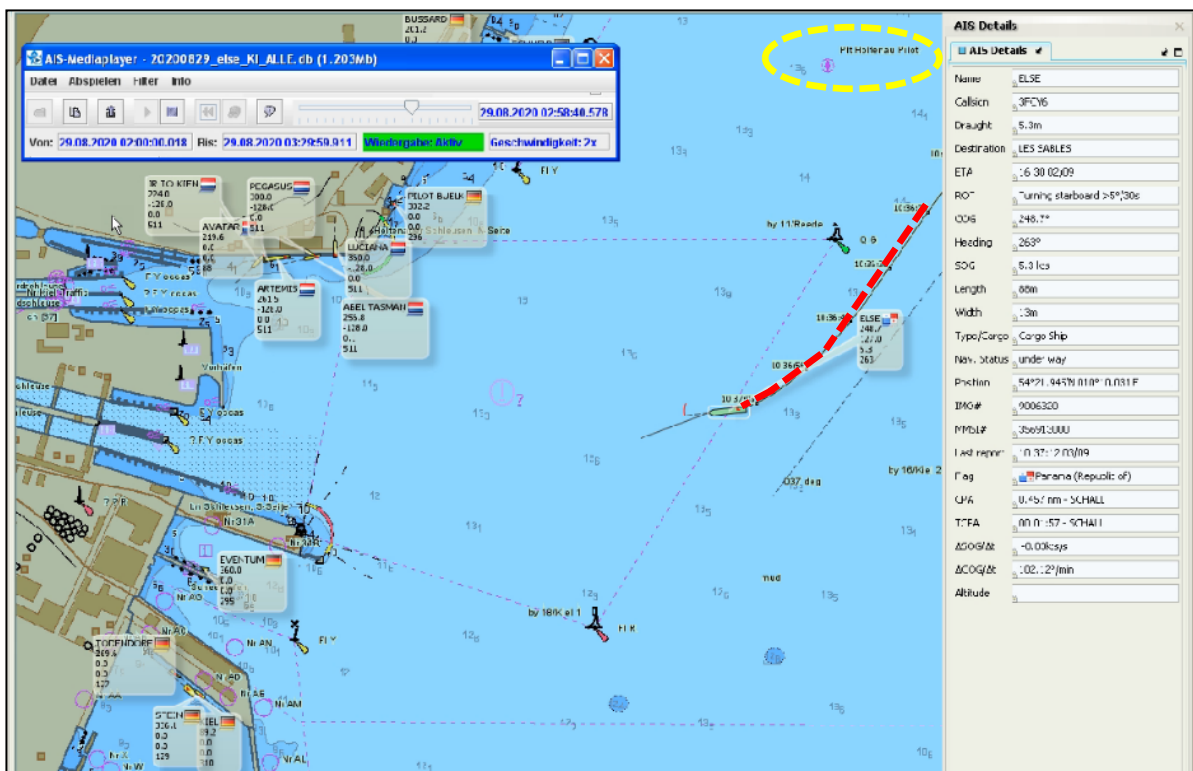
The ELSE passed the navigational chart position of the pilot boarding point (see yellow highlighting below in **Figure 3**) abeam at about **0453** but continued her voyage without making any significant course or speed alterations and without reporting in to VTS NOK or the pilot station.

The ship then began to leave her aforementioned general course at about **0457** and turned purposefully towards the Kiel-Holtenau lock entrance, maintaining a speed of just under 6 kts (see red highlighting in **Figure 3**). It was not possible to verify whether this course alteration was carried out by a helmsman – as claimed on the ship – or the chief mate personally. However, the sources of information evaluated by the BSU indicate that the master was not on the bridge at that time.¹⁷

Figure 3: The MV ELSE alters course towards Kiel-Holtenau (0458)¹⁸

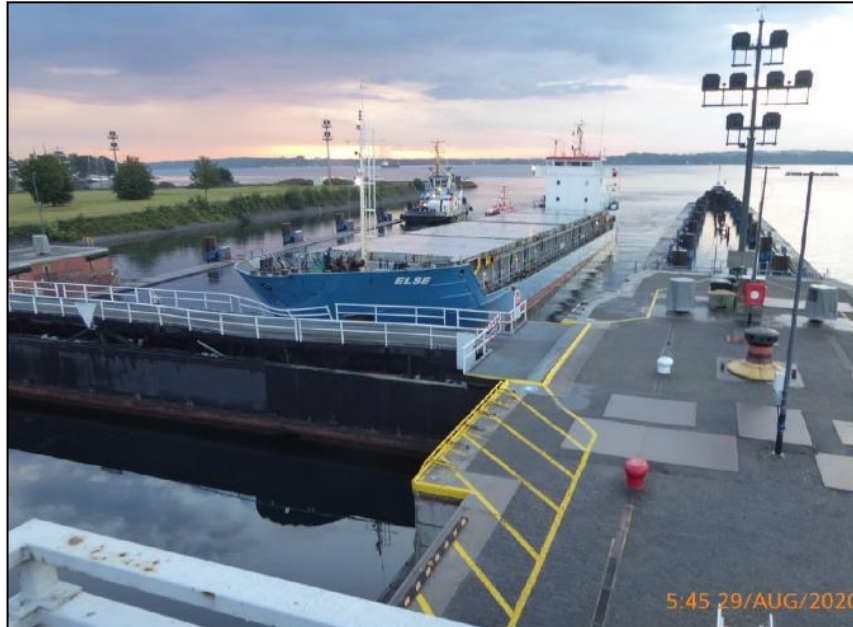
Instead, the ELSE's bow remained trapped there (see **Figure 4 f.** below) and this condition persisted until the arrival of the tugs **STEIN** and **HOLTENAU**.

Figure 4: MV ELSE with her bow in the lock gate (1)²¹

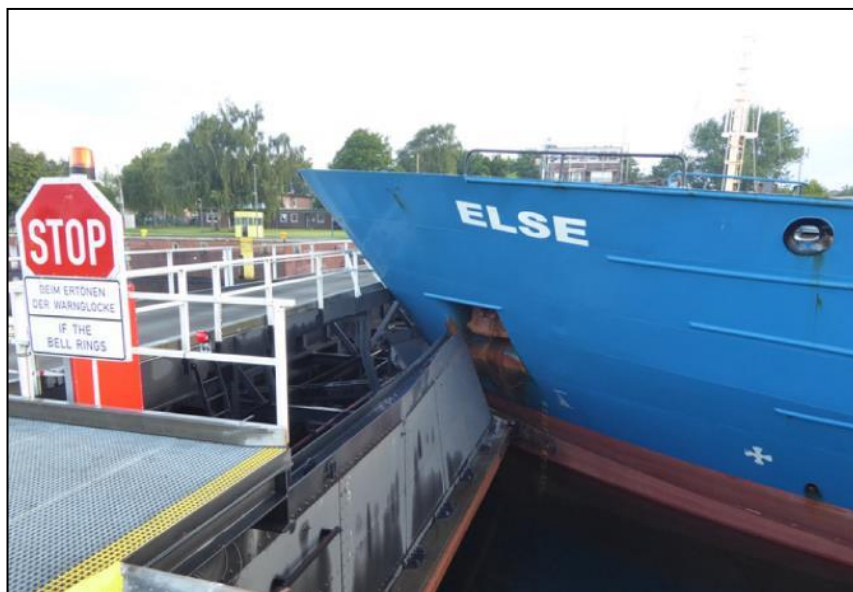
Figure 5: MV ELSE with her bow in the lock gate (2)

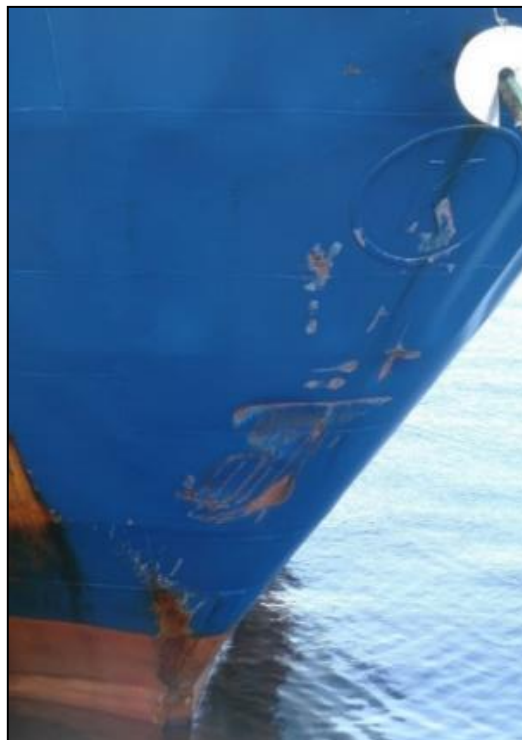
The ELSE suffered damage to the fore section during the allision between her bow and the lock gate. Damage above the waterline was confined to paint abrasions and small dents in the shell plating (see **Figure 6** below). There was a roughly 180 m long and 0.40 m wide crack in the forepeak below the waterline. The ballast tank located there (capacity: 88 t) thus flooded with seawater (quantity: about 60 t) up to the waterline.²² This damage did not result in a significant reduction in the ship's buoyancy or stability. No pollutants escaped.

Figure 6: Damage to the MV ELSE's bow above the waterline

Divers carried out an examination there and detected a hole in the ship's forepeak tank. The corresponding repair necessitated dry-docking but since the damage had not significantly impaired the ELSE's seaworthiness, the classification society issued an interim class certificate (so-called 'Interim Cargo Ship Safety Construction Certificate'). Subject to certain conditions listed in the certificate, it granted the ship permission to call at the French port of destination to unload her cargo there. The classification society also instructed the ELSE to call at a repair yard in Brest (France) immediately afterwards to have the damage to the forepeak repaired in dry dock.

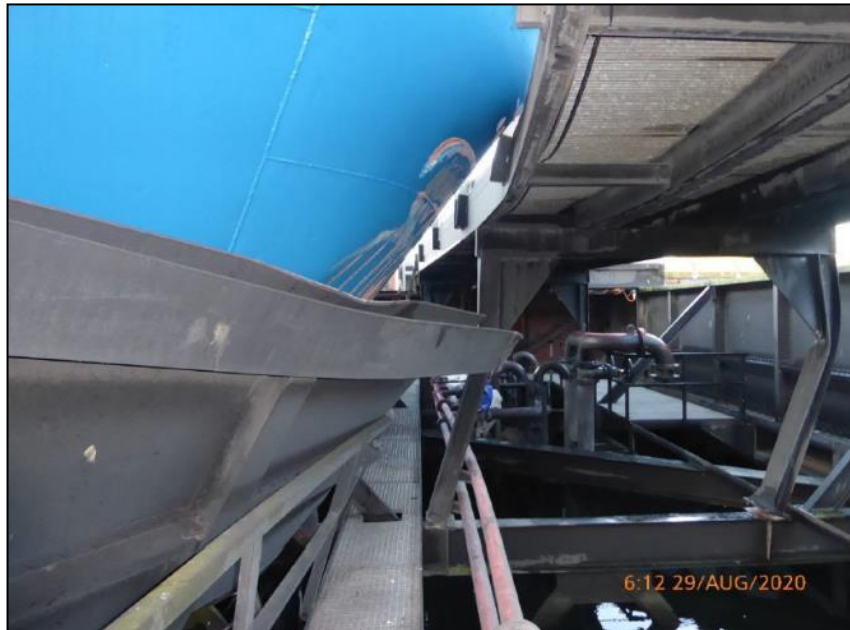
The fjord-facing sliding gate 3 of the north chamber of the 'Neue Schleuse' lock, which was fully closed at the time of the accident, was severely deformed by the impact of the ELSE's bow. The ship's bulbous bow pushed forward about 2 m to the tank deck of the gate, damaging the gate's structure and the steel girders in the area of the accident (see **Figures 7 ff.** below) in the process. The gate had to be dismantled for extensive repairs and replaced by a spare one.

Figure 7: Damage to the lock gate (close-up 1)²³

VTS NOK took the lock's north chamber out of service and the south chamber was used for incoming and outgoing NOK traffic in the days that followed. The damaged gate was dismantled and replaced by a spare one.

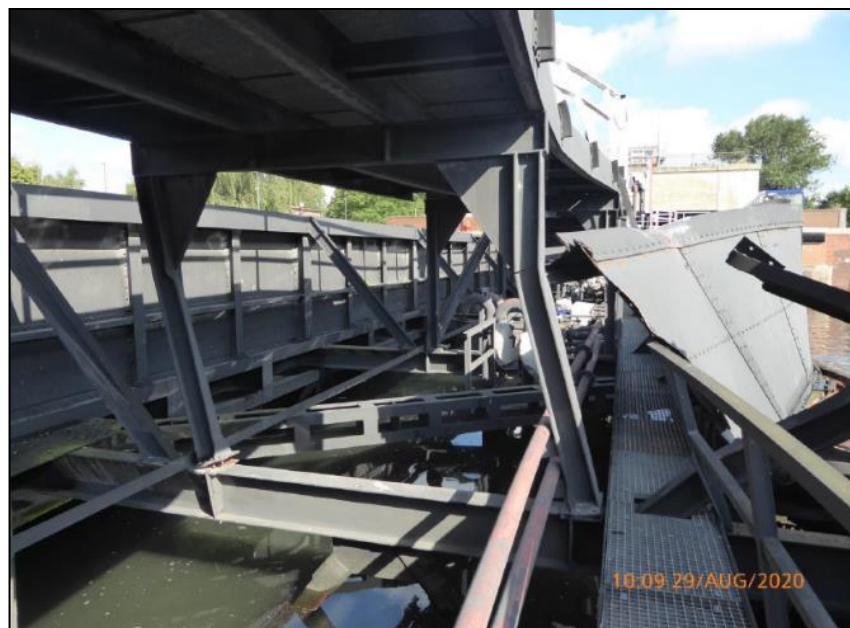
Figure 8: Damage to the lock gate (close-up 2)

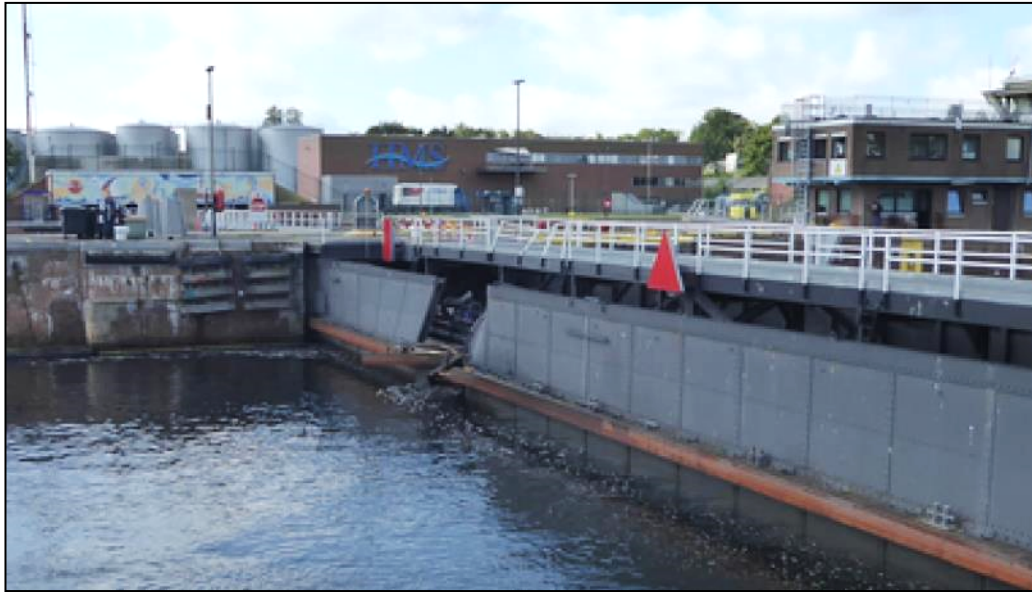
Figure 9: Damage to the lock gate (general view)²⁴

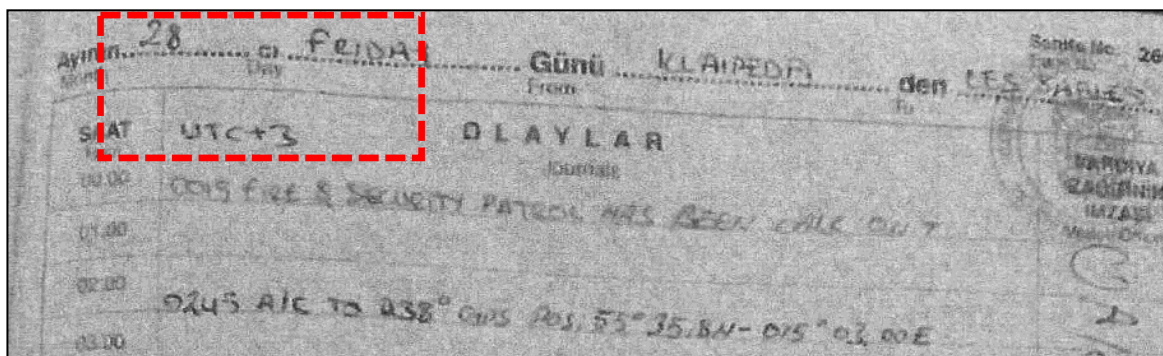
A review of the entries in the ELSE's deck log book confirmed the suspicion that ship time, which originally corresponded to local time in Klaipėda, had not been adjusted since they left the port of departure. In the log entry for 28 August, "UTC + 3" is still noted as the time on board (see **Figure 22**).

Figure 22: Extract from the MV ELSE's deck log book, 28 August 2020

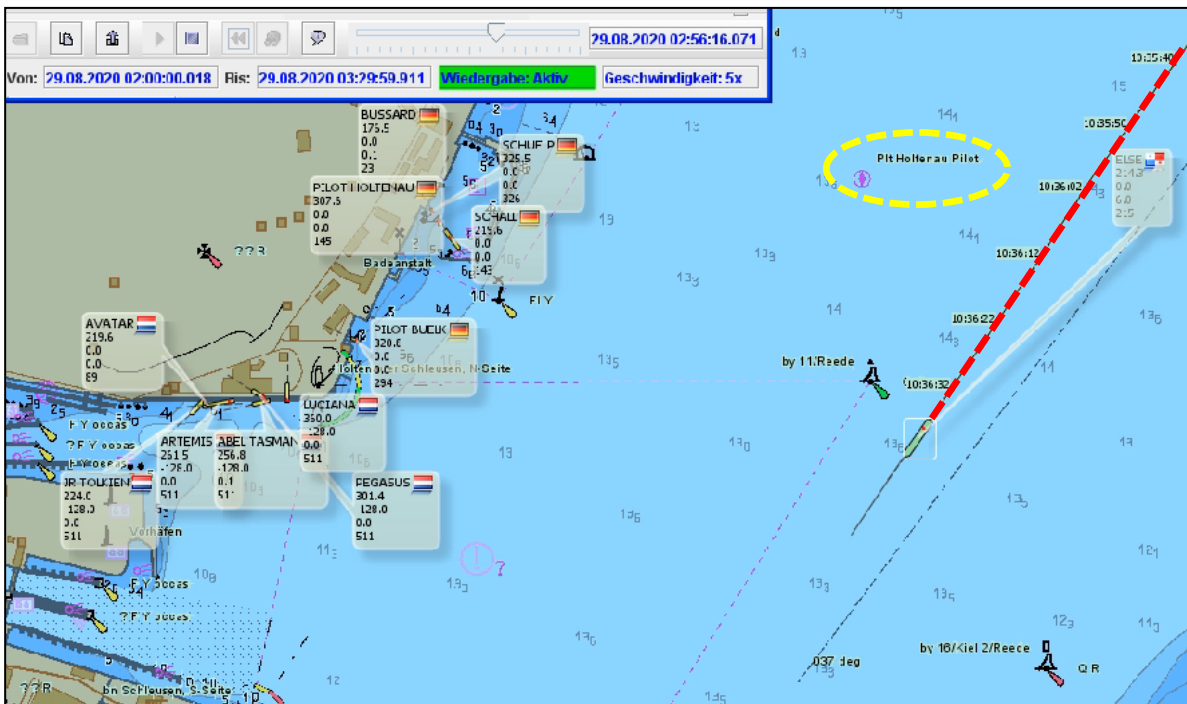
The ship then passed the Holtenau roadstead on the starboard side without any further course alterations but then passed the pilot boarding point marked on the navigational chart at about **0453** without reducing speed (see **Figure 27** below).

Figure 27: The ELSE sails past the pilot boarding point (track here until 0456)

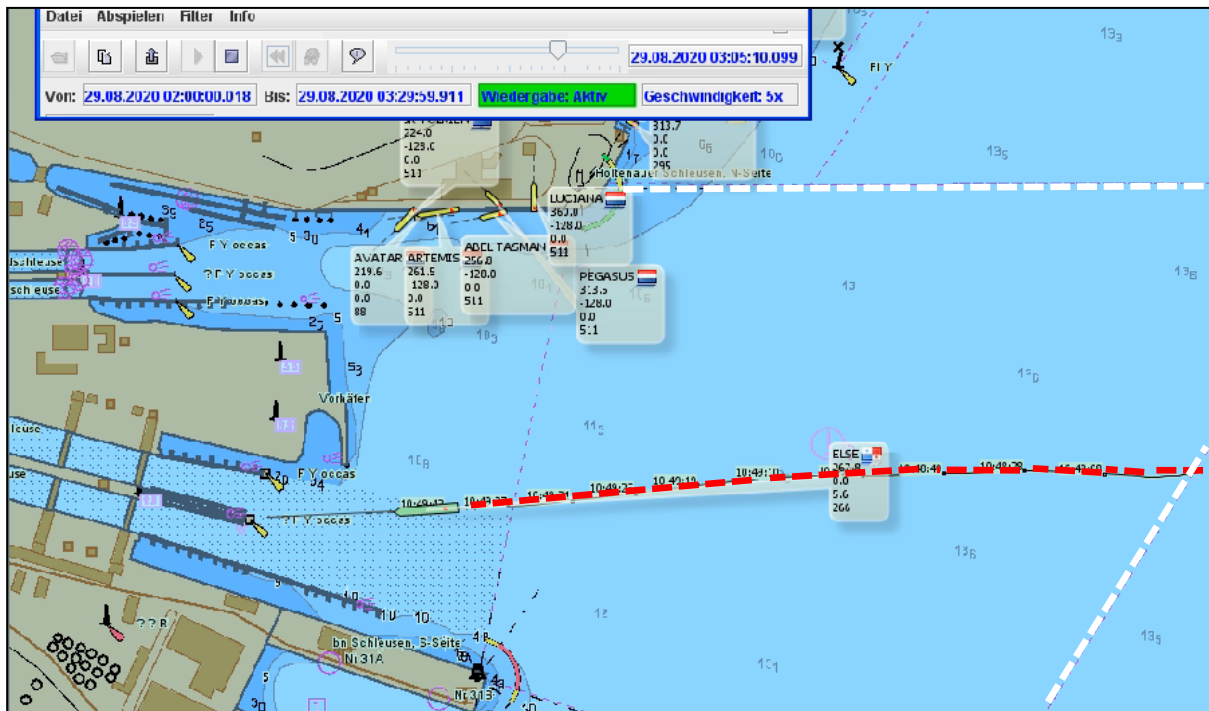
Shortly afterwards (from about **045630**), the ship began to make a continuous course alteration to starboard, turning into VTS NOK's area of responsibility at about **0458** (see white boundary marking in **Figures 28 ff.**). The ELSE then maintained a more or less constant course (or rather even with minor course adjustments and at an unchanged speed) directly towards the entrance to the north chamber of the 'Neue Schleuse' lock. She inevitably sailed into the closed lock gate at **0507** (see **Figures 29 f.**).

Figure 29: The ELSE approaches the lock chamber without any reduction in speed (track here until 0505)

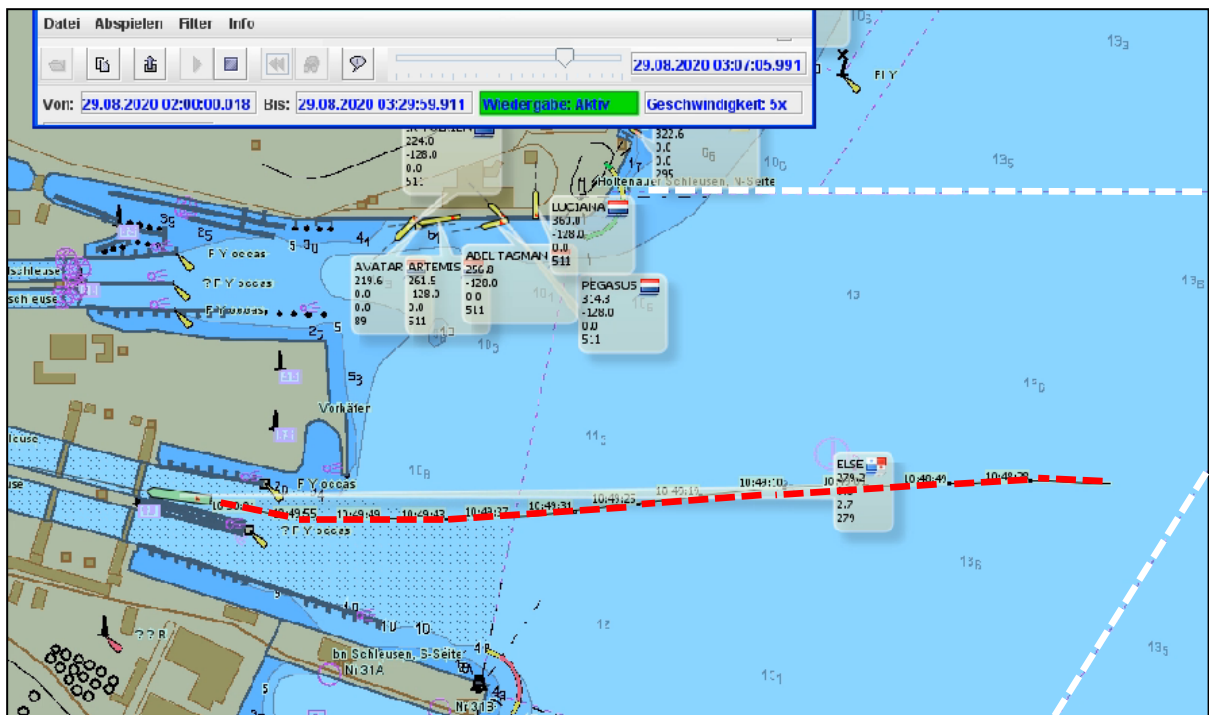
Figure 30: The ELSE just before the collision with the lock gate (0507)

The AIS recordings imply that the ELSE reduced speed immediately before the collision with the lock gate, i.e. an emergency stop manoeuvre was presumably made on board. This is probably why the gate was not breached but rather absorbed the energy of the impact and thus brought the ship to a standstill.

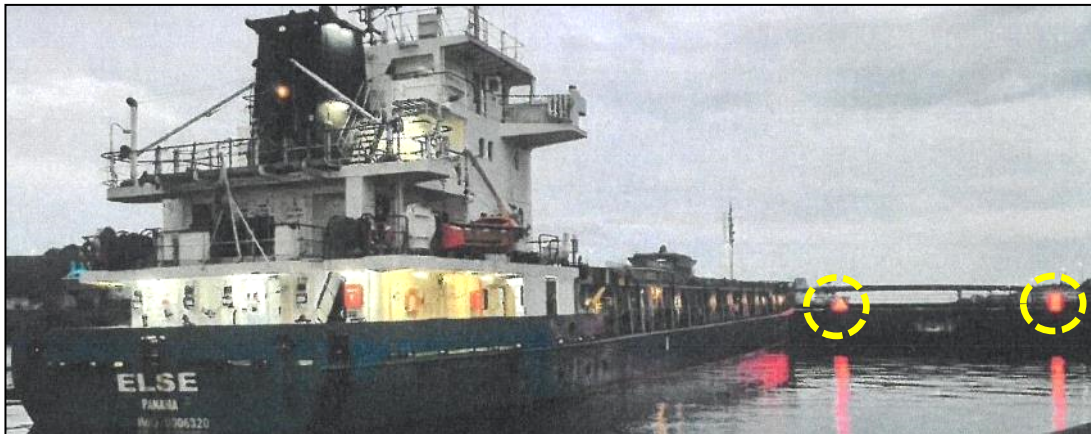
In addition to the traffic control signal installations, three large red warning lamps are mounted on the upper edge of the respective lock gate on its right-hand side, in the middle and on the left-hand side (left and right in the form of a rectangle in vertical format and in the middle in the form of a triangle; see **Figures 41 f.**). This warning system informs ship's commands and pilots clearly and unambiguously that the lock gate is closed if, for example, the above-mentioned signal installations have failed and/or the closed gate's contours cannot be clearly identified in the dark or due to other visual restrictions.

Figure 41: MV ELSE in front of the closed lock gate (red illuminating warning lamps visible)⁶⁸
