Bundesstelle für Seeunfalluntersuchung
Federal Bureau of Maritime Casualty Investigation

Investigation Report 301/21

Foundering of the fishing vessel RAMONA in the mouth of the River Elbe on 21 September 2021

20 December 2022

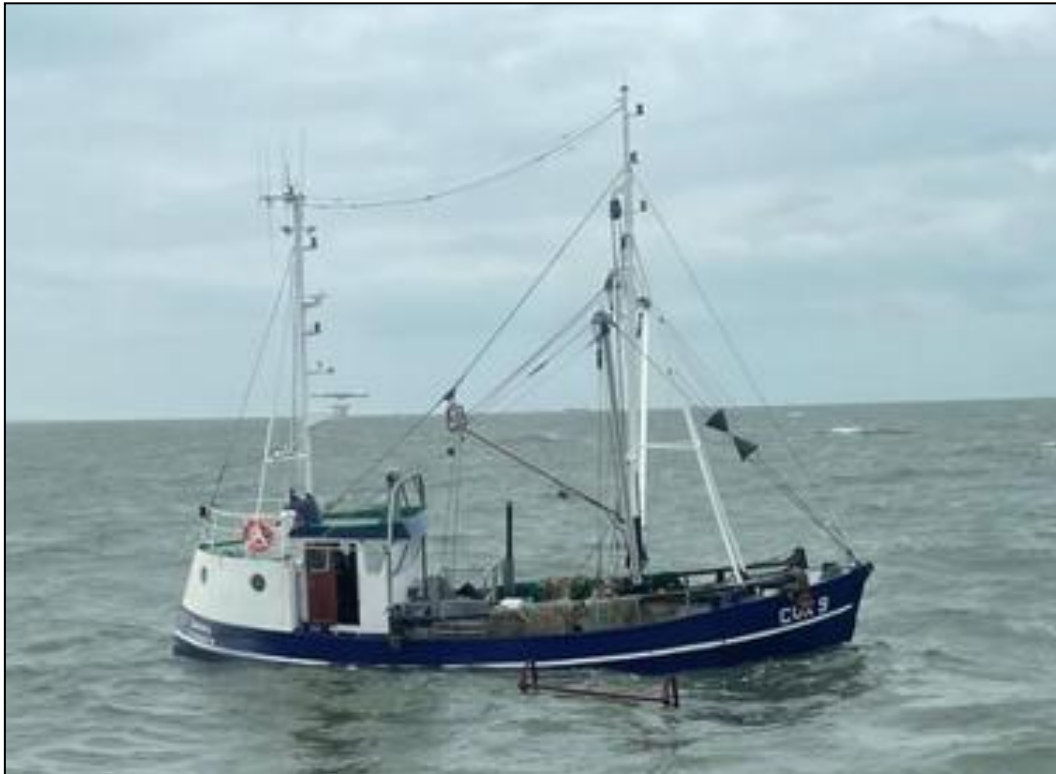
Figure 1: RAMONA already in the process of foundering.²

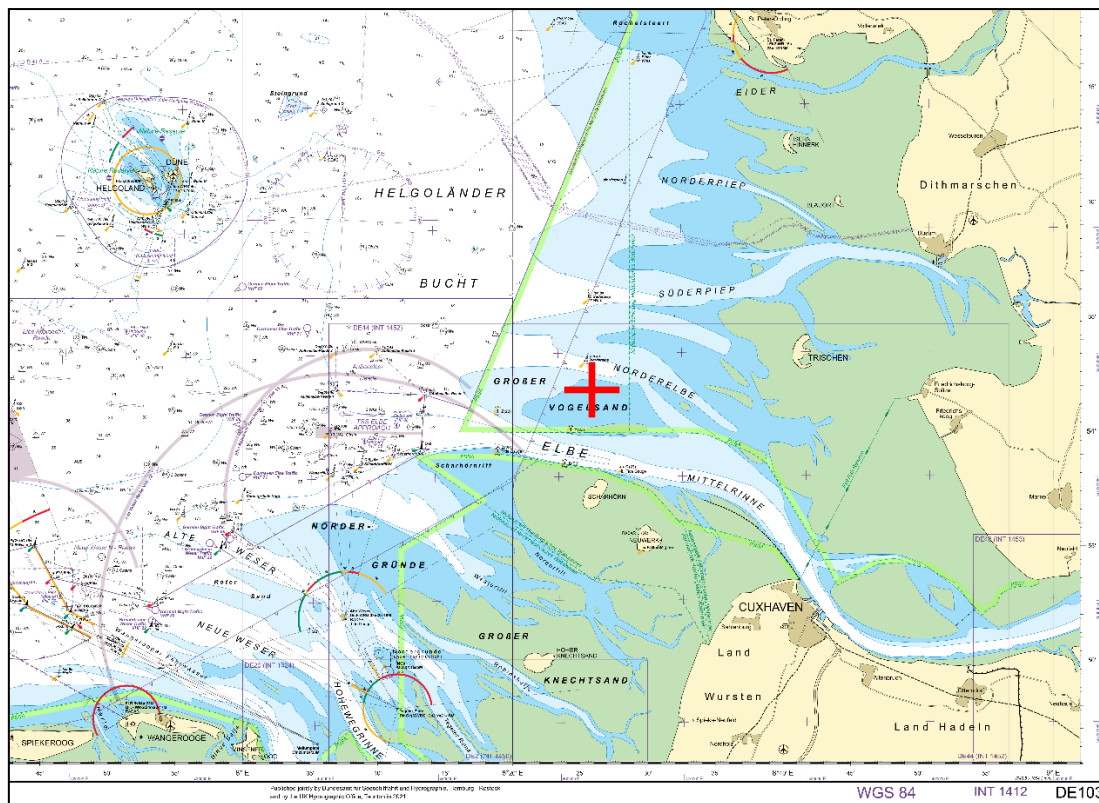
Figure 2: Scene of the accident

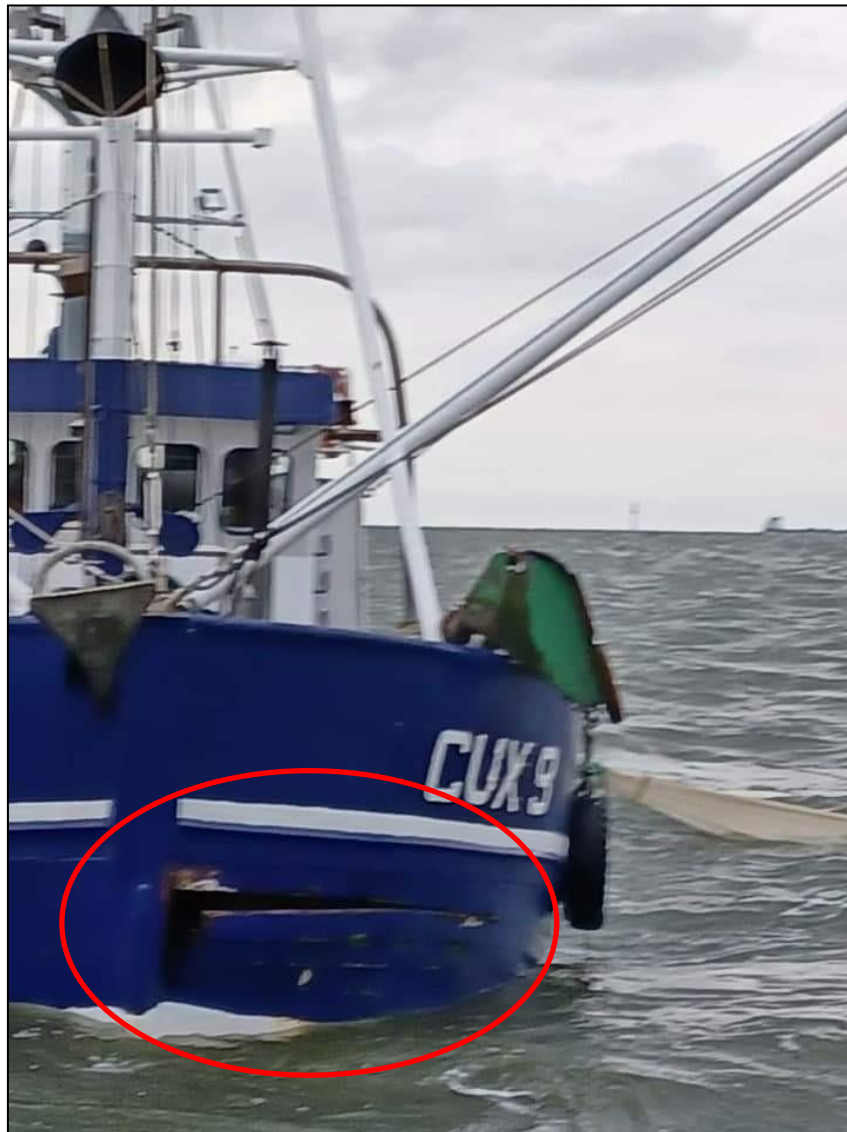
Figure 3 shows the protruding planks on the bow of the RAMONA. The image is unfortunately not available in better quality but the BSU is nonetheless grateful to the crew of the rescue cruiser ANNELIESE KRAMER for having the presence of mind to take photographs during this emergency. Accordingly, pointers as to the cause of the accident were at least available for the investigation.

Figure 3: Loose planks at the bow of the RAMONA⁴

Due to the total loss of the fishing vessel, the BSU was unable to determine the cause of the damage that occurred. It appears likely that there must have been a barely noticeable collision with an obstacle in the water, which caused the planks on the bow to loosen, followed by rapid and heavy water ingress. It seems rather improbable that the RAMONA struck an obstacle while casting off in Cuxhaven such that she remained afloat for another three hours with the unnoticed damage. However, it is possible that a minor allision occurred when she cast off, causing the planks at the bow to loosen almost unnoticeably and then continue to loosen more and more over the hours that followed due to the swell, until the water ingress became so heavy that it was noticeable.

Despite the fortuitous reality that the DGzRS took photographs of the distressed fishing vessel, the one photograph that actually shows the damage on the bow is so blurred that it is impossible to draw any conclusions from it. Inconspicuous flecks of a different colour can be seen on the loose planks, which look like minor damage and paint abrasions and could thus point to an allision. However, these flecks of colour may have been caused by other influences that are not connected with the accident under investigation. Since evidence of either possibility could not be found, the cause of the accident must ultimately remain open due to the lack of other findings.

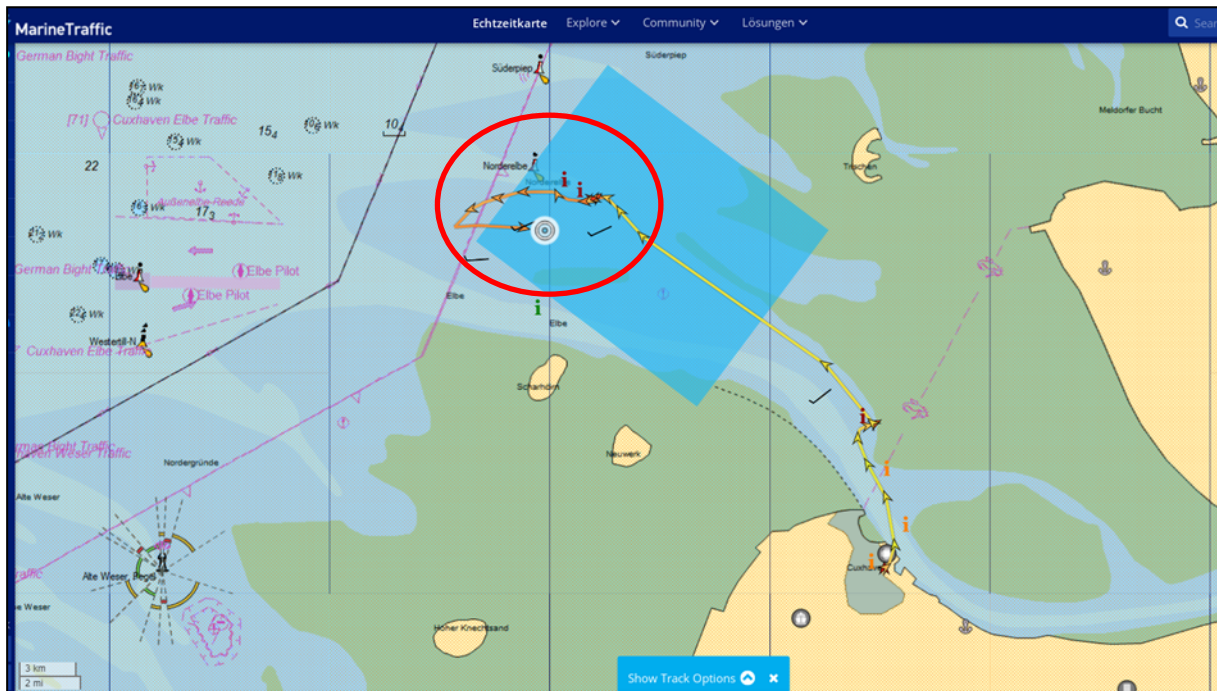
Figure 4 below shows the course of the vessel's voyage recorded by the MarineTraffic AIS portal. The voyage begins at about 0530 in the morning with the departure from the port of Cuxhaven and ends with the last AIS signal at 1008. The rescue cruiser

Figure 4: Course of the RAMONA's voyage and scene of the accident⁵

None of the five people on board the fishing vessel was able to explain how the damage to the bow occurred. In particular, no collision with a buoy or other floating object such as a partially submerged container was observed. The recorded AIS track confirms there was no encounter with a buoy. WSA Elbe-Nordsee stated that there was reportedly no knowledge of any floating containers at the time of the accident.
