**Bundesstelle für Seeunfalluntersuchung**  
**Federal Bureau of Maritime Casualty Investigation**

## **Interim Investigation Report 138/22**

### **Very Serious Marine Casualty**

**Person Over Board Resulting in Fatality  
on Board the Sailing Yacht SPEEDY GO  
on the Flensburg Firth on 8 April 2022**

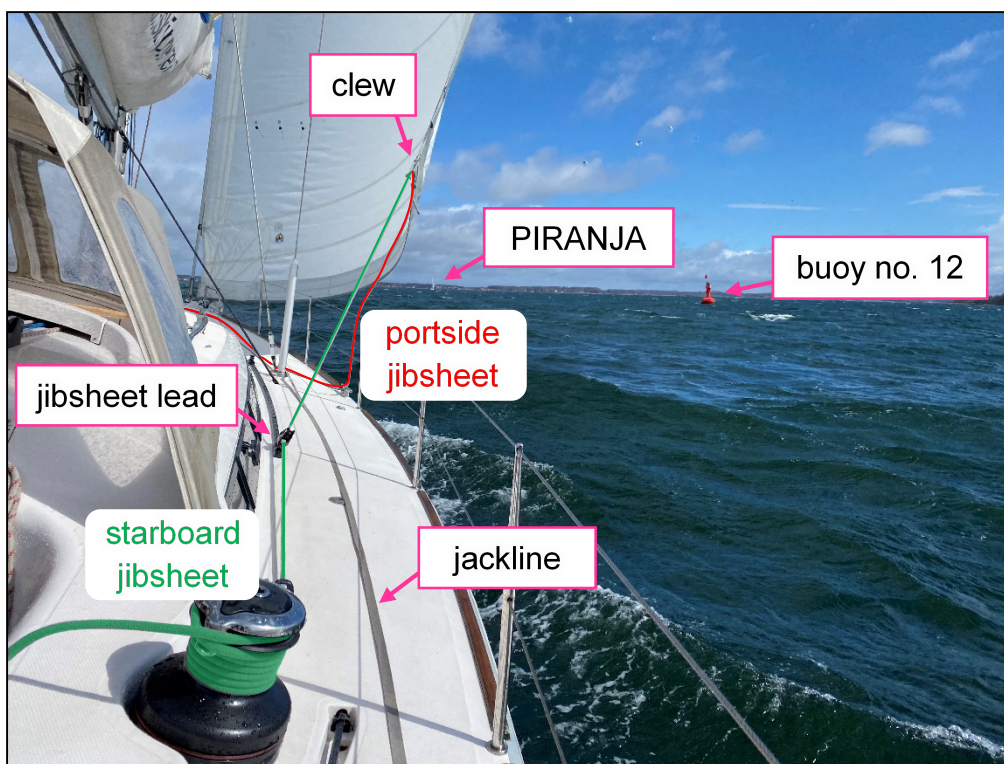
Figure 4: View ahead at 12:06<sup>14</sup>

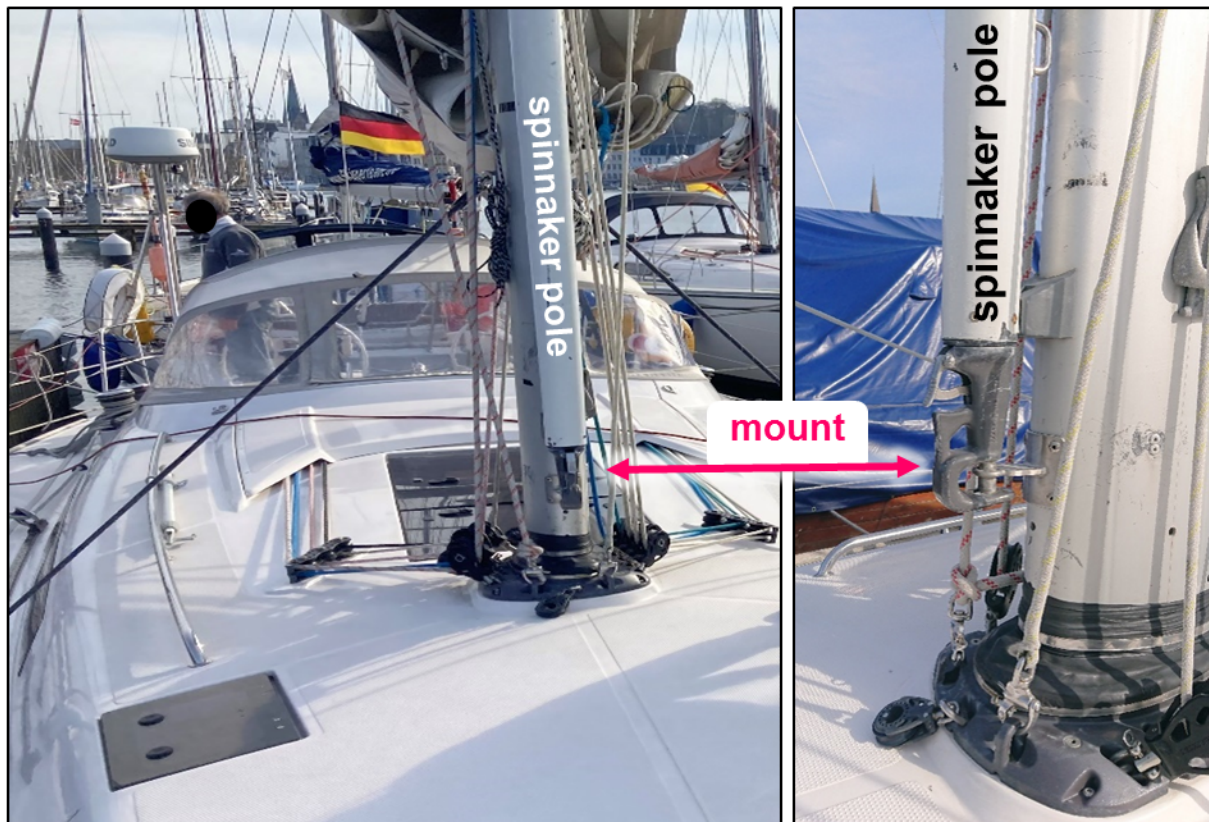
During the manoeuvre, the sheets of the foresail became entangled underneath the end mount of the spinnaker pole<sup>16</sup>, which was stored at the mast:

Figure 5: Spinnaker pole attached to the mast where the sheet became entangled<sup>17</sup>

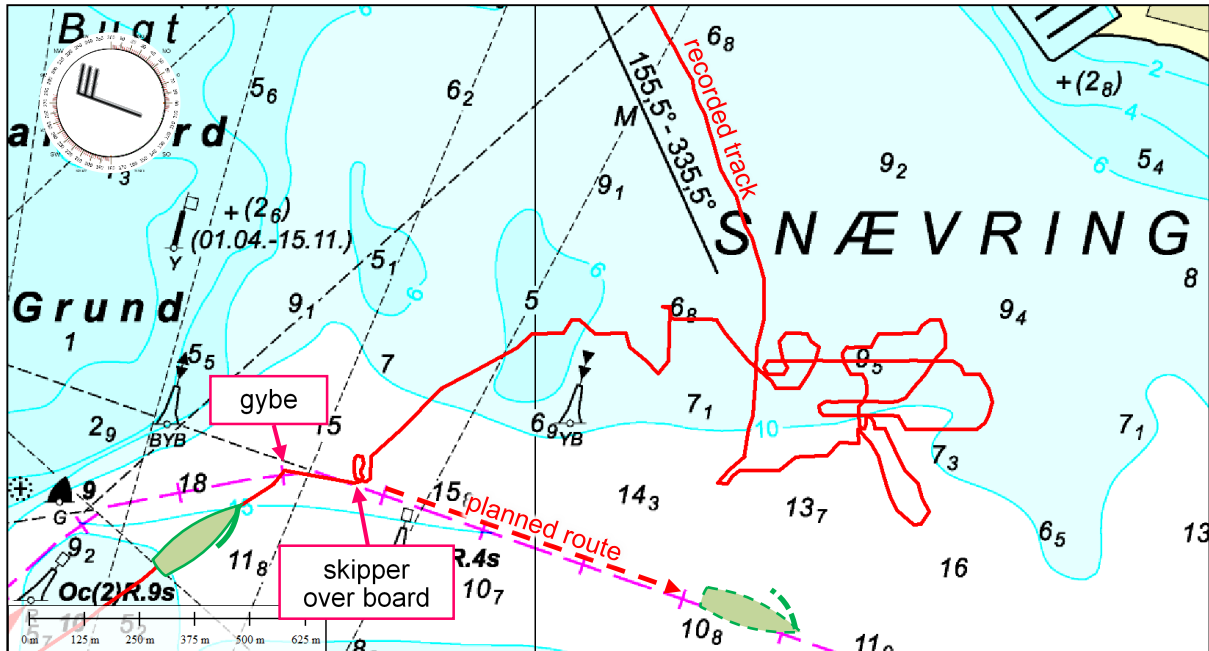
Figure 6: SPEEDY GO's track<sup>19</sup>

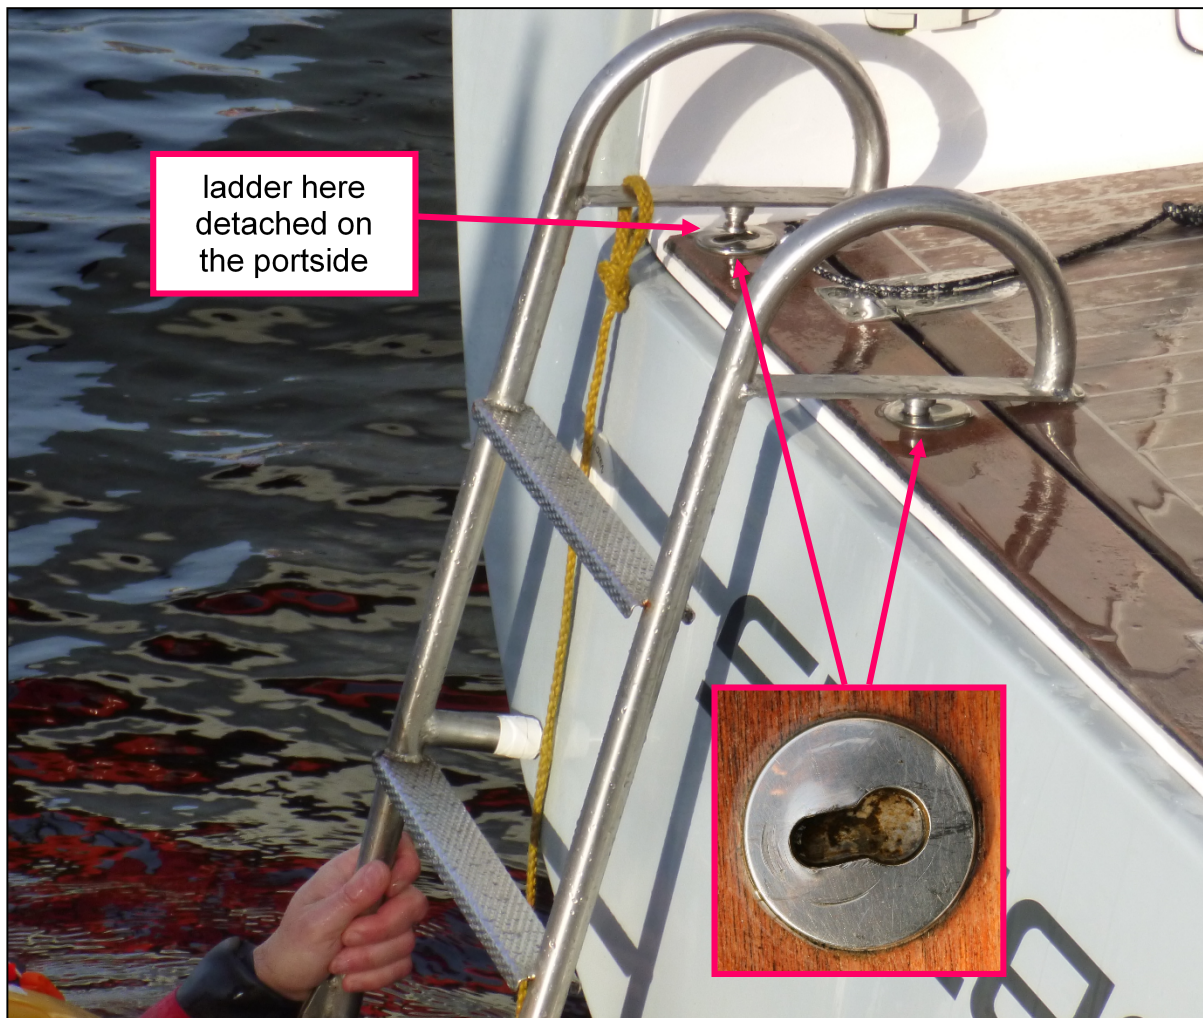
During the rescue attempts, the swimming ladder had to be constantly held in place, as it kept lifting out of its intended mount on deck and had to be pushed backwards to hold it inside the slotted hole (cf. Figure 12). The skipper's face was repeatedly several centimetres under water before he resurfaced.

Figure 12: Swimming ladder (replica) SPEEDY GO<sup>25</sup>

To fix it in place, the swimming ladder was inserted into the fitting and then pushed sternwards. The ladder shown here is a replica that was manufactured immediately after the accident.

The swimming ladder first detached on one side and then on both sides altogether, went overboard and sank instantly. The skipper and his fellow sailor in the water immediately drifted off the boat several metres in different directions.
