Interim Investigation Report No. 380/22

Very serious marine casualty

**Fatal occupational accident on board the bulk carrier
PETER OLDENDORFF in the port of Mukran
on 3 August 2022**

2 August 2023

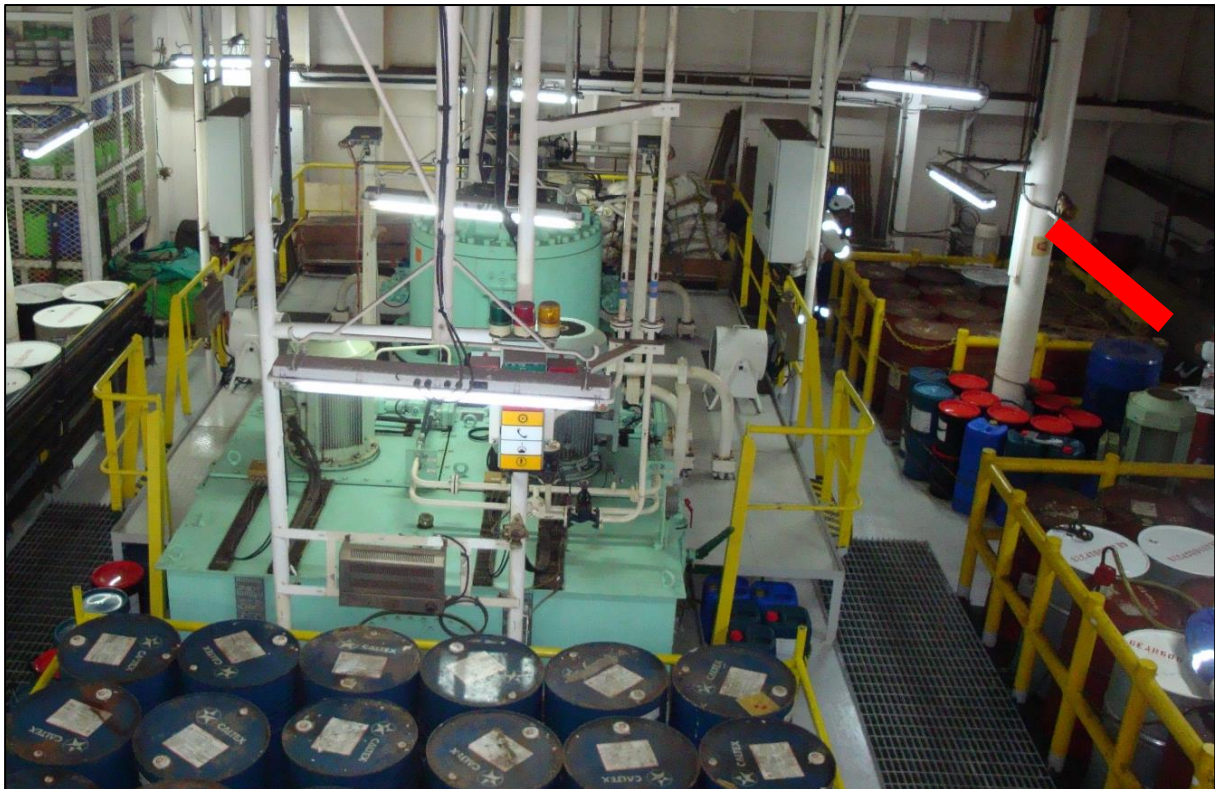
The required steel plate was located in a vertically "stacked" plate stock in a corner of the steering gear room (cf. regarding the location of the stack the red marking in the upper right corner of **Fig. 3**).

Figure 3: Steering gear room (Site of the steel plates marked red)

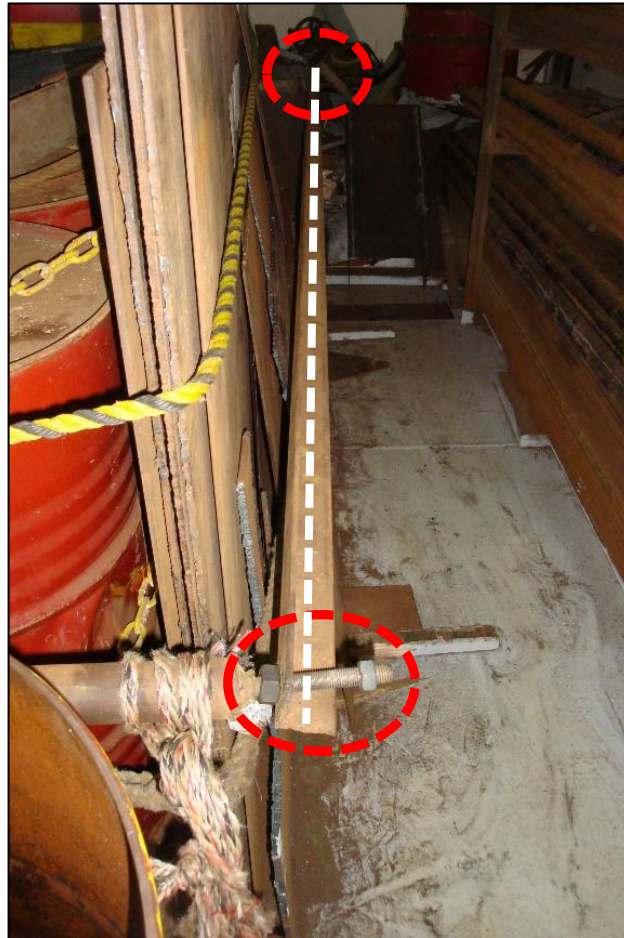
The pile consisting of differently dimensioned plates is secured against tipping over in a height of about 80 cm by a steel cross strut (L-section). The cross strut is held at both ends by a threaded rod and locked by nuts (see white and red markings in **Fig. 4**).

Figure 4: Stack of plates⁴ secured by a steel cross strut

⁴ Note: The black and yellow rope visible in the photo was tensioned during the reconstruction of the accident and is not normally part of the plate safety system.

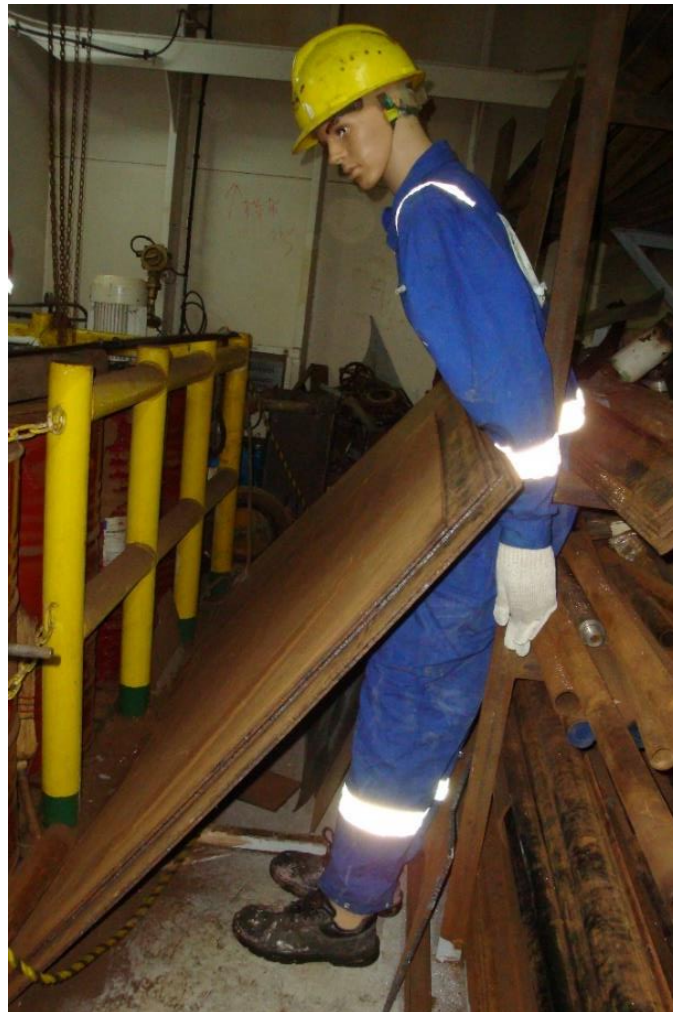
Figure 5: Reconstruction of the accident with a dummy

It became clear that, after the cross strut securing the stack of plates had been released, the stack could tip sideways with great force in a flash and without any particular cause. A person standing between the stack and the shelf mounted on the ship's side at the time in question will inevitably be trapped between the tilted plates and the shelf. Due to the great weight of each individual plate, there is subsequently hardly any realistic possibility for the accident victim to free himself from the situation described with his own strength or even to call for help with any prospect of success, insofar as he has not already lost consciousness or suffered fatal injuries as a result of the massive crushing.
