Bundesstelle für Seeunfalluntersuchung
Federal Bureau of Maritime Casualty Investigation

Interim Investigation Report 582/22

Serious Marine Casualty

**Allision of a mobile harbour crane, transported on
the heavy-lift vessel MERI, with two overhead bridge
constructions crossing the Kiel Canal
on 30 November 2022**

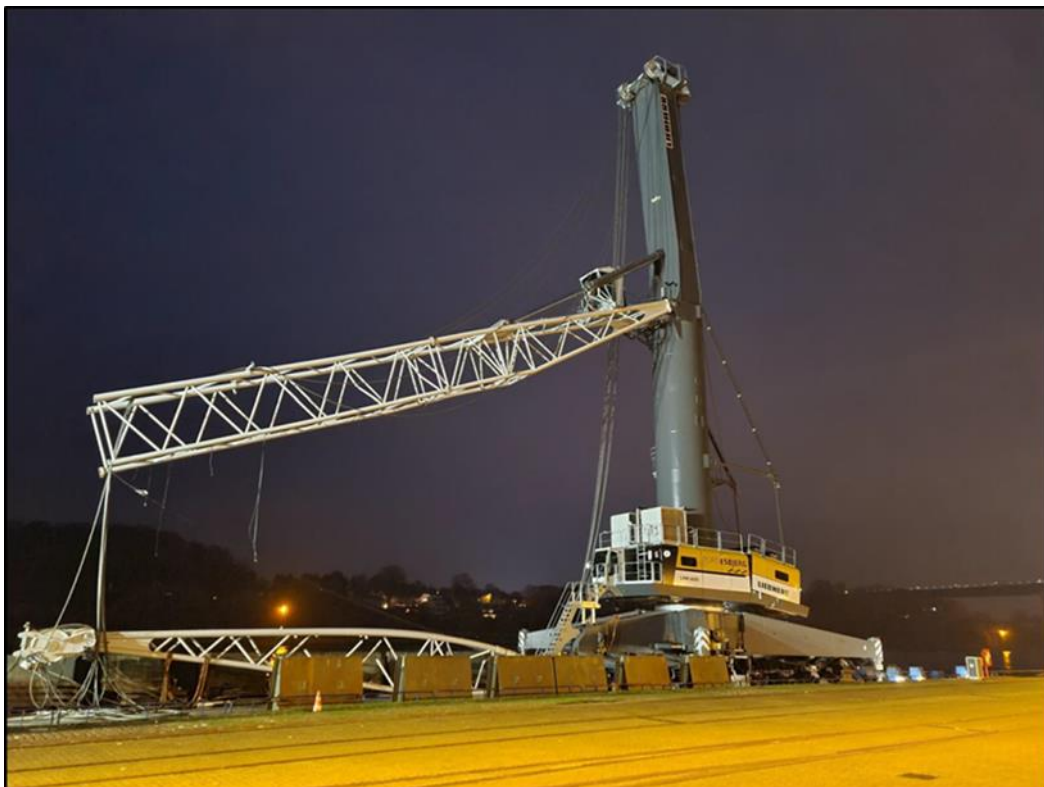
However, while passing the first overhead constructions on the Kiel Canal, the Holtenauer Hochbrücken, on 30 November 2022, the tower tip of the mobile harbour crane hit the box girders of both lanes of the bridges. The force of the impact broke the lashings securing the 643-tonne crane on deck. This caused the crane to tip so far backwards that it passed under both bridges. In the process, it lost 8 counterweights, 3 of which fell into the water. After passing the bridges, the crane fell forward again in both cases due to its center of gravity and crashed back onto the deck with its undercarriage and support plates. The crane was destroyed. The deck of the MERI was also affected, it was deformed and perforated in one place by the crane jib. The bridges sustained considerable damage. The bridges and the Kiel Canal were temporarily closed to all traffic. The repair work on the bridges could not be completed by the time this interim report was published. Motor vehicle traffic is therefore still impaired (see section 1.4).

Figure 2: General view of the crane with broken jib⁴

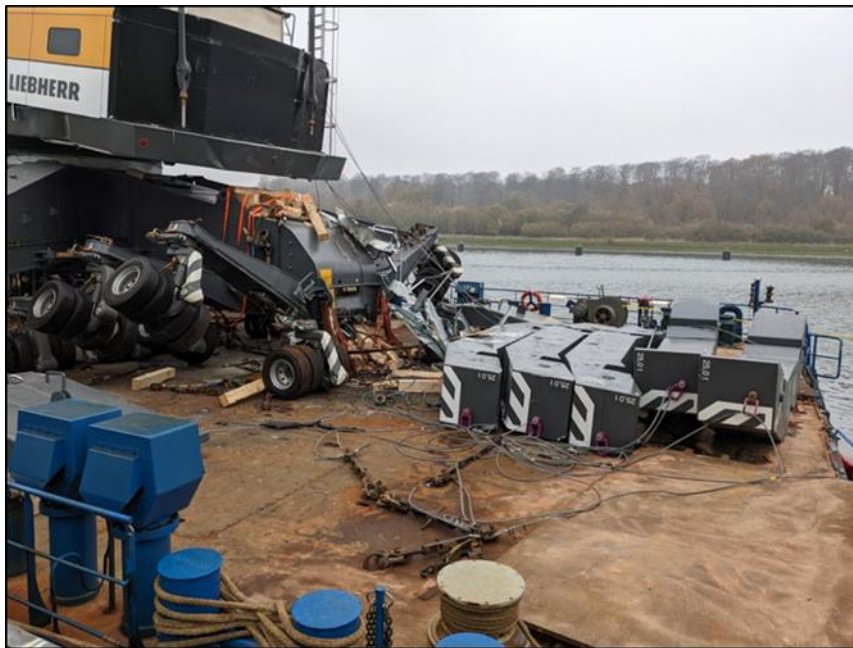
Figure 3: Fallen counterweights⁵

Part of the railing at the stern is missing, which - together with three counterweights - fell into the canal.
