Bundesstelle für Seeunfalluntersuchung
Federal Bureau of Maritime Casualty Investigation

Interim Investigation Report 600/22

Serious Marine Casualty

Grounding of the PARANA on the Ems on 9 December 2022

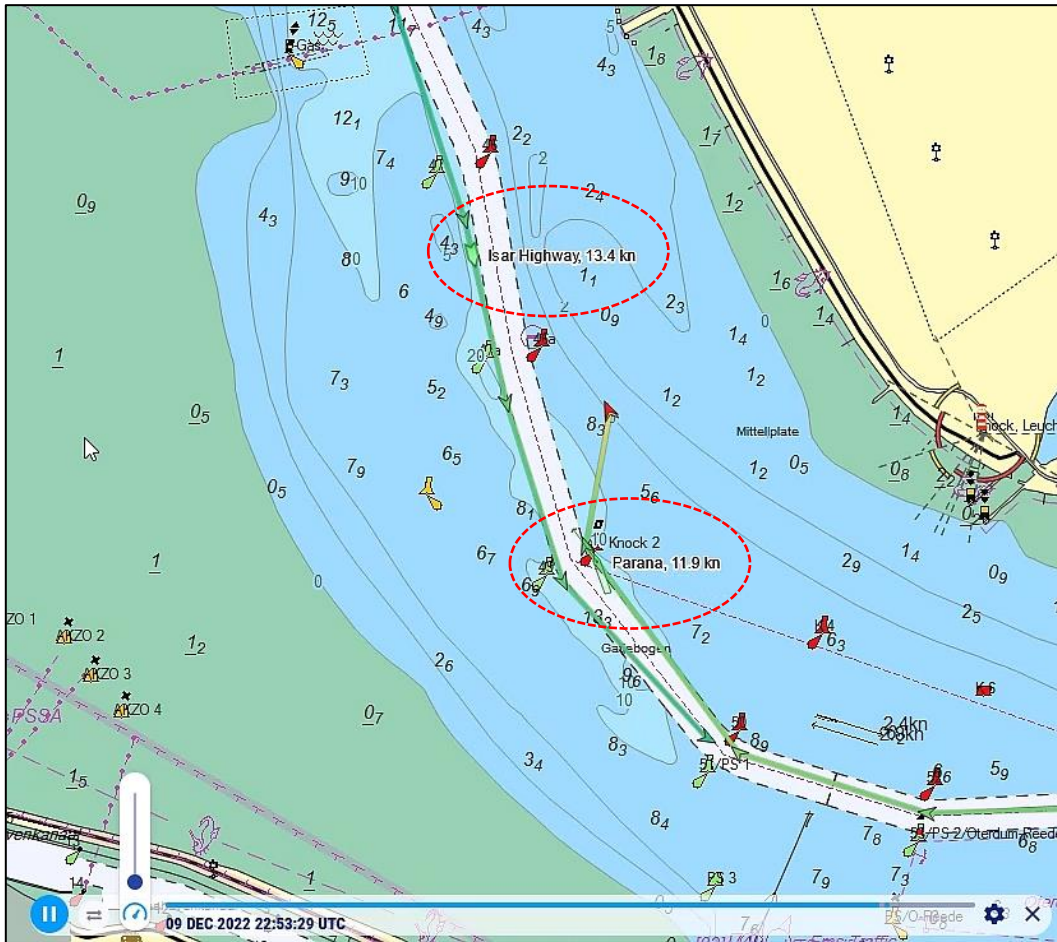
Figure 3: Screenshot at 23:53:29⁵

The passage of the oncoming ISAR HIGHWAY on the Ems was not affected by the PARANA. Figure 3 provides a rough overview of the encounter between the PARANA and ISAR HIGHWAY in the fairway of the Ems at 235329. At this point, the PARANA had buoy 48 / Knock 2 directly ahead. The distance between the vessels was about 0.75 nm.
