Bundesstelle für Seeunfalluntersuchung
Federal Bureau of Maritime Casualty Investigation

Interim Investigation Report 37/22

Grounding of MUMBAI MAERSK while entering the Weser fairway on 2 February 2022

1 February 2023

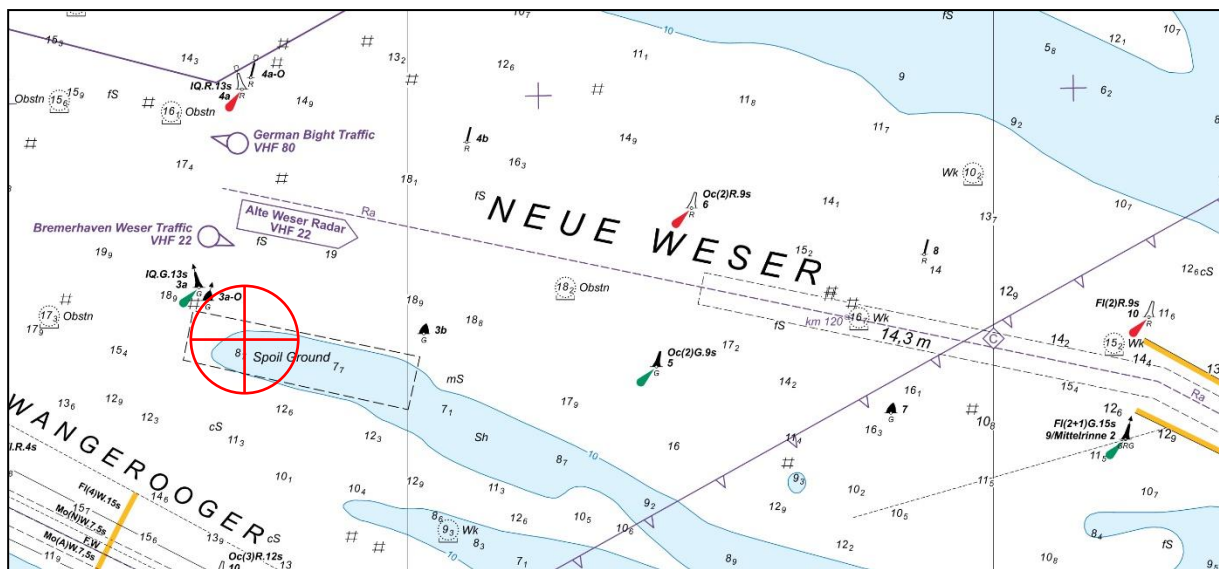
| Location: | A dumping ground for dredging silt in the North Sea (adjacent to the Weser fairway entry, approx. 3.5 nm north of the island of Wangerooge, south of the Weser buoys 3a and 3a-O) |

Figure 2: Scene of the accident, “Neue Weser” fairway entry.

Less than half an hour later, the MUMBAI MAERSK was informed that she could now enter Bremerhaven after all. With the tide window threatening to close, the ship immediately turned back to her original course. The planned manoeuvre failed, however, and the MUMBAI MAERSK ran aground on a dumping ground for dredging silt just south of the fairway.
