**Bundesstelle für Seeunfalluntersuchung**  
Federal Bureau of Maritime Casualty Investigation

## **Investigation Report 138/22**

**Person Over Board Resulting in Fatality  
on Board the Sailing Yacht SPEEDY GO  
on the Flensburg Firth on 8 April 2022**

1 June 2023

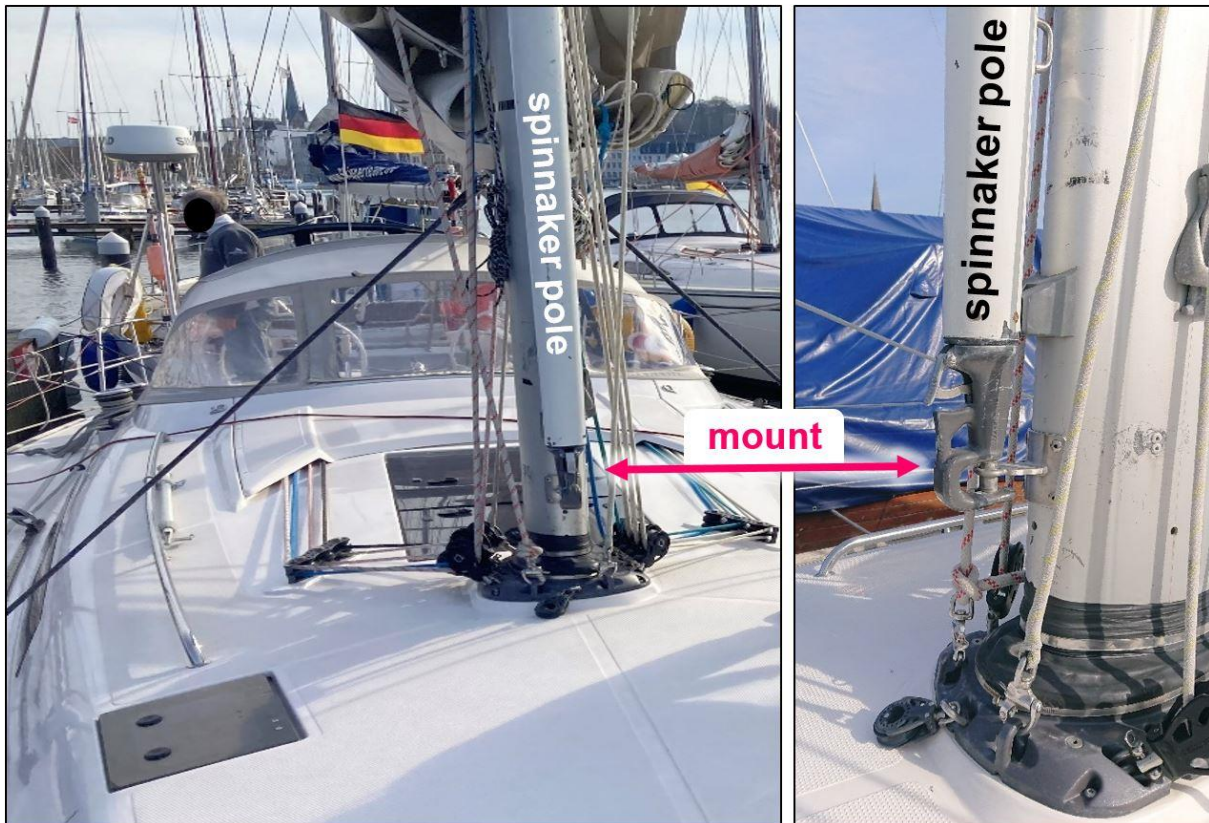
During the manoeuvre, the headsail sheets became entangled underneath the end mount of the spinnaker pole<sup>21</sup>, which was stored at the mast:

Figure 5: Spinnaker pole attached to mast – where the sheet became entangled<sup>22</sup>

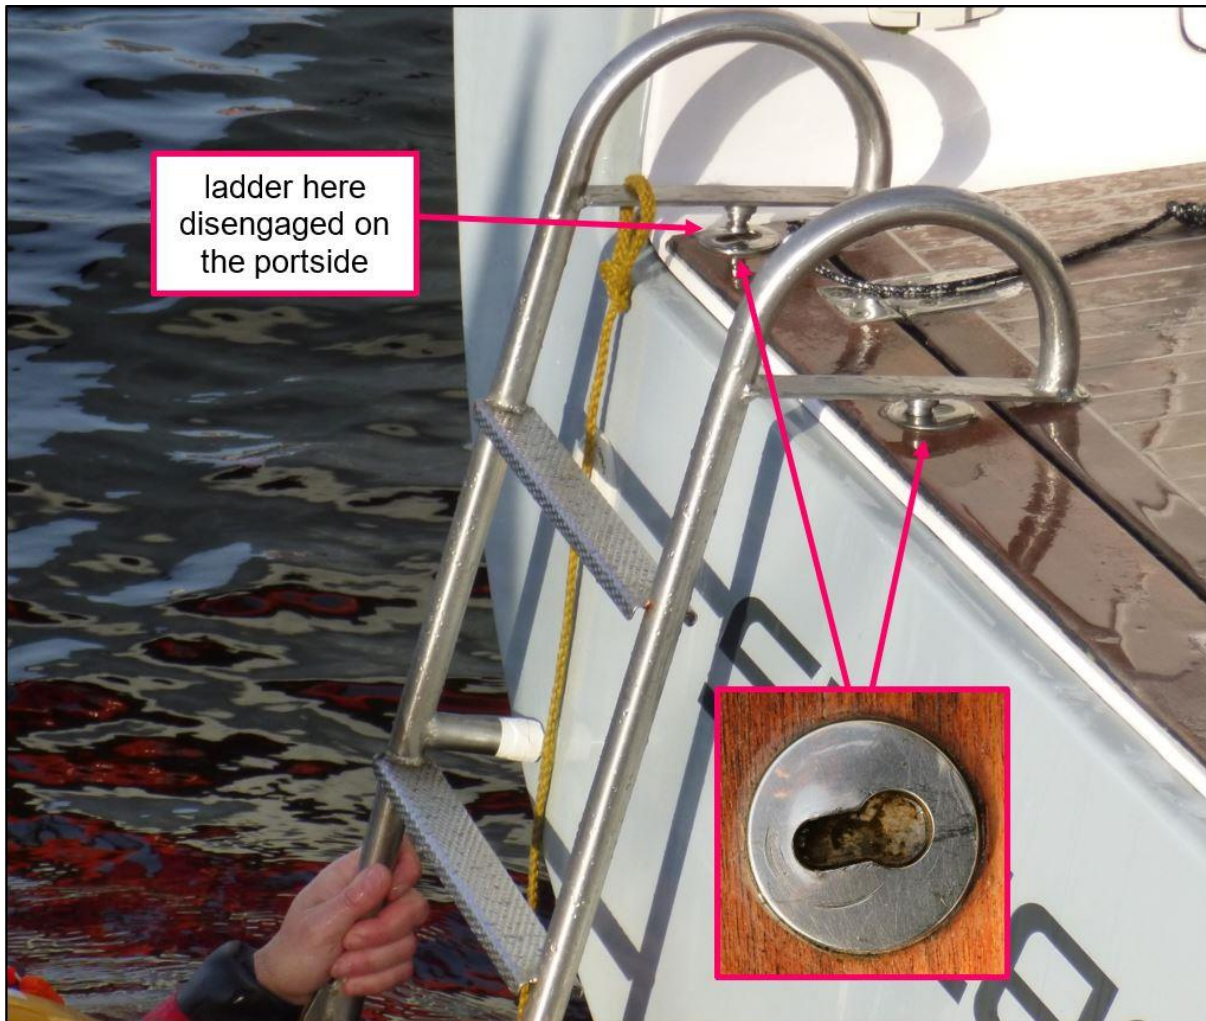
Figure 12: Bathing ladder (reconstruction) SPEEDY GO<sup>32</sup>

To fix the bathing ladder in place, it was inserted into the fitting and then pushed backwards. The ladder shown here is a reconstruction that was manufactured immediately after the accident.

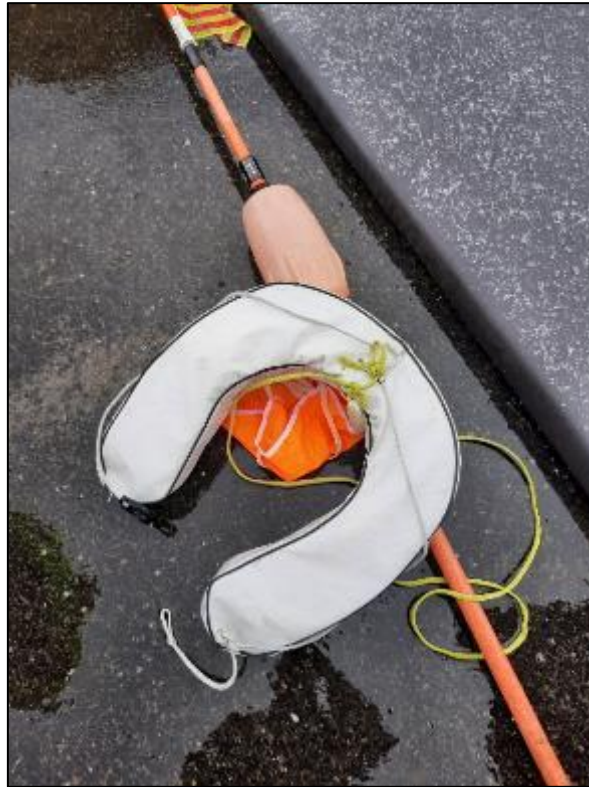
At 1500, the ALSIN sailed out of Egersund to search for the casualty's lifejacket, which had been spotted by the rescue helicopter, for the Danish police. Contrary to the assumption of the rescue services, it was not a lifejacket but rather the horseshoe lifebuoy connected to the POB marker buoy. The ALSIN found the lifebuoy and marker buoy in the water at about 1530 and took them to Egersund. After the police had inspected them there, both were returned to the co-sailors of the SPEEDY GO.

Figure 15: Rescue equipment of the SPEEDY GO secured by the ALSIN in the fjord<sup>35</sup>

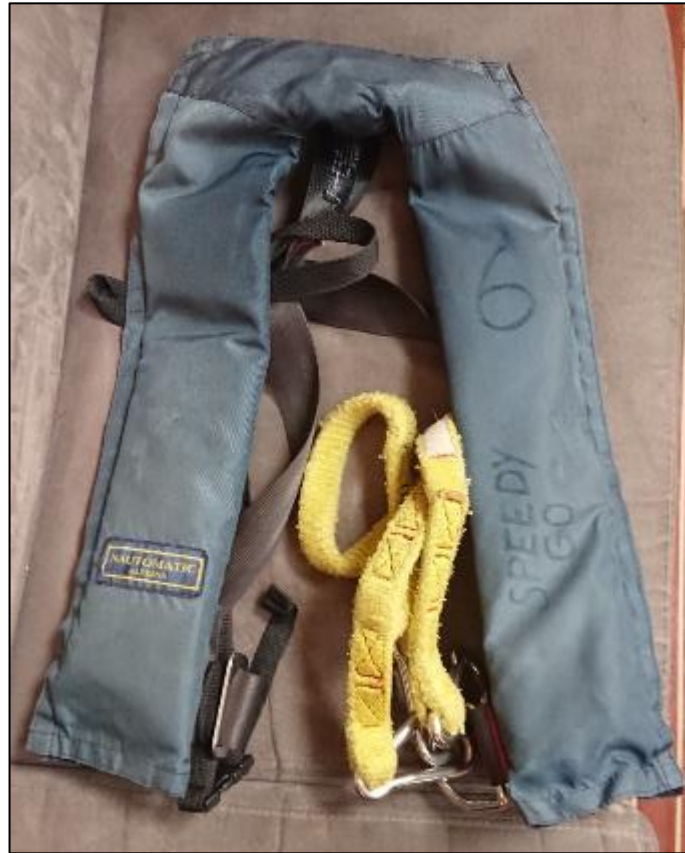
Figure 19: Vessel's own lifejacket no. 6 with lifeline<sup>84</sup>

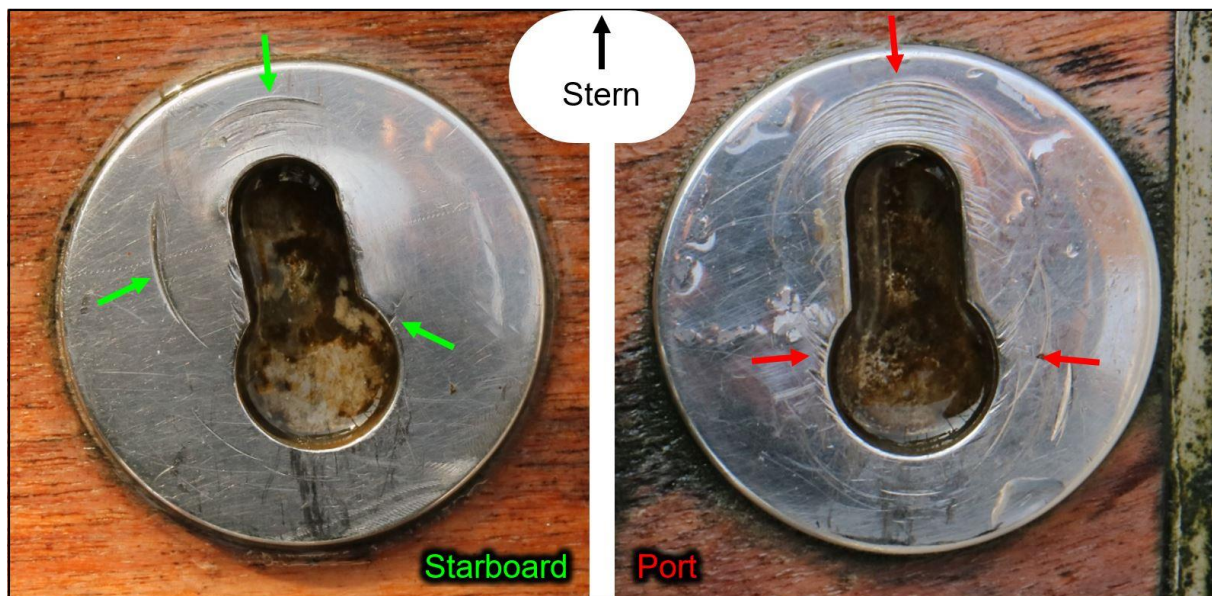
An enquiry made with the SPEEDY GO's shipyard revealed that the bathing ladder supplied with the yacht could be secured on each side with knurled thumb screws to prevent it from slipping out of the deck fittings. This information coincides with the findings of an earlier investigation by the BSU into the very serious marine casualty involving the sailing yacht SPECIAL ONE (Ref.: 143/11. Yacht type: Salona 45) in 2011. Moreover, scratch marks indicating that the bathing ladder was not only inserted but also secured with knurled thumb screws in the past are clearly visible on the deck fittings of the SPEEDY GO (see Figure 22):

Figure 22: Deck fittings/mounting points for the bathing ladder at the stern of the SPEEDY GO<sup>89</sup>

The scratch marks on the port-side fitting indicate that the knurled thumb screw did not always hold the bathing ladder securely in the fitting's elongated hole.

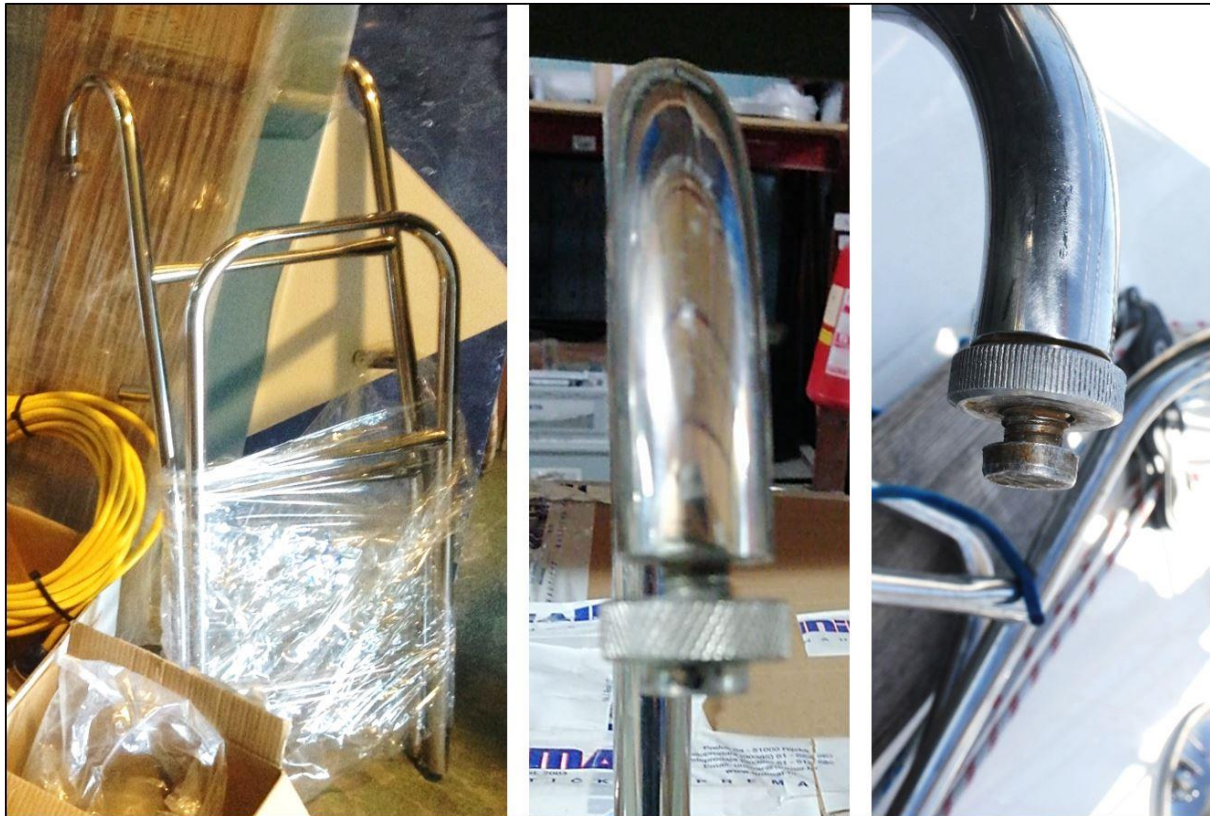
Figure 23: Original bathing ladders of Salona Yachts

Left: Original bathing ladder of the SPEEDY GO; taken on 10 October 2014.<sup>90</sup>

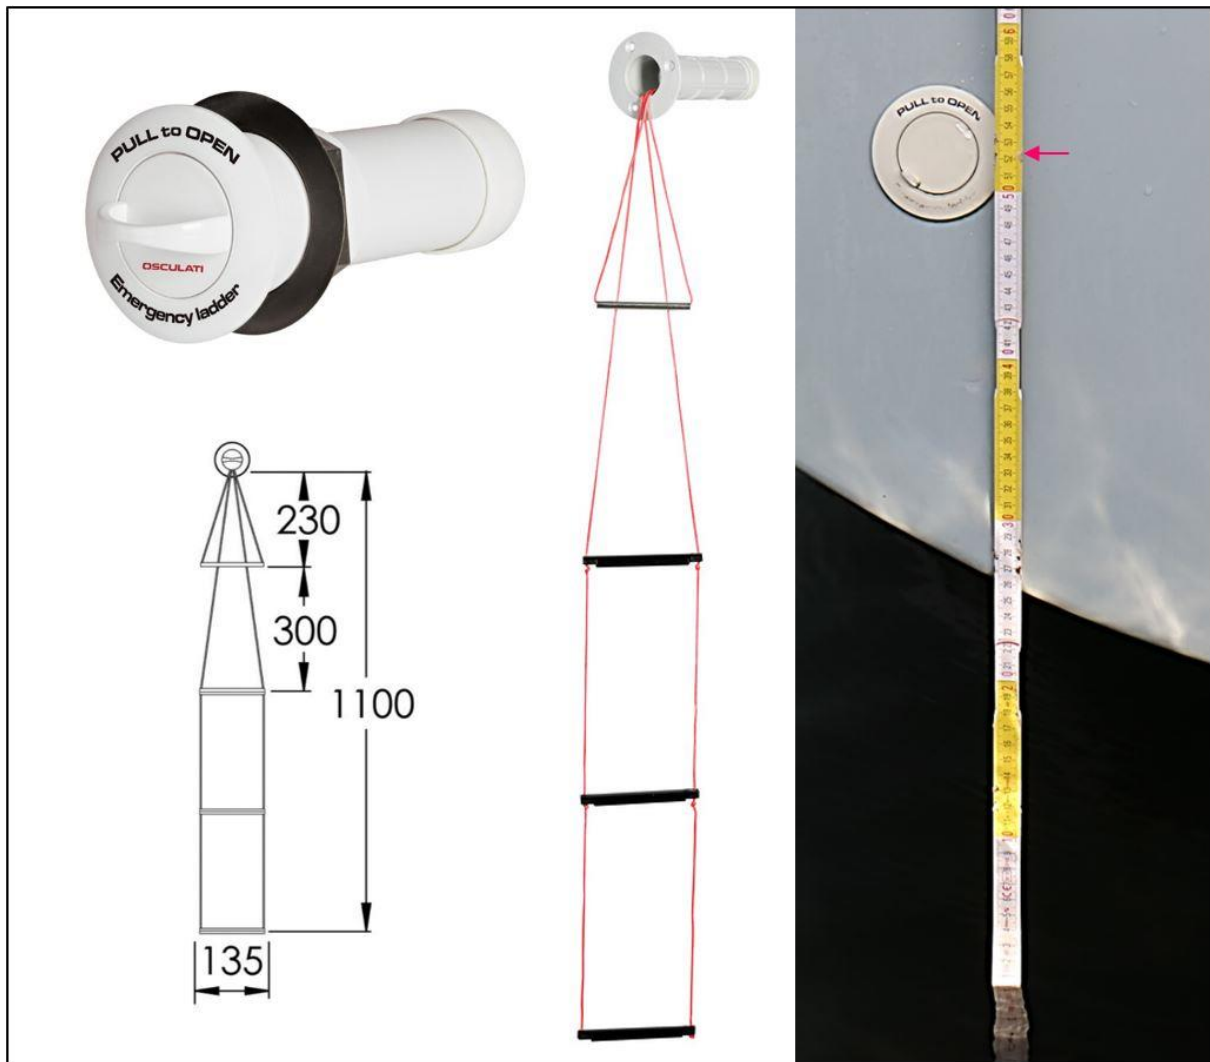
Figure 24: Dimensions of the SPEEDY GO's emergency ladder<sup>92</sup>

The handle of the emergency ladder inserted into the yacht's transom is about 52 cm and the highest point of the actual ladder about 50 cm above the water surface. Since the ladder's length is 1.10 m, it reaches about 60 cm below the surface of the water. The plastic handle for pulling out the ladder at the stern of the SPEEDY GO (see top right Figure 24) had broken off on an unknown date and possibly before the marine casualty investigated here. Accordingly, the emergency ladder could not be tested on 26 October 2022 during the series of rescue tests in Flensburg (see 3.2.12).
